## **Cataloged Observed Patterns of Failure**

## **US 90 Henderson Point—No Vertical Restraint (if bond breaker used on dowels)**

## I-10 Twin Spans—Broken Connections

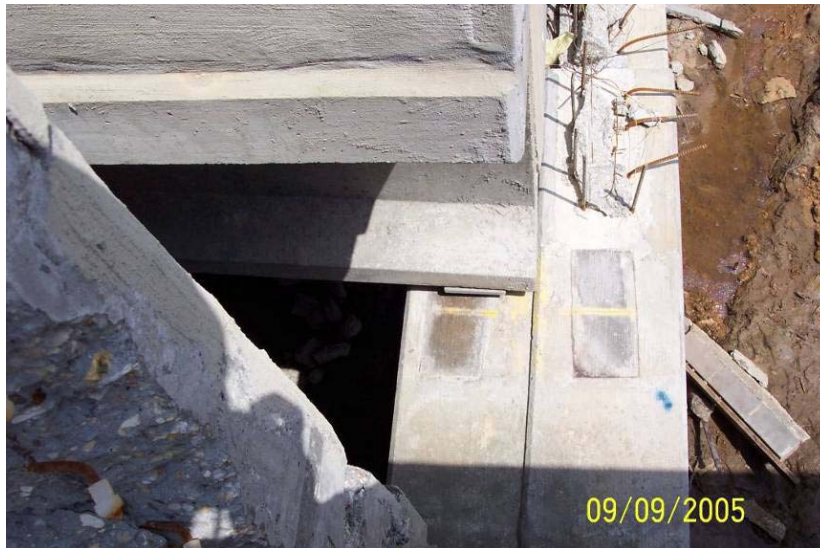
- Dowel bars still intact (not sheared)
- Some dowels bent (from beams landing on them)
- Others still upright (at edge, where span moved away from them)
- Dowels in fixed diaphragm are double leg #5's at 12" (See bridge plan sheets 16 to 19, and 23)
- Some States use bond breakers between the steel dowel bars and the diaphragm concrete to enable jacking of the beams for bearing replacement and other maintenance
- No bond breaker details given in plans
- Do dowel bars provide any vertical restraint?

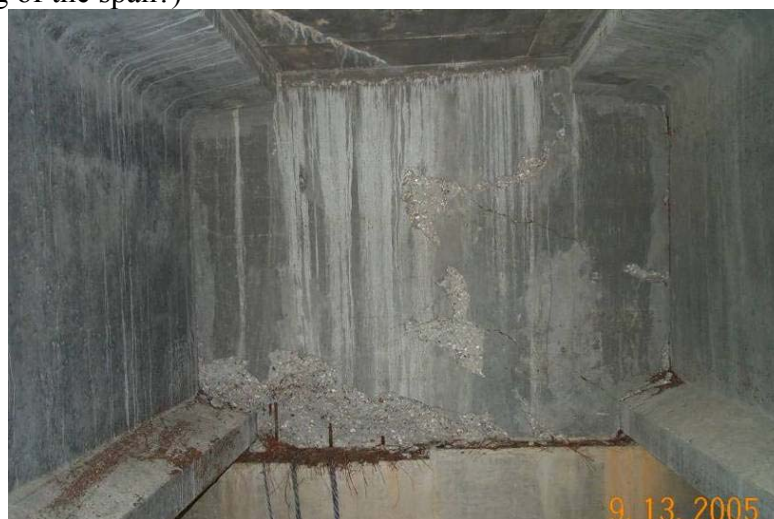
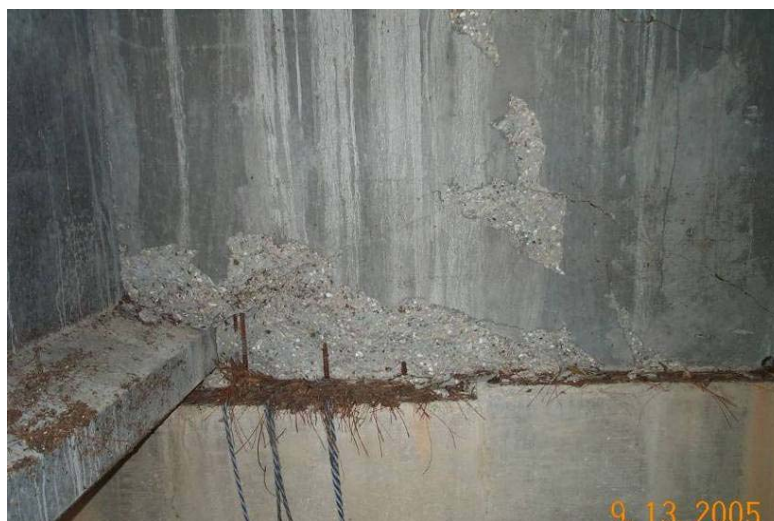
- Concrete in end diaphragm is damaged (due to rotation of span about fixed end or dropping of the span?)

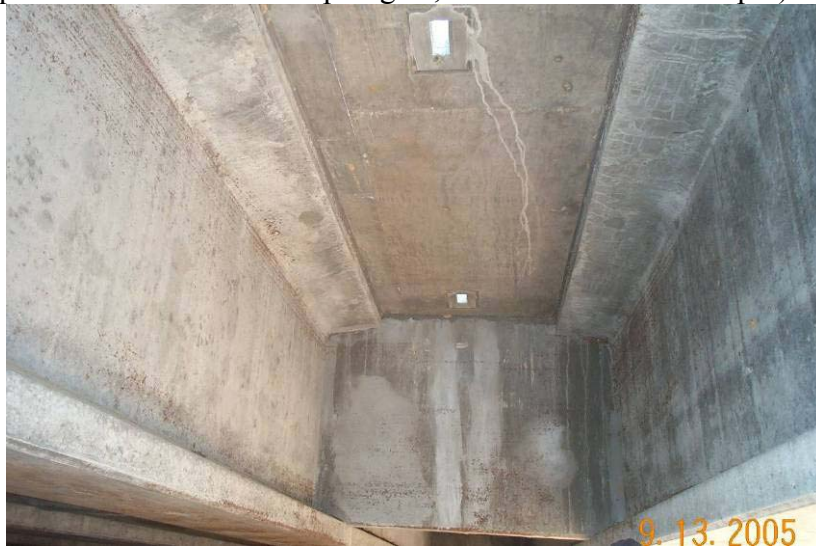
- Change in elevation along the length of the dislodged span was about 2.85', or about 1' of elevation change between successive diaphragms
- Higher end has about 5'6" average airspace height, two other air pockets have about 5'0" average air space height. (full depth end diaphragm allows more air to be trapped than intermediate diaphragms, which were not full depth)

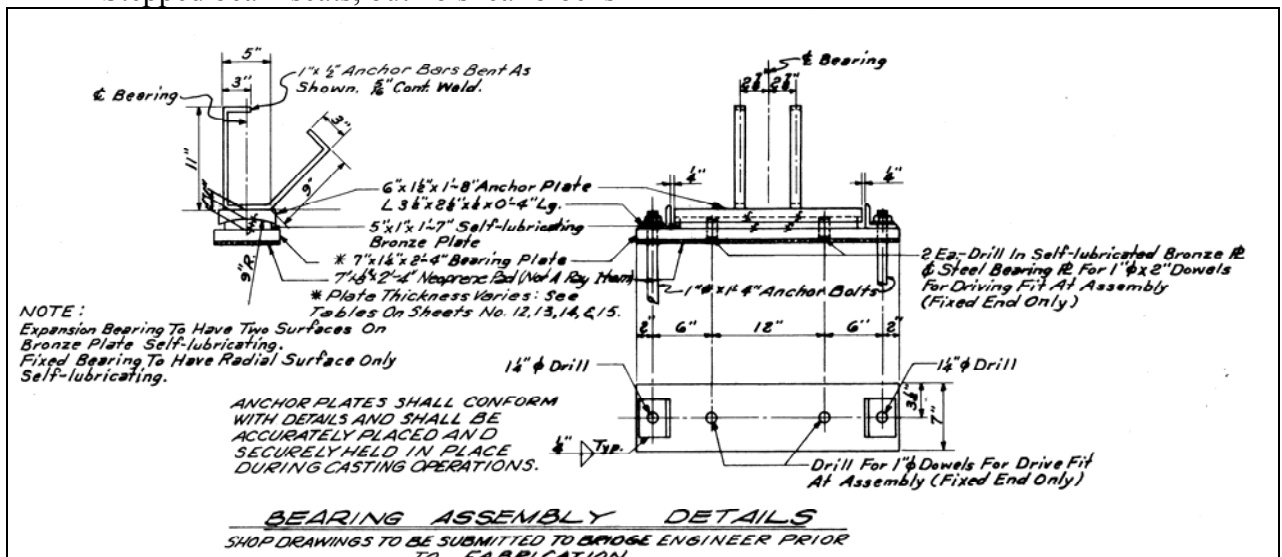
- Bronze bearings used (Bridge plans, sheet 19)
- No positive connection between beams and pier cap (uplift not resisted)
- Small angles used to restrain transverse movement of bronze bearings (2 1/2" high)
- Stepped beam seats, but no shear blocks

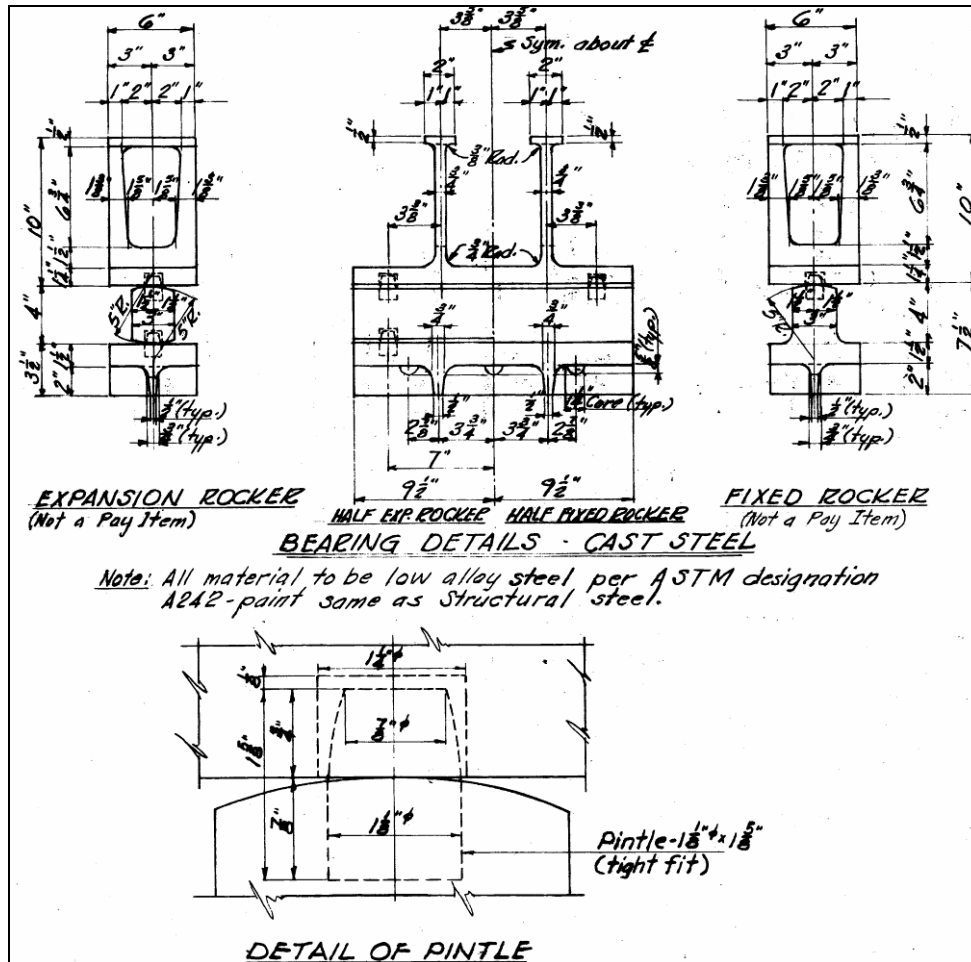
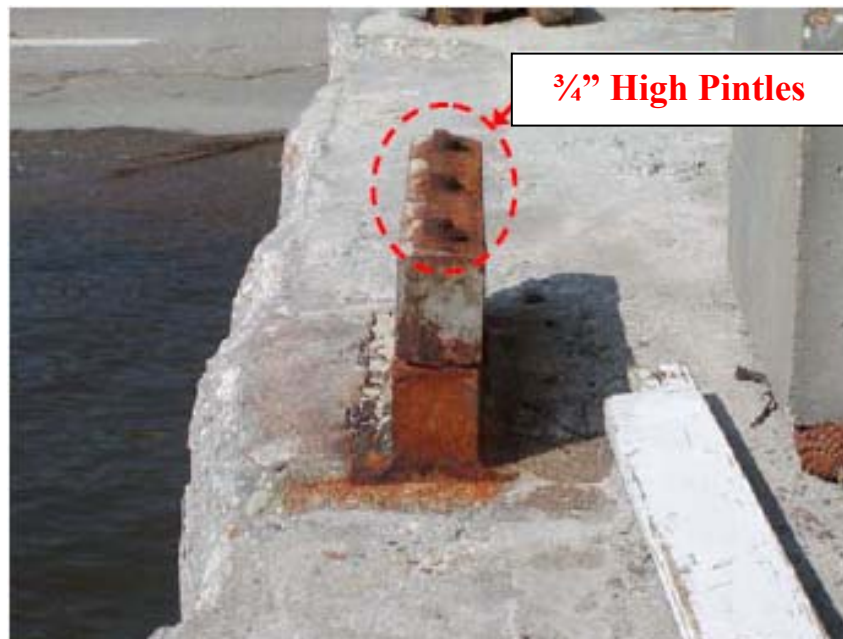
- Bearings provide no positive connection that would resist uplift
- Bearing details shown below are from sheet 12 of the bridge plans
- Pintles should project  $\frac{3}{4}$ " from the rocker or sole plate
- The picture below from Robertson et al shows Pintles that appear to be undamaged

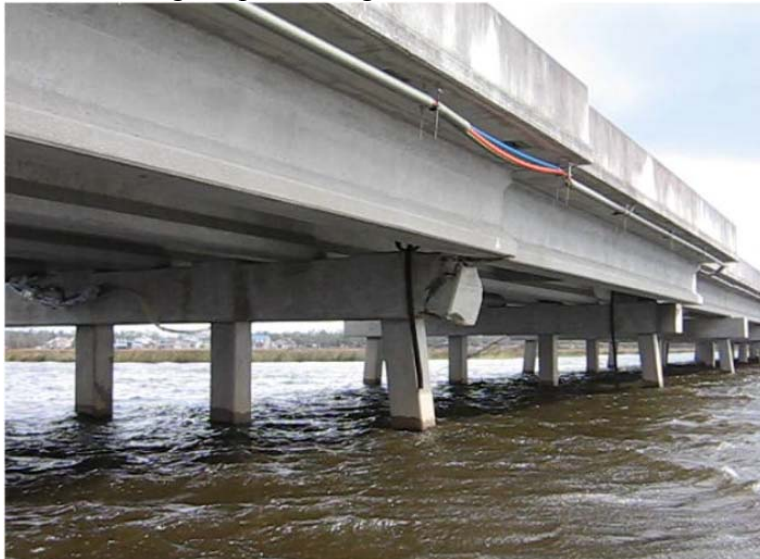
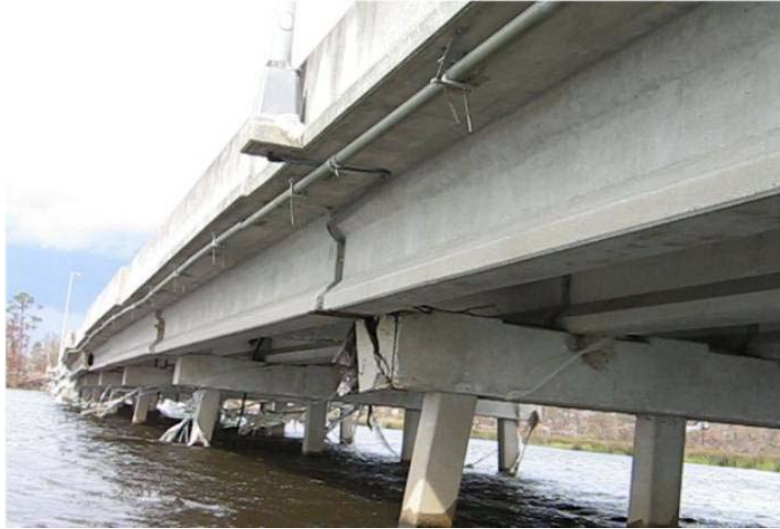
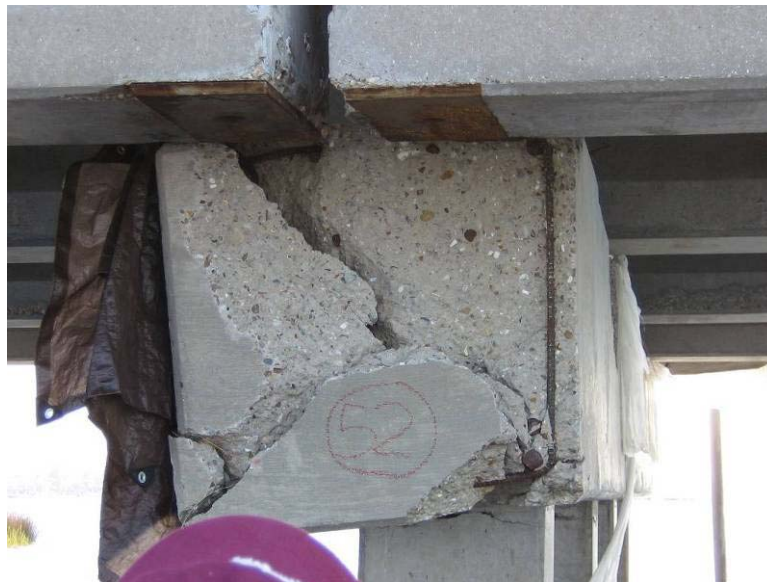
- Cracked pier cap ends
  - Beams came to rest at the end of pier caps
  - The pier cap of pier 52 looks like it sheared where reinforcement started (i.e. beam came to rest with 2" or 3" of bearing on end of pier cap and the cap failed in direct vertical shear along the plane where the first tie/stirrup was)
  - Shallow member beam theory is not applicable to the pier cap overhang due to the large depth to length ratio.

- Damage to pier cap is due to movement of spans - prevent spans from moving to solve this problem
- Cracked beam near midspan diaphragm – more information needed, may be potential future specification issue
- Failed sidewalk – more information needed, may be a potential future specification issue (see also I-10 Twin Spans)
- Damage to beam near sole plate – prevent spans from moving to solve this problem

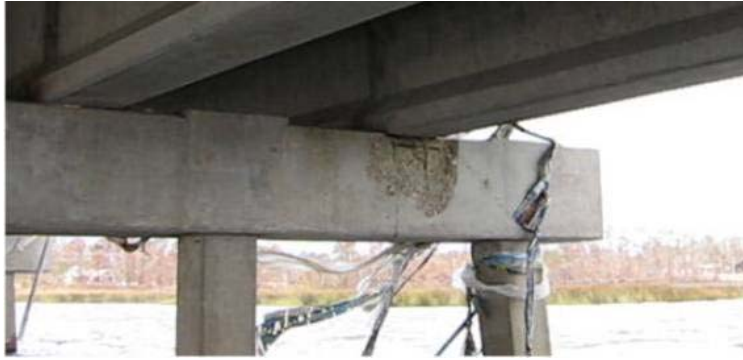
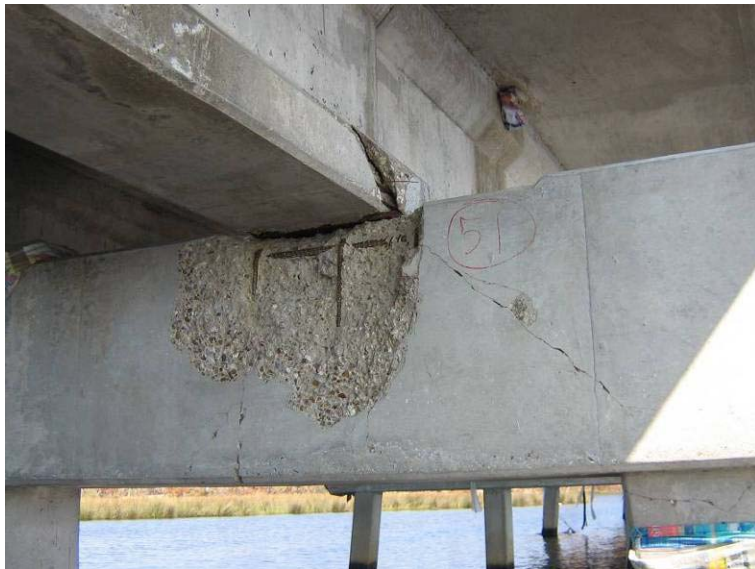
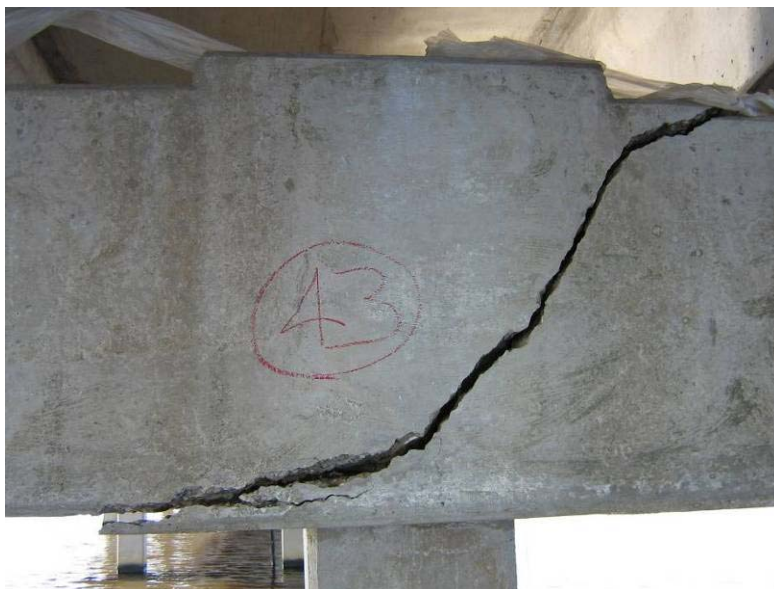
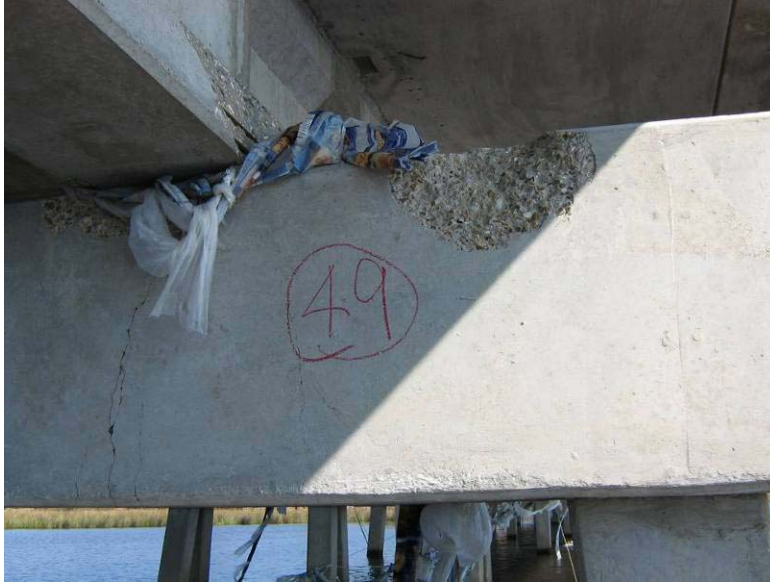
- Pier cap beam cracked between columns
  - Superstructure beams came to rest midway between columns
  - Pier cap beam shows inclined shear crack from face of column
  - Flexure cracks observed directly below some of the shifted superstructure beams.
  - Spalling under superstructure beam, insufficient bearing / bearing on corner???
  - Pier cap beam likely not designed to take superstructure reactions at these locations – beams supposed to sit directly over the columns

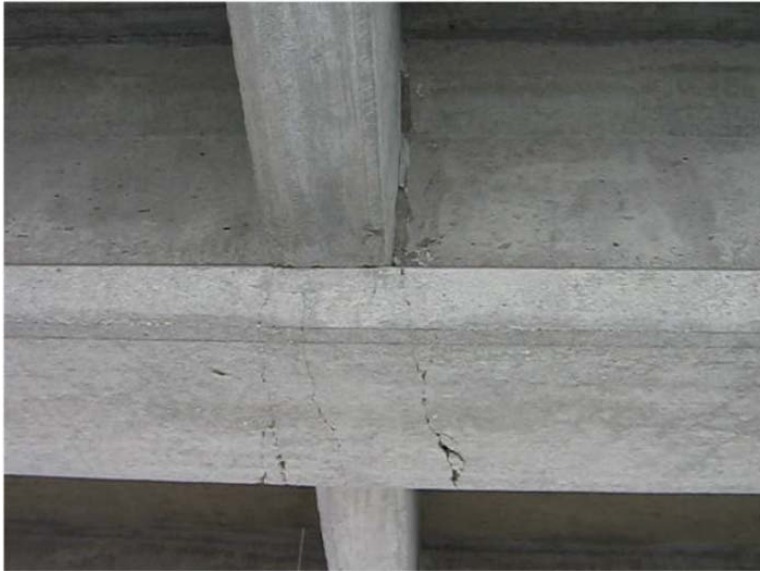
Cracked p/s beam in span / away from end -- Bottom flange at external diaphragm

- The overall context of the picture is not clear
- Other pictures indicate that there are intermediate diaphragms at midspan only
- Positive bending (tension cracks) when span picked up and dropped (or slammed)???
- Does not appear to be crushing from compression (negative bending from uplift or removal of the selfweight that counteracts the prestress force)

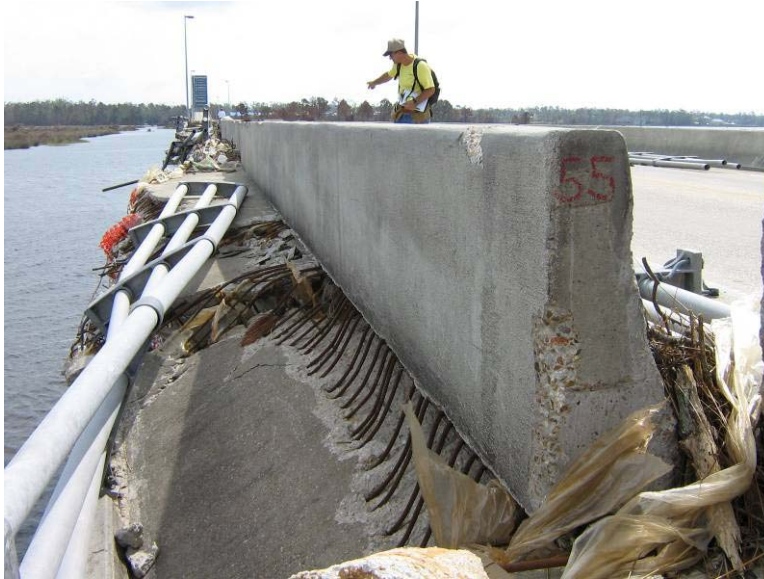
Deck/sidewalk failed

- Context of the picture is unclear
- Cantilevered section?
- Failed due to uplift on cantilever?

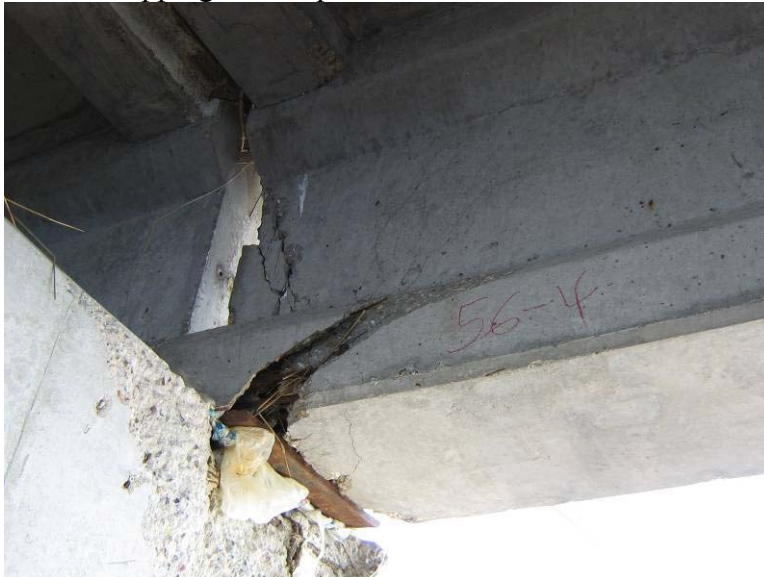
- Cracked beam end in area of sole plate
  - Due to shortened bearing length after span shifted?
  - Due to dropping of the span?

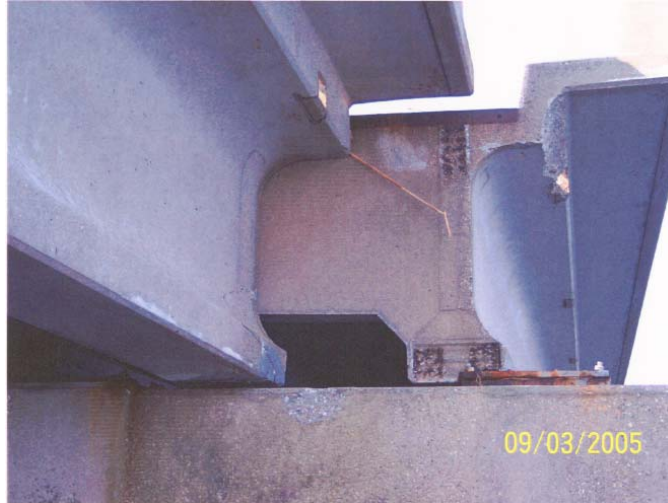
Fixed bearing at an exterior beam - Bronze plate still attached to pier  
Straps holding the bronze plate to the beam failed while the anchor bolts remain intact

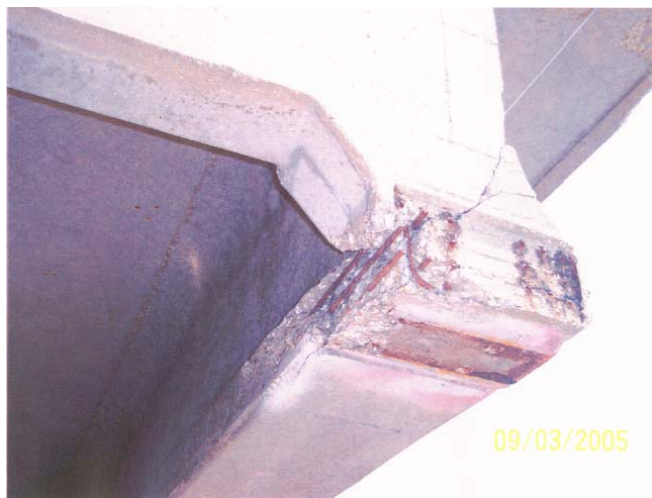
Fixed bearing at an exterior beam - (Bronze plate is still attached to pier, not shown)  
Straps holding the bronze plate to the beam failed while the anchor bolts remain intact

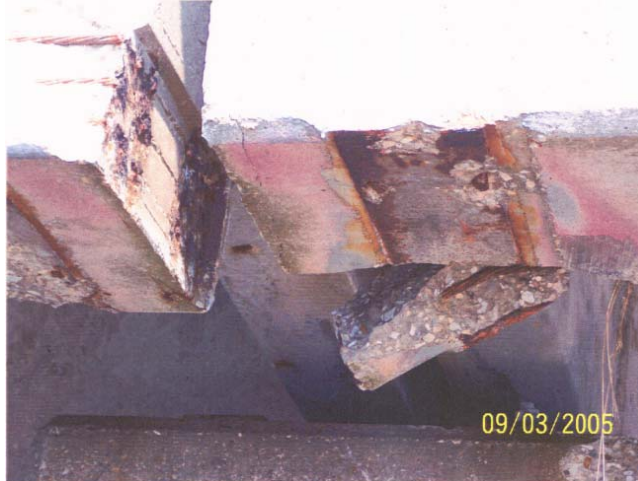
Fixed bearing at an exterior beam - (Bronze plate is still attached to pier, not shown)  
Straps holding the bronze plate to the beam failed while the anchor bolts remain intact

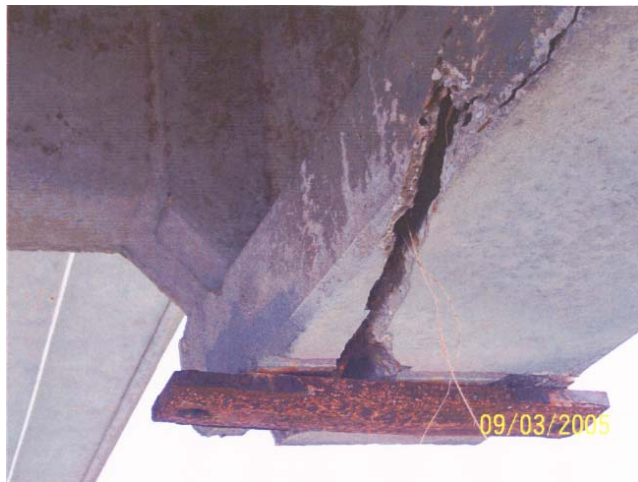
Fixed bearing at an exterior beam - Bronze plate is still attached to the beam  
Straps holding the bronze plate to the beam are intact while the anchor bolts failed

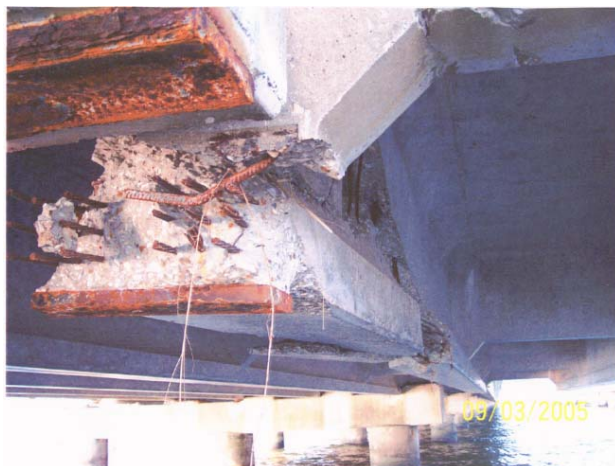
Free end of any beam or fixed end of interior beam (locations where plate not bolted to pier)  
Bronze plates remain attached to the beam through the straps (expected behavior)

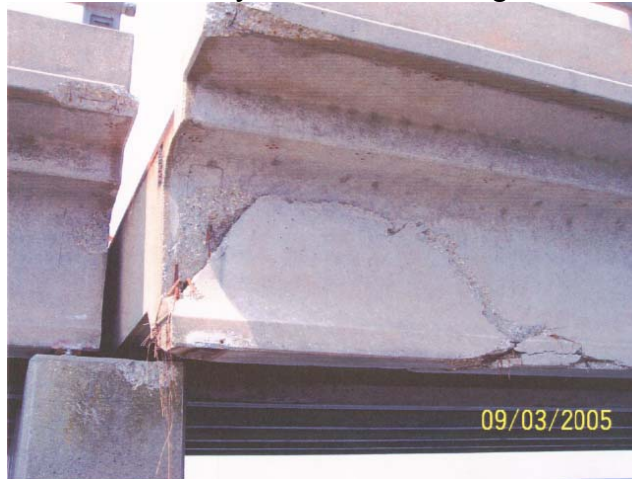
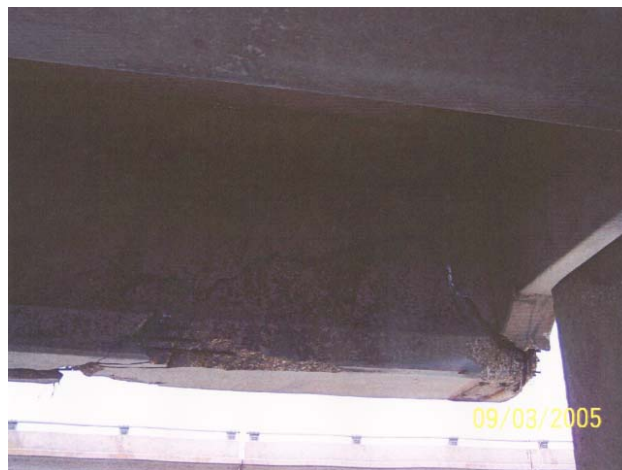
#### Cracks and spalls at beam ends

- Beams banging on pier?
- Shifted beams being supported with insufficient bearing area/surface?
- At locations where the bronze plates were anchored to both the beam and the pier, the beam to plate connection may have caused damage to the concrete?

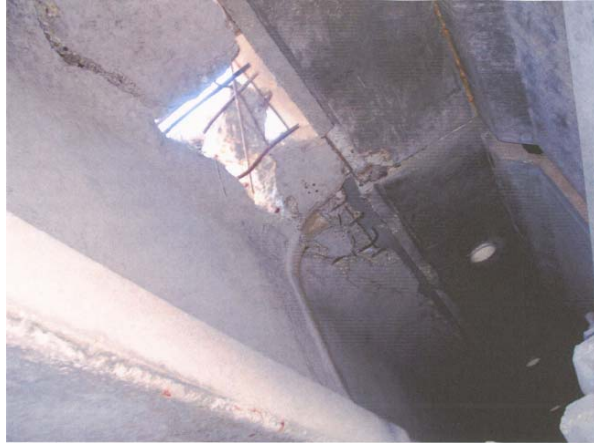
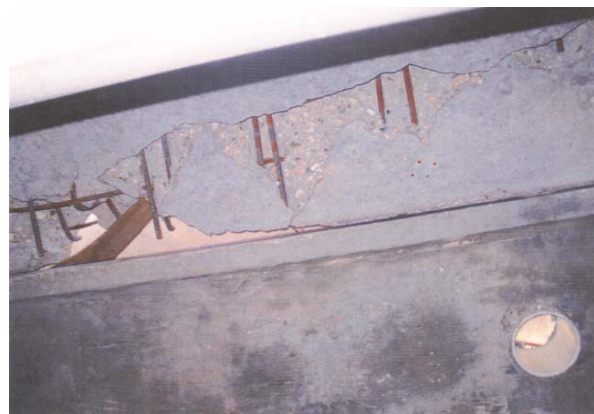
#### Cracking/spalling/missing concrete in top of girders/deck

- Context of pictures unclear
- Negative bending--tension?
- Positive bending—compression—picking up and dropping (or slamming) of span?

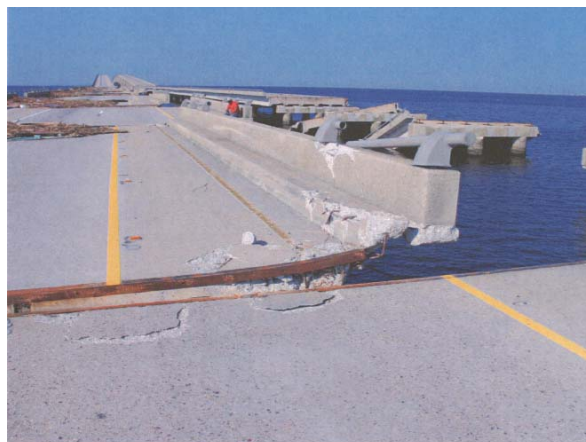
Damage to end of decks, ends of parapets, and ends of curbs

- Longitudinal movement caused banging?
- Spans become misaligned as they move sideways and get pinched between spans on either end (free end moves first)?

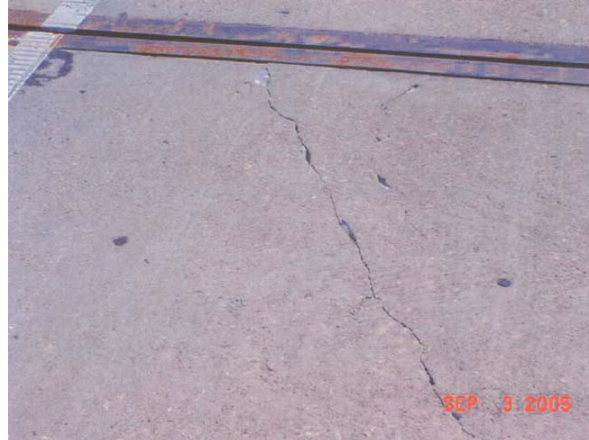
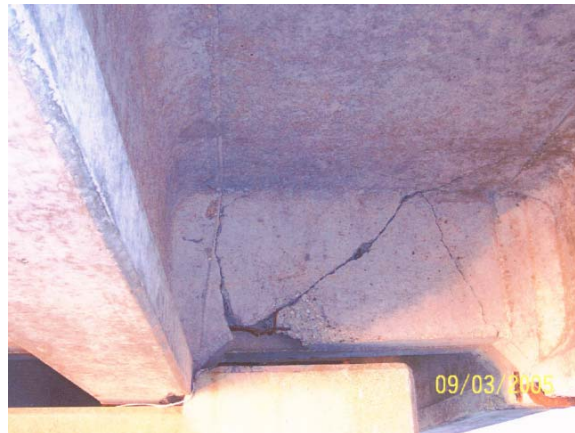
45 degree cracks at ends of decks

- Initiated through end diaphragms

- Beams gets caught on a stepped bearing seat as it moves sideways, halts sideways movement, tension transferred through diaphragm, cracks initiate and propagate into deck??
- Span shifts so that fascia beam is no longer supported by pier, weight of unsupported beam is now transferred through diaphragm which develops an inclined shear crack that propagates through the deck??

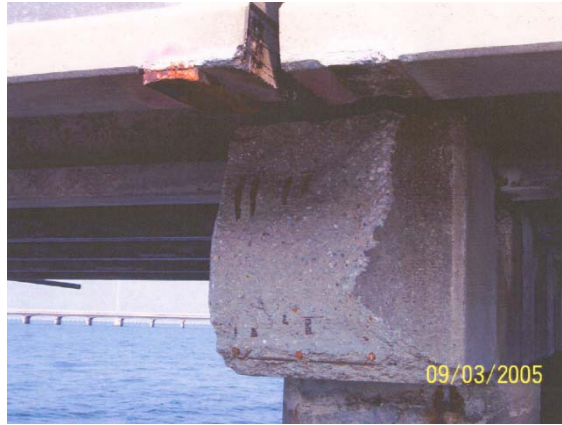
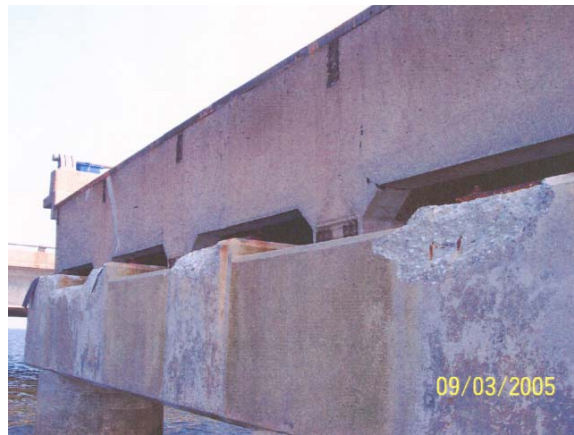
Spalls on pier, cracking at ends

- Insufficient bearing area when girder shifted??
- Dropping or banging of spans??
- Bending or direct shear on cantilevered bent cap

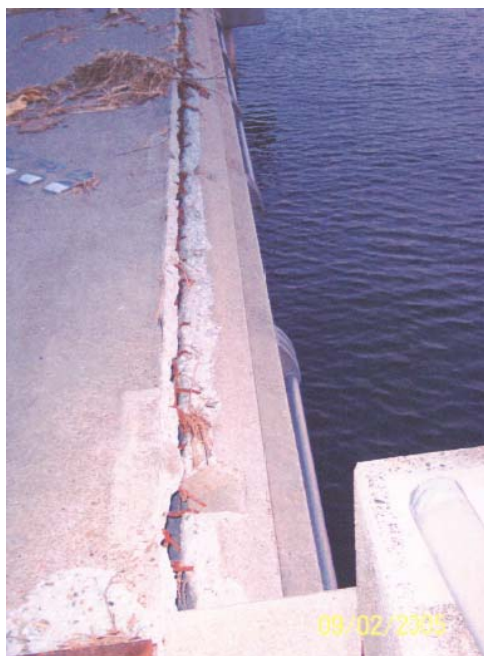
Missing barrier rail

- Cause of top of girder damage listed above?

- Use of open rails
  - Use of more robust reinforcement
  - Consideration of uplift on cantilevered section of deck for quantity and development of reinforcement

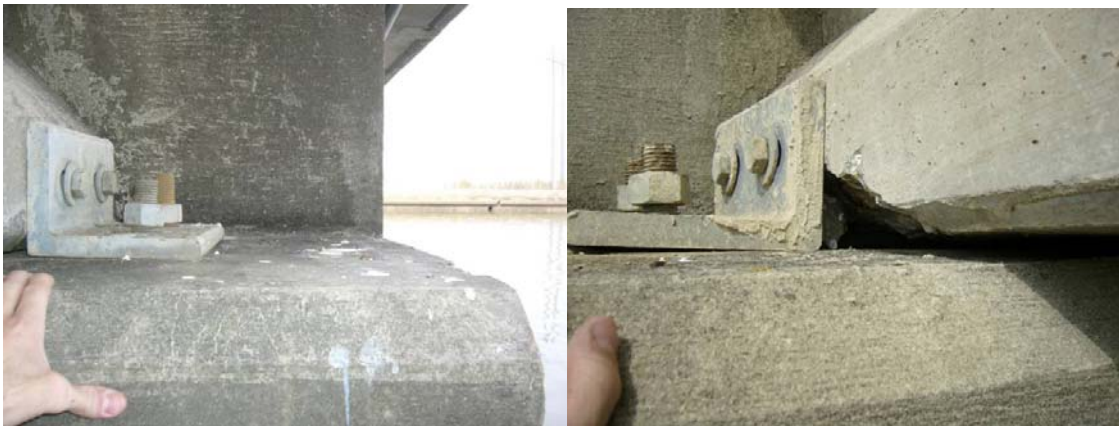
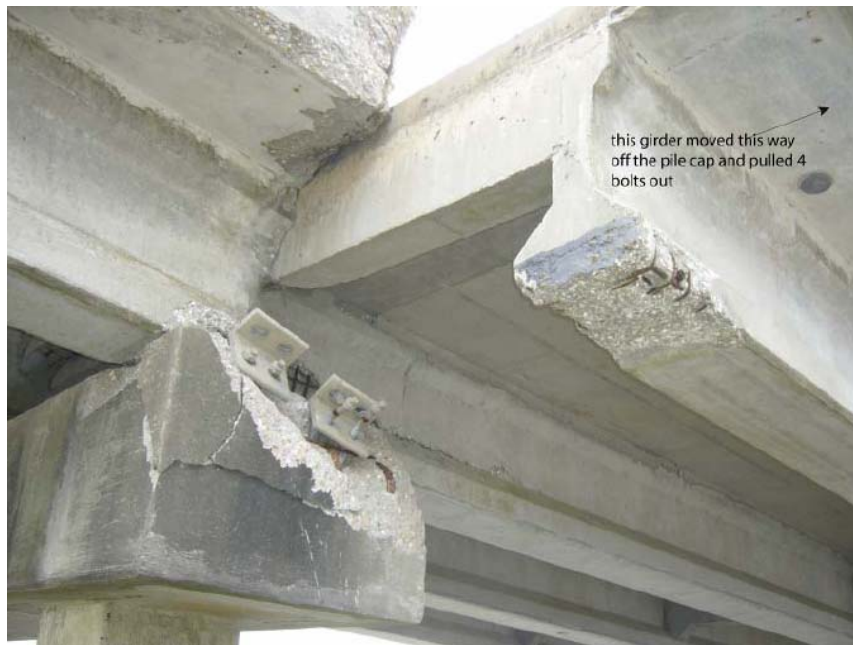
- Prestressed concrete simple spans 45' in length
- Built in 1970's
- Beams anchored using 1" diameter anchor bolts and 6" x 9" x 1" steel angles (ASCE)
- Concrete around bolts broke (Douglass et al.)
- Broken anchor bolts (ASCE)
- Some spans on curve were pushed toward center of the curve, so this may have prevented them from being fully dislodged
