Technical Memorandum

Re. Forensic Desktop Study Report: Pennsylvania LTPP Test Section 42_1597

The Long-Term Pavement Performance (LTPP) General Pavement Studies-1 (GPS-1) Asphalt Concrete (AC) Pavement on Granular Base test section 42_1597¹ was nominated for a desktop study under TPF-5(332) "LTPP Forensic Evaluations." This test section was originally constructed in 1980 and was incorporated into the LTPP program in 1988 as 6.5 inches of asphalt concrete (split between two layers) and 16.8 inches of unbound granular base over a fine-grained subgrade soil. During the first 20 years of the pavement's history, the test section received five treatments—crack sealing in June 1990, June 1996, and May 1999, patching in August 1997, and a shoulder restoration and mill and overlay in July 2000, which moved the test section to GPS-6S AC Overlay of Milled AC Pavement Using Conventional or Modified Asphalt. Following the mill and overlay in 2000, the pavement section received crack sealing in June 2011, a slurry seal in June 2015, and crack sealing again in June 2019. The overlay event in 2000, which occurred approximately 20 years after the construction of the pavement section, provides an

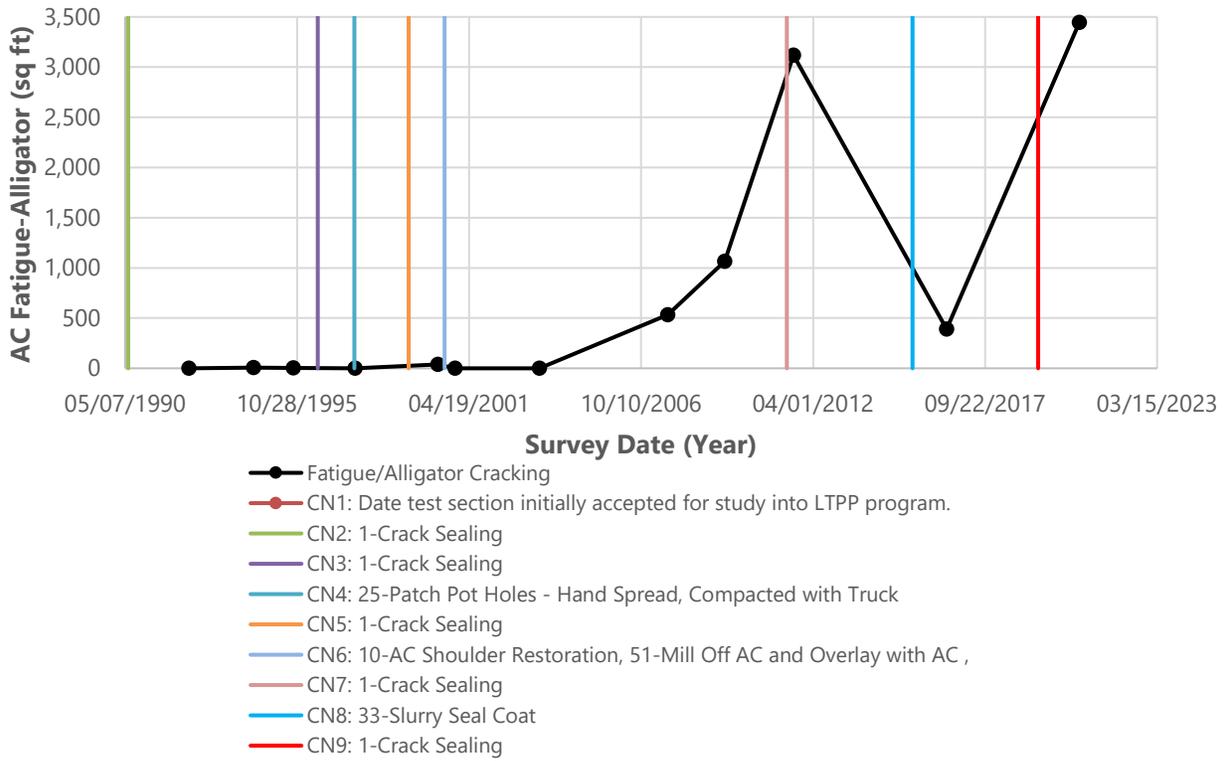
Figure 11. Time history of the length of fatigue cracking.

Fatigue/alligator cracking was first reported during the manual distress survey in June 1994, 14 years after the construction of the roadway, when 5.4 ft² was observed. However, fatigue/alligator cracking on the test section remained minimal between 1994 and April 2000, when 38.8 ft² of fatigue/alligator cracking was observed. Following the mill and overlay event in 2000, fatigue/alligator cracking is not reported again until the manual distress survey conducted in 2007, 7 years after the overlay, when 532.7 ft² of fatigue/alligator cracking was observed on the section. Between 2007 and 2011, the amount of fatigue/alligator cracking observed continued to increase at a rate of 647 ft²/year, reaching 3,118.3 ft² by 2011. The test section received a slurry seal in 2015, which appears to have hid the amount of fatigue/alligator cracking observed. However, by 2020, the last year a manual distress survey was conducted, the cracking observed prior to the slurry seal reappeared, with 3,445.5 ft² reported.

As depicted in the figure, fatigue/alligator cracking was not significant on the test section until after the mill and overlay event. The increase in the fatigue/alligator cracking after 2000 is likely related to a combination of environmental and structural factors. One possible reason for the increase in fatigue/alligator cracking following the overlay is increased levels of precipitation reported during this period. As water infiltrates the pavement, unbound granular layers tend to weaken (especially when reaching saturation conditions), which can contribute to the observed fatigue cracking. Another factor that could have played a role in the increase in fatigue/alligator cracking reported following the overlay is a combination of loading and the freeze-thaw periods the test section undergoes. During the thaw period, the pavement’s base layer tends to weaken which may have magnified the effect of any loading experienced on this test section during the thaw period. Lastly, as the AC overlay at this test section consisted of three separate AC mixes, how well the individual AC overlay layers bonded may also have

played a role in the fatigue/alligator cracking observed. If the bonds between these three AC layers were weak or if they de-bonded, this could have ultimately led to a weakened pavement structure more apt to develop fatigue/alligator cracking. As the mechanism of the developed cracking (top-down versus bottom-up) is important for understanding the cause(s) of fatigue/alligator cracking, coring is recommended as a follow-up activity at this test section.

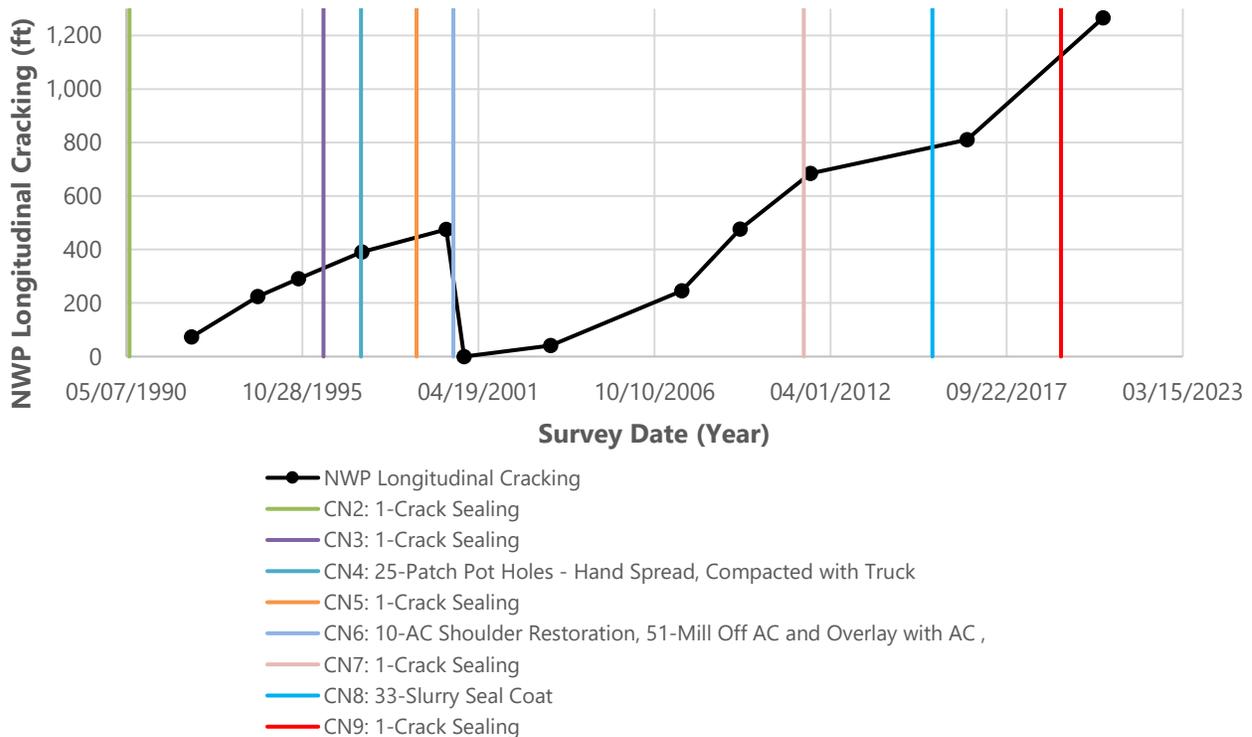
Non-wheel path (NWP) longitudinal cracking, depicted in **Error! Reference source not found.**, was reported during the first manual distress survey in May 1992, 12 years after the construction of the roadway, when 73 feet of cracking was observed. Between May 1992 and April 2000, the NWP longitudinal cracking increased at a rate of 50 feet/year, reaching 475 feet by 2000. Following the mill and overlay in July 2000, NWP longitudinal cracking was not observed again until the July 2003 manual distress survey, three years after the mill and overlay event, when 42 feet of cracking was reported. The NWP longitudinal cracking continued to increase between July 2003 and June 2020, at a rate of 72 feet/year, reaching 1,266 feet by 2020. NWP longitudinal cracking was predominantly located on the centerline (between the section lane and the lane in the opposite direction) prior to the mill and overlay event in 2000 and on both the centerline and edge of the lane following the 2000 mill and overlay. Given the location of the cracking, it is hypothesized that the propagation of the NWP longitudinal cracking is construction-related; the cracking is likely a result of the construction joint locations. Following the mill and overlay event, the cracking developed on the centerline of the roadway appears to have been reflected to the overlay layers.

Figure 12. Time history of the length of NWP longitudinal cracks.

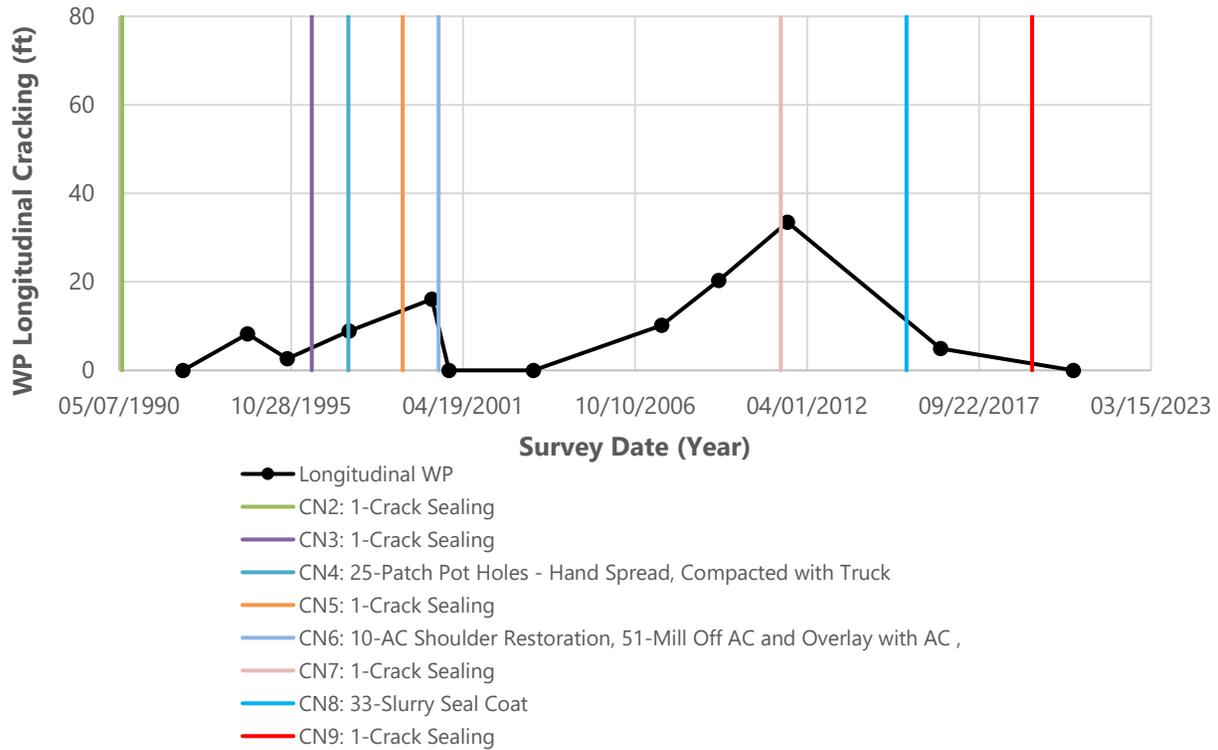
Minimal wheel path (WP) longitudinal cracking was observed on the test section as depicted in Figure 13. Prior to the mill and overlay in 2000, the WP longitudinal cracking observed increased at a rate of 2 feet/year, reaching 16 feet by April 2000. Following the mill and overlay in July 2000, WP longitudinal was reported between August 2007 and August 2011, increasing at a rate of 6 feet/year, reaching 33 feet by 2011. The test section received a slurry seal in 2015 that hid the amount of WP longitudinal cracking

observed previously. During the 2020 manual distress survey, while most cracking types observed prior to the mill and overlay reappeared, WP longitudinal cracking was reduced as fatigue/alligator cracking inside the wheelpath increased (which likely captured the previously reported WP longitudinal cracking). Like fatigue/alligator cracking, the increase in the WP longitudinal cracking between 2000 and 2011 was likely related to a combination of the increased levels of precipitation, freeze/thaw, the ESALs reported during this period, and the de-bonding of the three mix types used in the AC overlay.

Figure 13. Time history of the length of WP longitudinal cracks.

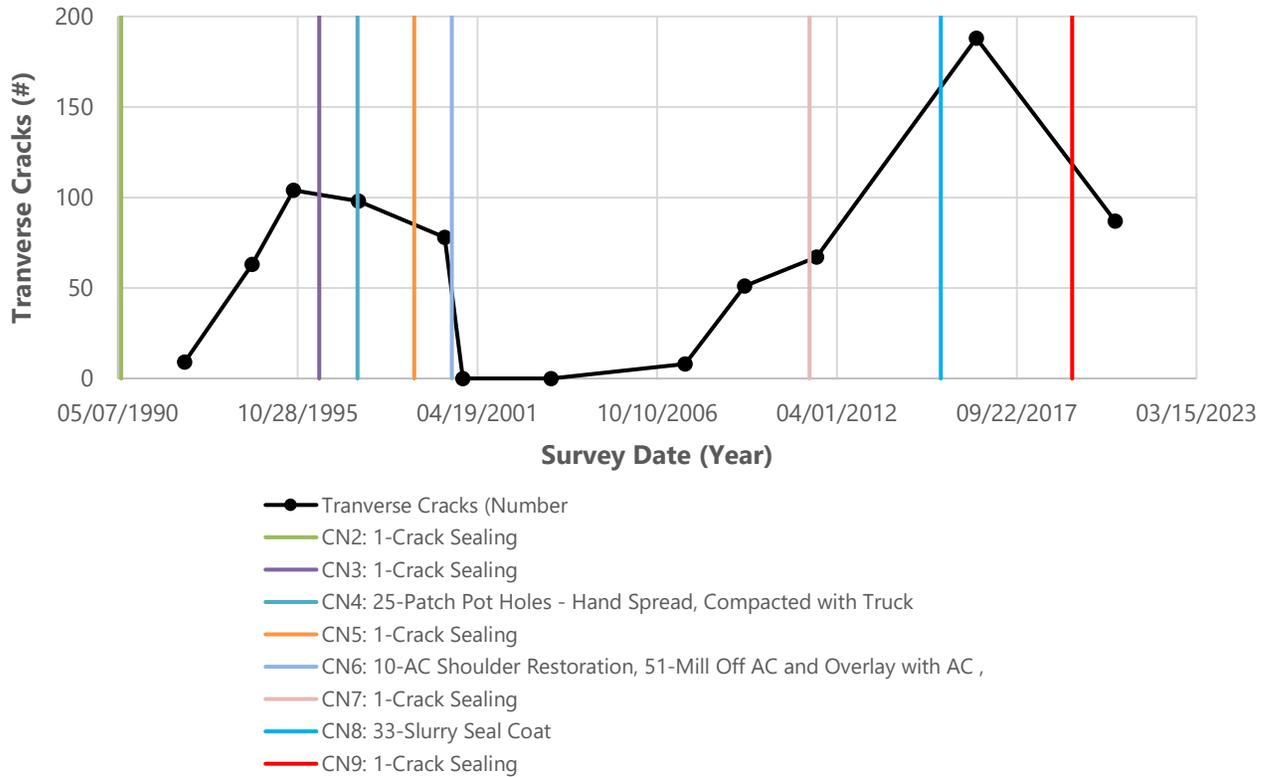
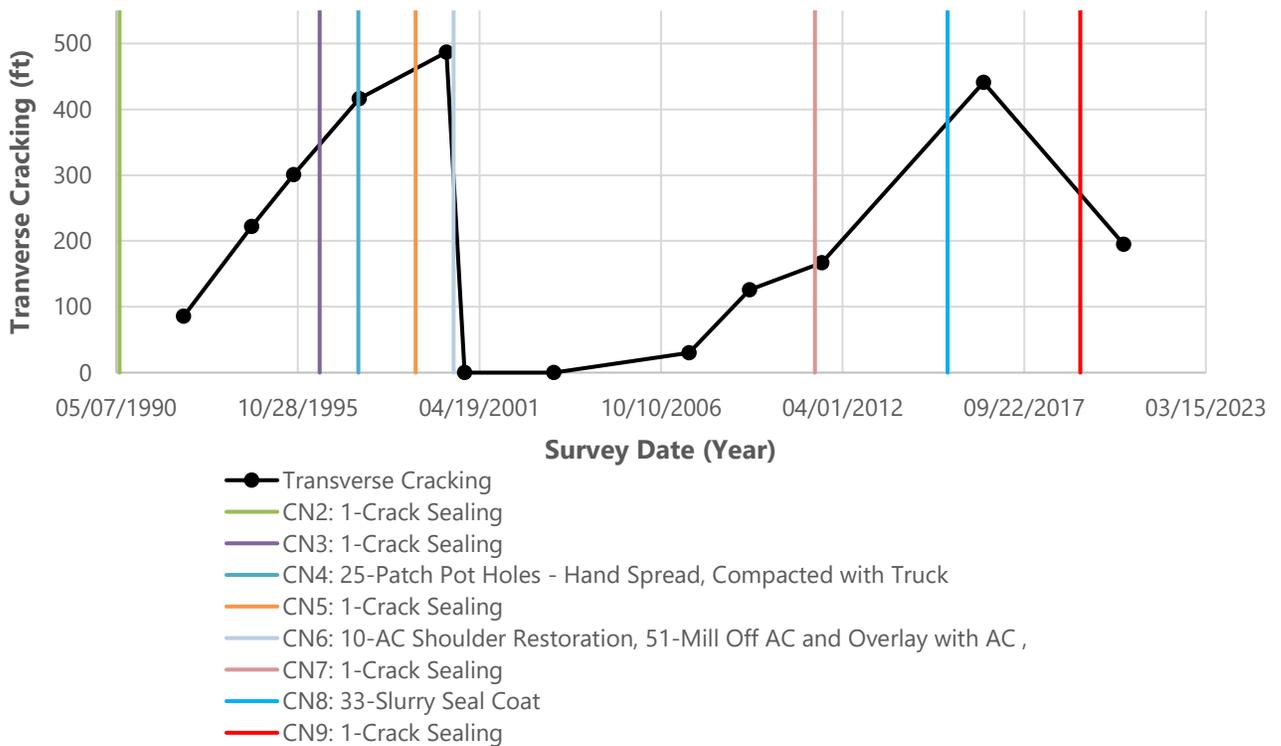
Data on transverse cracking was collected between 1992 and 2020, as shown in **Error! Reference source not found.** and **Error! Reference source not found.**. Transverse cracking was first reported during the manual distress survey in May 1992, 12 years after the construction of the roadway, when 86 feet of transverse cracking (9 cracks) was observed. The transverse cracking continued to increase between 1992 and April 2000, at a rate of 50 feet/year, reaching 487 feet (78 cracks) by 2000. Prior to the mill and overlay event, transverse cracking was a mix of low, medium, and high severity cracking. Following the mill and overlay event in 2000, transverse cracking was not observed again until the August 2007 manual distress survey, seven years after the construction event, when 30 feet (8 cracks) of transverse cracking was reported. The transverse cracking continued to increase between 2007 and June 2016 at a rate 45 feet/year of reaching 441 feet (188 cracks) by 2016, despite the application of a slurry seal in 2015. During the last distress survey, conducted in 2020, the observed transverse cracking decreased to 195 feet (87 cracks) due to the initiation of block cracking on the test section in 2020 (1,177 ft² of block cracking observed in 2020). Transverse cracking reported after the mill and overlay event was strictly low and medium severity.

Figure 14. Time history of the number of transverse cracks.

Figure 15. Time history of the length of transverse cracking.

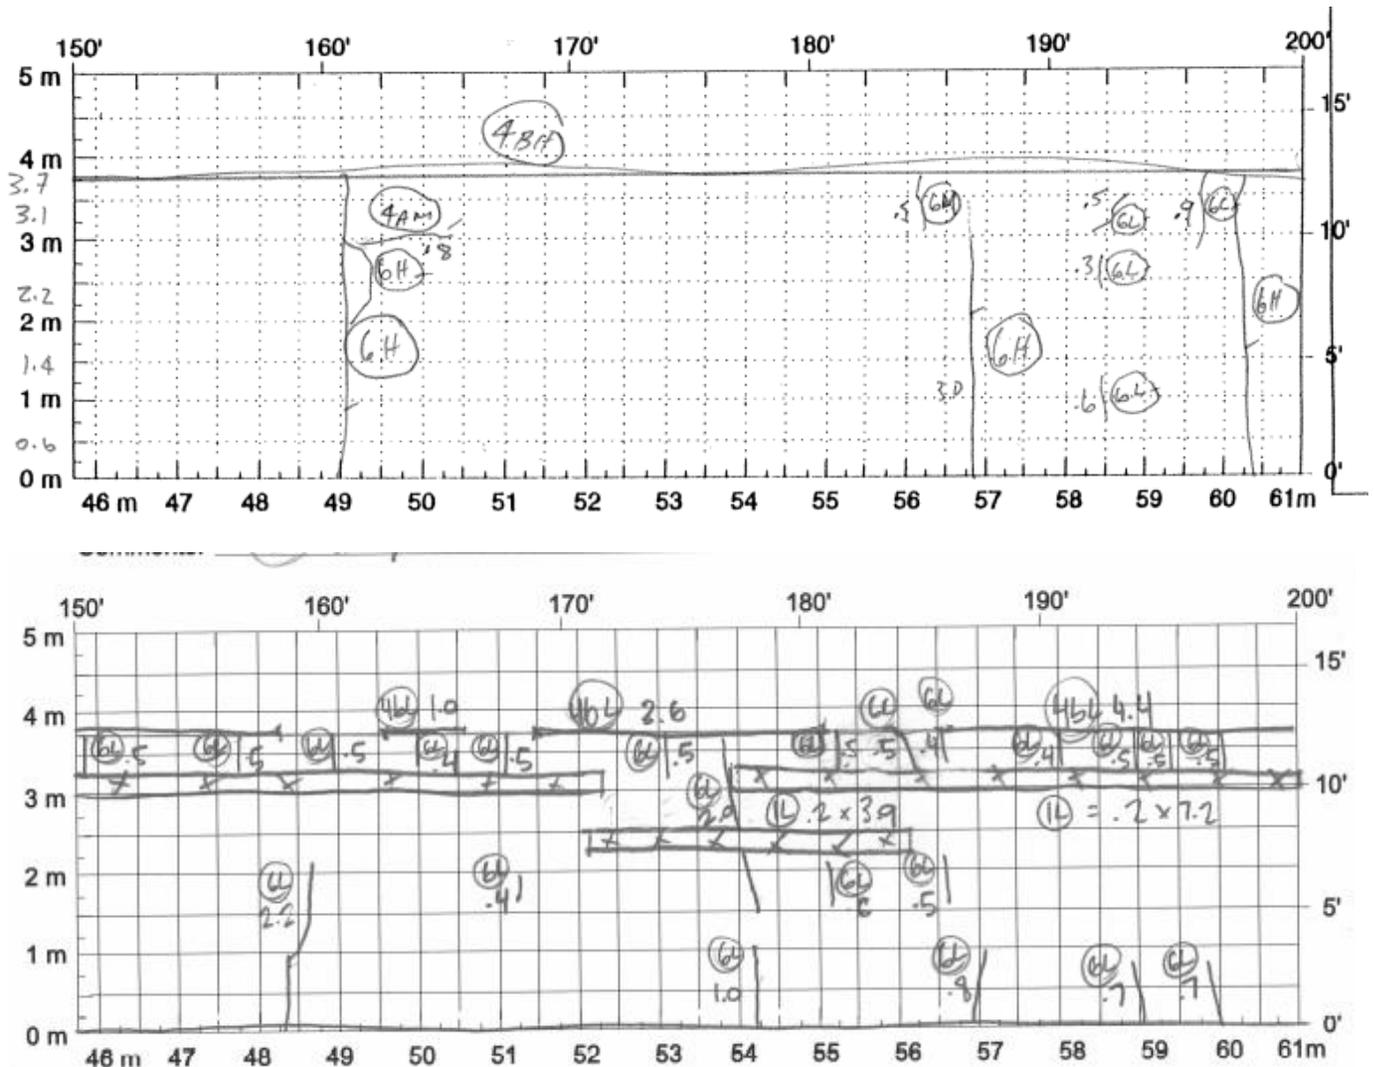
The rate of propagation before and after the mill and overlay was similar; however, the location of the transverse cracking before and after the event was not consistent. While it was hypothesized there was a shift in stationing following the application of the mill and overlay, due to the construction event, a comparison of distress surveys conducted before and after the mill and overlay event did not show consistent shifts in transverse crack locations. As shown in Figure 16, prior to and following the overlay, there were some cracks that were likely reflected through the overlay (e.g. at 57 meters), but there were also transverse cracks that were located in different locations prior to and following the mill and overlay. In addition, after the mill and overlay event, there appeared to be more partial width cracks perpendicular to NWP longitudinal cracking at the centerline and edge of the lane.

Both prior to and following the 2000 mill and overlay, it is hypothesized that the propagation of transverse cracking was related to the freeze-thaw periods (evidenced by the high freezing indices) of the pavement section over time. Additionally, the presence of rumble strips along the centerline of the pavement section after the 2003 manual distress survey may have also contributed to the transverse cracking reported after 2003.

Figure 16. Manual distress surveys from April 2000 (top) and June 2016 (bottom) showing transverse cracking in both similar and different locations before and after the overlay.

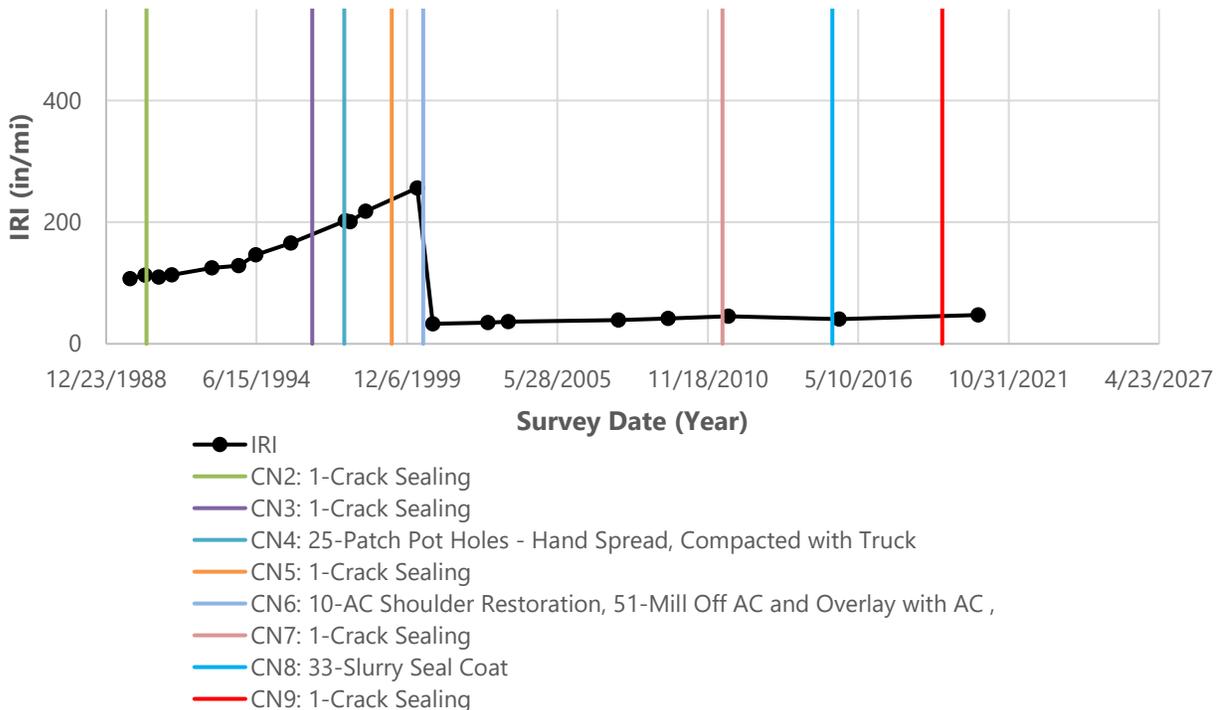
The average IRI measurements for the section over time are shown in Figure 17. During the first performance period of the test section, from its incorporation into the LTPP program to the mill and overlay event in 2000, the IRI on the test section increased substantially over time. The IRI on the section prior to the mill and overlay event in 2000 averaged 256 in/mi, which means the performance of the pavement was classified as “Poor” based on FHWA performance definitions. During the second performance period, after the 2000 mill and overlay event, the IRI of the test section dropped to 33 in/mile in November 2000 and remained low, reaching 47 in/mi by 2020. The average IRI during this performance period is classified as “Good” based on FHWA performance definitions.

Figure 17. Time history plot of pavement roughness.

The IRI reported during the two performance periods does not correlate with the observed cracking over time. Specifically, the predominant cracking types that purportedly affect the overall IRI of the test section—fatigue/alligator and transverse cracking—are present in equal or higher quantities following the mill and overlay in 2000 than prior to the overlay event despite the significantly lower average IRI reported post-overlay. This may be related to the severity of the cracking observed on the section following the mill and overlay—predominantly low and medium—which plays less of a role in the roughness of the test section. The higher IRI values reported prior to the mill and overlay may also be related to the initial smoothness of the road when it was constructed in 1980 (at which point the specification for pavement smoothness may have differed from current specifications); the thick overlay placed in 2000 may have helped correct this smoothness. The smoother a pavement is during the construction of the pavement, the slower the expected deterioration rate. Therefore, if the pavement’s starting IRI was higher, the IRI pre-overlay may have deteriorated at a faster rate.² Additionally, as will be described in the section to follow,

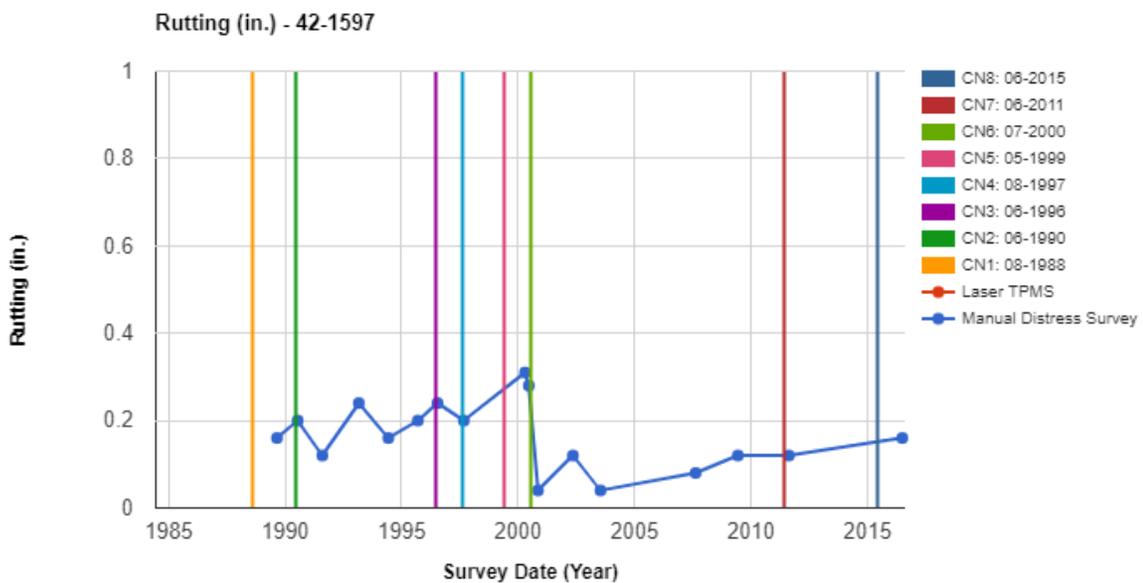
The average rut depths observed for the section between 1989 and 2016 are shown in Figure 18. While transverse profiles were collected as a part of the closeout monitoring conducted in 2020, they were not readily available during the preparation of this desktop study memorandum and therefore, will not be considered until the follow-up investigation related to this test section. The rutting on the section prior to the mill and overlay in 2000 increased from 0.16 in in 1989 to 0.28 in in 2000. Following the mill and overlay in 2000, the average rut depth dropped to 0.04 in. The average rut depth began to slightly increase following the overlay, at a rate of 0.01 in/year between 2000 and 2016. It is hypothesized the majority of rutting observed prior to 2000 occurred within the top 1.5-inch AC layer (which was entirely removed during the mill and overlay event in 2000, leading to lower rutting values following the overlay).

Figure 18. Time history plot of average rut depth.

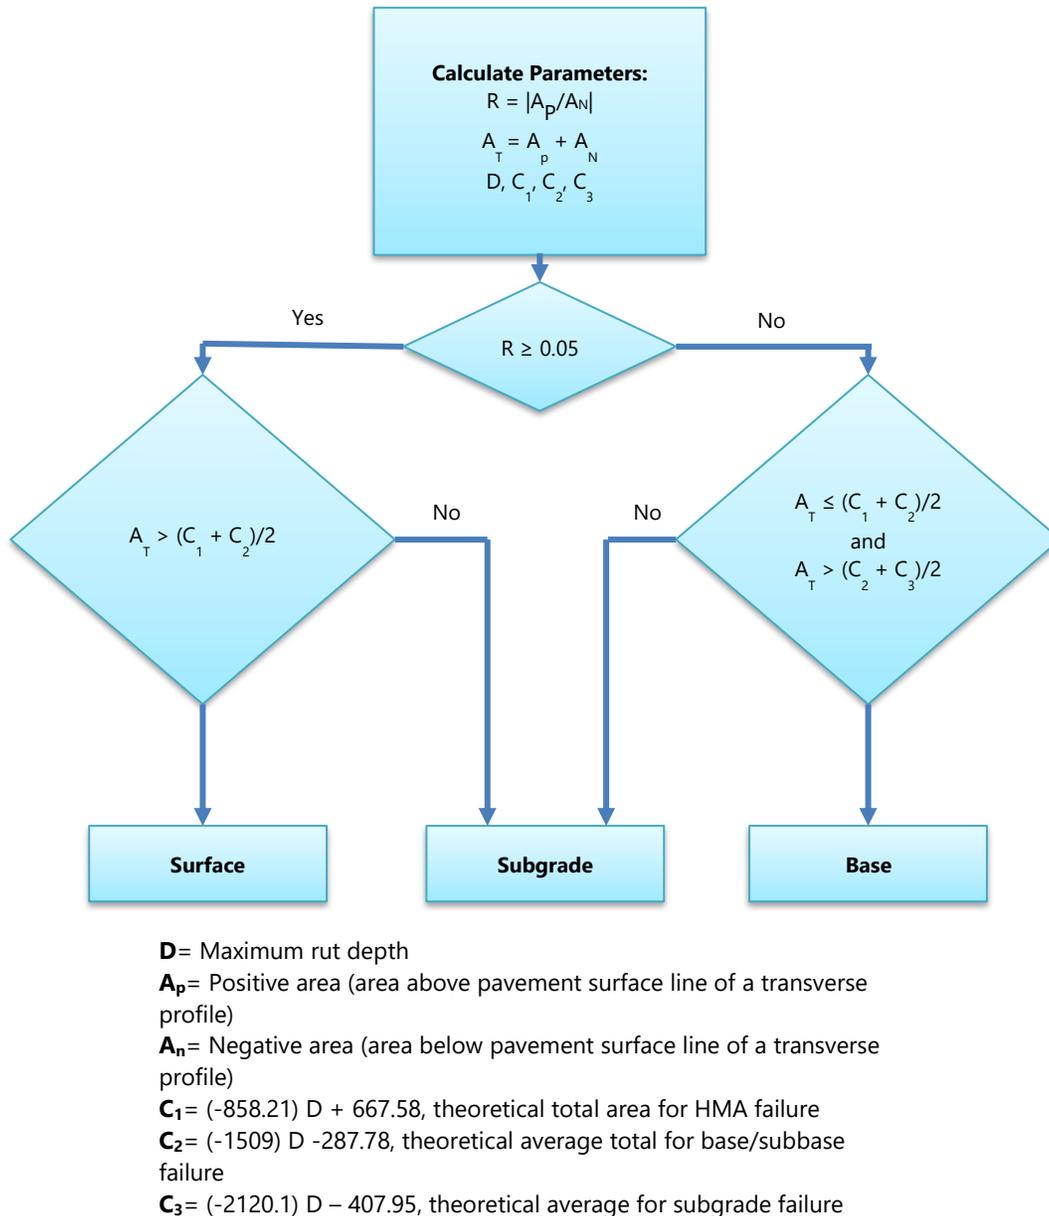
Based on the analysis conducted for each of the transverse profiles of the test section (between 10 and 11 profiles spaced at 50 ft) for the 17 collection dates between August 1989 and June 2016, the predominant lowest layer contributing to rutting was calculated for each date of collection at multiple locations along the section. For all years, the predominant layer contributing to rutting was the surface layer (except one profile in June 2009 which was classified as a base failure). This helps to support the claim that the rutting observed prior to 2000 mostly occurred within the top 1.5-inch AC layer (which was effectively removed during the mill and overlay event in 2000), leading to lower rutting values following the overlay.

Figure 20. Failure layer determination using methodology by White et al. (2002)

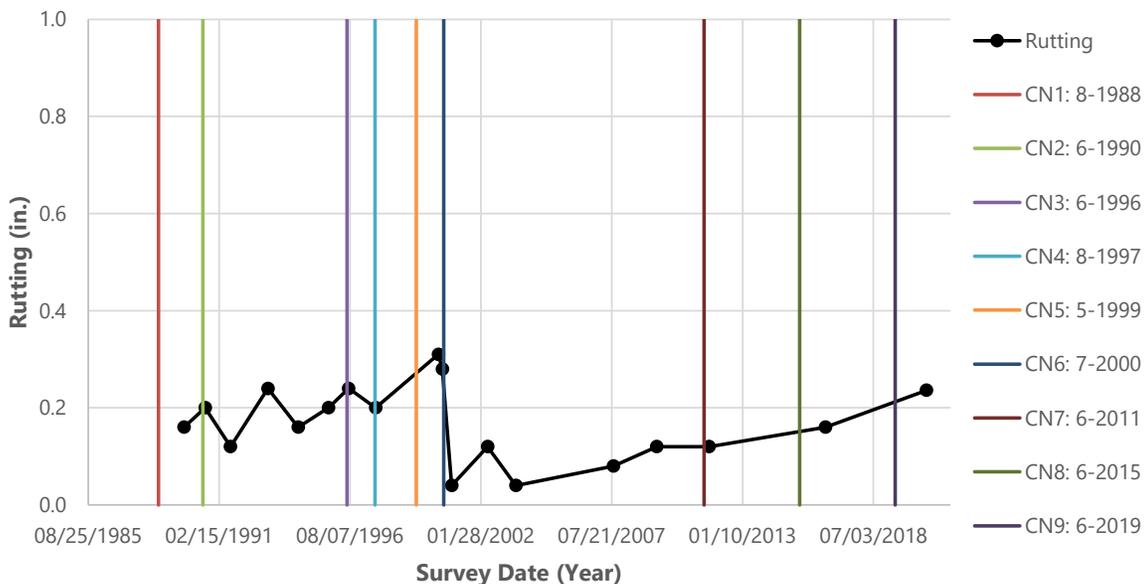
As noted above, both the 2020 distress and roughness data were integrated into the desktop study. While the transverse profiles were collected as part of the September 2020 closeout monitoring, the computed rutting parameters was not available at the time of the original memorandum, and hence, an update to the transverse profile analysis has been included in the follow-up investigation. Figure 21 is an updated graph showing the average rut depth which includes the September 2020 measurements. The average rutting reported was 0.24 inches, which follows the same trend as previously shown – i.e., a rutting rate of 0.01 in/year between 2000 to 2020.

Figure 21. Time history plot of average rut depth.
