**FATIGUE TESTS OF CRACKED AND
REPAIRED ALUMINUM CONNECTIONS
OF OVERHEAD SIGN STRUCTURES –
FINAL REPORT**

**New York State Department of Transportation
Utah Department of Transportation**

August 2003

**Civil & Environmental Engineering
College of Engineering
University of Utah
Salt Lake City, Utah**

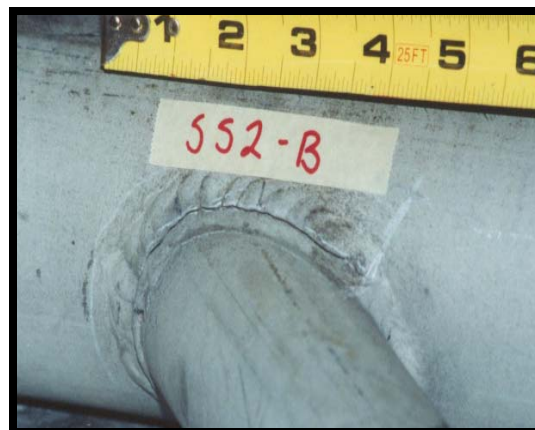
Figure 2. Crack through aluminum-welded joint of overhead sign structure

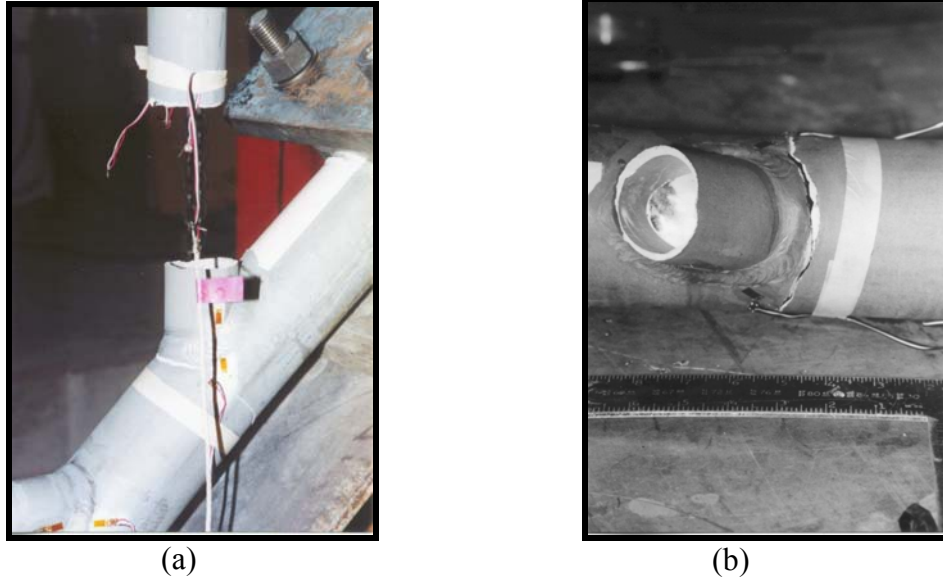
Static tests I-a and I-b had a similar failure mode and load/displacement curve. Failure occurred at the toe of the weld and continued almost entirely around the chord, as can be seen in Figure 7. Immediately following failure of the chord the diagonal was subjected to combined tensile and bending stress, due to the large deflection of the cracked chord, which subsequently caused the diagonal to fail as seen in Figure 8. This failure of the diagonal was secondary to the failure of the chord. This failure mode is different from the static test of the as-is connection in the previous study (Pantelides and Nadauld 2001). In this case, the weld performed well and the base material at the toe of the weld was seen to be the primary failure mode. In the previous study, the failure was through the throat of the weld.

Figure 7. Test I-a: (a) Failure of Diagonal, (b) Failure of chord at toe of weld

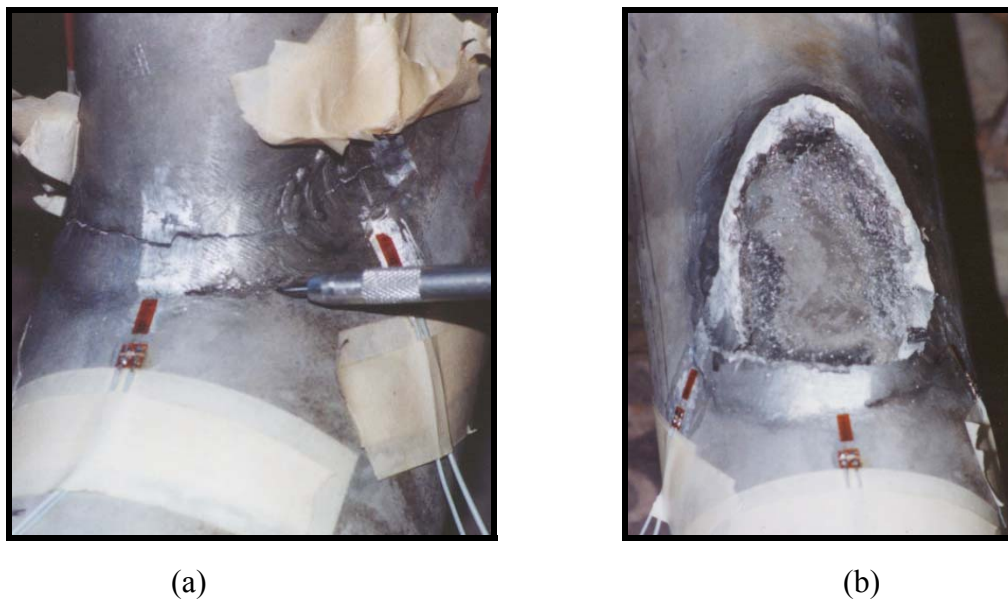
was a result of fatigue loading of the test unit, as shown in Table 3. Figure 9(a) shows the crack prior to failure, and Figure 9(b) shows the chord of the failed test unit. The crack shown in Figure 9(a) was first observed to occur at the toe of the weld and propagated from that point, until a rapid failure of the remaining weld occurred.

Figure 9. Test II-a (2): (a) cracking through weld prior to failure, (b) chord after failure

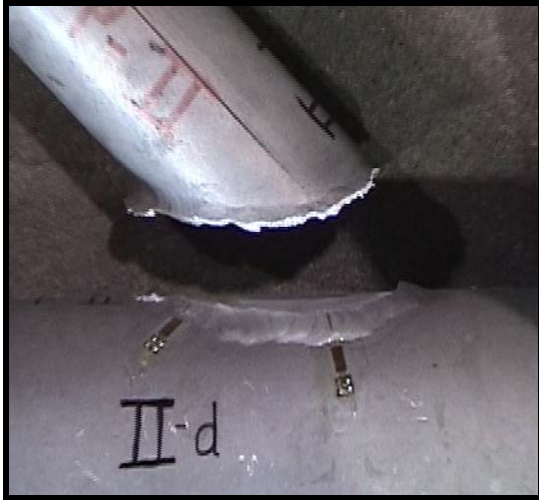
In test II-d the failure was a result of static loading after being fatigued to 1×10^6 cycles. Prior to the static test there was no visible crack in the weld. The load, displacement, and damage curves for this test are shown in Figures 10(a), (b), and (c), respectively. From Figure 10(a) it can be seen that the maximum load was not constant through the test. This loading sequence was not intended, but was a result of the testing system. This problem was only encountered for the tests that were conducted at a load less than 10 kips. Despite the varying loading, it can be seen that the Cumulative Damage remained relatively constant through the duration of the test. The maximum damage calculated was 0.22, which means the stiffness was reduced by 22% over the 1×10^6 cycles. The failed specimen after the static test is shown in Figures 11(a) and 11(b); the static load–displacement curve for test II-d after 1×10^6 is shown in Figure 11(c).

Figure 11. Static Load Test for Specimen of Test II-d after 1×10^6 cycles: (a) diagonal and chord, (b) failure plane on chord, (c) Force–Displacement curve

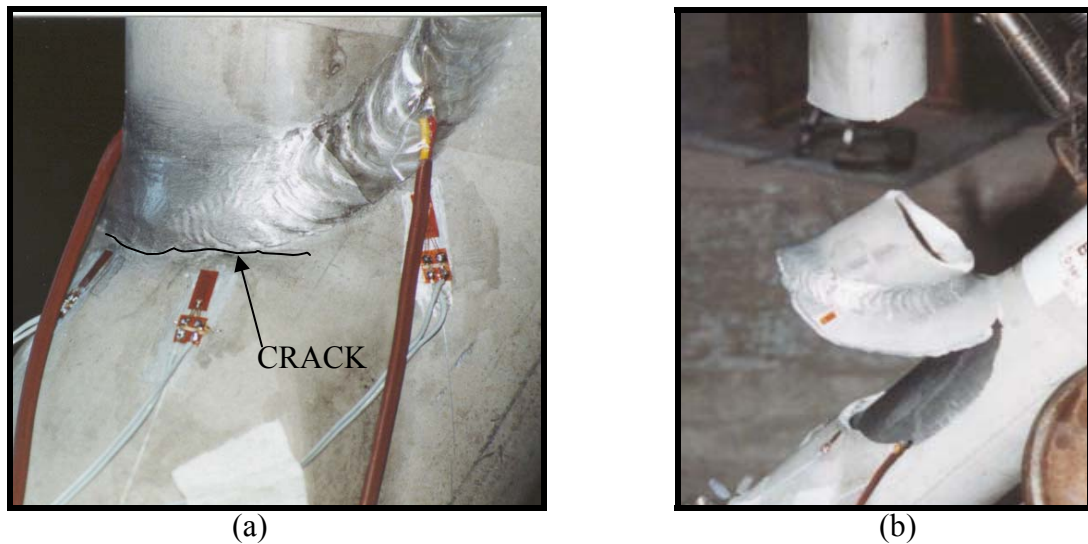
The second failure mode for the Series (II) testing was observed in tests II-a (2), II-b (1), II-b (2), and II-c. The failure consisted of a crack initiated at the toe of the weld, through the base metal. The crack then propagated away from the weld through the chord, and would have continued around the chord – similar to the failure of the series I tests, as shown in Figure 12(a). However, the steel pipe inside the chord forced the crack to propagate through the base material outside the weld, a distance of $\frac{1}{2}$ " to 1" following the weld contour, as shown in Figure 12(b). Figures 13, 14, 15, and 16 show the load, displacement, and cumulative damage curves for tests II-a (2), II-b (1), II-b (2), and II-c, respectively. In all of the fatigue plots failure is indicated by

Figure 12. Fatigue test of as-is welded joint Test II-b: (a) crack prior to failure, (b) Typical failure of Series II tests

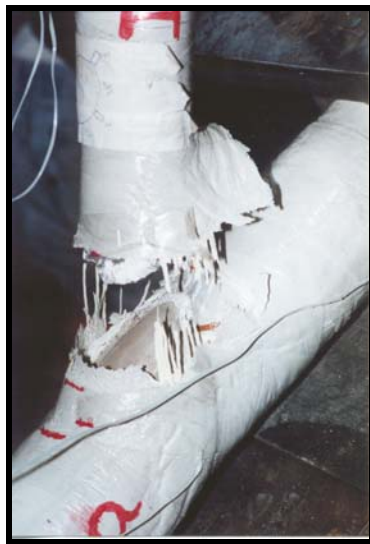
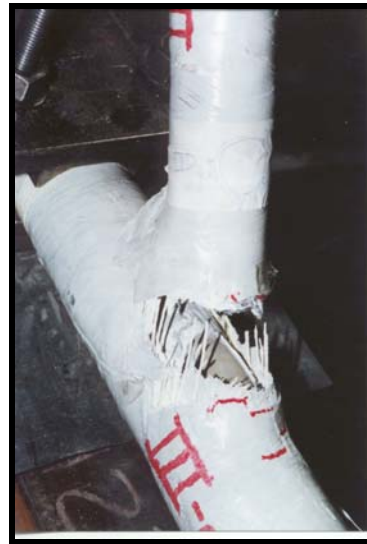
Series (III) tests had two basic failure modes: (1) cracking through the throat of the weld and FRP tensile failure, and (2) cracking through the toe of the weld, followed by cracking through the throat of the weld and FRP tensile failure. The first failure mode occurred in tests III-a and III-d and is shown in Figure 17 and Figure 18. This failure consisted of initial cracking of the FRP composite (note the horizontal lines in Figure 17) followed by cracking failure through the throat of the weld and finally by tensile failure of the FRP composite. The load, displacement, and cumulative damage curves are shown in Figure 19 for test III-a, and Figure 20 for test III-d. It can be seen in Figure 19(b) and (c) that the weld failed at about 5000 cycles, and the FRP failed much later at 6763 cycles. From Figure 19(c) it is also evident that the damage did not increase as rapidly near the failure point, as compared to the Series (II) tests. This indicates that for this particular failure mode, the failure is more brittle than that of the Series (II) tests. This is also shown by the lower cumulative damage of 0.33 at failure for test III-a, which is slightly less than the comparable test II-a (2).

Figure 17. Test III-a: (a), and (b) Failure of weld and FRP composite

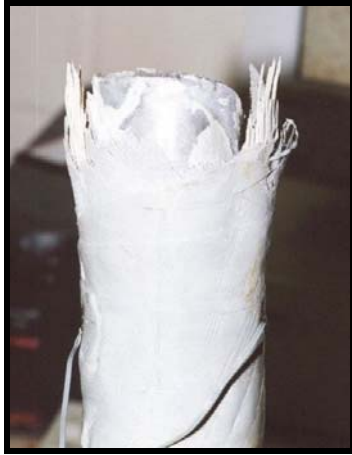
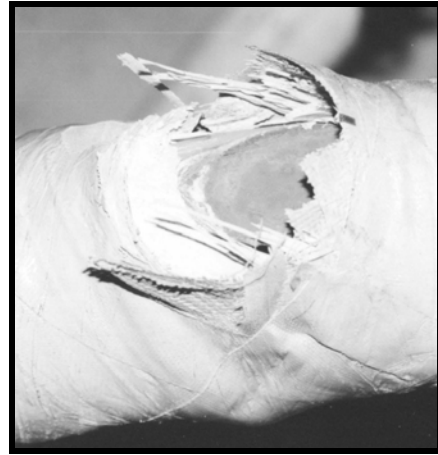
Test III-d lasted the pre-determined infinite-life-limit of 1×10^6 cycles, and was subsequently tested in static tension to failure, as shown in Figure 18. Of all the tests in the present research and the previous research (Pantelides and Nadauld 2001), test III-d obtained the largest static tensile load of 44.17 kips at a displacement of 0.75 in., as shown in Figure 21. This test also had the least damage after reaching 1×10^6 cycles; the maximum cumulative damage was 0.19, as shown in Figure 20(c). The cause of this large static strength and superior fatigue behavior is not clear.

Figure 18. Test III-d: (a), (b), and (c) Failure of weld and FRP composite

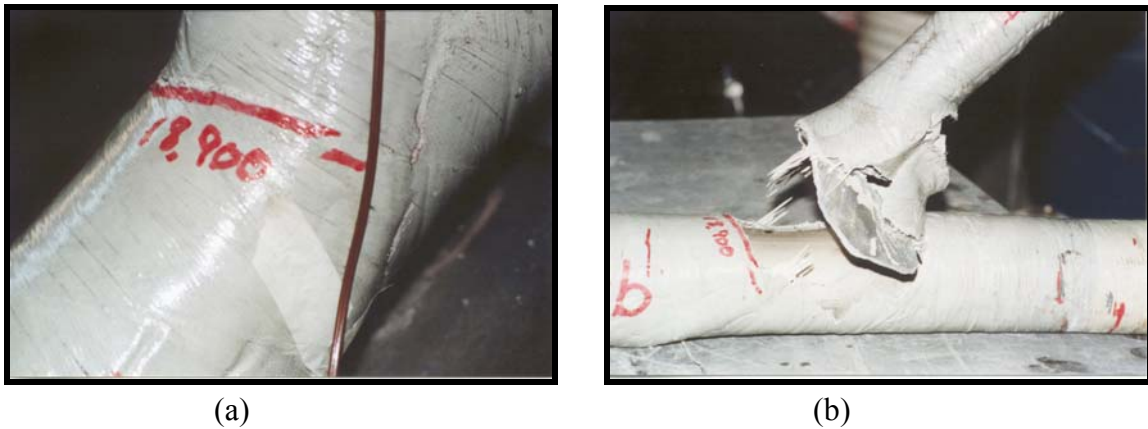
The second failure mode seen in the Series (III) tests is shown in Figures 22 and 23. This failure was seen in tests III-b and III-c. In this failure mode, cracking was seen in the FRP first. This cracking was directly above the initial crack of the aluminum at the toe of the weld; this failure was not through the throat of the weld. This crack at the toe of the weld propagated around the chord, similar to the failure mode of Series (II) tests. Next the weld was slowly fatigued; this occurred in the throat of the weld, until the weld completely fractured. This was followed by tensile failure of the FRP composite.

Figure 22. Test III-b: (a) Initial cracking of FRP composite, (b) Failure of Base Material, Weld, and FRP composite

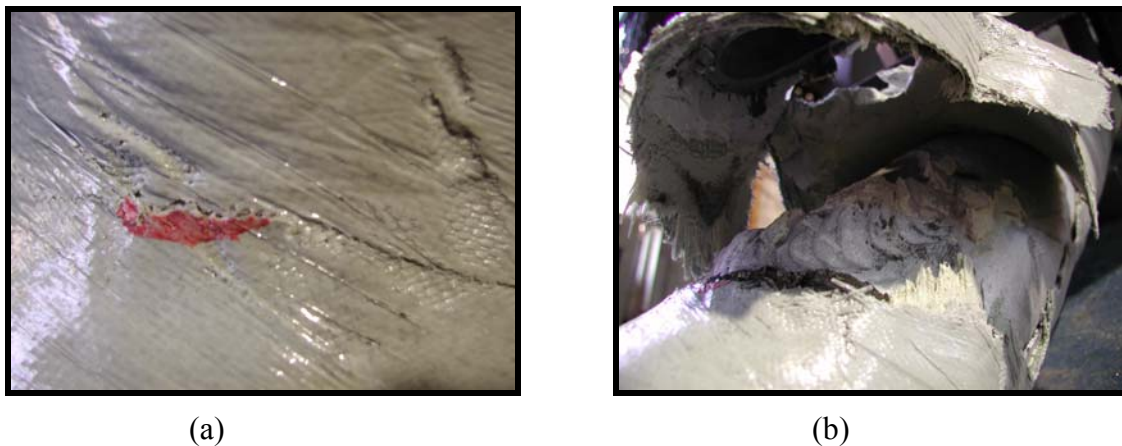
Test III-c was fatigued until 1×10^6 cycles were reached. After 1×10^6 cycles the crack in Figure 23(a) had formed. The remaining strength of the connection after 1×10^6 cycles was determined with a tensile static test, as in test Series (I). The static test revealed a failure mode similar to test III-b, i.e. Failure Mode 2, which included failure of the aluminum at the toe of the weld, followed by failure of the weld through the throat of the weld, and finally failure of the FRP composite. These failures can be seen in Figures 25 and 26. In this test these failures occurred immediately after one another, with only 0.72 seconds from initial failure to complete failure. The occurrence of three distinct failure phases was also verified through testing

Figure 23. Test III-c: (a) Crack in FRP after 1×10^6 cycles, (b) Picture of III-c after static loading to failure

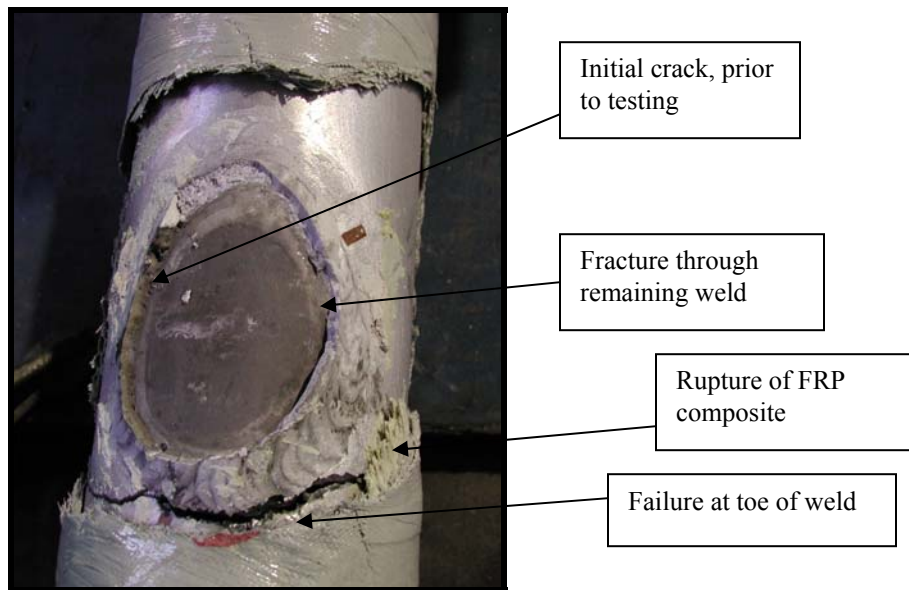
Figure 25. Picture of test III-c after static test showing failure stages

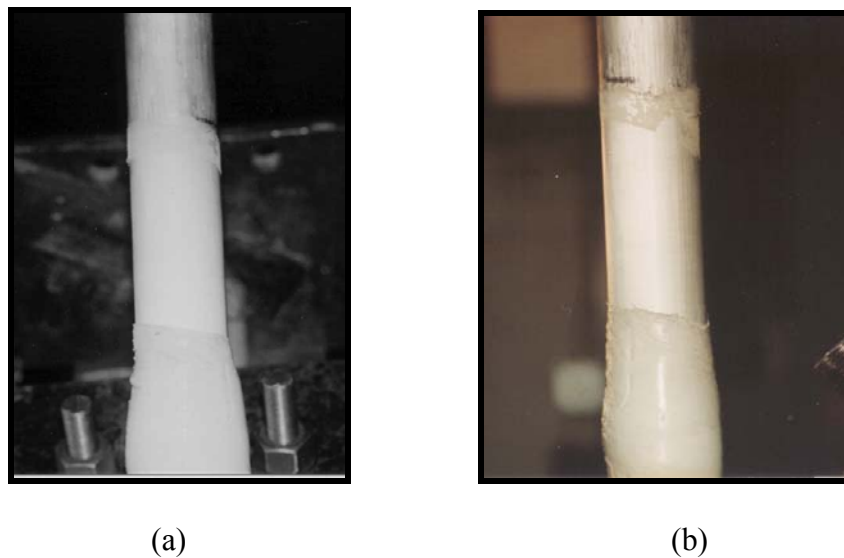
Series (IV) tests had two failure modes: adhesive failure, and FRP composite tensile failure. The adhesive failure occurred in tests IV-a (1) and IV-c. The adhesive failure of tests IV-a (1) and IV-c is shown in Figure 28. This failure is identical to the adhesive failure described in the previous report regarding static tests of similar joints (Pantelides and Nadauld 2001). In this failure mode, the aluminum tube simply pulls out of the FRP jacket. For more information regarding this failure mode consult the previous report (Pantelides and Nadauld 2001). Figures 29 and 30 show the load, displacement, and cumulative damage curves for tests IV-a (1) and IV-c, respectively. Figure 29 shows the load and displacement curves as continuous plots, rather than envelopes of the maximum and minimum values. This was done due to the small number of cycles to failure in this test, and to allow the reader a better understanding of what occurred during the test. It can be seen that test IV-a (1) did not perform very well, and must have been very close to its static tensile capacity. This is shown by the low amount of cumulative damage prior to failure, which was only 0.20 as compared to 0.33 in test III-a. This indicated that the failure was rather abrupt, and would give very little warning as to impending failure. This same behavior was observed in test IV-c, as shown in Figure 30. The cumulative damage was only 0.24 just prior to failure, which indicates even less warning as to impending failure.

Figure 28. Adhesive failure (a) IV-a (1), (b) IV-c

After completion of the above tests it was determined that the poor overall performance of the Series (IV) tests was due to poor bond between the aluminum and the FRP. There may be many reasons for this poor bond. Any aluminum surface exposed to air develops a thin oxide film, which is hard, chemically stable, and tightly keyed to the metal. Though very thin, typical thickness 0.0002 in., this layer prevents further oxidation (Dwight 1999). When damaged, it immediately reforms, provided oxygen is available, and it is this that gives aluminum its good durability. In moderate industrial environments, the aluminum surface will darken and roughen. As the atmosphere becomes more aggressive, the discoloration and roughening increases with visible white powdery oxides. When surface attack occurs, there is a rapid initial loss of reflectivity over 6 to 36 months, thereafter slowing down with little change over the next 10 to 80 years (Bull 1994). Practically all the units from the field had obvious discoloration and roughening, and for some the white powdery oxides were visible.

Because the Series (IV) test units were constructed of new aluminum pipes, which were brand new and not exposed to the atmosphere, the dark and roughened surface observed in the field units was not there; on the contrary, the Series (IV) units had a very shiny and smooth surface. In addition, the aluminum surface of the Series (IV) units contained oils and other elements that were not completely removed in the preparation steps outlined in the first report (Pantelides and Nadauld 2001). Therefore, the poor performance of the Series (IV) units can be attributed to the reduced roughening of the surface and the presence of oils, both of which contributed to the poor bond. In order to determine if the use of new aluminum was having an effect on the performance of the Series (IV) tests, the Series (V) tests were performed.

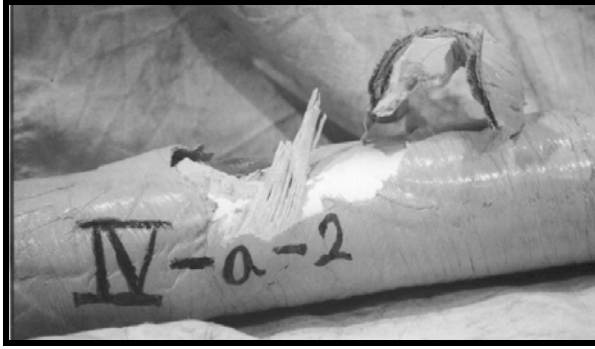
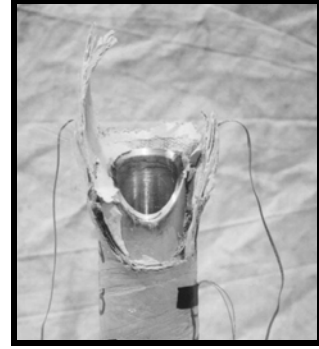
Figure 31. FRP composite failure of test IV-a (2)

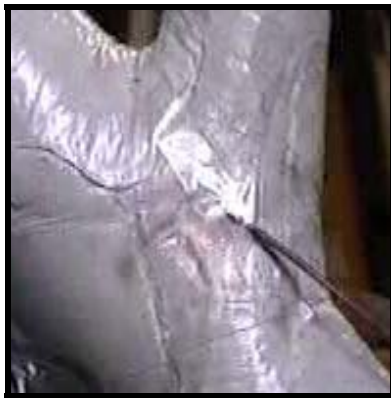
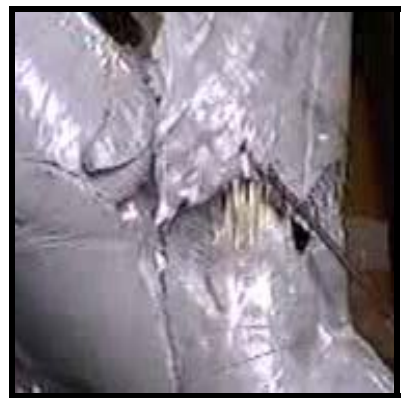
Figure 32. Sequence of failure for test IV-b: (a) 0.004 sec. prior to failure, (b) 0.467 sec. after failure, (c) 1.746 sec. after failure

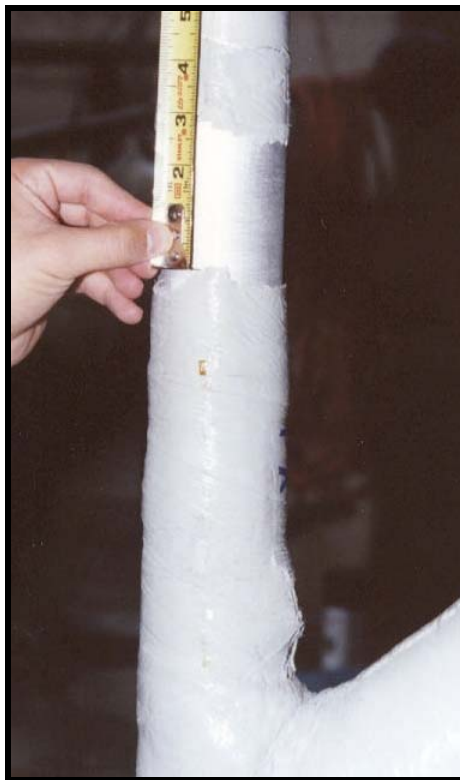
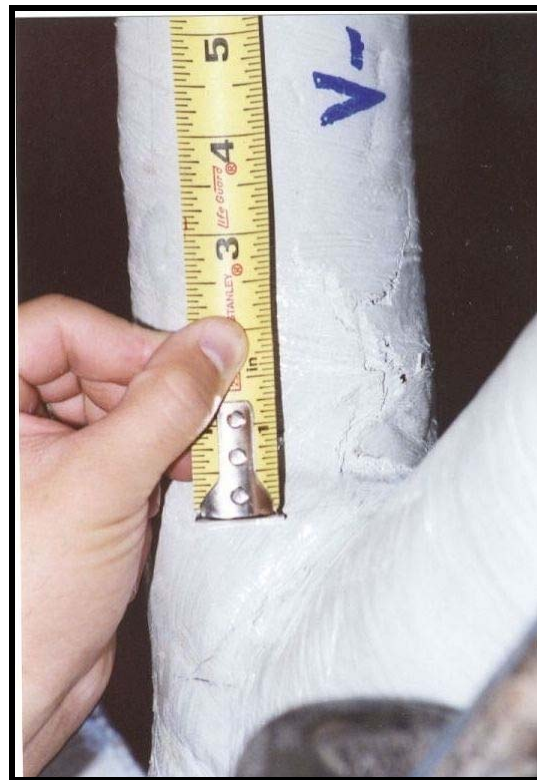
This failure mode was only observed in test V-b (1), as shown in Figure 35(a). This type of failure was caused by the decreased bond length of test unit V-b (1) that was about 2 inches shorter than all the other retrofitted test units in this study. However, in this particular test the FRP was also observed to tear open as the aluminum tube was pulled out of the FRP jacket, as shown in Figure 35(a) and (b). This tearing was caused by the weld that remained at the end of the diagonal member, which caused the diameter of the diagonal at the weld to be larger than the pipe diameter. This is certainly an advantage, due to the mechanical interlocking of the diagonal and the FRP, even though this failure mode is the least desirable due to its lower strength and sudden failure. It can be seen in Figure 36 that the cumulative damage of test unit V-b (1) increased very rapidly at the beginning of the test, likely due to the failure of the remaining 10% of the weld. The damage then slowly increased until it reached 0.28 at 224,101 cycles, at which point the damage jumped to 0.35. This sudden increase in damage is likely the onset of the adhesive failure, which was interrupted by the weld interlocking with the FRP as discussed earlier. The damage then continued to increase at a much more rapid rate until it reached 0.69, when the weld at the end of the diagonal ripped through the FRP composite jacket as shown in Figure 35.

Figure 35. Test V-b (1): (a) Adhesive failure w/FRP tearing, (b) Close-up of FRP tearing failure

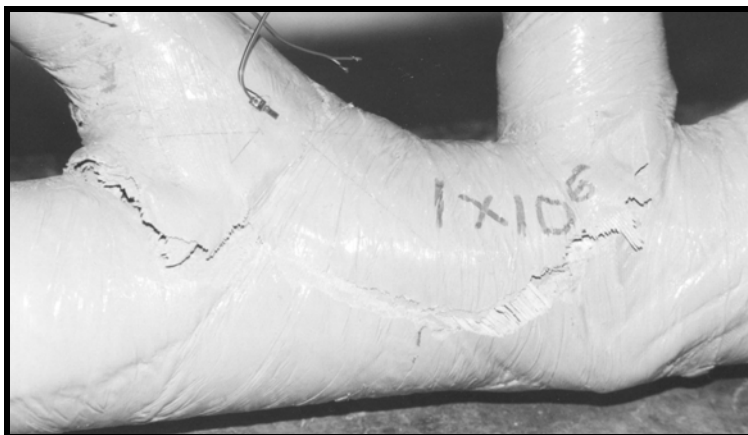
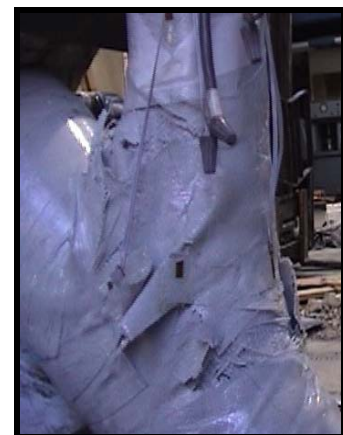
Figure 37. FRP Composite Tensile Failure: (a) V-a, (b) V-c

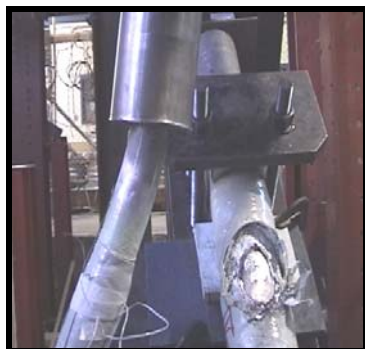
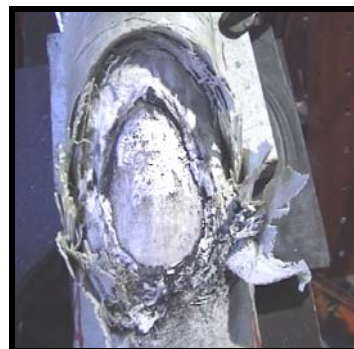
Figure 41. Test V-b (2): (a) Buckled diagonal, (b) Failed FRP at chord

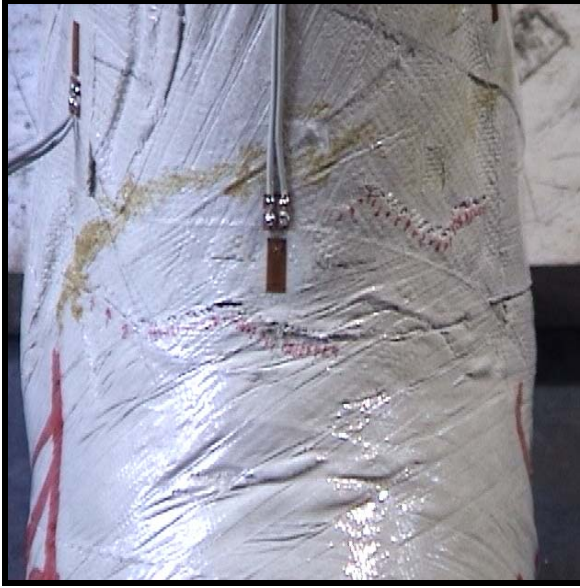
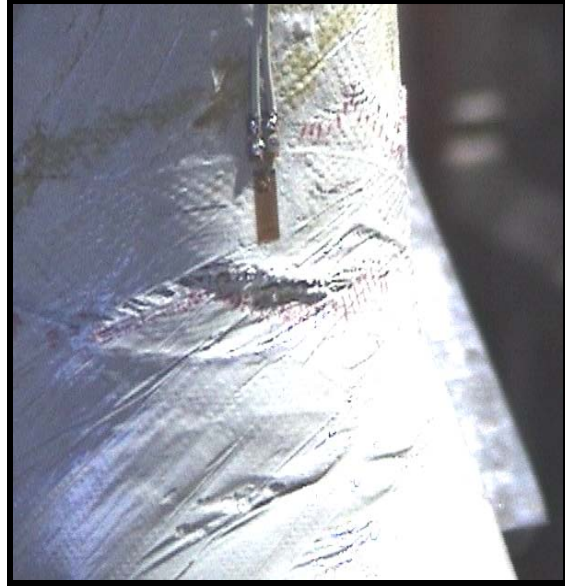
Figure 43. Test V-b (2): (a) cracking at approx. 65,000 cycles, (b) cracking at approx. 290,000 cycles
