TRANSPORTATION POOLED FUND PROGRAM QUARTERLY PROGRESS REPORT

Transportation Pooled Fund Program Project # TPF-5(189)	Transportation Pooled Fund Program - Report Period: <input type="checkbox"/> Quarter 1 (January 1 – March 31) <input type="checkbox"/> Quarter 2 (April 1 – June 30) <input checked="" type="checkbox"/> Quarter 3 (July 1 – September 30) <input type="checkbox"/> Quarter 4 (October 4 – December 31)	
Project Title: <i>"Enhancement of Welded Steel Bridge Girders Susceptible to Distortion-Induced Fatigue"</i>		
Project Manager: John Jones, KDOT	Phone: 785-368-7175	E-mail: jjones@ksdot.org
Project Investigator: Caroline Bennett Adolfo Matamoros Stan Rolfe Ron Barrett-Gonzalez	Phone: 785-864-3235 785-864-3761 785-864-3767 785-864-2226	E-mail: crb@ku.edu abm@ku.edu srolfe@ku.edu barretr@ku.edu
Lead Agency Project ID:	Other Project ID (i.e., contract #): KAN00063732	Project Start Date: 08/31/2008
Original Project End Date: 08/31/2011	Current Project End Date: 08/31/2013	Number of Extensions: 1

A large number of steel bridges within the national inventory are affected by distortion-induced fatigue cracks. Repairs for this type of failure can be very costly, both in terms of di

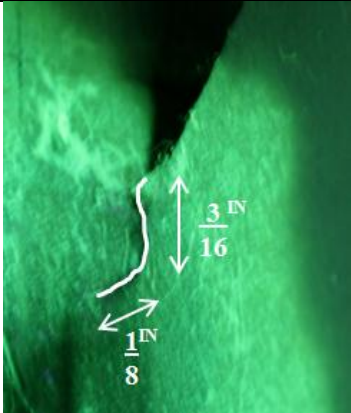
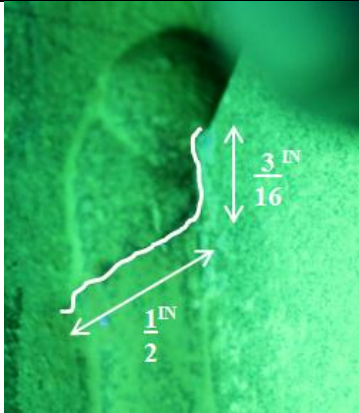
Before Retrofit	After Retrofit Cycled 1.2 Million
Interior Face, Left Side

Cracking on the interior face of the north girder experienced low growth under the application of the retrofit, and crack geometries pre- and post- retrofit are presented in Table 2. No cracking was noted in the fascia side of the north girder.

While counterintuitive, finite element analyses performed by the researchers regarding field bridges and of the 9-ft. specimens have shown that very short crack lengths induce the most demanding stress condition in the web gap. Additionally, this test marks the first time this retrofit has been installed over crack lengths this small. Therefore, this is likely an extremely demanding scenario for the web gap and retrofit application.

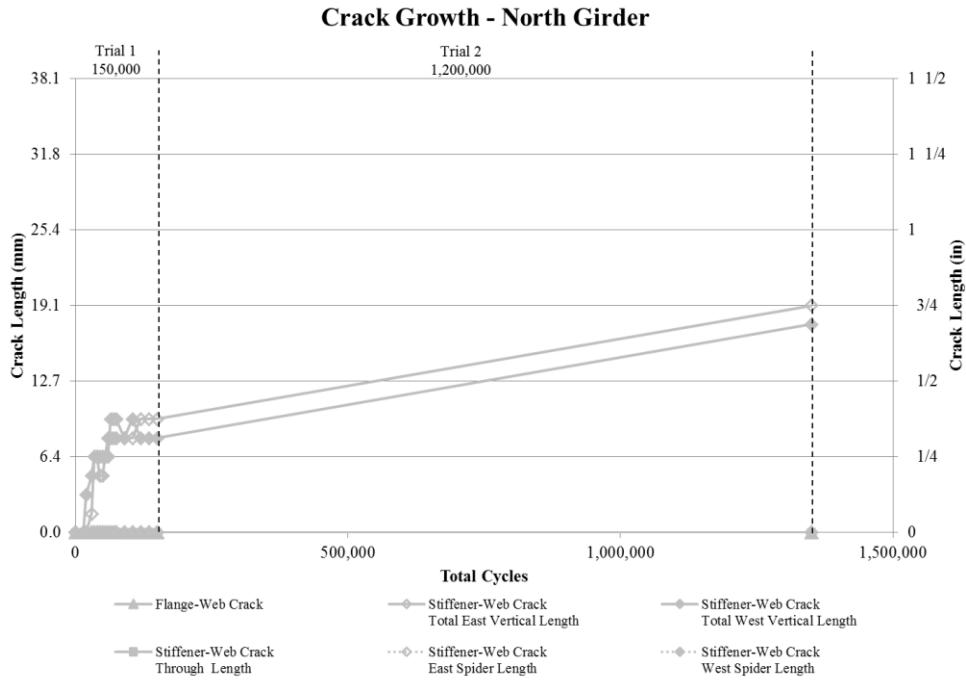
Figure 1: Crack growth plot for Trials 1 and 2 in the north girder

Plots showing crack length over time (cycles) for both the north and south girders are shown in Figures 1 and 2.

To continue to assess the effectiveness of this retrofit, the applied stress range will be increased. A load range of 72 kips (8 kips – 80 kips) will be applied to the bridge in the retrofitted condition. This will further increase the demand placed upon the web gap region, and will be a very stringent test of the retrofit's effectiveness.

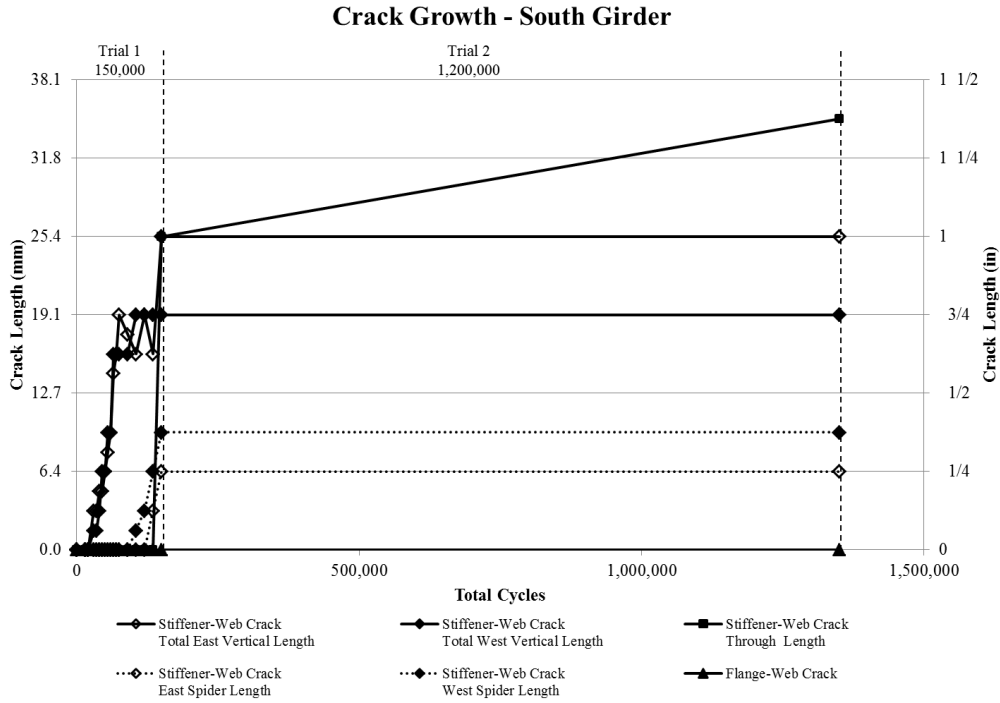
Figure 2: Crack growth plot for Trials 1 and 2 in the south girder

It can be seen that cracks did not propagate under the retrofit on the interior face of the girder. The crack on the fascia side of the girder experienced ¼-in. of crack growth while the retrofit was applied. This crack formed as a through-thickness crack from the spider cracking that can be seen on the interior side of the girder. The total length of the crack seen on the fascia side is 1³/₈-in. This crack length correlates with the total projected crack length on the interior side of the girder, including the spider crack length (3/8-in. + ¼-in.), stiffener width (3/8-in.) and weld width (3/8-in.). Therefore, it is likely that the change in the fascia crack length can be attributed to the existing interior crack propagating through the girder thickness.

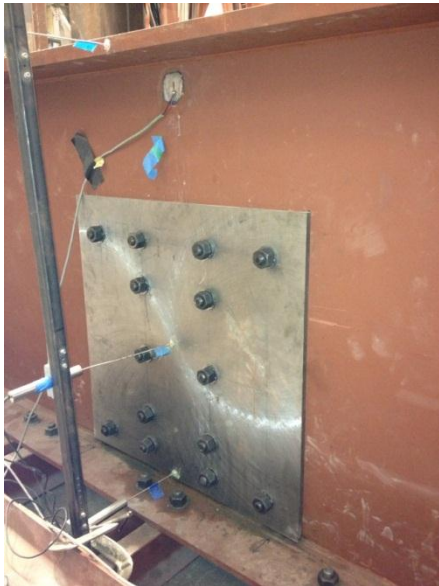
Specimen 3 has undergone a significant testing series including various trials, and the crack lengths at the onset of the trial described in this progress report are quite significant. The horizontal web-to-flange crack had a total length of 21.5 in. at the onset of this new trial, and cracks emanating out of the web-to-stiffener weld extended approximately 14-in. into the web.

Figure 3: View of backing plate used in most recent test trial of Specimen 3

A version of the angles with backing plate repair was implemented on Specimen 3 in this highly-damaged state, in which two L6x6x3/4 segments 19-in. long were utilized with a backing plate having dimensions 24-in. x 24-in. x 1/2-in. This retrofit application covered the lengths of the horizontal and vertical cracks. Testing was performed until 1.2 million cycles were achieved, after which the specimen was inspected for crack growth. No additional crack growth was detected. The retrofit applied to Specimen 3 is shown in Figures 3 and 4.

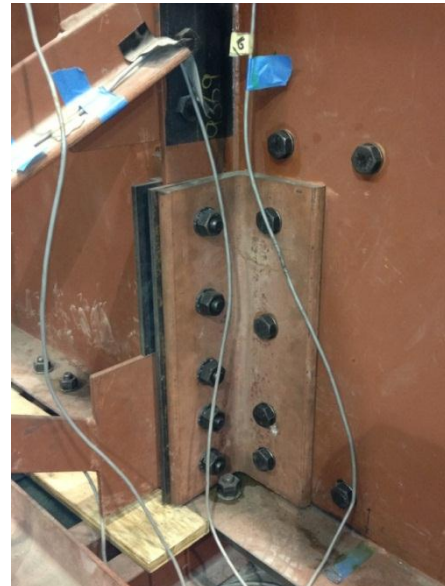
Figure 4: View of double angles used in most recent test trial of Specimen 3

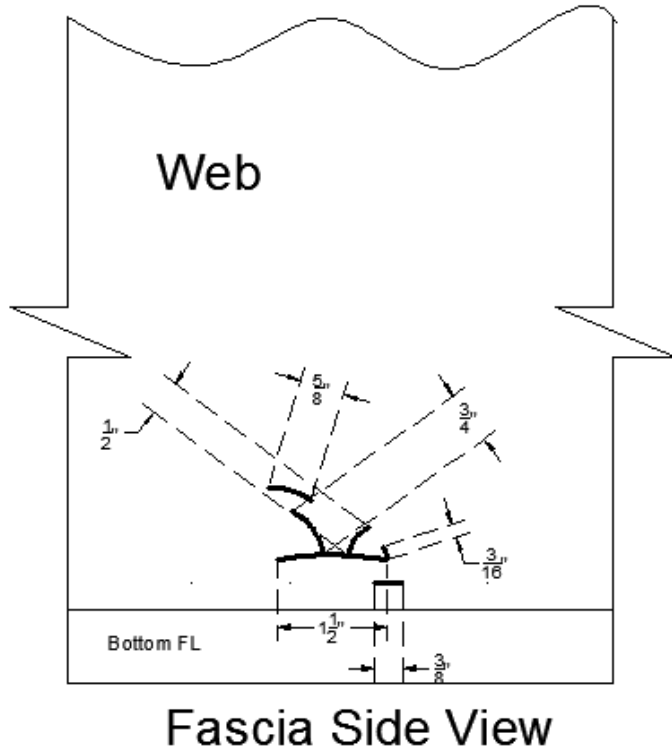
The composite block retrofit discussed in the June, 2012 progress report was removed after 1.2 million cycles. The web gap region was inspected for crack growth, and it was found that the cracks had propagated modest amounts, with the greatest propagation occurring at the flange-to-web weld (1 5/16" growth over 1.2M cycles).

Figure 5: Cracking pattern in Specimen 4 on the fascia side of the web gap region

The CFRP block was removed from Specimen 4, and the cracks were allowed to grow freely for approximately 30,000 cycles. Then, to begin investigating the performance of crack-arrest holes under distortion-induced fatigue, very small 1/4-in. dia. crack-arrest holes were drilled at the tips of the cracks. The cracking patterns just prior to drilling the crack-arrest holes are shown in Figures 5 and 6.

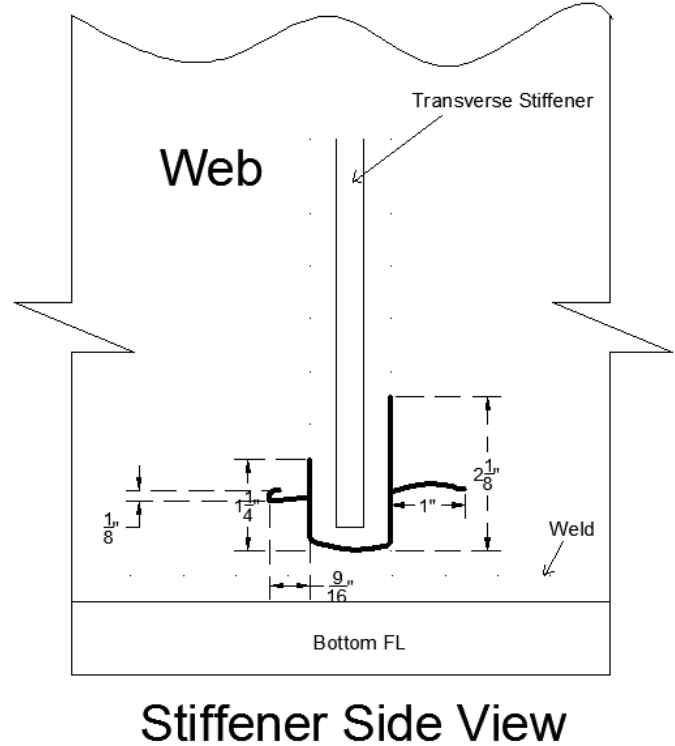
Figure 6: Cracking pattern in Specimen 4 on the interior side of the web gap region
