## TRANSPORTATION POOLED FUND PROGRAM QUARTERLY PROGRESS REPORT

<b>Transportation Pooled Fund Program Project #</b> TPF-5(189)	<b>Transportation Pooled Fund Program - Report Period:</b> <input type="checkbox"/> Quarter 1 (January 1 – March 31) <input type="checkbox"/> Quarter 2 (April 1 – June 30) <input type="checkbox"/> Quarter 3 (July 1 – September 30) <input checked="" type="checkbox"/> Quarter 4 (October 4 – December 31)	
<b>Project Title:</b> <i>"Enhancement of Welded Steel Bridge Girders Susceptible to Distortion-Induced Fatigue"</i>		
<b>Project Manager:</b> John Jones, KDOT	<b>Phone:</b> 785-368-7175	<b>E-mail:</b> <a href="mailto:jjones@ksdot.org">jjones@ksdot.org</a>
<b>Project Investigator:</b> <b>Caroline Bennett</b> Adolfo Matamoros Stan Rolfe Ron Barrett-Gonzalez	<b>Phone:</b> <b>785-864-3235</b> 785-864-3761 785-864-3767 785-864-2226	<b>E-mail:</b> <a href="mailto:crb@ku.edu">crb@ku.edu</a> <a href="mailto:abm@ku.edu">abm@ku.edu</a> <a href="mailto:srolfe@ku.edu">srolfe@ku.edu</a> <a href="mailto:barretr@ku.edu">barretr@ku.edu</a>

A large number of steel bridges within the national inventory are affected by distortion-induced fatigue cracks. Repairs for this type

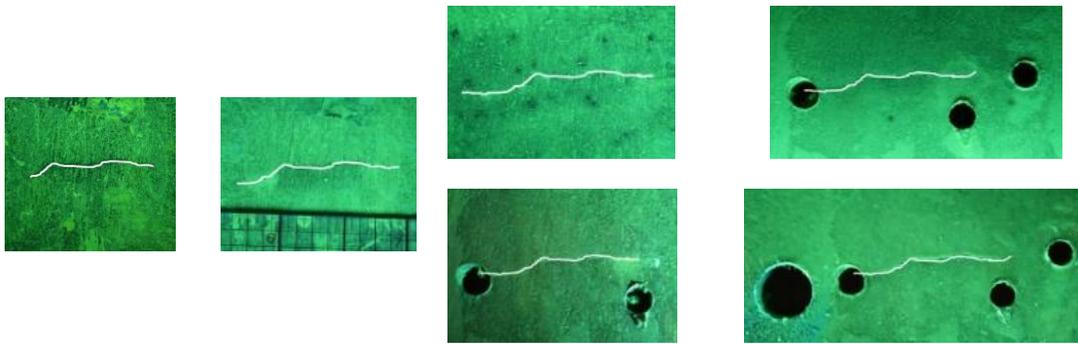
**Exterior, South Girder**

Table 2: Cracking patterns for Trials 1 – 4 for the South Girder

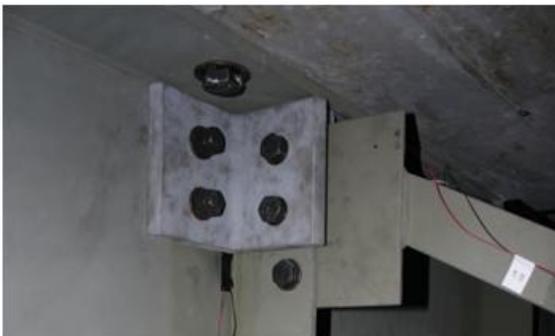
Figure 1. View of double angles and backing plate retrofit on interior face of an exterior girder.

After cracking reached 1 in., the double angle and back plate retrofit was applied to the bridge in the top web gaps of both the North and South exterior girders, as shown in Figures 1-3. It should be noted that crack-arrest holes were not drilled at the tips of the cracks in this test trial, to produce the most demanding test for the retrofit.

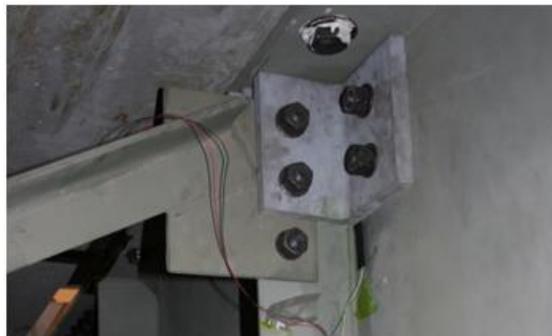
Figure 2. View of double angles and backing plate retrofit on interior face of an exterior girder.

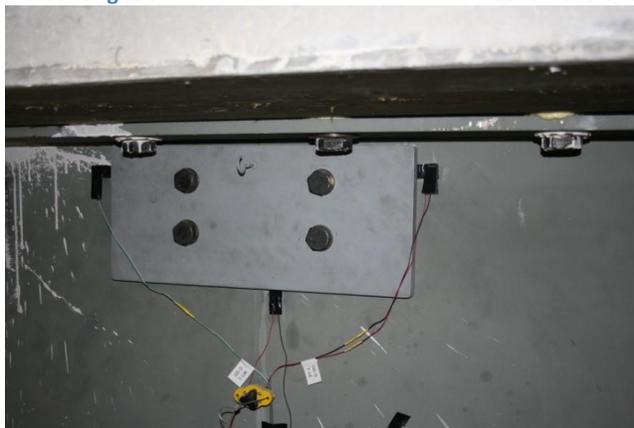
Figure 3. View of double angles and backing plate retrofit on exterior face of an exterior girder (backing plate shown)

After the bridge was subjected to 1.2 million cycles cycling between 6 - 60 kips in the retrofitted condition, the retrofit was removed and the bridge was inspected for cracking. No crack growth was noted on the interior face of the south girder;

however, the through-thickness crack grew  $\frac{3}{8}$  in. Some crack growth was also noted in the cracks on the interior face of the north girder. On the left side of the stiffener, cracking extended from  $\frac{5}{16}$  in. to  $\frac{11}{16}$  in., while on the right side of the stiffener, cracks grew from  $\frac{3}{8}$  in. to  $\frac{3}{4}$  in.

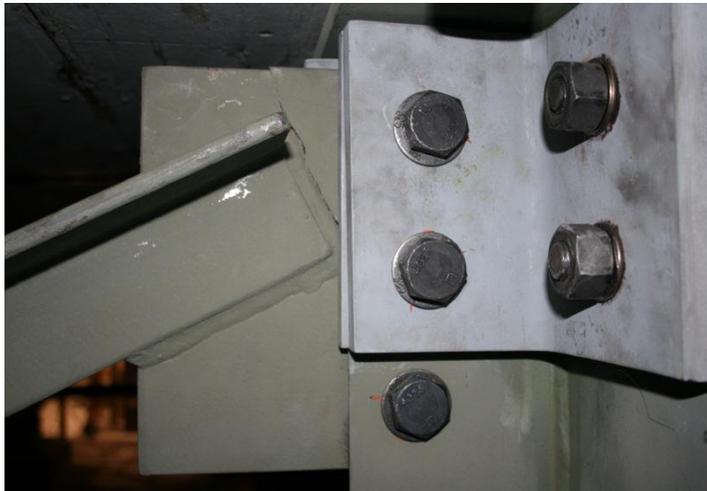
At approximately 650,000 cycles, a faint clicking noise was noticed coming from the connection stiffener in the north girder. After inspection, no change in bridge response was noticed. While under inspection at 1.061 million cycles, the cross frame between the north and center girders was found to be cracked through the depth of the connection tab plate, as seen in the following images. It appears that the crack started at the bottom corner of the weld toe where the angle framed into the tab plate.

Figure 4. View of crack in the cross frame table plate before removal of the cross frame

- (1) While cracking did propagate during this test, the load demand was quite severe. Additionally, the crack-arrest holes were much smaller than is commonly used the field, and were purposefully installed as such to create a demanding test.
- (2) Only minimal crack propagation was sustained within the top web gap regions, and a significant crack was produced in the connection between a cross frame member and tab plate. This indicates that the location most susceptible to cracking was *shifted* from the sensitive web gap regions to a detail that is generally not highly susceptible to fatigue cracking. This finding indicates that a high level of protection was provided to the web gap regions.
- (3) Because the cross frame tab plate cracked through, uneven load distribution occurred in the web gap regions.

Therefore, the south girder likely experienced much higher stress ranges than would have been induced had the north cross frame been undamaged. Because of this, crack growth in the south girder should not be taken as indicative of the 10 – 100 kip load range.

Following discovery of the damaged cross frame, the cracked cross frame was removed from the bridge and repaired. The repaired cross frame was exchanged with an undamaged cross frame from the end support region of the bridge. Trial 4 was halted, due to the fact that load redistribution occurred when the cross frame cracked. Therefore, Trial 4 is not considered to be a controlled test of the retrofit's effectiveness, in that the retrofits in the North and South girder likely experienced varying and unequal stress levels; however, Trial 4 still has merit in that it showed that the retrofit was capable of shifting the "fragile" location in the bridge to a region outside the web gap region.

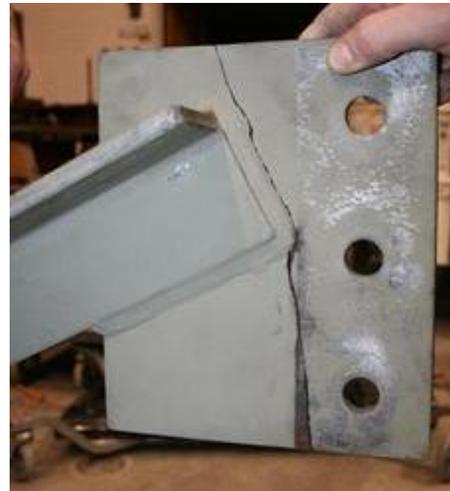
Figure 5. View of cracked tab plate after cross frame removal

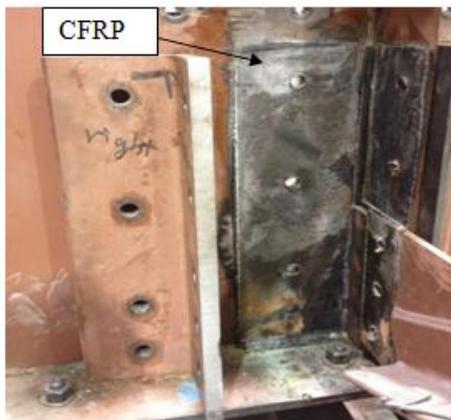
This quarter, Specimen 3 was retrofitted with a steel-CFRP sandwich composite. Specimen 3 had a crack extending 14-in. into the web, and a 21.5-in. long crack between the flange and web at the onset of testing. Therefore, this specimen was severely distressed and posed a significant demand for a retrofit. CFRP fabric, 1/16-in thick, was applied to the interior and exterior sides of the girder as shown in Figures 6-8. The CFRP bridged the vertical cracking between the stiffener and the girder web. After the CFRP was in place (bonded to the specimen with West 105 resin), two 19-in. long steel angles were placed between the interior face of the web and the connection stiffener, and a 24"x24"x $\frac{1}{2}$ " steel backing plate was placed over the CFRP on the fascia side of the girder. The CFRP was allowed to cure under the applied steel elements.

The specimen was subjected to fatigue for 1.2 million cycles at a load range of 0.1 - 5.7 kips, after which, the retrofit was removed and cracks inspected. No crack growth was noted.

Figure 6. View of the steel-CFRP sandwich retrofit applied to Specimen 3 (interior face of girder; left side of connection stiffener) – steel angle has been removed from the CFRP in this view

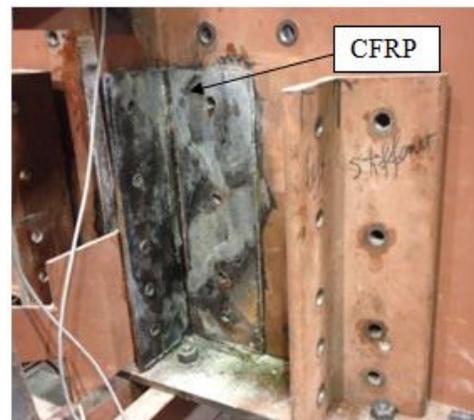
Figure 7. View of the steel-CFRP sandwich retrofit applied to Specimen 3 (interior face of girder; right side of connection stiffener) – steel angle has been removed from the CFRP in this view

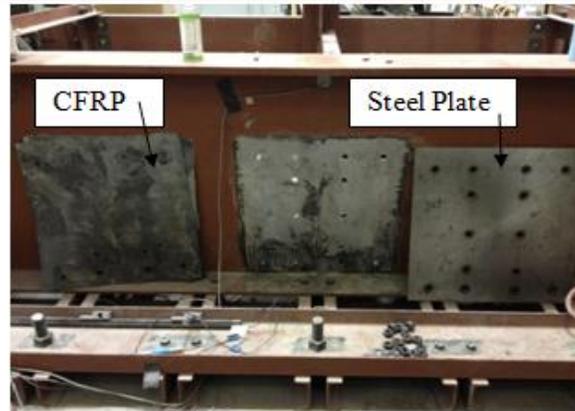
Figure 8. View of the steel-CFRP sandwich retrofit after both the steel and CFRP components of the repair have been removed from Specimen 3 (fascia side of girder)

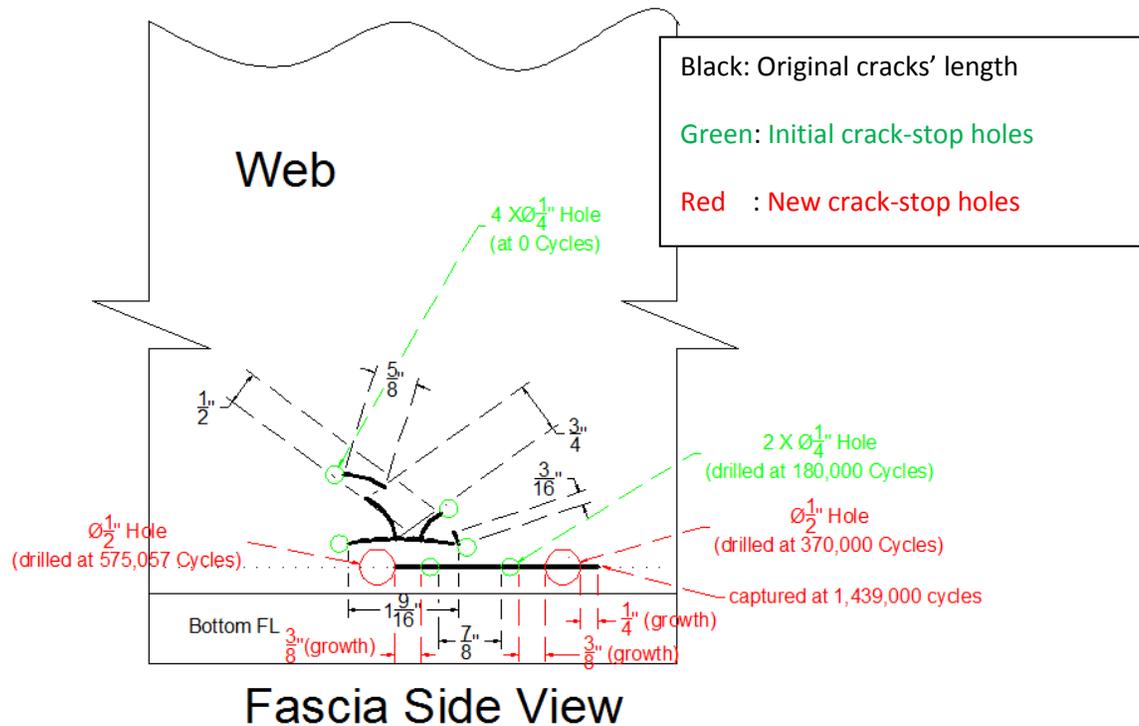
Specimen 4 was fatigue tested with a load range of 1 - 3 kips with a series of small-diameter crack-arrest holes this quarter. The purpose of this particular test sequence has been to gain a greater understanding of crack-arrest hole performance under distortion-induced fatigue loading. To accomplish this, cracking was allowed to develop, and then very small crack-arrest holes were drilled ( $\frac{1}{4}$ -in. dia.). The specimen was then subjected to fatigue testing, and crack propagation was observed in the left vertical crack on the stiffener side (Figure 10), and in the flange-to-web weld crack (Figure 9). For those cracks that reinitiated at the crack-arrest holes, the cracks were allowed to propagate a small distance. Then,  $\frac{1}{2}$ -in. dia. crack-arrest holes were drilled at the tips of the newly propagated cracks. Currently, Specimen 4 is being cycled again and monitored for crack reinitiation and propagation.

Figure 9. Schematic of crack-arrest holes on fascia side of Specimen 4

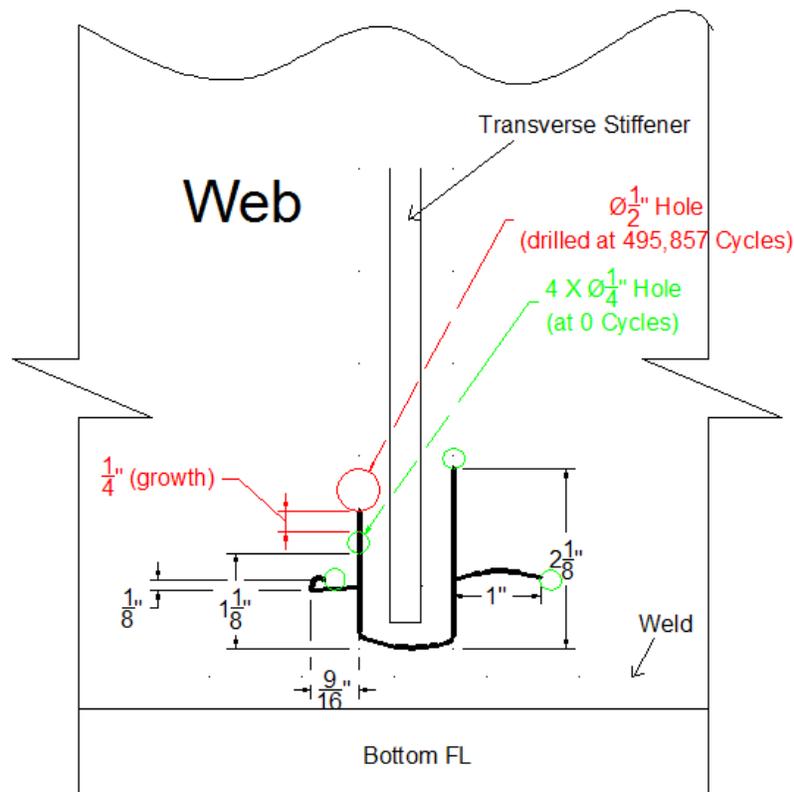
Figure 10. Schematic of crack-arrest holes on interior side of Specimen 4
