Testing of State Roadside Safety Systems Volume I: Technical Report

PUBLICATION NO. FHWA-RD-98-036

APRIL 1999

6. Performing Organization Code	
7. Author(s) King K. Mak, Roger P. Bligh, and Wanda L. Menges				8. Performing Organization Report No. Research Foundation 471470-Vol. I

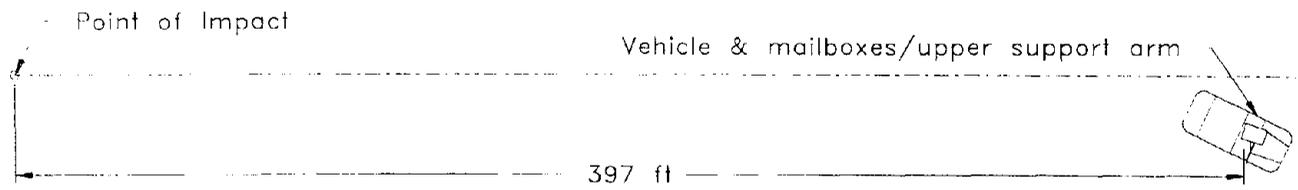
The vehicle sustained damage around the windshield area and in the occupant compartment. The mailbox assemblies intruded into the occupant compartment through the windshield and remained partially in the compartment throughout the test period. The roof of the vehicle was deformed upward from inside the vehicle approximately 50 mm (2 in). The passenger's side door was pushed out 40 mm (1.6 in) and the glass was shattered. The A-pillar and door post on the passenger's side were also deformed. The windshield was inside the vehicle.

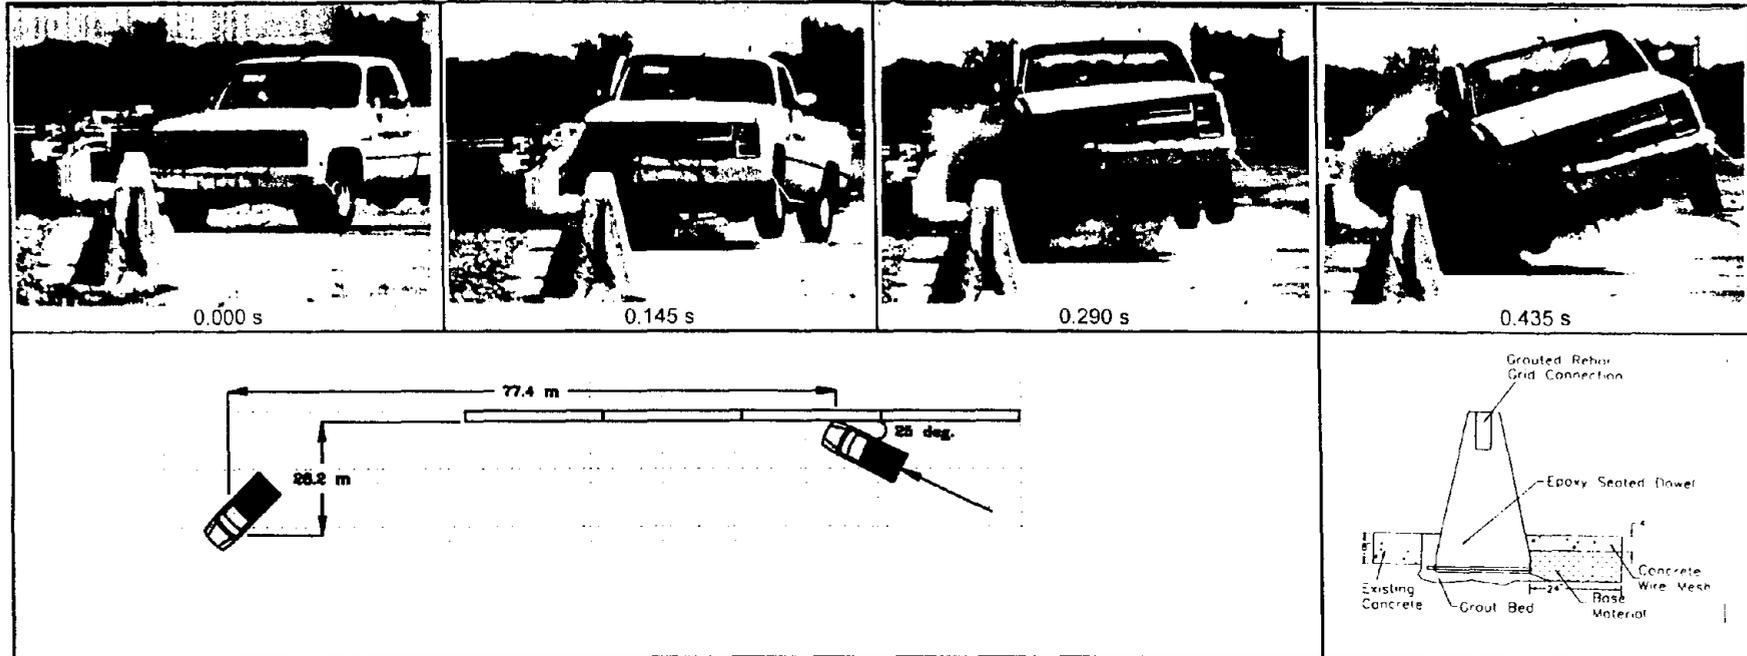
Figure 41. Summary of results for test 471470-15.

The barrier received only cosmetic damage (i.e., gouges, scrapes, and tire marks). Maximum permanent movement of the barrier was 2 mm (0.1 in) at the impact area. The vehicle was in contact with the barrier for 15.6 m (51.2 ft). The vehicle sustained extensive damage to the front suspension. Maximum crush at the right front corner of the vehicle was 178 mm (7.0 in). The front axle was separated from the vehicle and the spring shackles, U-bolts, shocks, mounts, tie rods, and steering arm were damaged. In addition, damage was sustained by the front bumper, the right front quarter panel, and the right and left running boards. The windshield was cracked and the fuel tank was scraped.

For the pickup truck test (test no. 471470-15), the single slope concrete bridge rail contained and smoothly redirected the vehicle. There were no detached elements or debris to cause undue hazard to occupants of the vehicle or to adjacent traffic. The vehicle sustained moderate damage with minor deformation into the occupant compartment. The vehicle remained upright and relatively stable during the collision period; however, there was some

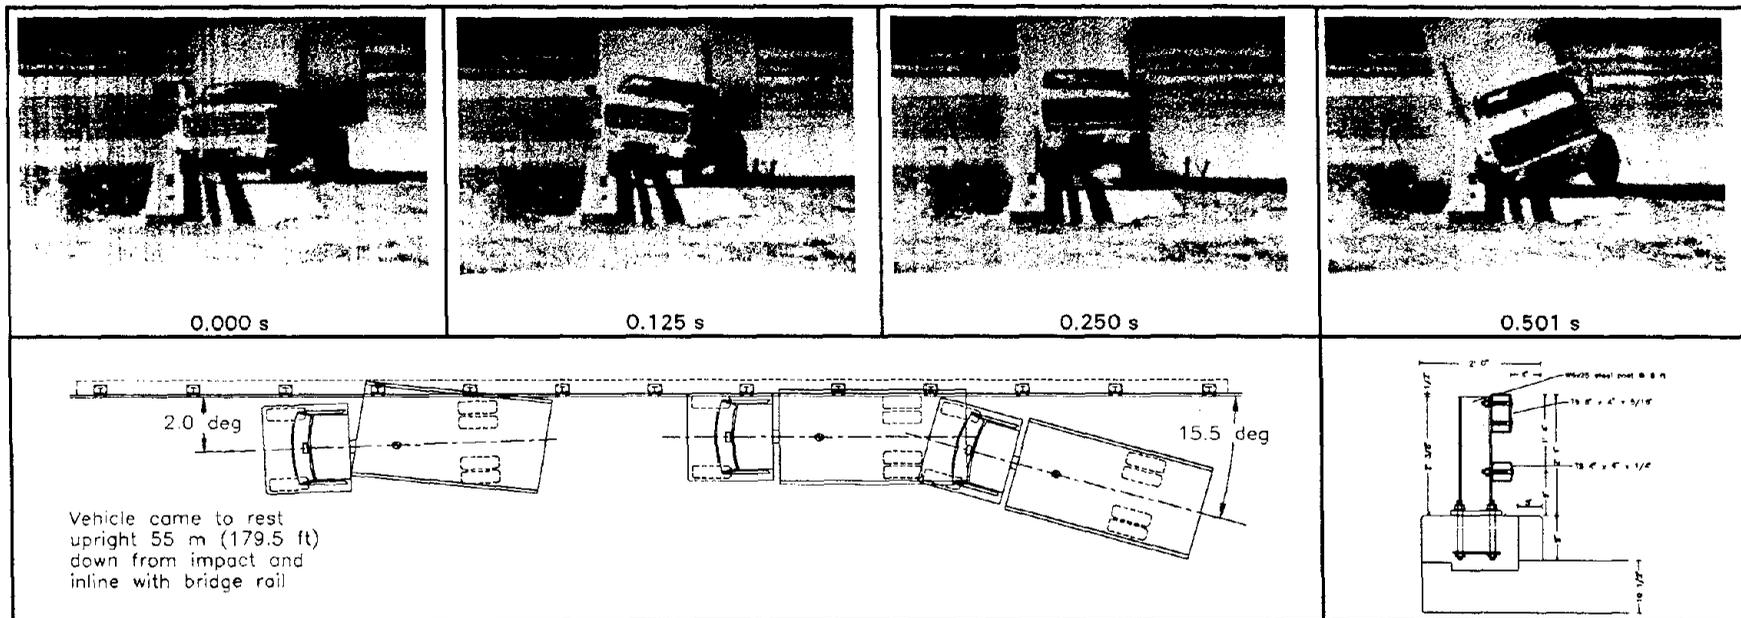
Maximum exterior crush at the right front corner of the vehicle was 120 mm (4.7 in) and there was no deformation or intrusion into the occupant compartment. The right-side spring U-bolts were damaged and the right front tire and wheel were pushed rearward into the fuel tank. The box was partially separated from the frame and shifted to the right. The bumper, hood, right front quarter panel, and right door also were damaged.

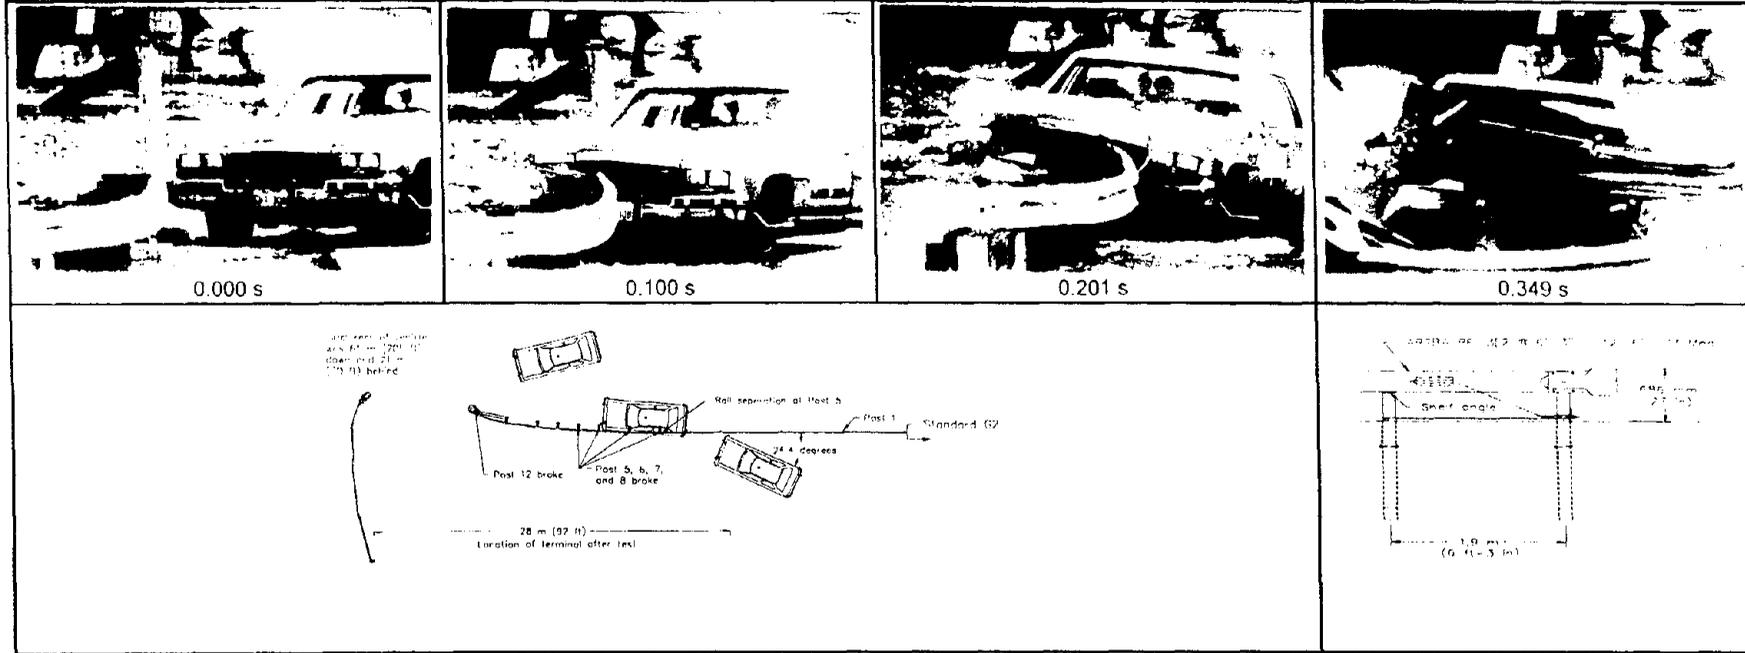
Figure 68. Summary of results for test 471470-23.

The vehicle impacted the transition area in the reverse direction (i.e., opposite to normal direction of travel) just upstream of post 13 (i.e., 4.6 m (15 ft) upstream of the last wooden post (post 8) of the Mini-MELT). As the vehicle impacted the terminal, the W-beam rail element began to deform and posts 12 and 13 began to displace laterally. The front tire of the vehicle impacted post 13 shortly afterwards, and movement began at posts 11, 14, and 10, respectively. The vehicle contacted post 12, and the right front tire aired out as it rode over post 12. Contact was made with post 11 and post 10 and the rear of the vehicle made contact with the rail near post 14. The vehicle then made contact with post 9 and post 8. The vehicle became parallel with the installation traveling at 73.2 km/h (45.5 mi/h). Maximum deflection of 0.96 m (3.15 ft) occurred near the post 10 location. The vehicle lost contact with the installation traveling at a speed of 58.4 km/h (36.3 mi/h) and at an exit angle of 8.8 degrees. As the vehicle exited the rail, it began to yaw clockwise, and subsequently came to rest 35 m (116 ft) downstream and 1.8 m (6 ft) forward of the point of impact. A summary of pertinent data from the electronic instrumentation, high-speed film, and field measurements is given in figure 69.
