# Enhancement of Welded Steel Bridge Girders Susceptible to Distortion-Induced Fatigue

*A Transportation Pooled Fund Study - TPF-5(189)*

## Final Report

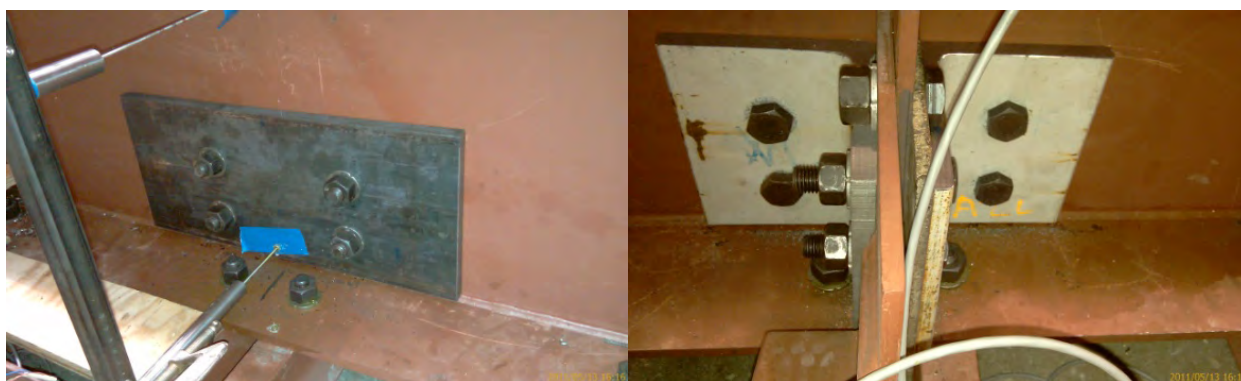
**Figure 3.3: Angles-with-plate repair installed in the bottom web gap of the 2.8 m (9.3 ft) girder model**

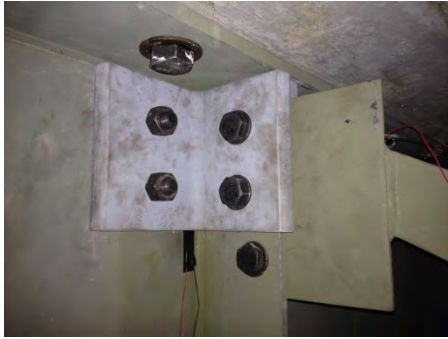
L152x152x19mm  
[L6x6x3/4"]

L127x152x19mm  
[L5x6x3/4"]

L457x203x19mm  
[18x8x3/4"]

**Figure 3.5: Angles-with-plate retrofit applied in Trials 2 to 6**  
(a) angles (b) back plate

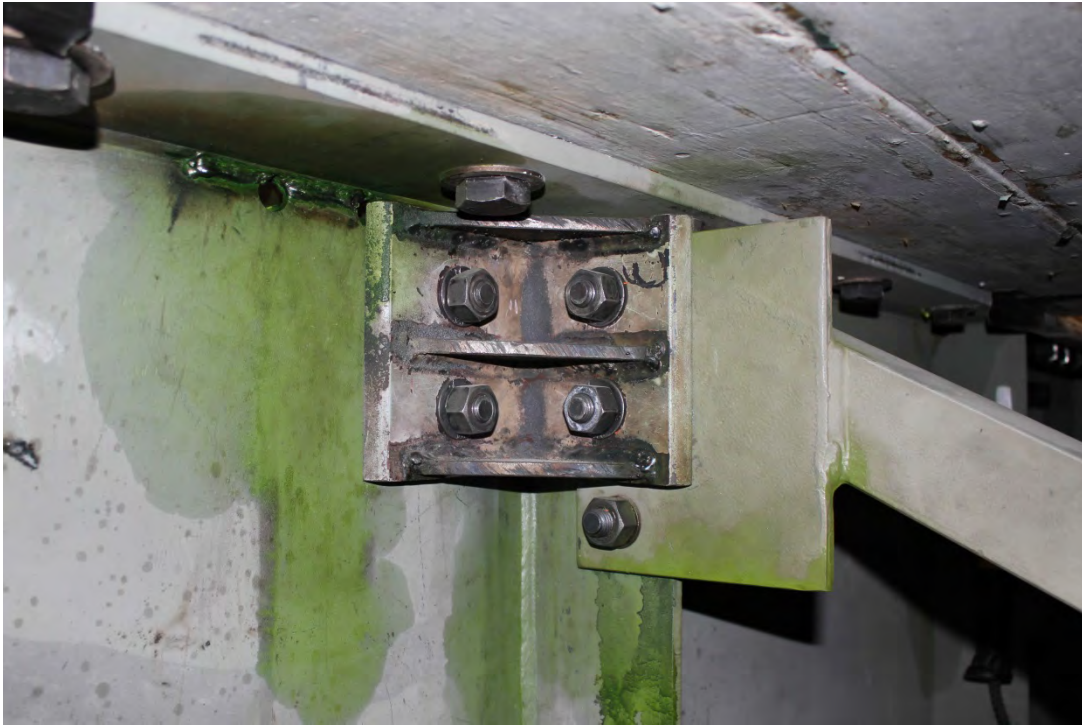
**Figure 3.6: Stiffened angles-with-plate retrofit applied to exterior girders in Trial 7**

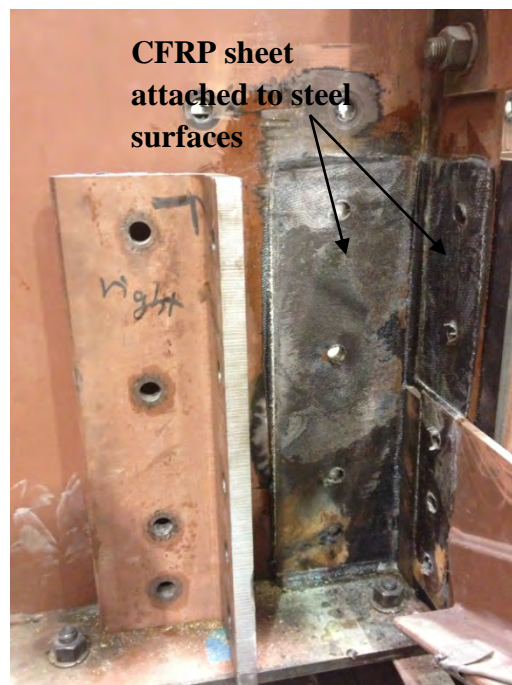
**Figure 3.15: Trial 2: view of the interior face of the girder's web before application of the angles-with-plate-with-CFRP retrofit measure**

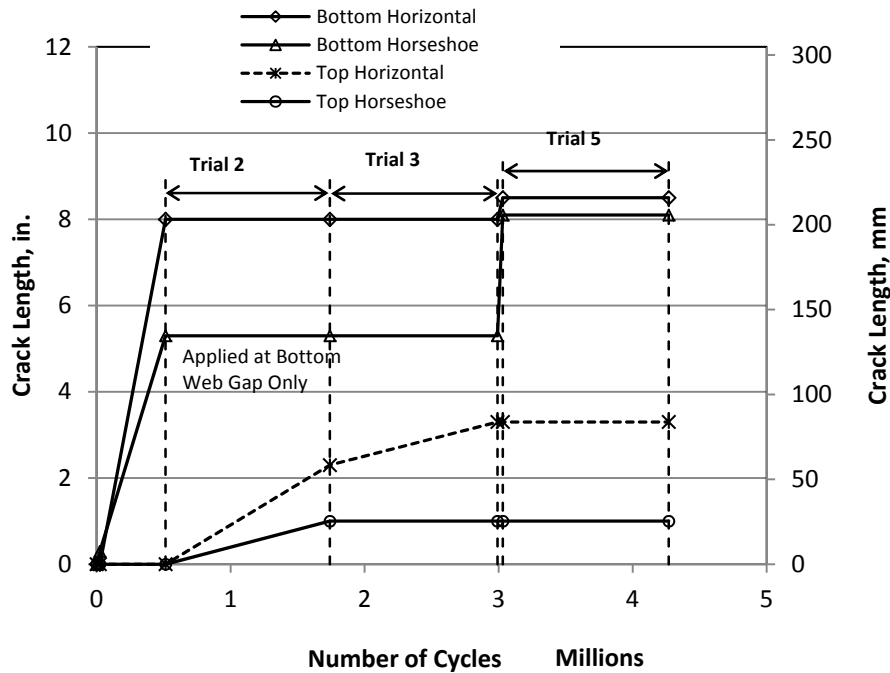
**Figure 4.1: Crack growth for Specimen 2**

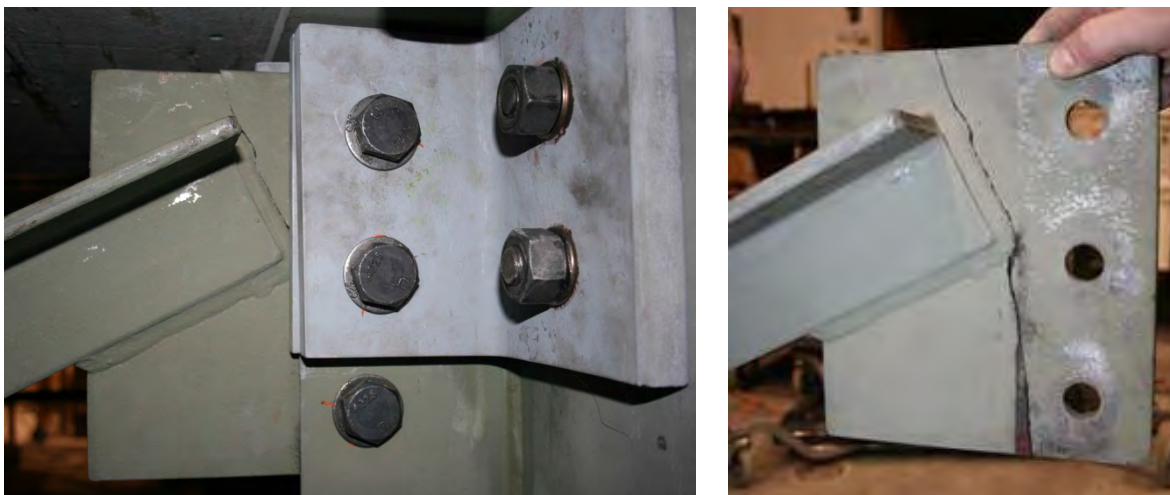
**Figure 4.6: North cross frame failure during Trial 4N**
