**ADVANCED SNOWPLOW DEVELOPMENT  
AND DEMONSTRATION:  
PHASE I: DRIVER ASSISTANCE\***

AHMCT Research Report  
UCD-ARR-99-06-30-03

Final Report of Contract  
Task Order 96-9 under IA65X875

June 30, 1999

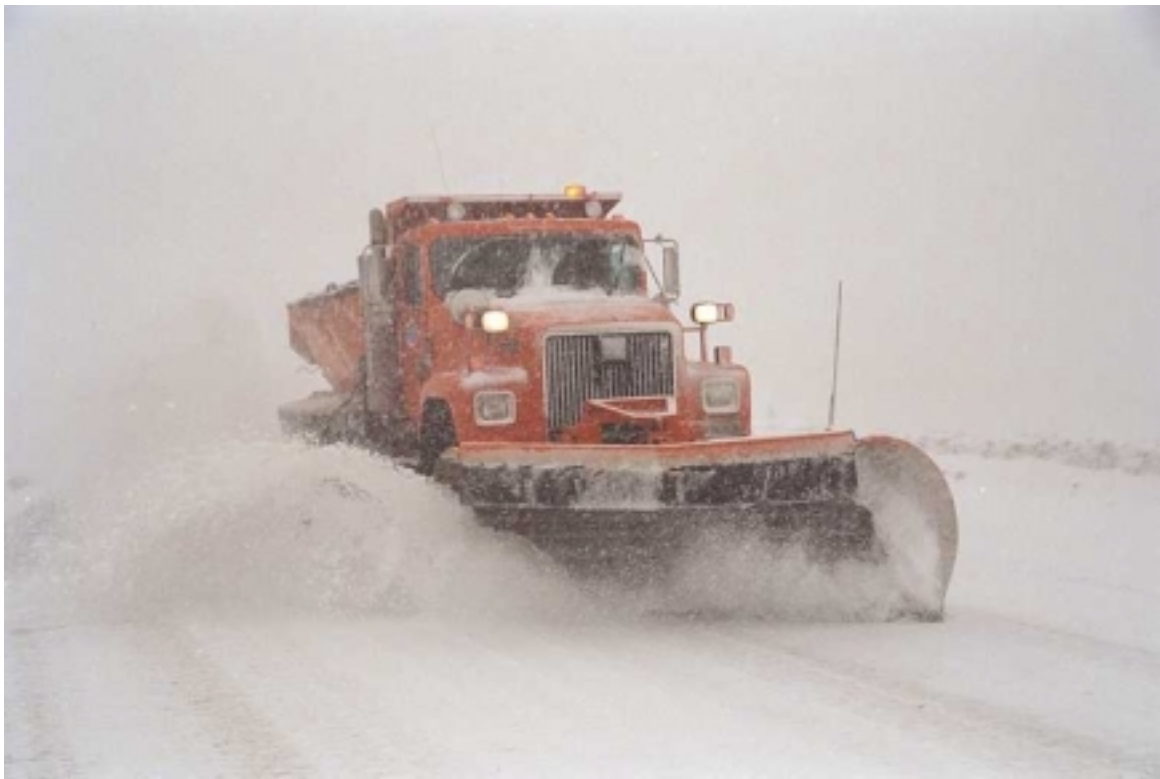
**Figure 1-1: The Advanced Snowplow (ASP) in Operation on Interstate 80, near Donner Summit, in California**

The ASP system functions include lane position indication, lane departure warning, and forward collision warning. Lane position indication and lane departure warning were developed by PATH using their embedded magnetic reference marker system for lateral position indication within the lane. Feasibility of this technology was shown at the National Automated Highway Systems Consortium (NAHSC) 1997 Demonstration; the technology is considered robust and well-suited for the current application. The Collision Warning System (CWS) was developed by AHMCT, using a millimeter wave radar system, which performs well in the snow environment; this system is intended to detect vehicles and other inorganic objects buried or obscured by snow. The current CWS on the ASP is based on the Commercial-Off-The-Shelf (COTS) Eaton Vorad EVT-200 sensor, which provides range and rate to targets, and supports serial communication via the RS-232 standard. AHMCT and PATH jointly developed the Human-Machine Interface (HMI). AHMCT integrated all subsystems on the snowplow. The overall system architecture used on the ASP is based on an open architecture, so that other sensors and subsystems can be incorporated in the future. Caltrans provided the snowplow. The vehicle, deployed into operation in December 1998, can be seen in Figure 1-1.

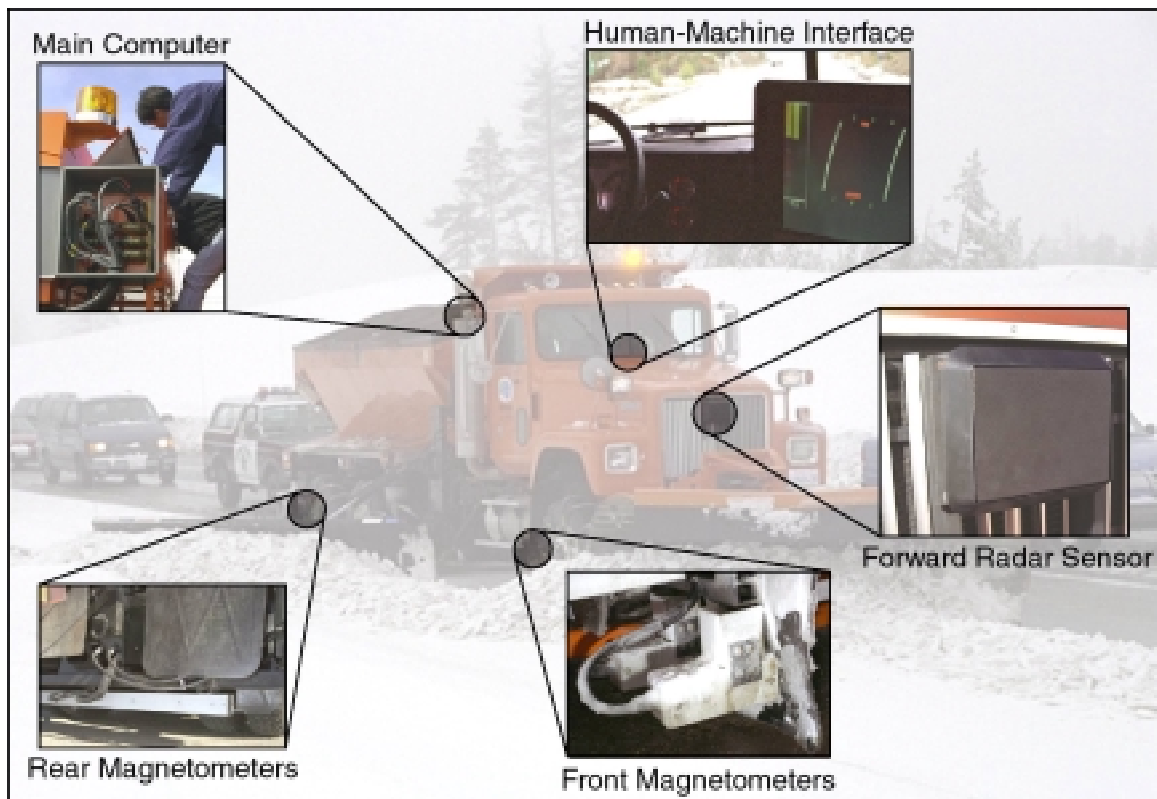
**Figure 2-1: System Call-Out for the Advanced Snowplow, with Key Subsystems**

The ASP system technology has been integrated onto a Caltrans nose/wing plow vehicle, based on an International Paystar 5000 platform. This chapter provides a brief description of the main subsystems of the ASP: the Lateral Sensing System, the Collision Warning System, and the Human-Machine Interface, all shown in Figure 2-1. Other support subsystems, e.g. computing and power, are discussed in detail in Chapter 3. The software architecture used to implement all ASP functions is discussed in Chapter 4.

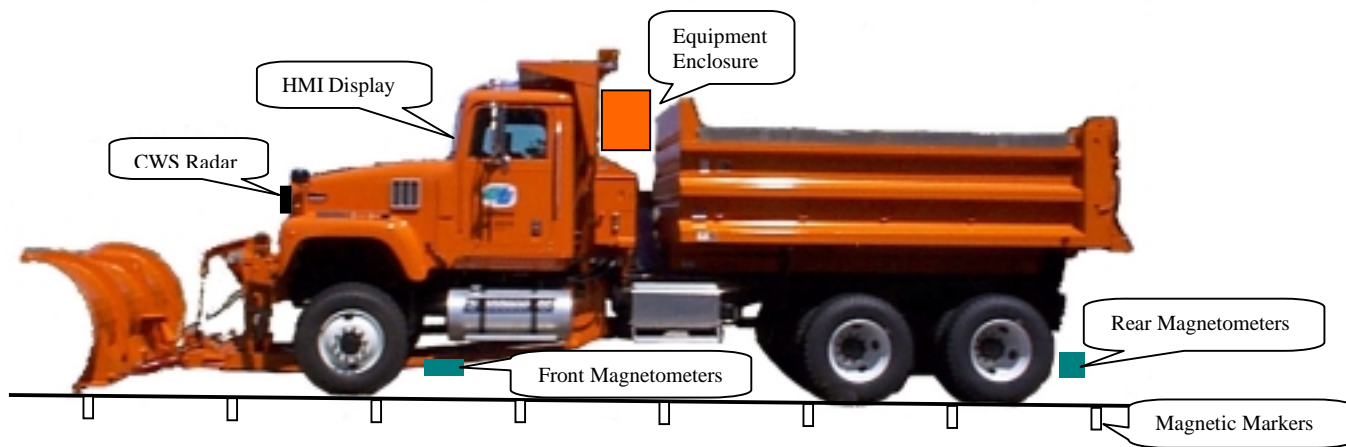
**Figure 3-1: Equipment Location Layout Schematic**

The Advanced Snowplow is composed of several tightly integrated subsystems. Commercial-off-the-shelf (COTS) items are employed when possible to reduce both time and cost. However, a few subsystems are custom designed and fabricated. The ASP system may be segmented into six subsystems: computing unit, human-machine interface (HMI), sensing system, sensor interface electronics, power supply system, and diagnostic laptop. Nearly all components, except sensors and HMI, are located inside the weather-tight equipment enclosure behind the truck cab, shown in the schematic in Figure 3-1.

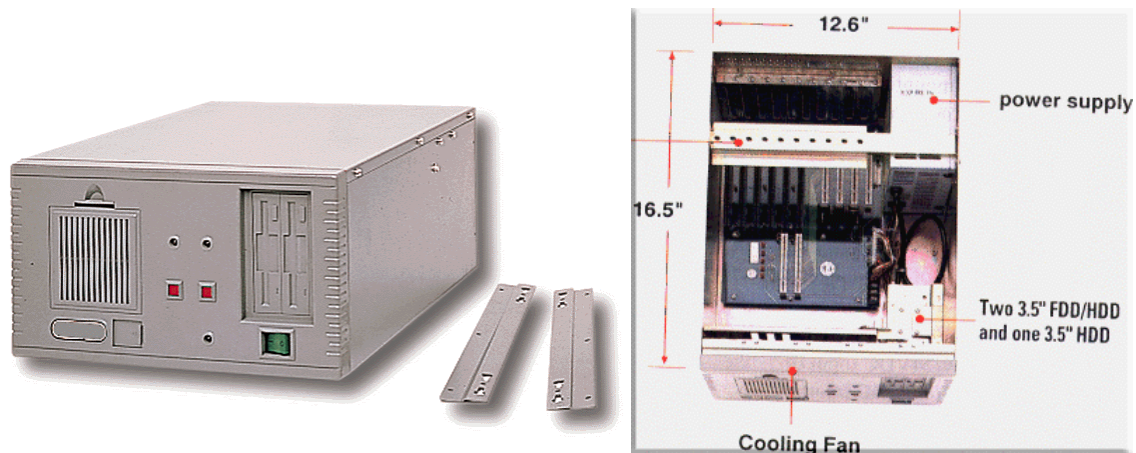
**Figure 3-2: Industrial Computer Chassis Used**

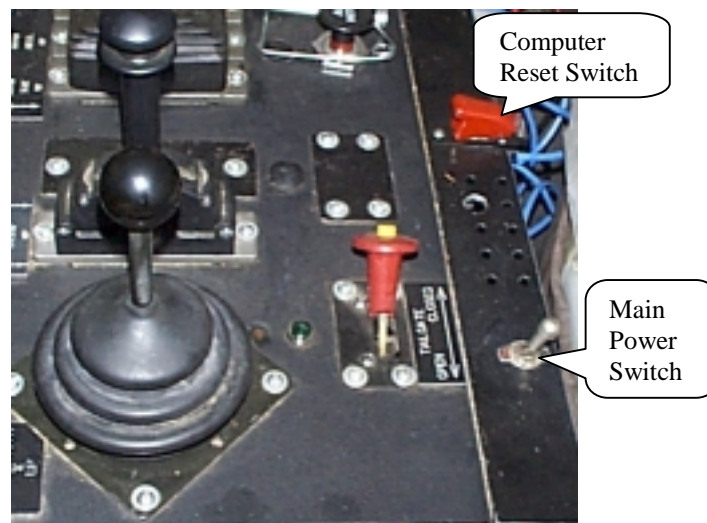
**Figure 3-3: System Power and Reset Switches**

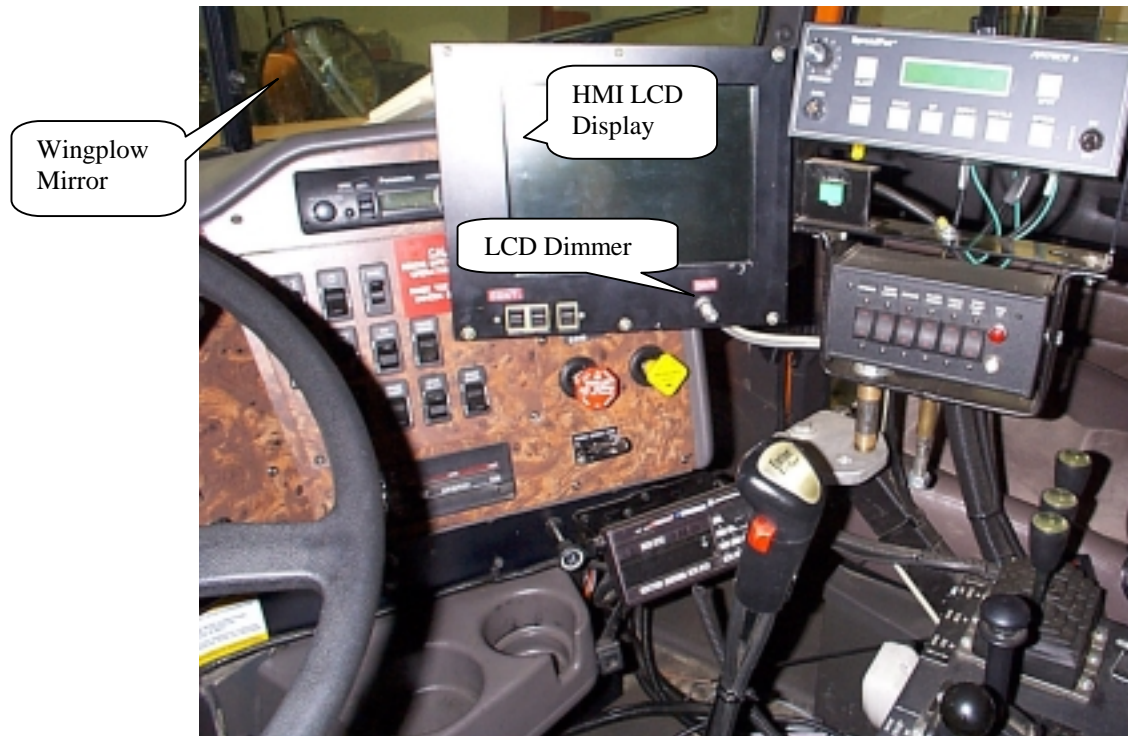
**Figure 3-4: System Layout, Including LCD Panel for HMI**

Figure 3-4. The HMI LCD panel, which displays the computer VGA signal, is produced by Computer Dynamics, and provides 640 x 480 resolution and a maximum brightness of 900 nit, and requires regulated +5 and +/- 12 VDC power input. The driver may adjust brightness and contrast by turning a knob or pushing a button attached to the display. A custom enclosure was designed and fabricated to better fit the dash with minimal interference with other controls at the dash. The mount location and hardware are shown in Figure 3-5.

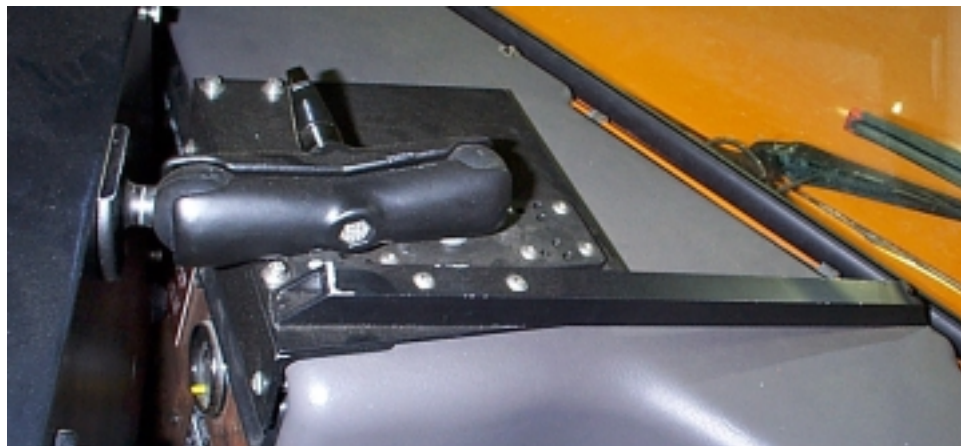
**Figure 3-5: Hardware Mount for the LCD Panel**

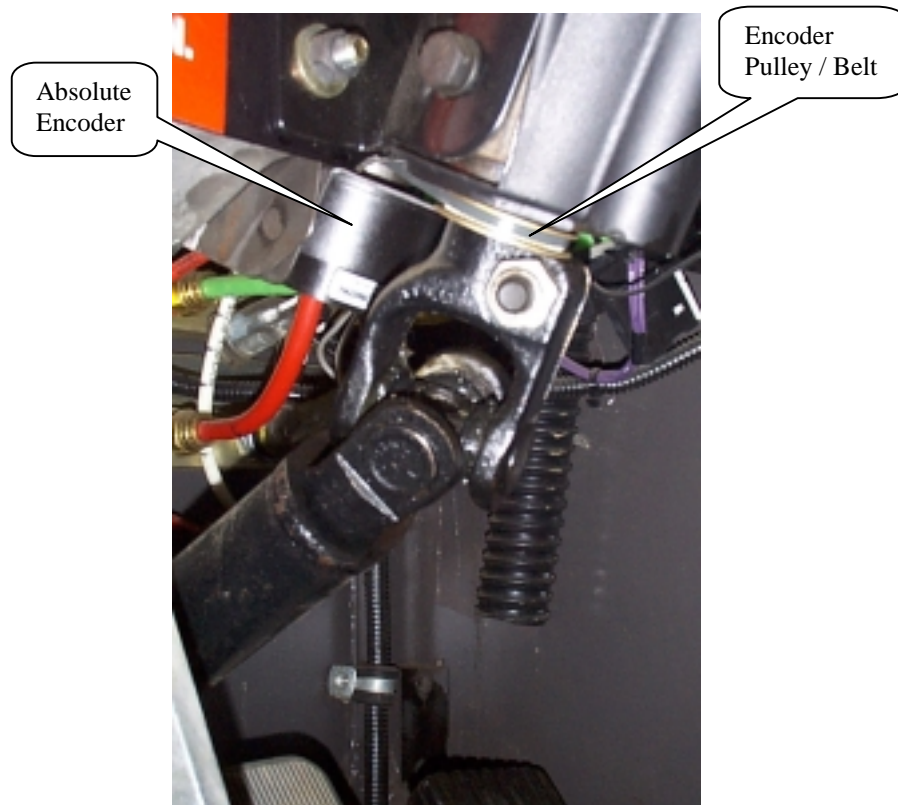
**Figure 3-6: Absolute Encoder for Steering Wheel Angle Sensing**

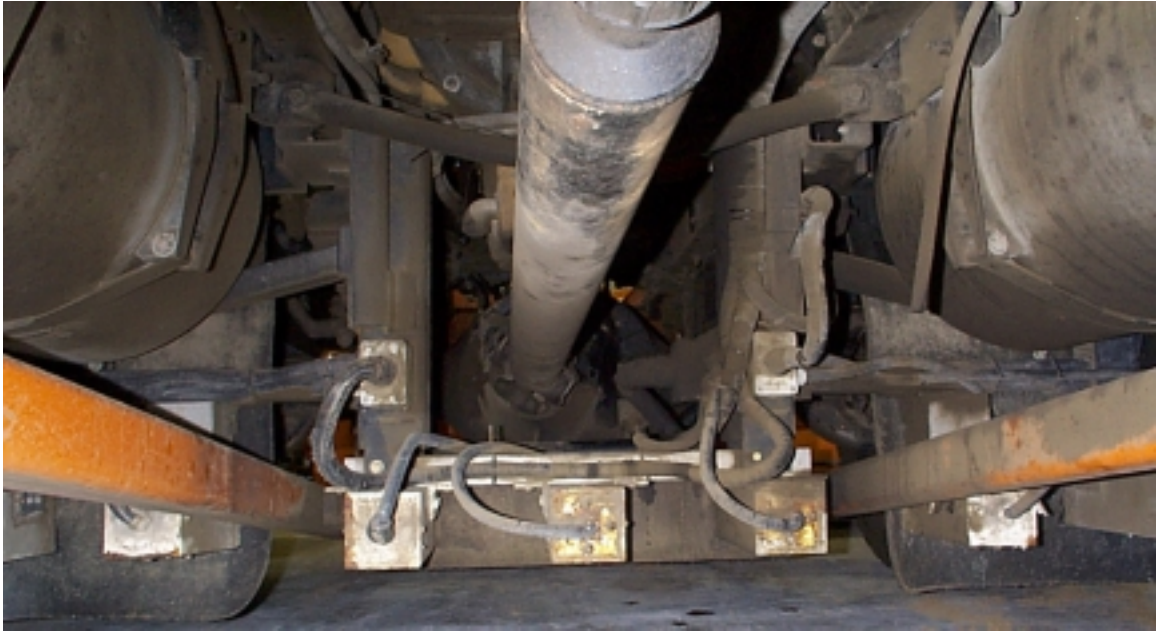
**Figure 3-7: Center Portion of Front Magnetometer Sensor Array**

snowplow formation. The magnetometers are encased inside a sealed enclosure to prevent any water damage. Each magnetometer output channel is connected to the sensor interface board. Extended details on magnetic marker detection and signal processing can be found in Chapter 6 and reference material.

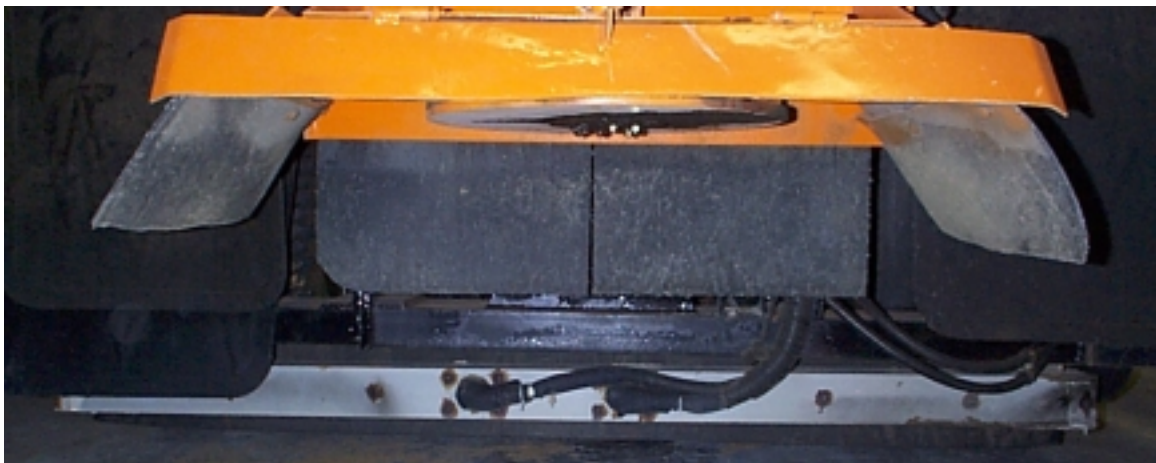
**Figure 3-8: Rear Magnetometer Sensor Array**

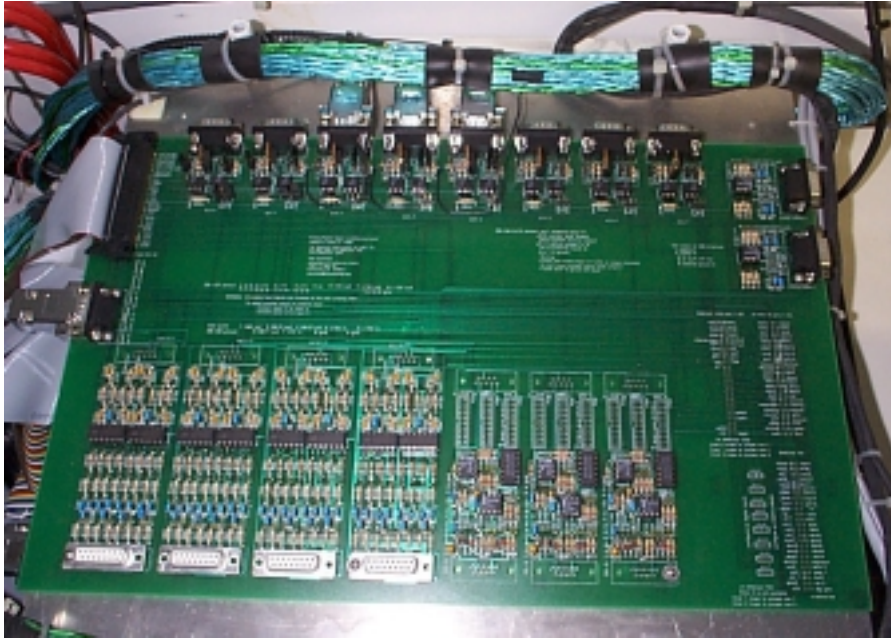
**Figure 3-8: Custom Sensor I/O Board, Top View**

Sensor interface electronics provides signal conditioning for the analog sensor output as well as overload protection for digital I/O and analog output from the AT-MIO-64E and PTIO-10. The three sensor interface boards, designed by PATH, are located above the computing unit. Each board provides an interface between the sensors and the National Instruments boards. The magnetometer outputs are fed through a low pass filter with an effective bandwidth of 140 Hz and connected to the upper 48 A/D channels of the AT-MIO-64E. The anti-aliasing filter must be selected rather carefully with the intended application and sampling rate in mind. The present

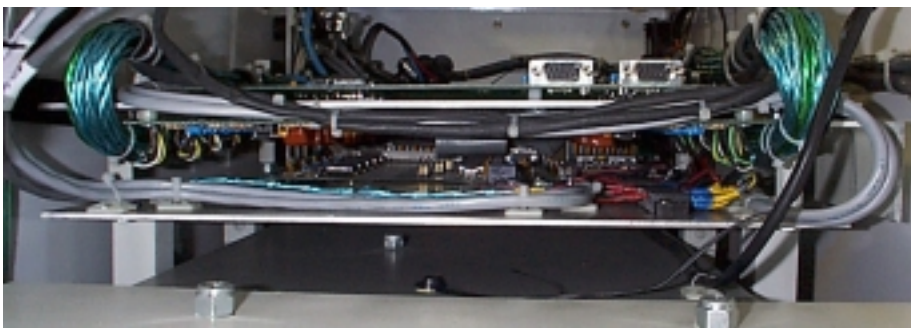
**Figure 3-9: Side View of Sensor I/O Boards**

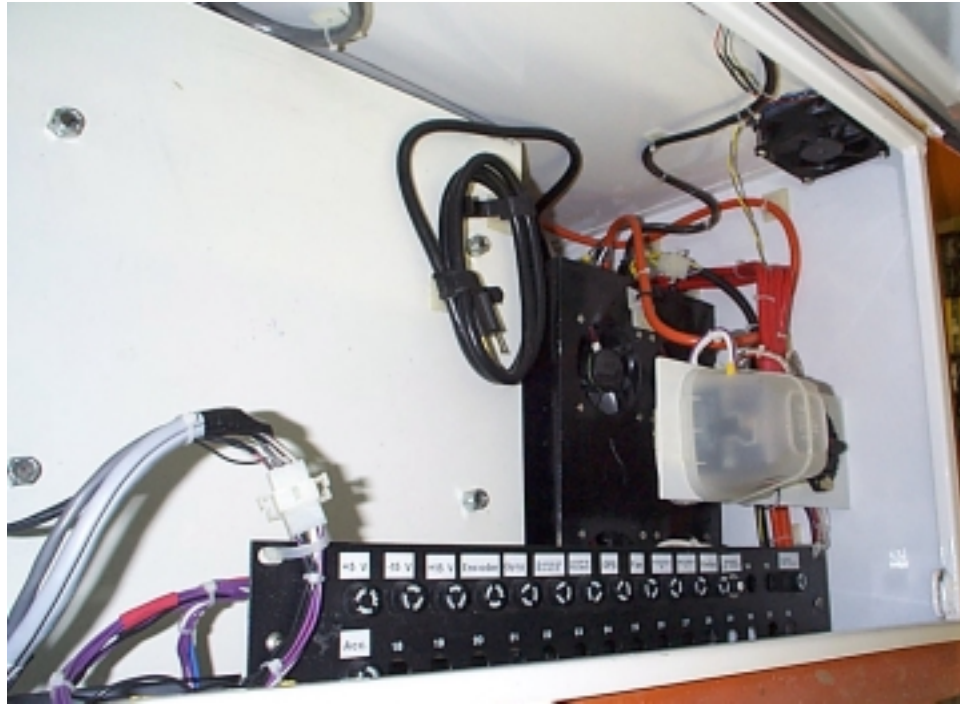
**Figure 3-10: ASP Power Supply System**

necessary DC-DC converters. A custom-designed power system is required for the final production unit.

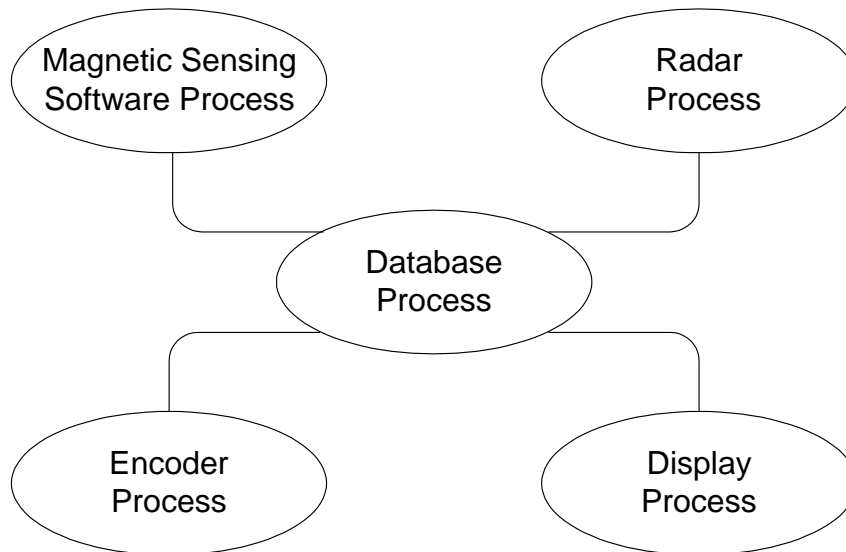
**Figure 4-1: System Diagram**

- Magnetic Sensing Software Process
- Database Process
- Radar Process
- Encoder Process
- Display Process

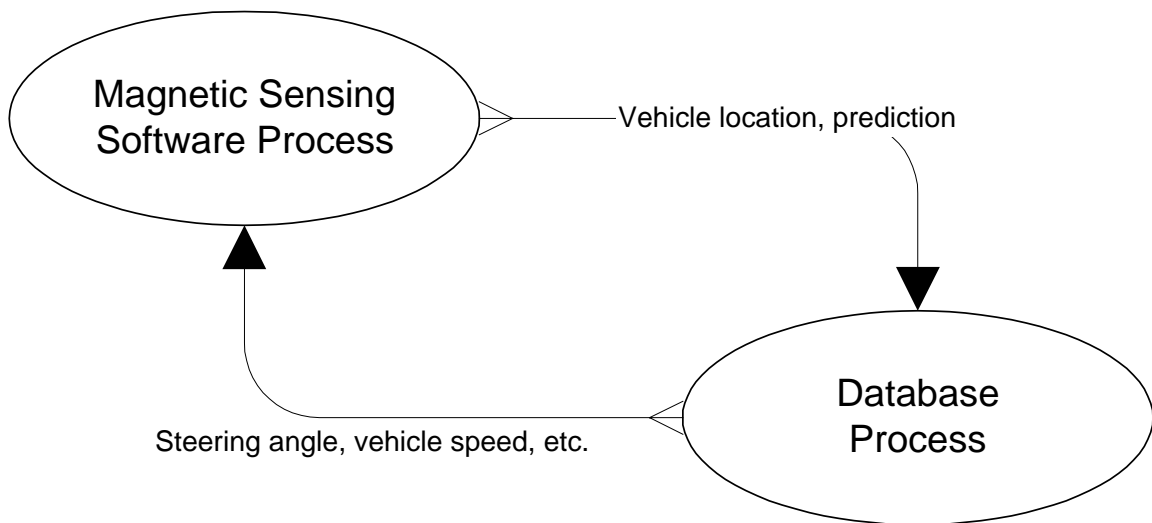
**Figure 4-2: Magnetic Sensing Software Process Diagram**

The MSS then uses the roadway curvature information provided by the coding, as well as the vehicle's current information (speed, trajectory, steering angle, location on roadway) to predict the vehicle's position at a future location if it were to continue on the same trajectory. The prediction information is displayed on the in-vehicle display, which dramatically improves the operator's ability to keep the vehicle on the desired path. The MSS process is shown in Figure 4-2.

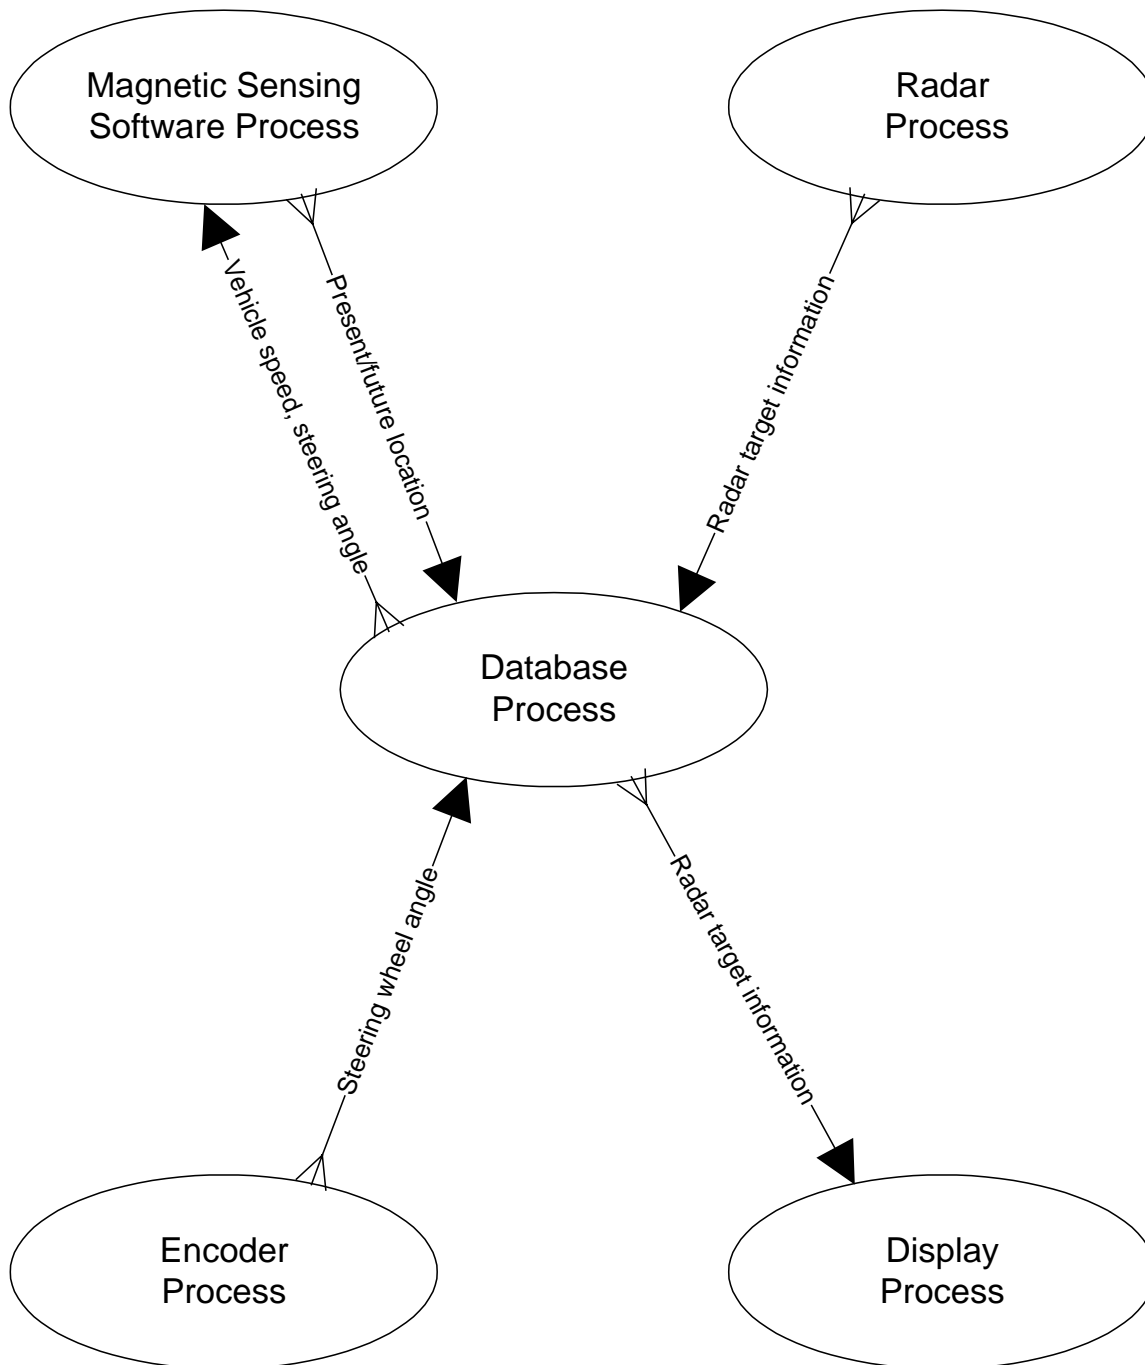
**Figure 4-3: Database Process Diagram**

Data is stored in the database using named variables. Processes access information for the desired variable, or write information to it. The processes write and read data at about 10 Hz. Simultaneous read/write problems are handled automatically and more than one process can access the database at the same time. The database process, including data flow information, is shown in Figure 4-3.

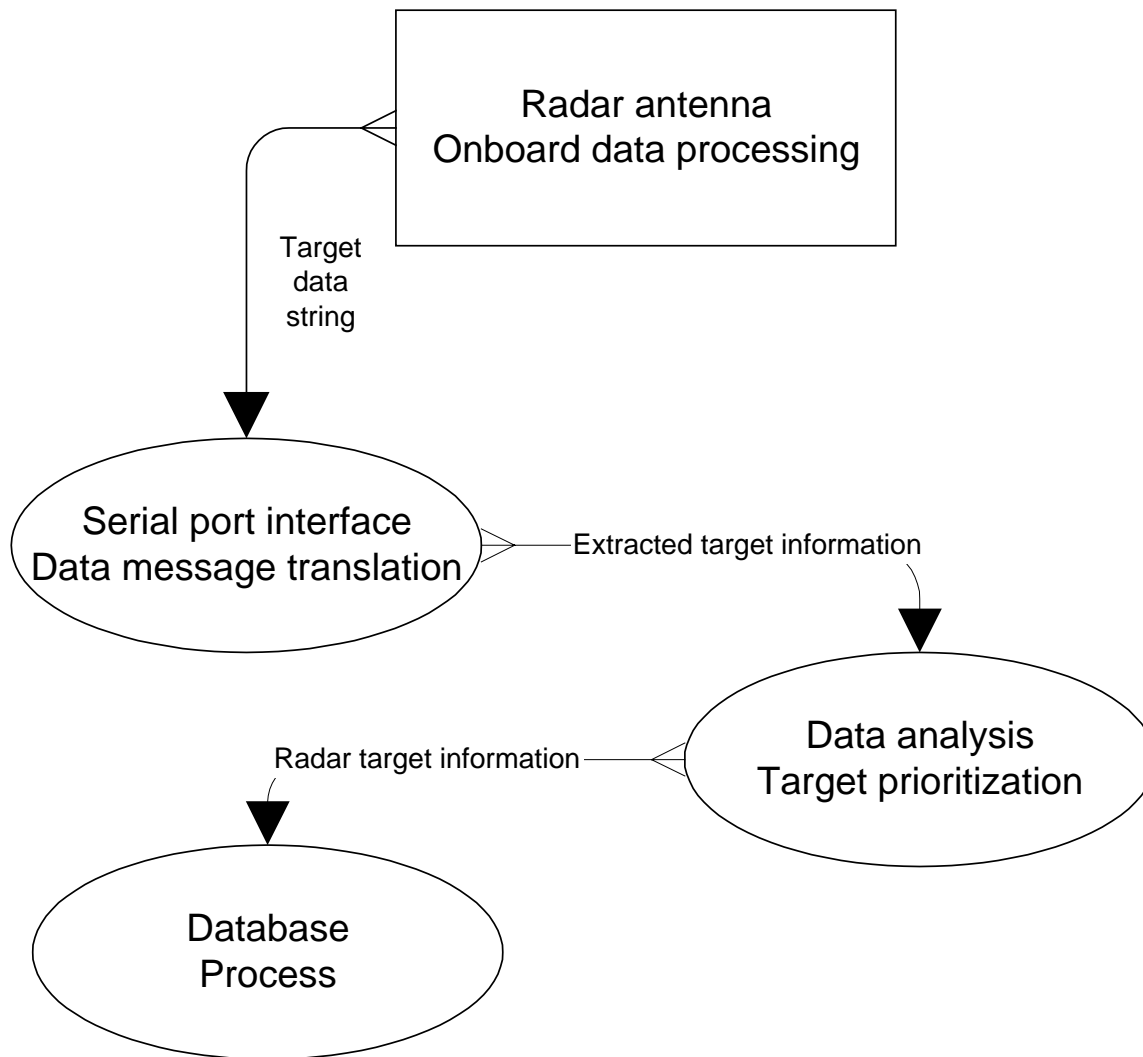
**Figure 4-4: Radar Process Diagram**

Once targets are prioritized, they are sorted to determine location on the display screen. The screen can show up to three targets, using three downward moving bars (or “tapes”) located in the left panel of the display (more information is given below). Thus targets can have left, center, or right position. Based on the information for each target, the left tape is for the fastest approaching objects, such as vehicles in the approaching lane (for two-lane highways) or snow banks on curved sections of road. The right tape is for objects with lowest relative velocity and close proximity to the plow, typically vehicles that the plow is following in its lane. The center tape is for targets that do not meet these criteria. In the Phase II CWS, using the EVT-300 sensor, tape position will correlate directly with lateral target position, so that the interface will be more intuitive for the operator, and the CWS will operate in a universal fashion for envisioned road types. The radar process is depicted in Figure 4-4.

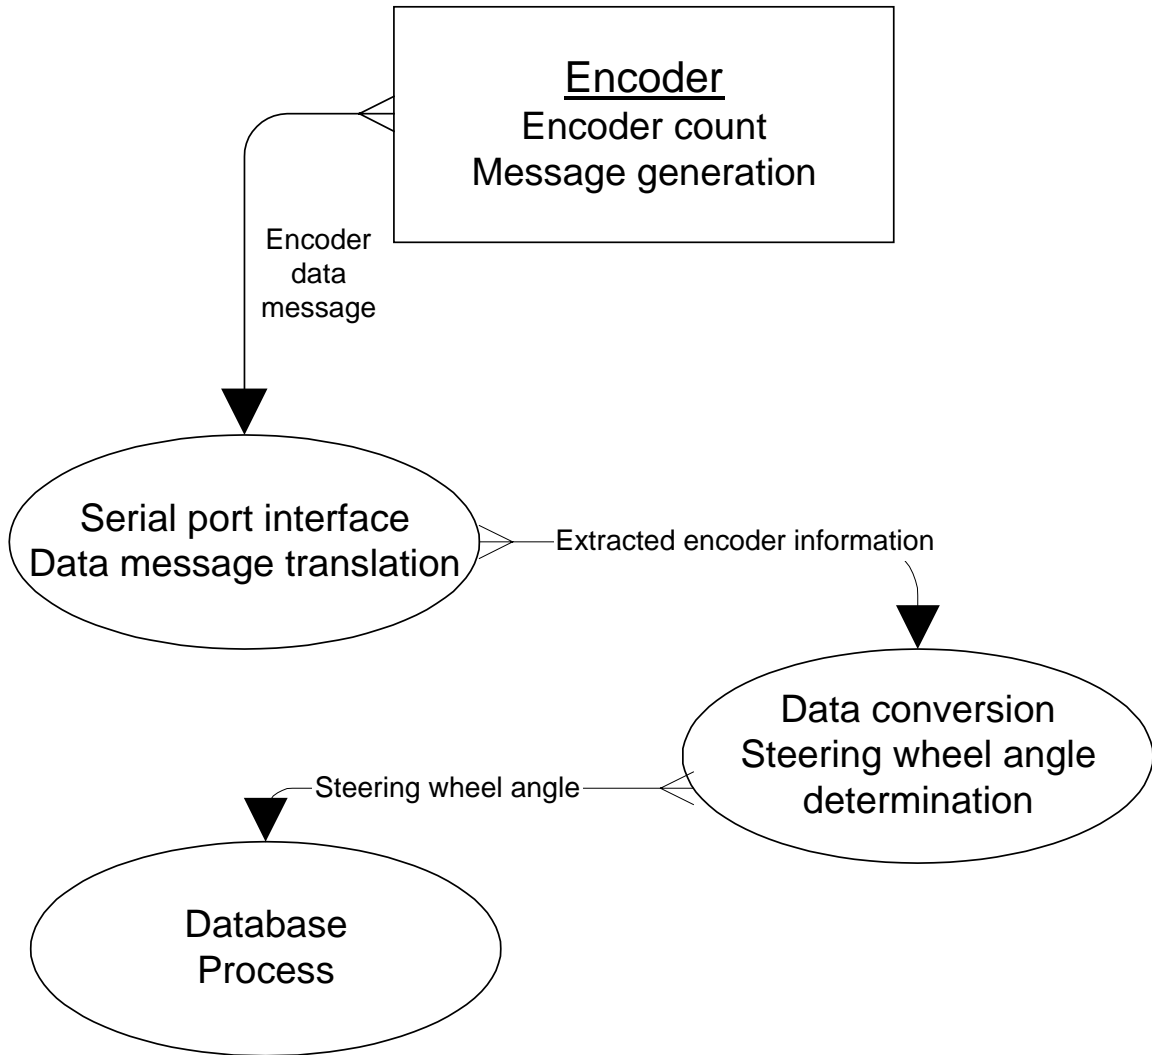
**Figure 4-5: Encoder Process Diagram**

vehicle's trajectory, from which it estimates the steering angle. When the program finds the steering angle between  $\pm 60$  degrees, it zeroes the encoder turn count. Once the count has been initialized, the encoder program keeps track of the number of turns and in which direction they are made, thus enabling the program to give accurate steering wheel angles for multiple turns of the encoder. The database steering wheel angle is updated regularly, and is used by the MSS to predict the vehicle's future location, a key aspect of the lateral assistance portion of the HMI. The encoder process is shown in Figure 4-5.

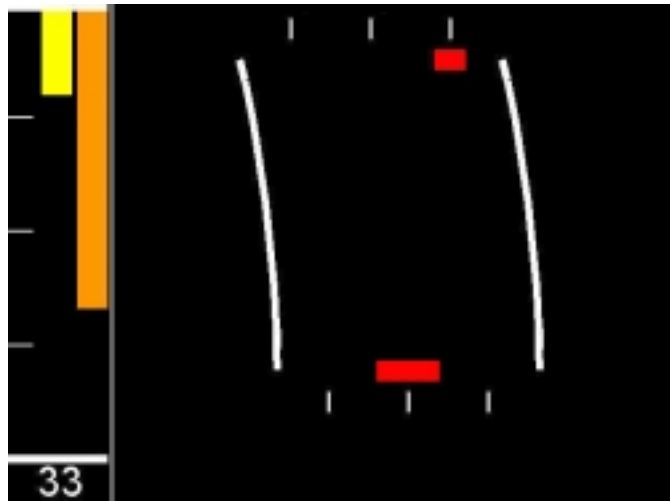
**Figure 4-6: Screen shot of the in-vehicle display.**

The display process creates a user-interface display based on the information generated by the radar and MSS processes. As shown in Figure 4-6, the display process generates radar information in the left panel of the screen, and provides MSS roadway information in the main portion of the screen.

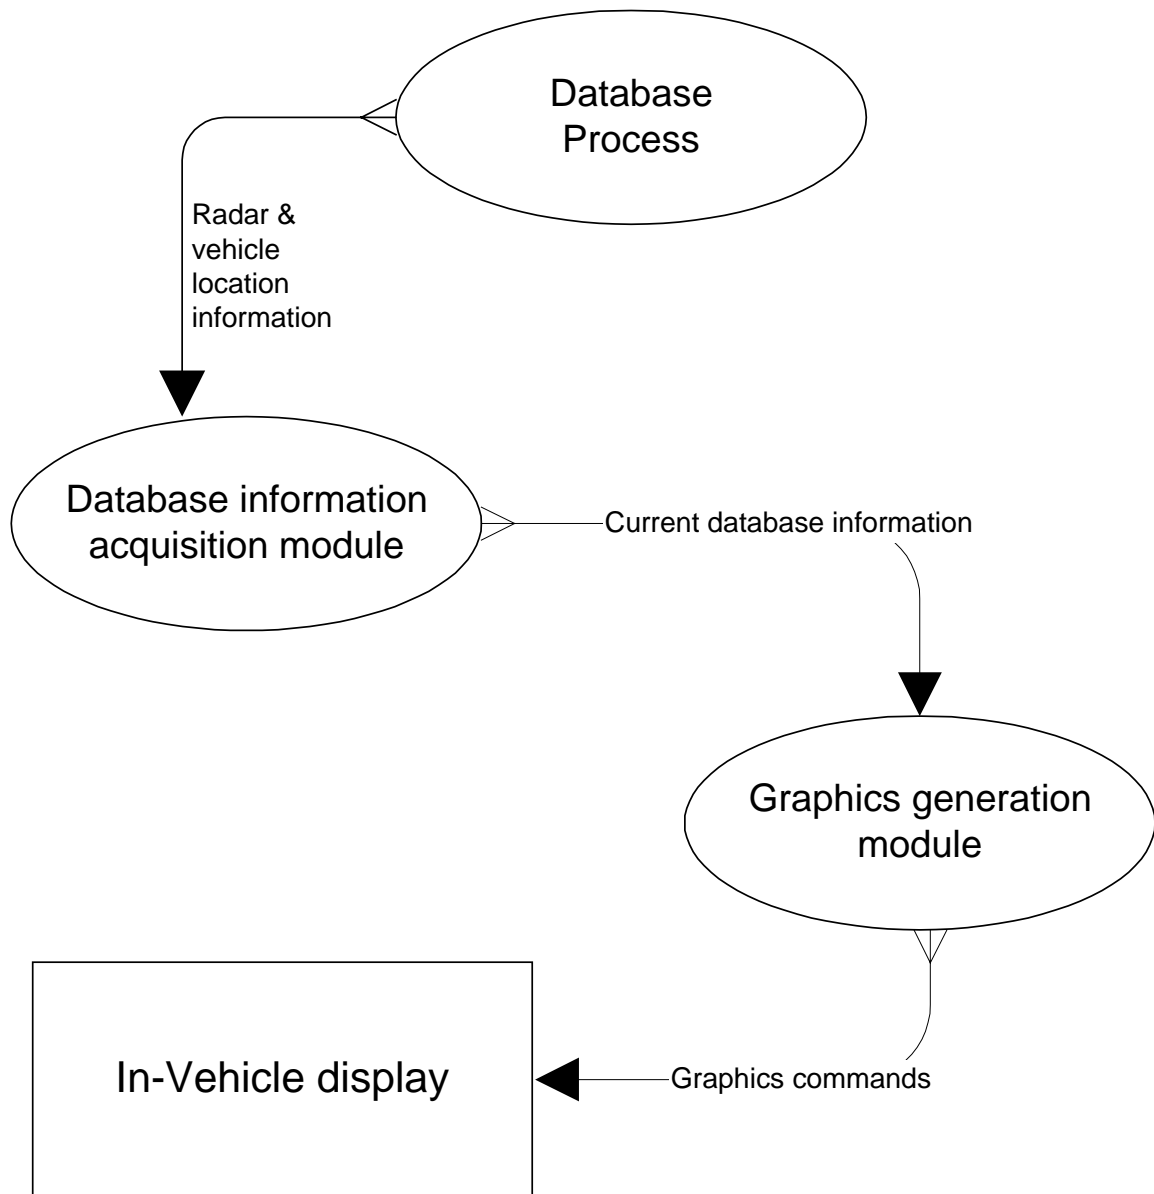
**Figure 4-7: Display Process Diagram**

The right panel of the display, comprising the majority of the screen real estate, provides lateral position and roadway geometry information. The tick marks at the top and bottom of the lane represent logical offsets, based on the need for up to a two foot offset from lane centerline during normal plowing operations. The vertical curves represent the upcoming roadway curvature. The horizontal bar at the bottom of the display represents the current plow position, while the smaller horizontal bar at the top of the display provides a predictor of future vehicle position, based on current position, roadway geometry, and plow steering angle. Further details of the HMI display are provided in Chapter 5. The display process diagram is shown in Figure 4-7.

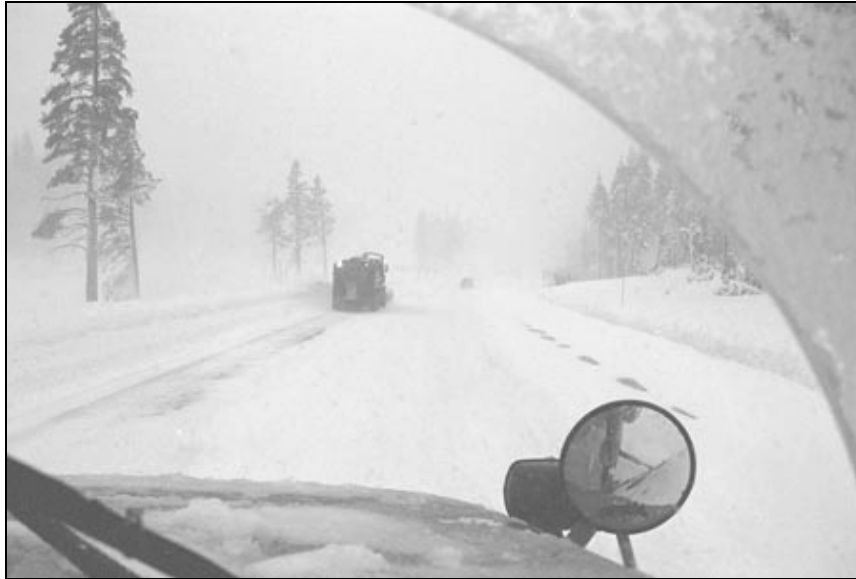
**Figure 5-1: A Typical View from the Cab of a Snowplow at Donner Pass. A Forward Plow Is Seen at the Left Shoulder, the Lead Plow Is Barely Visible.**

A subtask of staying on the road is maintaining a desired position within a lane. Even during periods of good visibility and without deep snow, this can be difficult since road markings are not easily perceived (Figure 5-1). In some regions (such as Donner Pass) a team of plows is used in an echelon formation. The position of the lead plow is especially important. The drivers following behind will adjust their lateral position based on the lead plow. Improper positioning by the lead plow can lead to inefficient road coverage and may lead to clean up runs by the team.

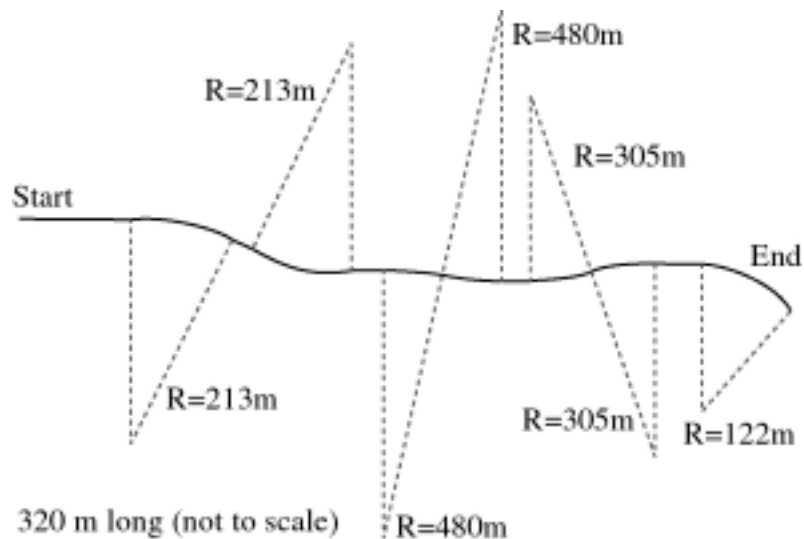
**Figure 5-2: PATH Richmond Field Station Track**

To test the bar display, three members of the development team who had not been exposed to the display were enlisted as drivers. Drivers were tested with a covered windshield (simulated white-out) using 0, 5, 10, and 15 meter look-ahead distances. The speed was fixed and automated at 6 m/s (13 mph). All driving was done on a short, closed-track course. All mini-studies were conducted on the PATH Richmond Field Station track, shown in Figure 5-2, which is about 320 m long and includes several short curves. Data was sampled at 33 Hz.

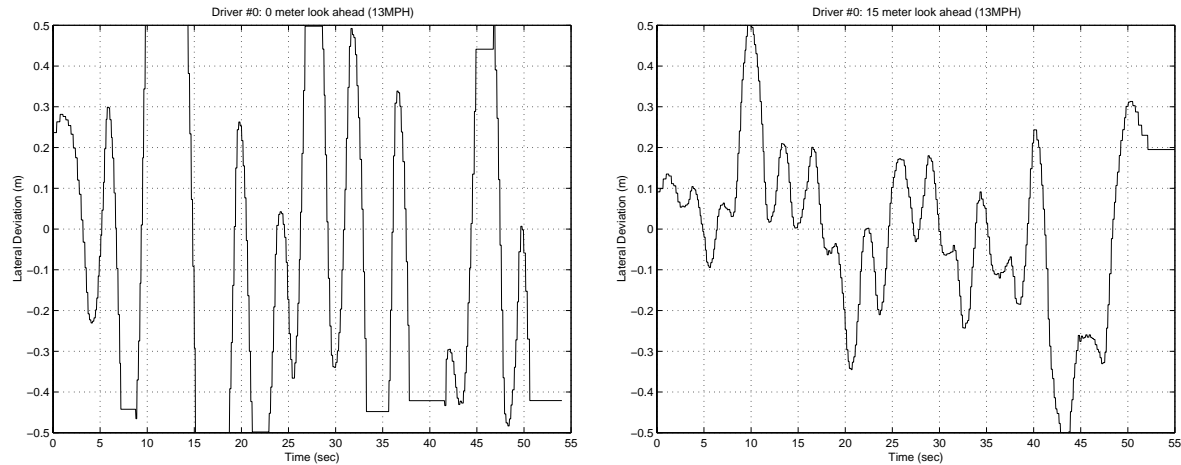
**Figure 5-3: Lateral Performance of Subject 0, 0 and 15 Meter Look-Ahead Distances**

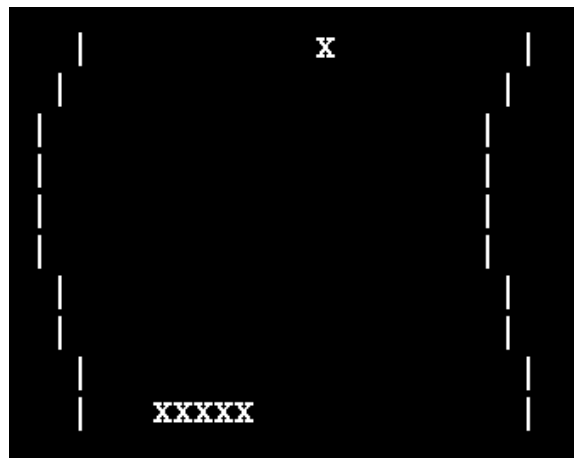
**Figure 5-4: A Text-Based Representation of the Road**

The need for a respectable look-ahead distance and the concern over the unacceptable amount of driver stress led to the desire to examine displays with multiple bars. The inclusion of more rows allowed miniature, iconic road scenes to be examined. This design was reinforced by initial contacts with the snowplow drivers who suggested a visual display that indicated lane position and road edges. Figure 5-4 presents an example of one of the text-based prototype displays that were created.

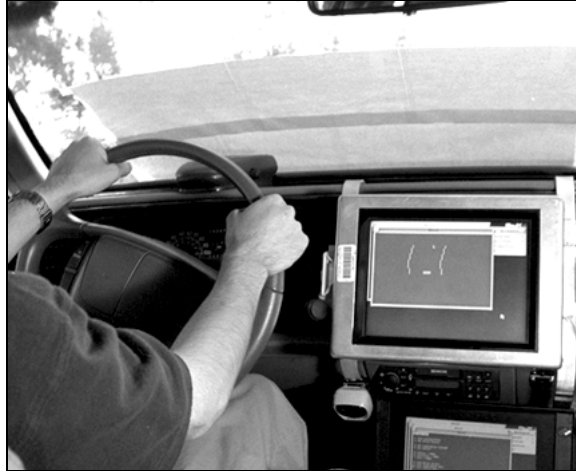
**Figure 5-5: Experimenter Driving from the Character Display with a Simulated Whiteout**

Since the snowplow was being outfitted, the character display was installed on a Buick LeSabre to allow ongoing development (Figure 5-5). The resulting simulated snowplow was also used to elicit further design suggestions from members of the development team. As in the first mini-study, the windshield was covered to mimic the worst-case whiteout condition. The peripheral view was visible and a team member sat in the passenger seat as a safety precaution.

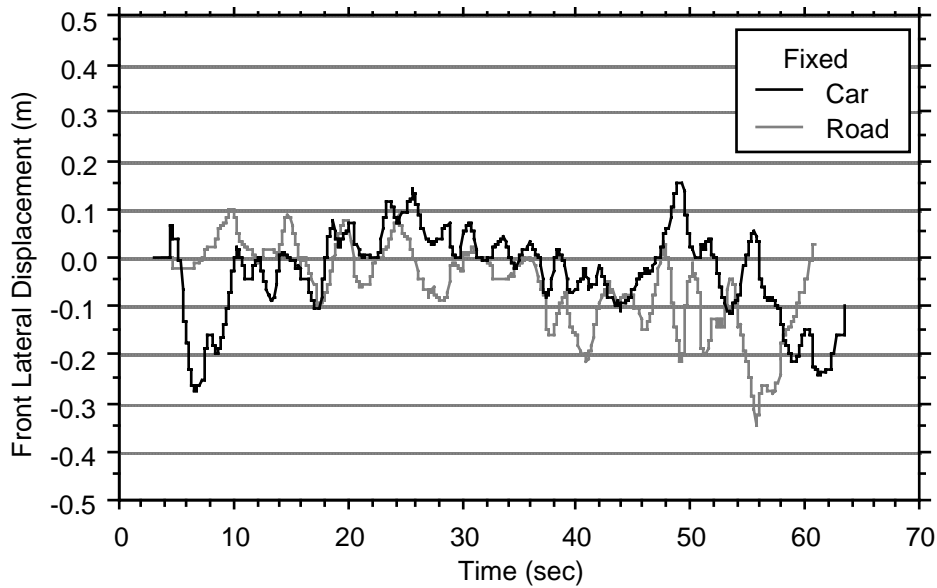
**Figure 5-6: Lateral Performance of Subject 2**

Figure 5-6 shows that the iconic road display with prediction was quite effective for maintaining lateral position. Note that this driver stayed within a range of a half-meter at the extremes and about 0.3 m for the bulk of the course. Front lateral displacement (FLD) corresponds to the lateral displacement from the center of the lane as measured by the sensors under the front bumper of the car. The car also utilized sensors under the rear bumper, but only the values from the front were used for analysis.

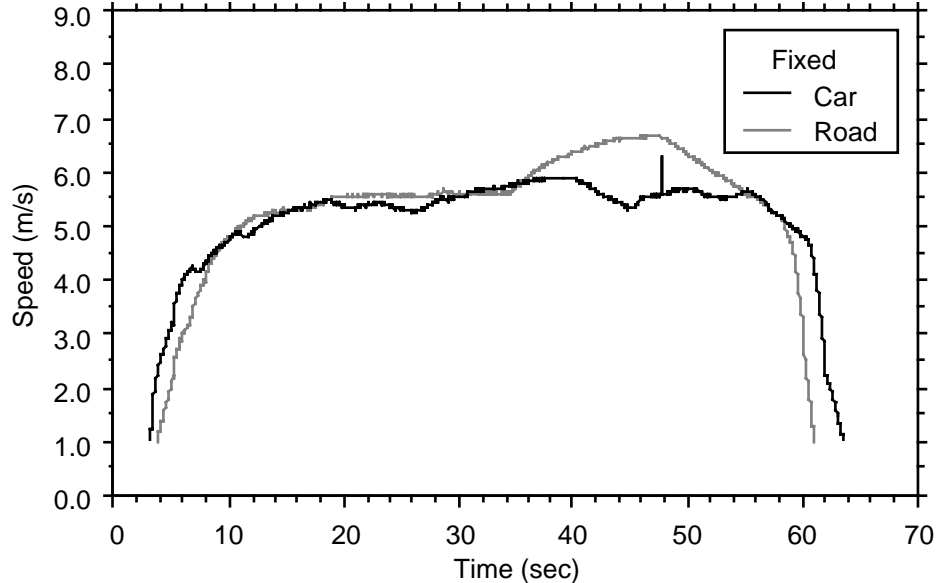
**Figure 5-7: Speed Performance of Subject 2**

While the speed was fixed for the first mini-study, the drivers were given control in this study (Figure 5-7). The drivers were instructed to maintain a speed between “10 to 15 mph.” Drivers generally reached a speed plateau near the previous study’s 6 m/s (13 mph). Drivers began and ended at a stop (speeds less than 1 m/s were not recorded).

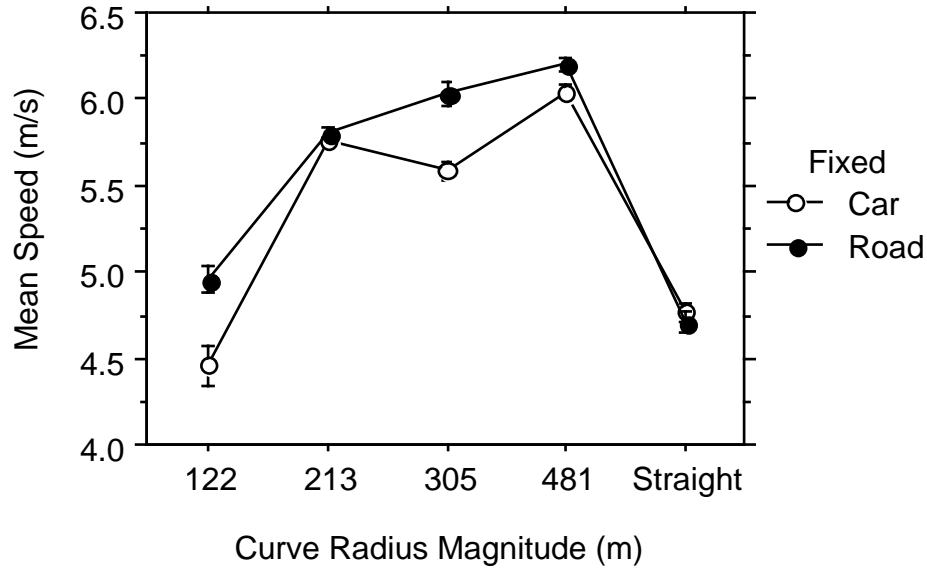
**Figure 5-8: Mean Driver Speed as a Function of Curve Radius and Display Type, with 95% Confidence Intervals**

The fixed-road display led to slightly faster speed performance, suggesting the display was easier to use (Figure 5-8). The considerably slower speeds seen for the straight and 122 m radius segments are due to the drivers speeding up and slowing down at the start and end of the track (as seen in Figure 5-7).

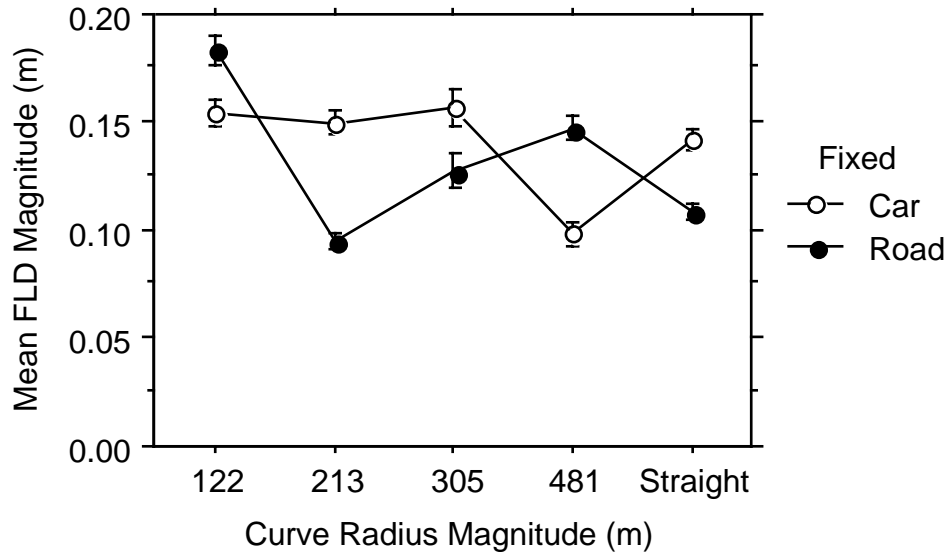
**Figure 5-9: Mean Forward Lateral Displacement Magnitude as a Function of Curve Radius and Display Type, with 95% Confidence Intervals**

The lateral performance over each curve radius was somewhat inconclusive (Figure 5-9). In general, the tighter curves seemed to produce slower speeds and more lateral deviation.
