**ADVANCED SNOWPLOW DEVELOPMENT  
AND DEMONSTRATION:  
PHASE I: DRIVER ASSISTANCE\***

AHMCT Research Report  
UCD-ARR-99-06-30-03

Final Report of Contract  
Task Order 96-9 under IA65X875

June 30, 1999

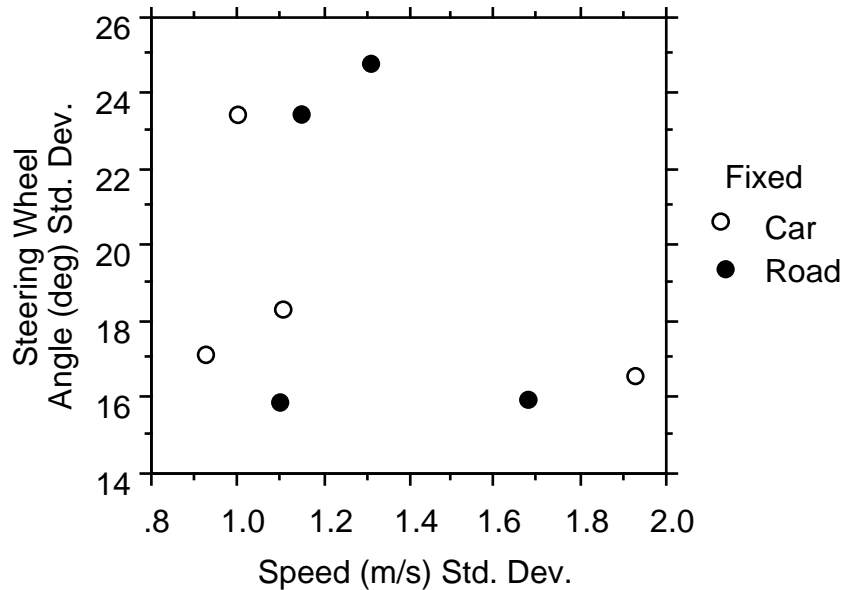
**Figure 5-10: Standard Deviation Data for Second Mini-Study**

The standard deviation behavior data (Figure 5-10) is inconclusive on which part of the display to fix (car or road). Larger steering wheel and speed standard deviations imply that the driving task is more difficult, so that proximity to the origin of Figure 5-10 suggests an easier task.

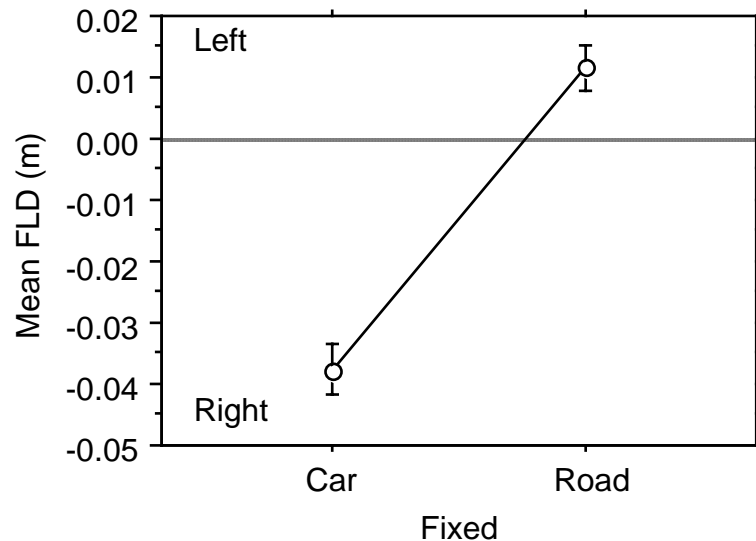
**Figure 5-11: Mean Lateral Displacement from Lane Centerline, 122 Meter Radius Removed, with 95% Confidence Intervals**

One potentially useful finding is that actual lane positioning was worse for the fixed car display (Figure 5-11). All curves on the track, with the exception of the 122 m radius curve, had counterparts that curved in the opposite direction. The curve pairs are within a few meters of each other in arc length. The better lateral position, coupled with the slightly better speed performance over curves results (Figure 5-8), lends credibility to tentatively endorsing a fixed-road display. A firmer endorsement cannot be made due to the predominance of inconclusive findings and the small subject pool.

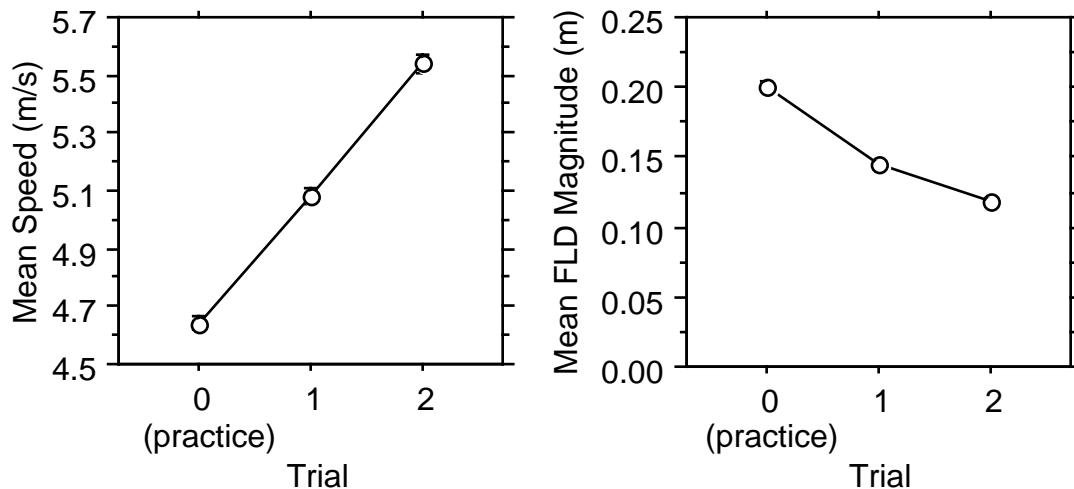
**Figure 5-12: The Impact of Practice, with 95% Confidence Intervals**

Regardless of the display, a rather promising practice trend was seen for both speed and lane deviation (Figure 5-12). The previously mentioned practice trial was run with a display that was half the size of the others. It was not included in the analysis above. The increase in speed and reduction in lane deviation (especially between trials 1 and 2) suggest that there was a promising learning curve present. This has positive implications for the final display.

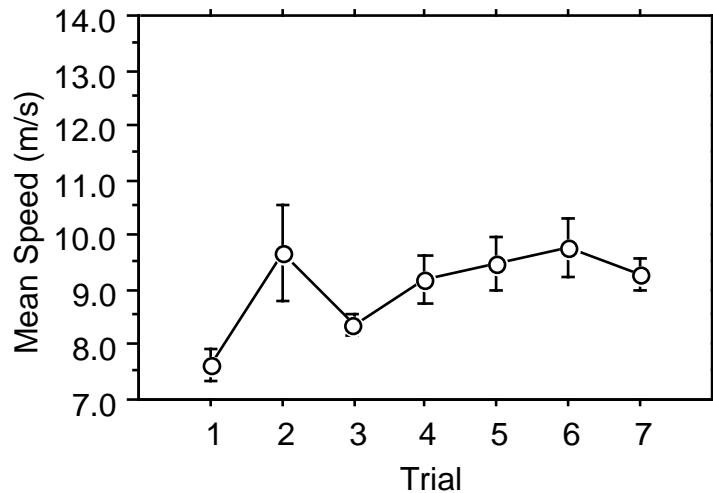
**Figure 5-13: Speed Behavior for Long-Break Practice, with 95% Confidence Intervals**

The long-break version consisted of seven single trials spaced five hours to one day apart. Speed began to reach a steady level after the 3rd trial (Figure 5-13). The means were computed using the interior portions of the test track (no start-up acceleration or end-trial deceleration). Mean speed was computed across the test track subsections.

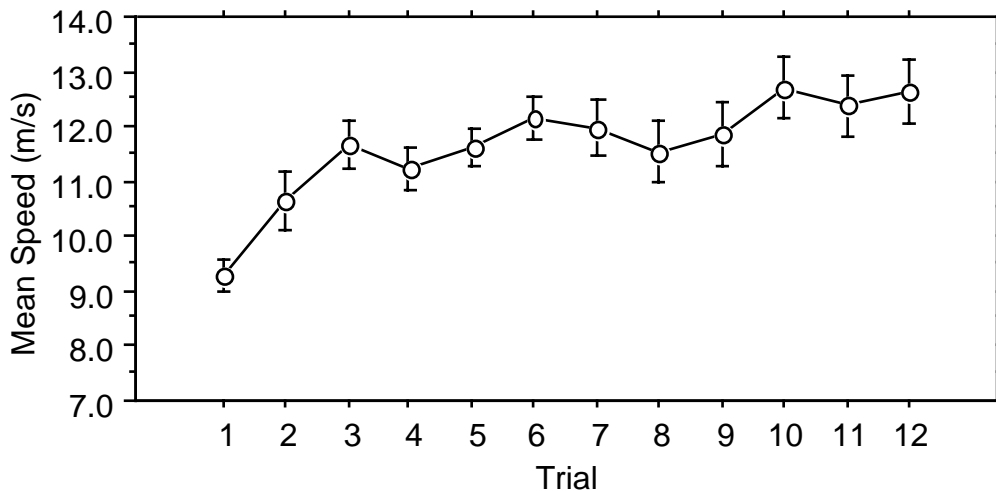
**Figure 5-14: Speed Behavior for Short-Break Practice, with 95% Confidence Intervals**

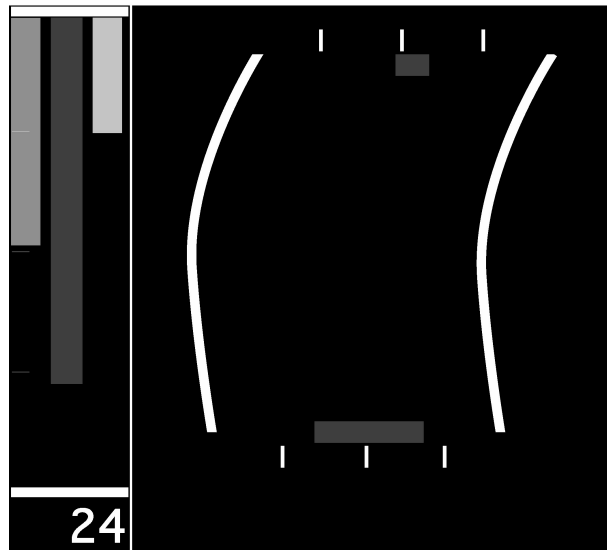
**Figure 5-15: A Drawing of a Display Scenario**

The lateral display is similar to the character display, but included lane position marks and color-coded system status information. In addition, the prediction capability was extended to 20 m and the displayed logical lane width was 2 m. The center tick marks indicated the center of the lane, while the exterior tick marks indicated 0.6 m (2 ft) offsets, which are used during certain plowing formations. Under normal conditions the lines were white and the current and prediction markers were red. If the computer was uncertain of its current longitudinal position

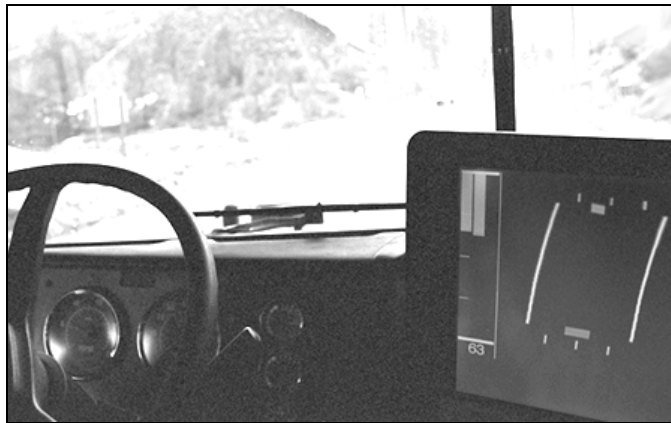
**Figure 5-16: Location of the Display in the Cab**

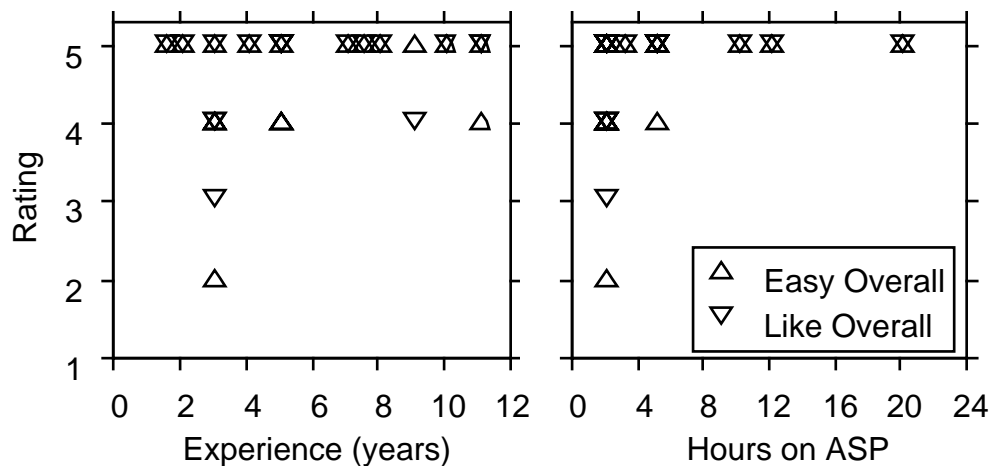
**Figure 5-17: Overall Ratings as a Function of Experience and Exposure, Ratings Are 1 - 5, Higher Being Better**

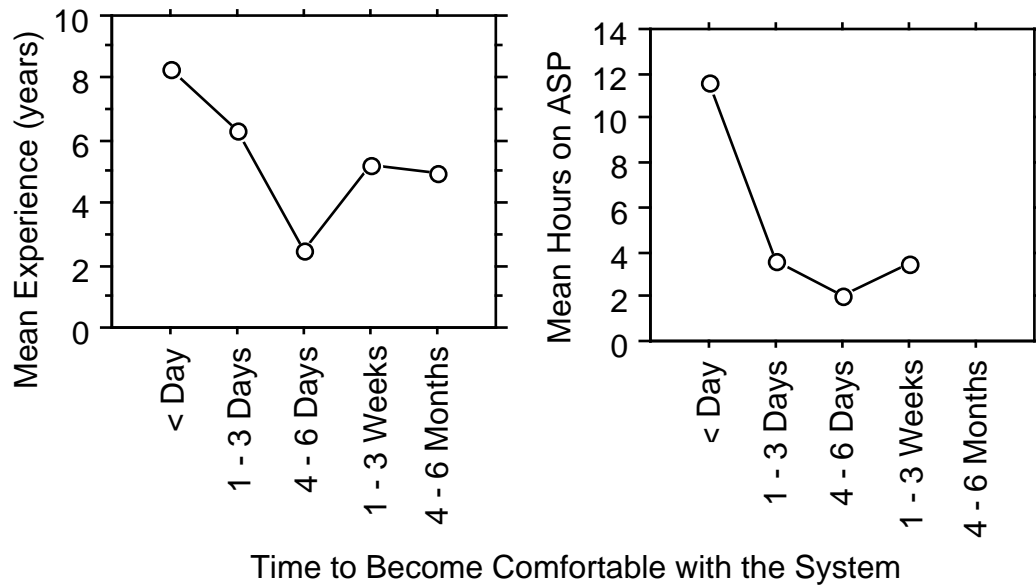
**Figure 5-18: Predicted Time to Reach Comfort with the System**

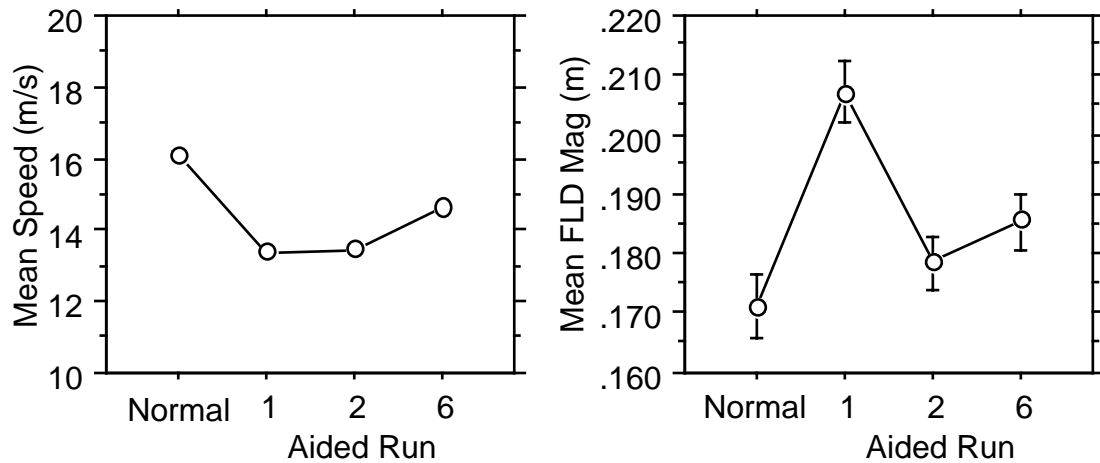
**Figure 5-19: Driver Behavior Data during System Testing in Arizona, with 95% Confidence Intervals**

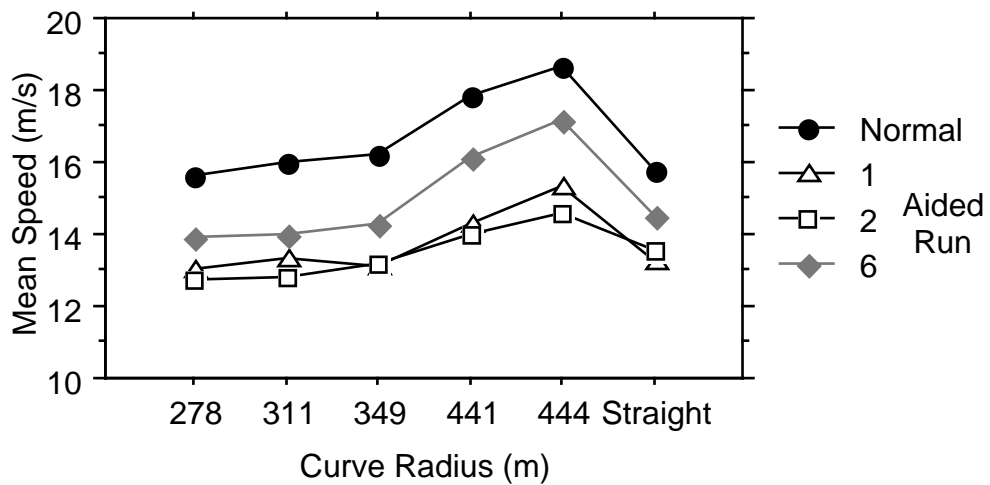
**Figure 5-20: Mean Speed as a Function of Curve Radius**

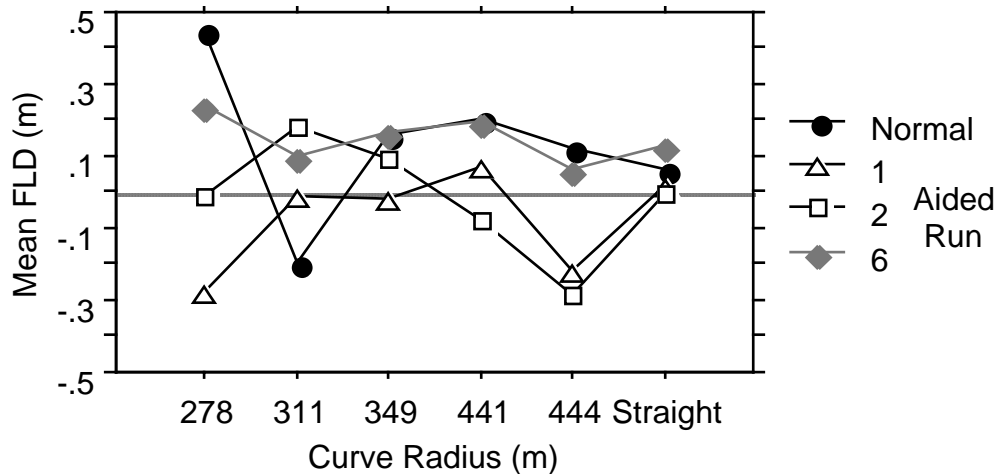
**Figure 5-21: Mean FLD as a Function of Curve Radius**

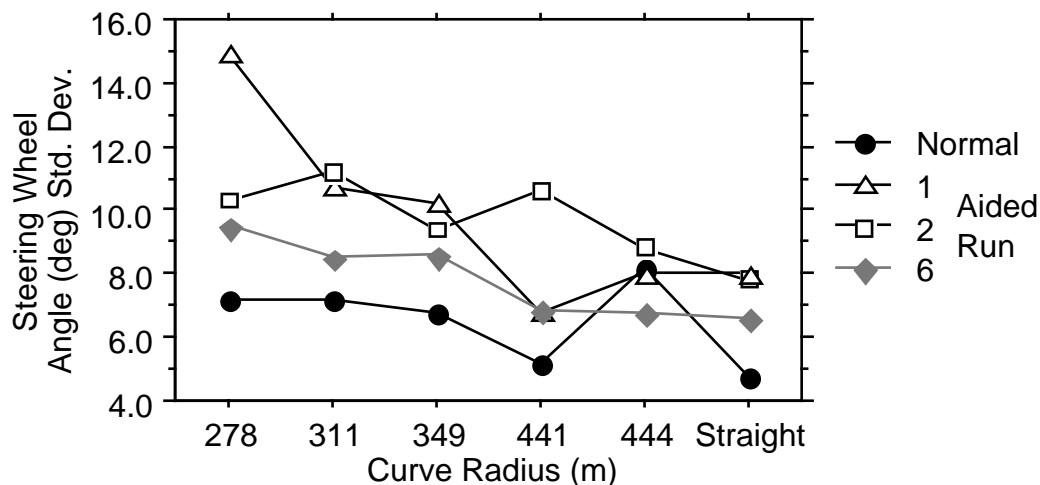
**Figure 5-22: Steering Angle Standard Deviation as a Function of Curve Radius**

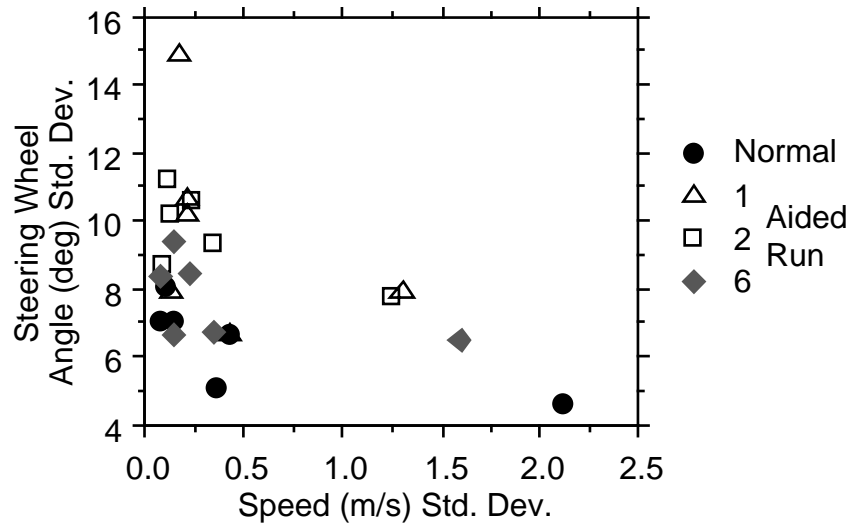
**Figure 5-23: Standard Deviation Data**

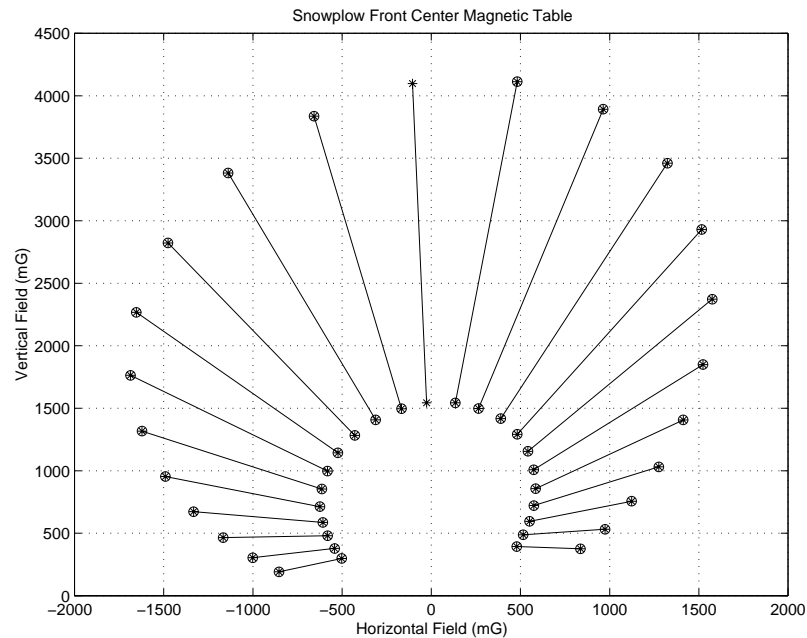
**Figure 6-1: Snowplow Front-Center Magnetic Table**

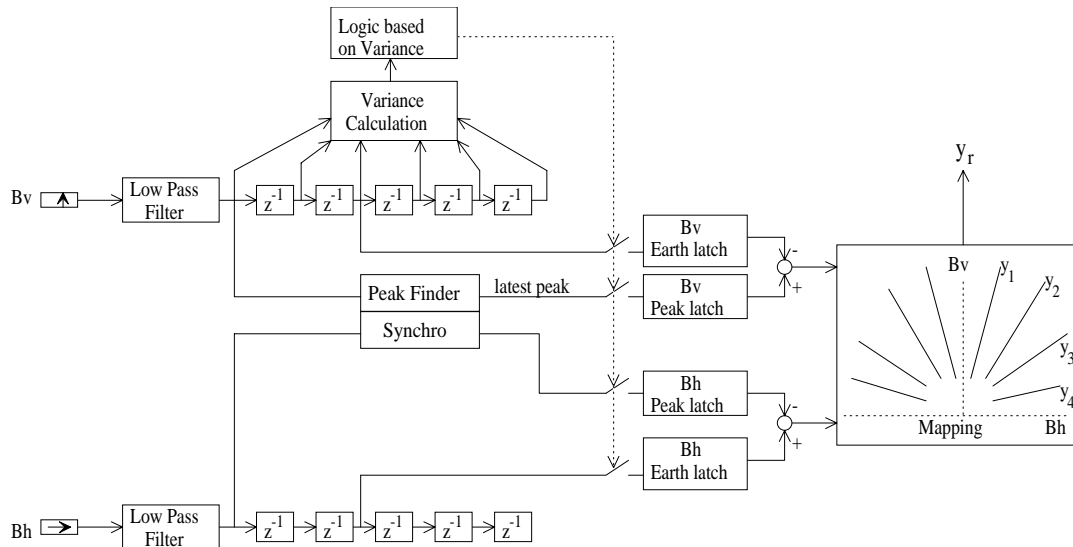
**Figure 6-2: “Peak-Mapping” Magnetometer Signal Processing Block Diagram**

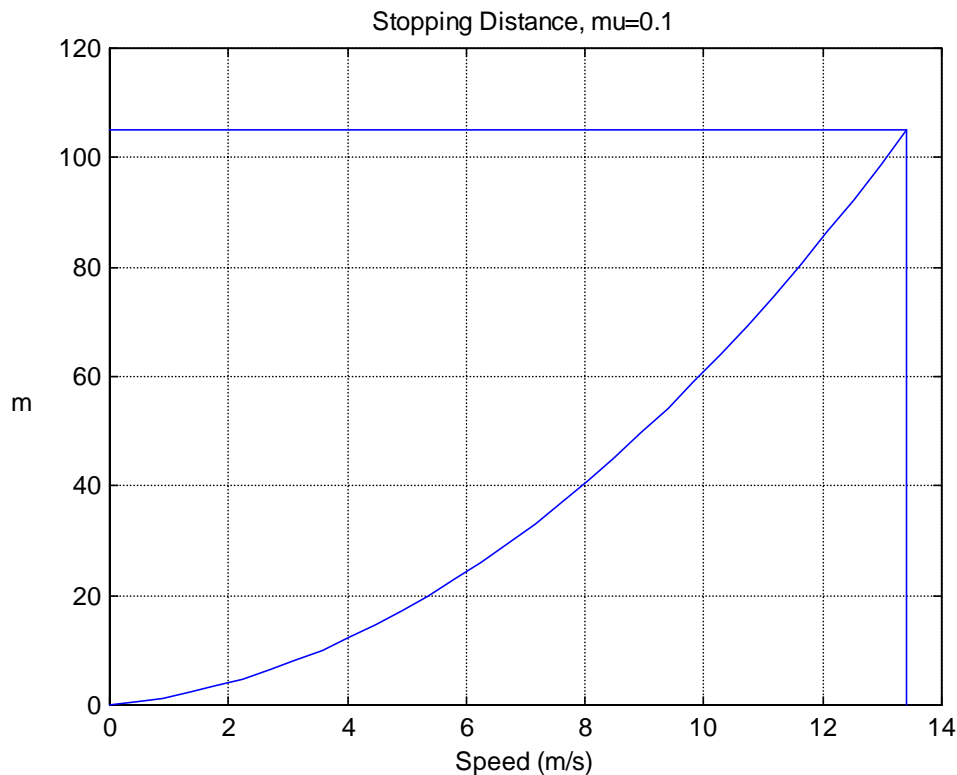
**Figure 7-1: Plow Stopping Distance for 0.1 g Deceleration and 1.0 Second Reaction Time**

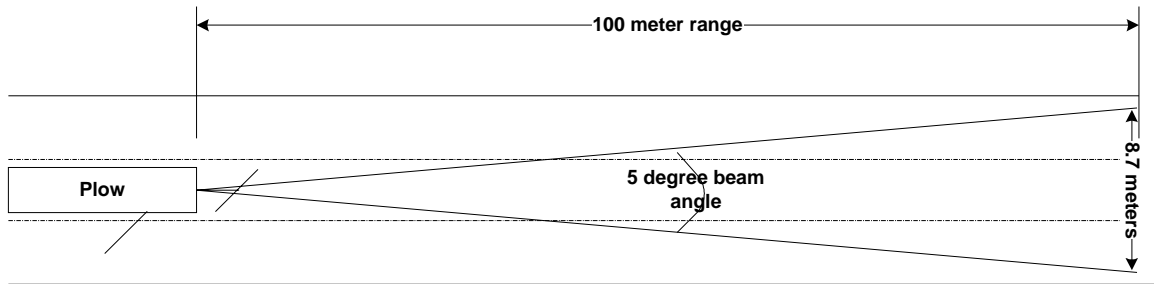
**Figure 7-2: Diagram of Area Covered by EVT-200 Collision Warning System**

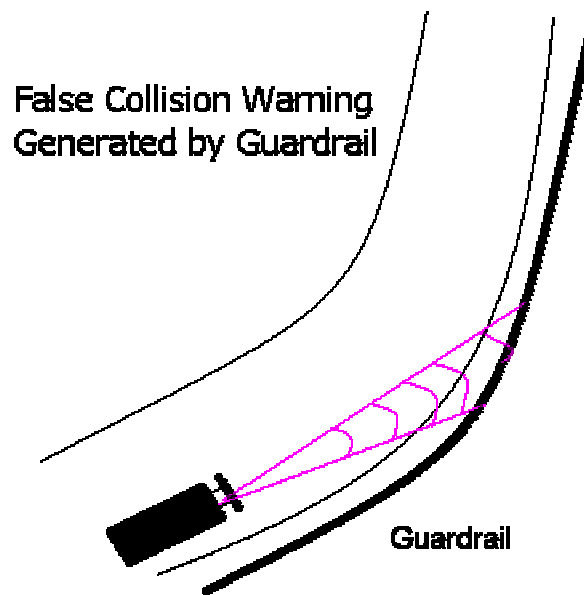
**Figure 7-3: Diagram of Situation Capable of Generating a False Collision Warning**

turning and because it is unable to suppress alarms caused by detecting bridges over a hill or changes in slope.

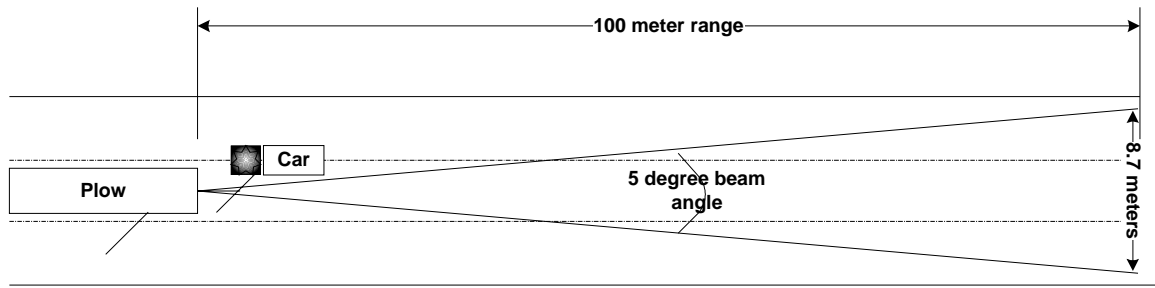
**Figure 7-4: Collision Caused by a Drifting Vehicle, a.k.a. “Clipping”**

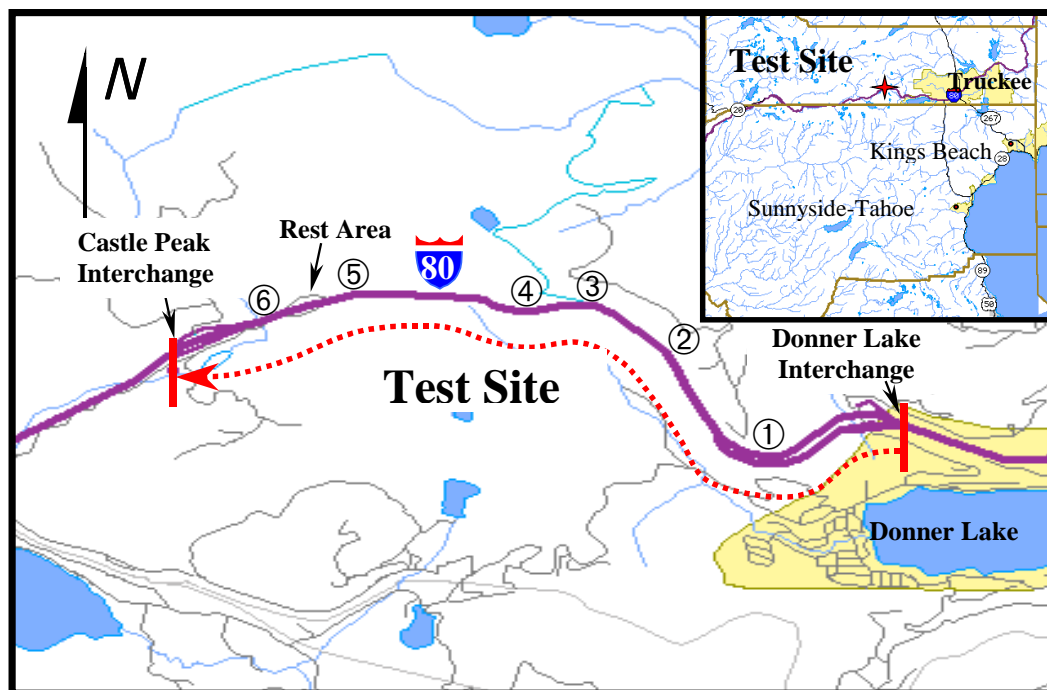
**Figure 8-1: Demonstration Site over Donner Pass, California**

California's instrumented test-site encompasses approximately 6.3 km (3.9 miles) of the westbound lane of Interstate 80 in Nevada County near Donner Pass (Figure 8-1). This site runs from the Donner Lake Interchange milepost (MP) Nev-9.1 to Donner summit MP Nev-5.1 reaching an elevation of 2206 m (7239 ft). The entire site is located in mountainous terrain, with steep grades and many curves. The designated location was chosen because this portion of I-80 typically closes before other sections of the road due to weather patterns and has a relatively high vehicle per hour traffic count. This stretch of divided interstate contains both two and three lanes of travel in each direction, with a shoulder on the right. For the sake of evaluation, the test site was divided into six segments, due to differences in elevation, weather, etc., as shown on the map in Figure 8-1.

The instrumented test areas were broken into subsections to allow the potentially variable road and weather conditions to be recorded across the test site. In particular, the California test site was broken into six subsections as previously shown in Figure 8-1. The names of each of the sections from MP 9.1 to MP 5.1 are ① Big Windy, ② Pole Line, ③ Schweitzer, ④ 60, ⑤ Slight Hill and ⑥ Flat. The Arizona site was broken into three subsections. The Arizona site was broken into three sections; ① open, ② downhill and ③ uphill (Figure 8-2). Data was recorded using the data collection sheets previously discussed. It was unknown as to whether the test site needed to be split into as many subsections as it was.

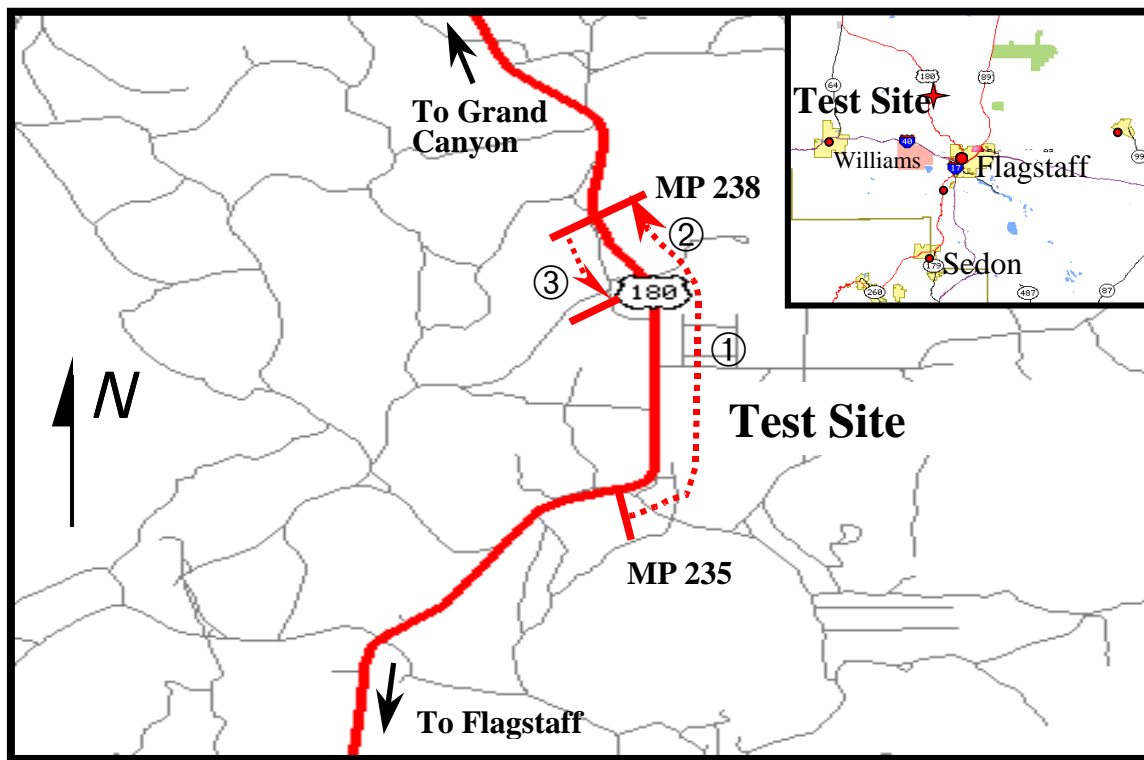
**Figure 8-2: Demonstration Site through Kendrick Park, Arizona**

The site chosen in Arizona represents a total of approximately 6.4 km (4 miles) within Kendrick Park on US 180, which is located about 32 km (20 miles) northwest of Flagstaff, Arizona (Figure 8-2). This instrumented test-site is situated at roughly 2440 m (8000 ft) in elevation and runs northward from MP 235.0 to MP 238.0 and southward from MP 238.0 to MP 237.0. The northbound three-mile segment begins in forest, continues through an open, windswept valley and ends with a winding eight percent downgrade. The southbound one-mile segment returns back through the winding uphill grade. This location receives frequent snowfall and is often exposed to winds of varying force, resulting in whiteout conditions and drifting. The designated road segment is in a relatively high traffic area because it is the shortest route from Flagstaff to Grand Canyon National Park. For the sake of evaluation, the test site was divided into three segments as shown in Figure 8-2. This test site differs significantly from the California site; in particular, this site is an undivided highway.

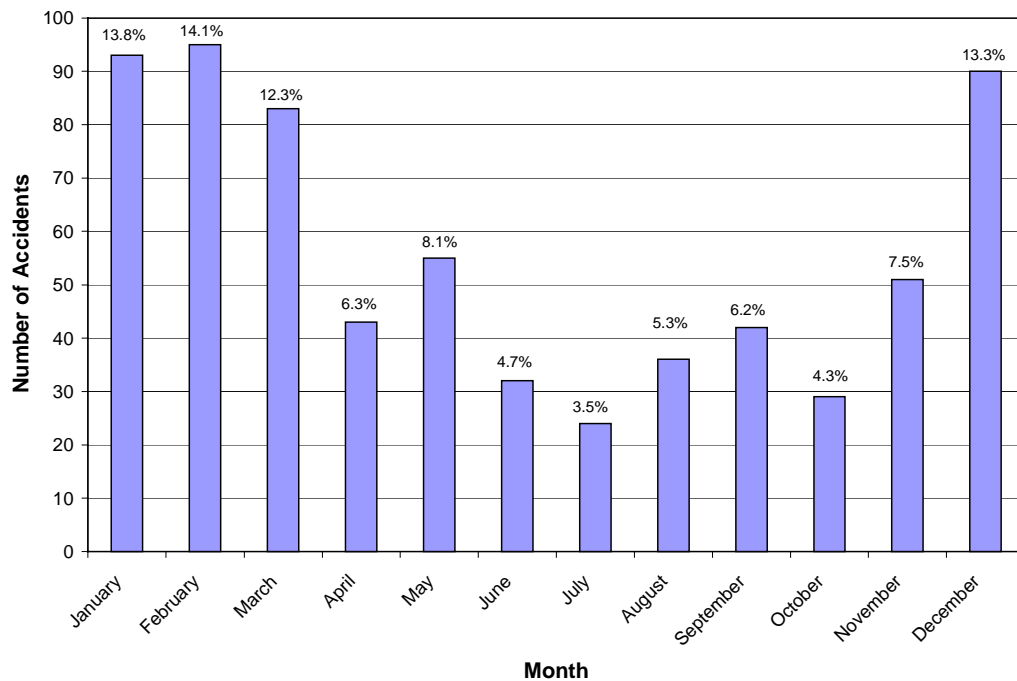
**Figure 8-3: Accident Distribution by Month over Donner Pass, California from October 1, 1995 to September 30, 1998**

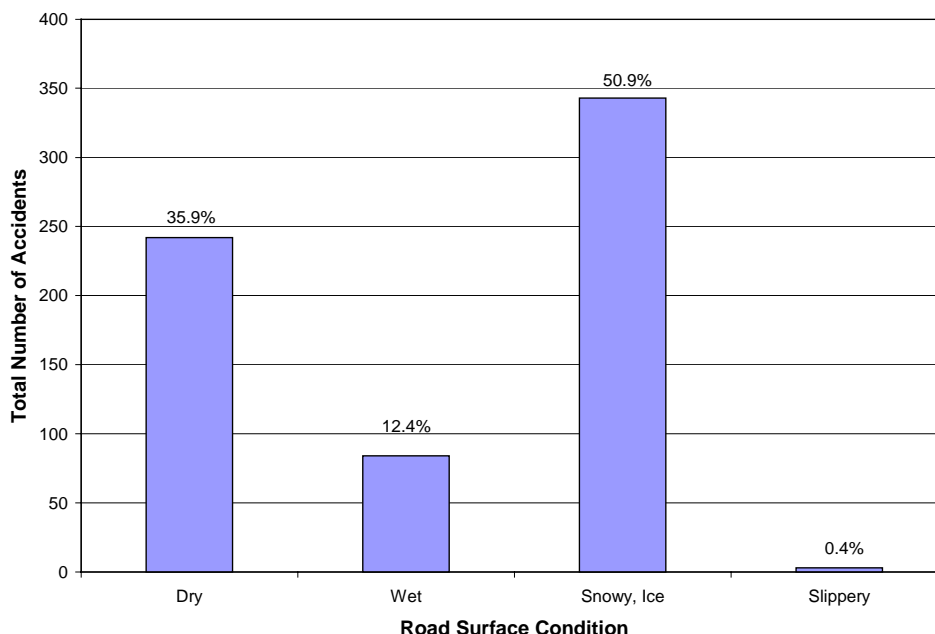
**Figure 8-4: Percent and Number of Accidents for Various Road Surface Conditions over Donner Pass, California from October 1, 1995 to September 30, 1998**

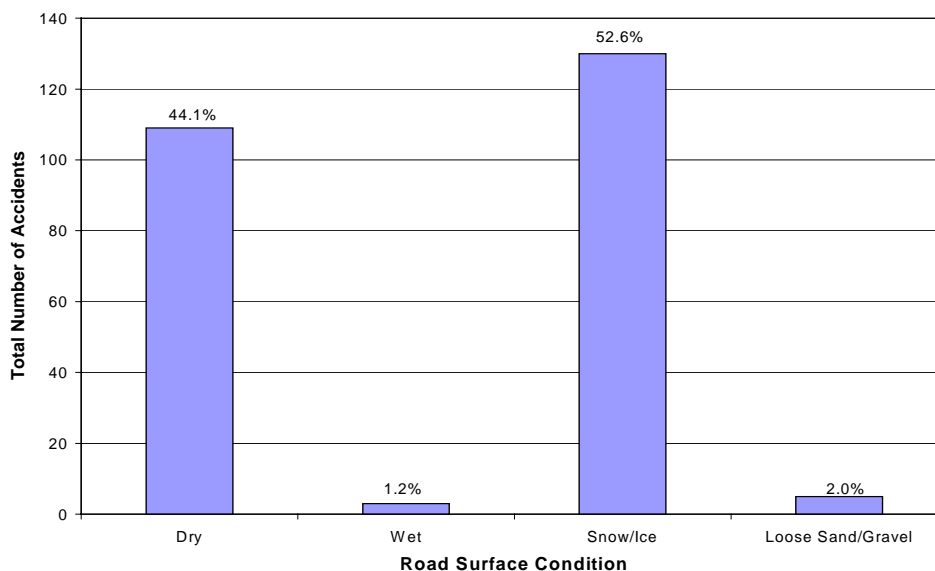
**Figure 8-5: Percent and Number of Accidents for Various Road Surface Conditions around Kendrick Park, Arizona for the Winters between October 1, 1994 and May 1, 1999**

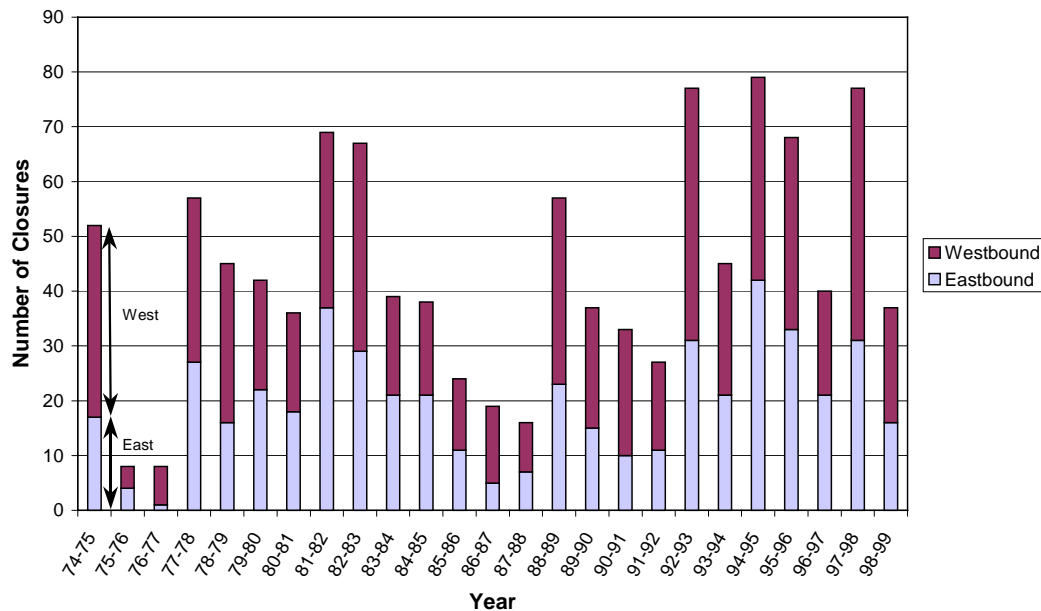
**Figure 8-6: Frequency of Road Closures on both Directions of Interstate 80 in California for 1974 - 1999**

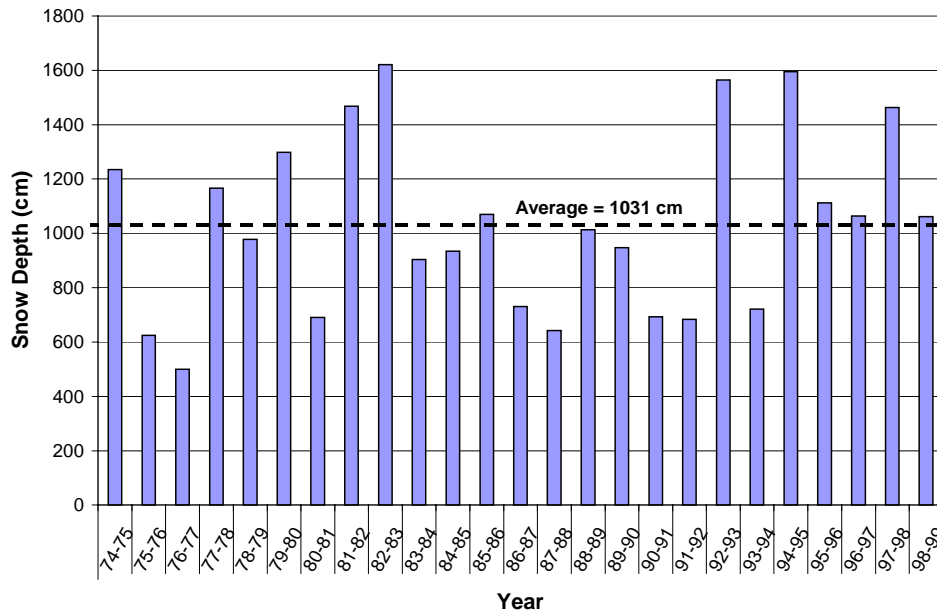
**Figure 8-7: Total Snowfall near Donner Pass, California for 1974 - 1999**

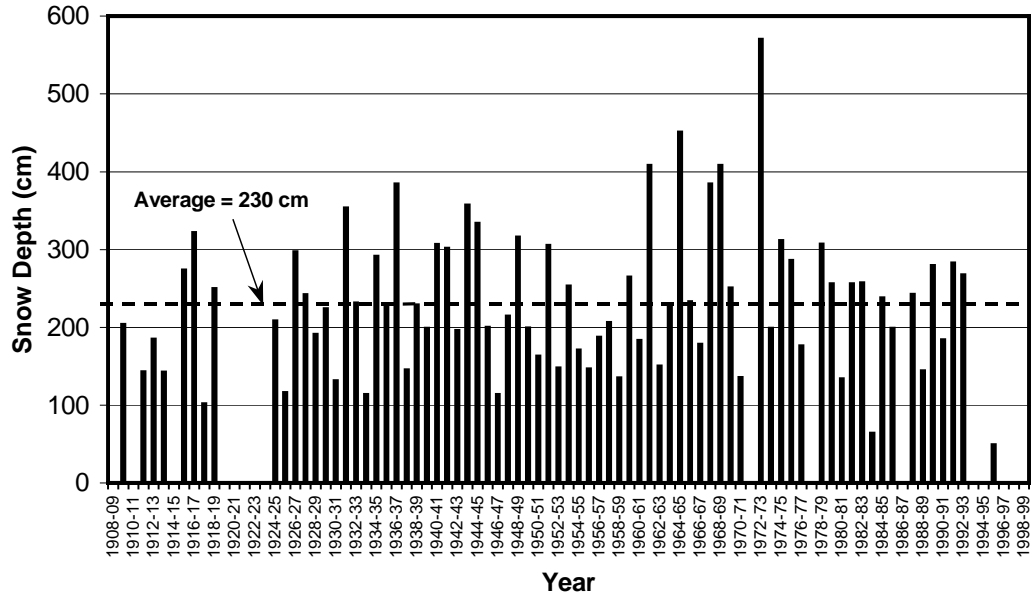
**Figure 8-8: Total Snowfall near Arizona Test Site for 1909 - 1996**

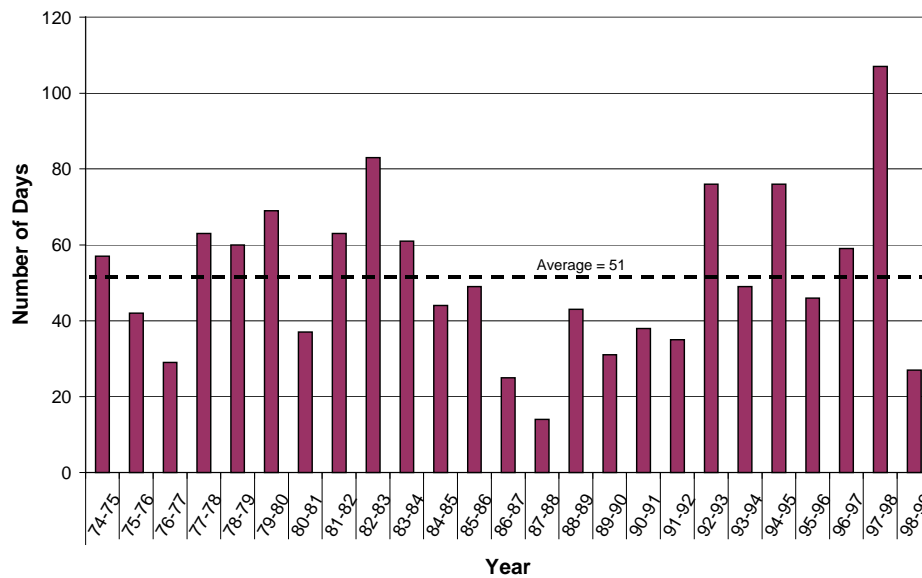
**Figure 8-9: Days Chains Required over Donner Pass, California for 1974-1999**

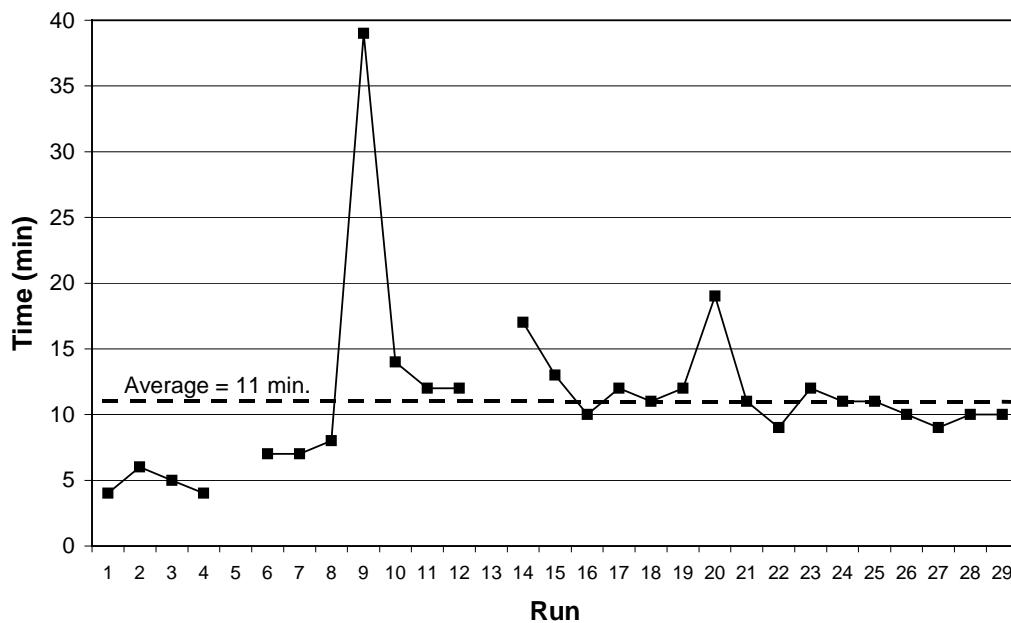
**Figure 8-11: Run Times for Ride-Alongs over Donner Pass, California**
