DEVELOPMENT OF AN IMPROVED DESIGN PROCEDURE FOR UNBONDED CONCRETE OVERLAYS

TPF-5(269)

Task 2 Report

Interlayer Characterization, Field Performance Assessment,
and Guidelines on Drainage

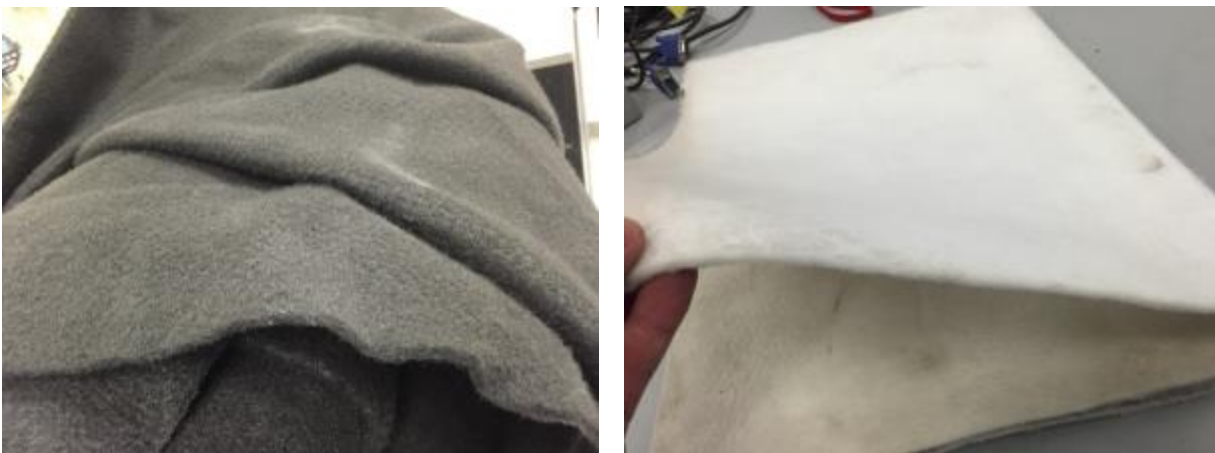
Figure 1. F15 on the Left and F10 on the Right

- Pins: Fabric interlayers were pinned to the existing concrete using a gas powered gun to attach 2 fasteners to each beam approximately 6 inches from the edge. This approximates methods used in the field.
- Glue: Fabric interlayers were glued to the existing concrete using a geotextile glue made by 3M called Scotch-Weld HoldFast 70 Adhesive.

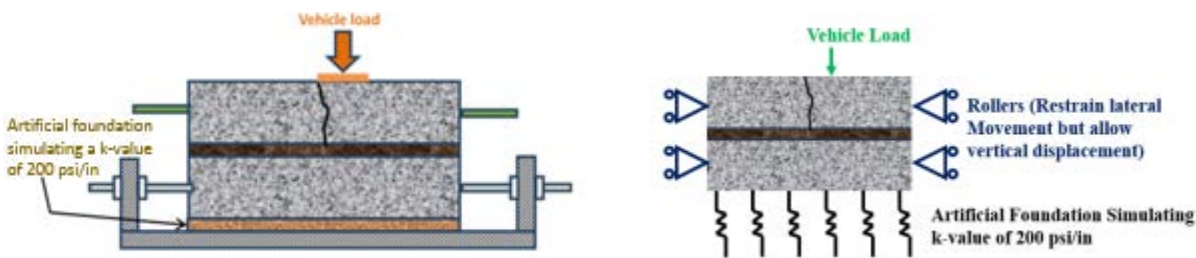
Figure 3. At left, a schematic of Deflection Characteristic Test Setup; at right, the boundary Conditions of Test Setup

The deflection characteristics of the interlayer were established using the setup shown in Figure 3.

Finite element analysis software was used to establish and confirm an appropriate setup and boundary conditions for the specimens. The goal of the finite element modeling was to establish

the specimen length, boundary conditions, and load magnitude and location required to create deflections and rotations representative of those in an overlay loaded by a 9,000 lb design load.

In the computational model, all components were assumed to be elastic solids, no load transfer was provided across the joint, and the three contact conditions between the layers were assumed. Contact conditions included fully bonded, unbonded, and an intermediate level of bond where some shear transfer was allowed. The contact for both interfaces at the interlayer was modified such that every reasonable permutation of contact conditions at the interfaces was considered.

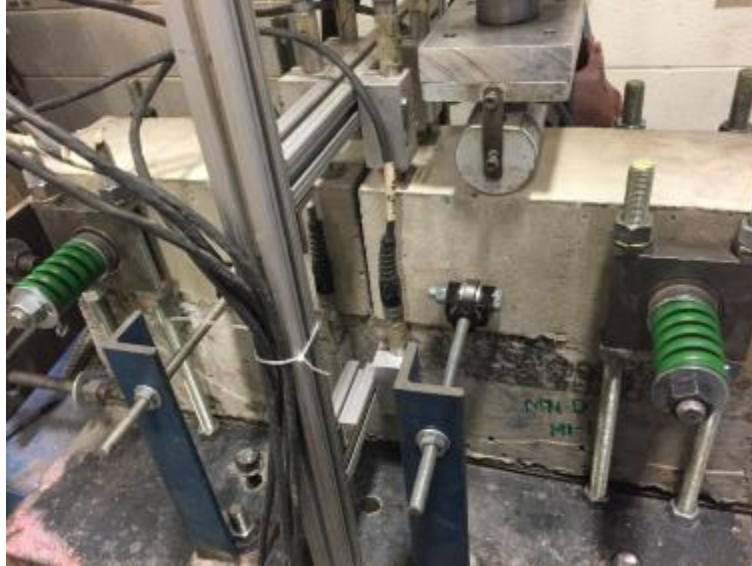
Figure 4. Test setup used to characterize deflection at the interface

Figure 4 shows a specimen in the testing frame used to isolate the deflection at the interface.

The loading head contains a ball joint and is the same loading head used for testing the modulus of rupture beams. The foundation support provided by the lower layers under the concrete slab in an in-service pavement was replicated by an artificial foundation of two layers of neoprene pads, known as Fabcel 25. Figure 5 shows the Fabcel 25 waffle-shaped neoprene pads.

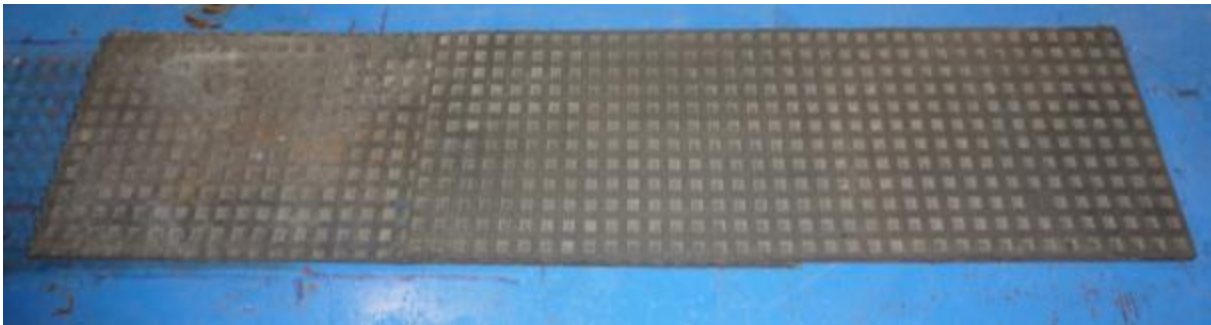
Figure 5. Neoprene pads used to simulate support conditions

The stiffness of the two combined Fabcel layers was determined by conducting a plate load test (ASTM D1195/D1195M), and was found as 200 psi/in. The bearing assembly used to initiate points of rotation can be seen in Figure 6.

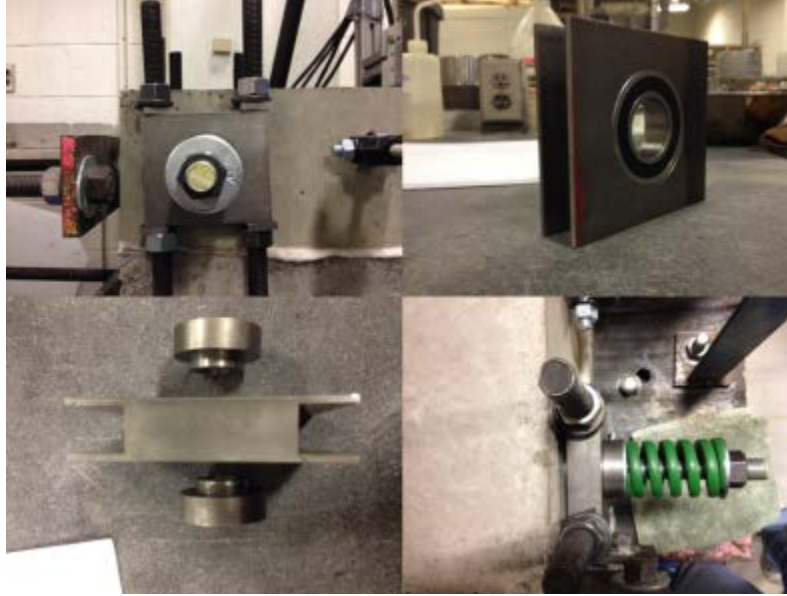
Figure 6. Bearing assembly

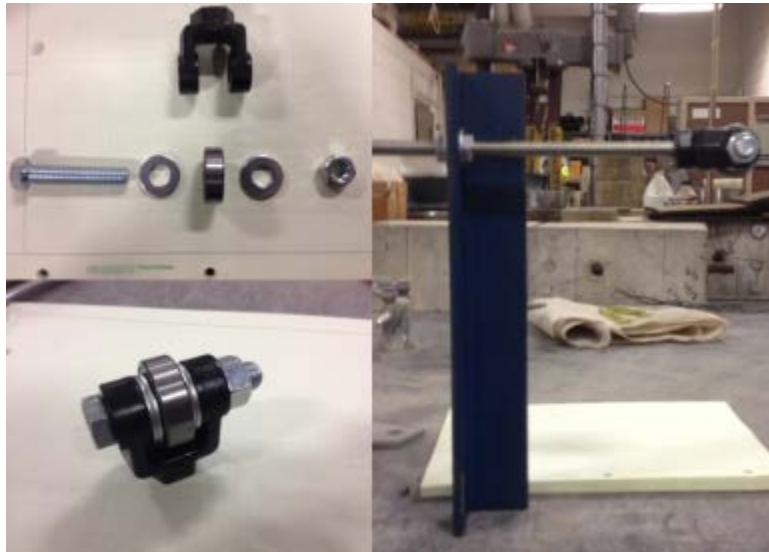
Figure 7. Roller assembly

The green spring is used in conjunction with a torque wrench to apply the same compression every time. A torque of 40 inch-pounds was applied to the bearings for all specimens. Additional restraint was provided by vertical rollers on both the loaded and unloaded sides of the beam on the front and back to prevent horizontal displacement of the specimen. Figure 7 shows the components of this assembly.

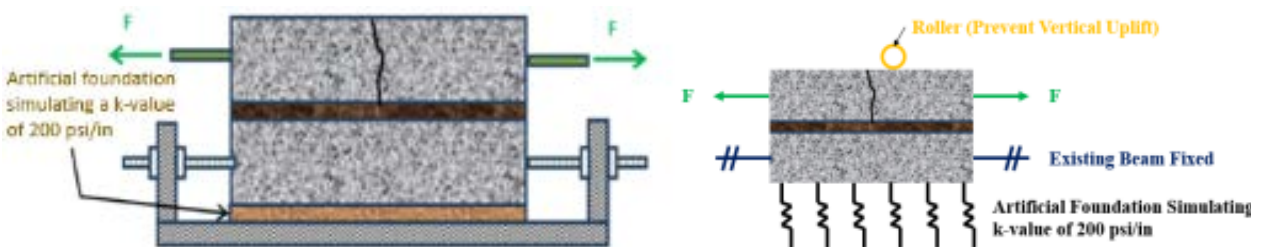
Figure 9. At left, Schematic of Modified Push Off Test Setup; At right, Boundary Conditions of Modified Push Off Test

In order to characterize the resistance to sliding of each interlayer system, a modified push-off test was performed in the laboratory. In this test, a joint is sawn in the overlay of a 30-inch beam. The bottom beam is not sawn, and both ends of this beam are restrained to prevent translational displacement. One side of the overlay is also restrained against displacement. The other side of the overlay is attached to a threaded rod instrumented with strain gauges to record force. Two LVDTs attached to the loading frame are used to measure displacement of the loaded section. A thrust bearing attached to the vertical actuator is placed on the top of the loaded section of the overlay beam near the joint to prevent vertical displacement. The actuator is used in a displacement control mode to ensure no vertical displacement of the test block occurs near the joint during a test. The variable force provided by the actuator prevents rotation of the loaded half of the overlay and subsequent tensile debonding failure near the joint. A schematic of the test setup can be seen in Figure 9, and the test setup in the laboratory is shown in Figure 10.

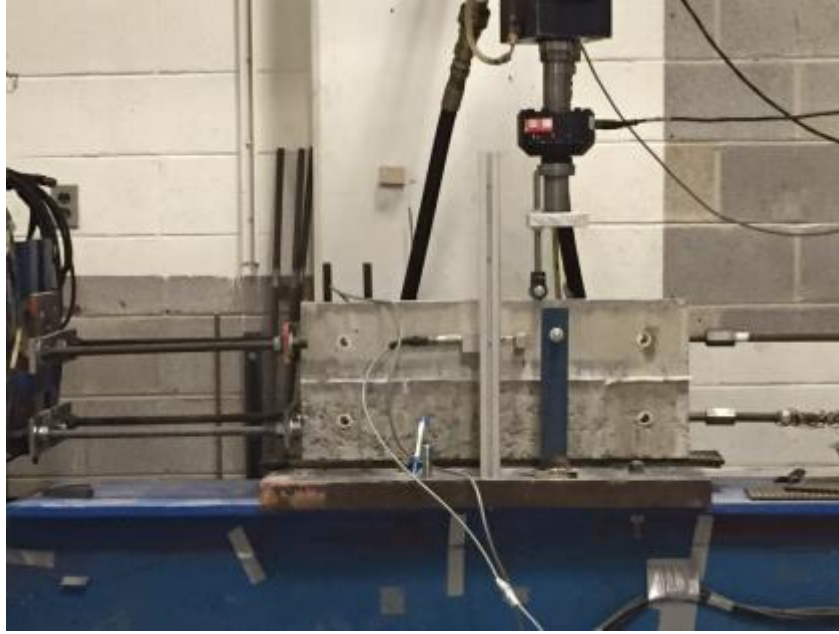
Figure 10. Laboratory setup for the modified push-off test

The horizontal push-off load is applied by manually tightening the instrumented threaded rod. The modified push-off test has two phases. Phase 1 is the cyclic loading phase. In this phase, load is applied until the loaded portion of overlay reaches approximately 80 mils of displacement. The 80 mil displacement corresponds to a 100 degree Fahrenheit drop in temperature for a 12 foot slab cast of concrete with a thermal coefficient of expansion of 5.3 microstrain per degree F. The load is then held constant to observe the relaxation of the interlayer system until the force is relatively constant over time. The load is then removed from the rod. To account for non-elastic displacement, a load is applied in the opposite direction of the initial load until the overlay section returns to its initial position. This position is then held until the force is relatively constant over time. The load, relaxation, opposite load cycle is repeated between 6 to 8 times for each test. Phase 2 is the ultimate loading phase. In this phase, load is applied until the interlayer system fails, or very large displacements (over one inch) are observed.

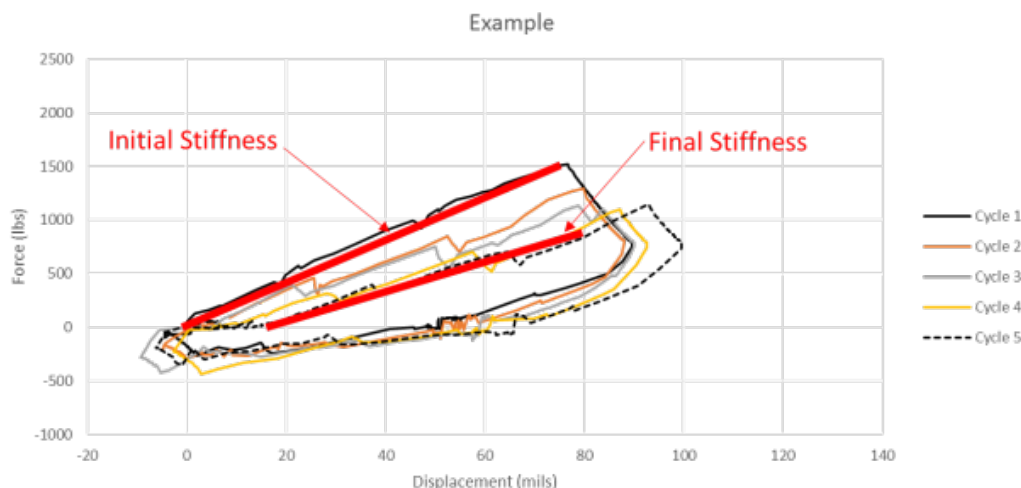
Figure 11. Example of Initial and Final Stiffness determination

During testing it was determined that the interlayer system stiffness stabilized between 5 and 8 load cycles. This stiffness is relevant when calculating the stress in the overlay caused by the interlayer resisting uniform volume changes due to a decrease in temperature and/or moisture. An overly stiff unbonded overlay system can prevent true debonding, cause high stresses to develop in the overlay, and prevent proper joint deployment. The average final stiffness for each interlayer is summarized in Table 6. The definition of the initial and final stiffness is shown in Figure 11.

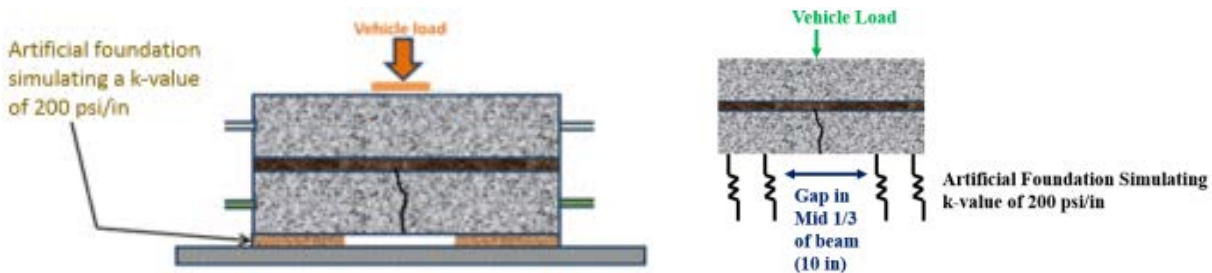
Figure 12. At left, Schematic of Reflective Cracking Test Setup; at right, Boundary Conditions of Reflective Cracking Test Setup

Reflective cracking is a potential concern for unbonded overlays. The reflective cracking test setup is designed to assess the ability of the interlayer system in deterring cracks in the existing pavement from reflecting up into the overlay. For this test setup, a saw cut is made in the lower beam at midspan to represent a joint or crack in the existing concrete. The beam was loaded directly above the sawed joint in the middle of the 30 inch beam using the same loading head used for the deflection test setup. Figure 12 below illustrates the schematic used in the planning of the reflective cracking test setup, while Figure 13 illustrates the as-built apparatus in the laboratory.

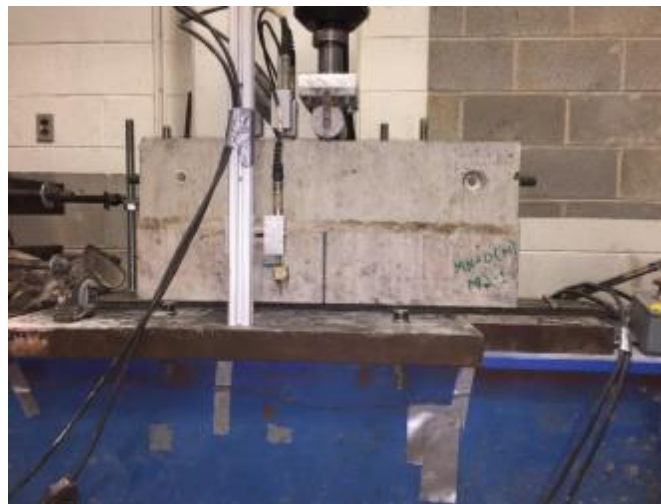
Figure 13. Final test apparatus for reflective cracking

The load in the test configuration is applied at a constant rate until a reflective crack is generated in the overlay beam. The load rate was chosen to be 30 pounds per second, which is the loading rate specified when performing modulus of rupture testing for concrete beams (ASTM C78).

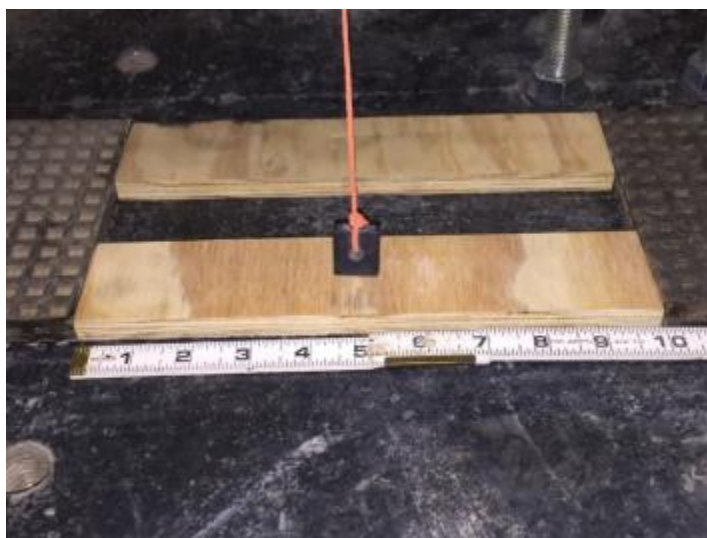
Figure 14. 10-inch Gap in Fabcel with Plumb Bob to Center the Gap

In order to overcome this problem, a gap was created under the central 10 inches of the beam by removing the Fabcel so there was no support in this area. This gap under the center of the beam is intended to simulate a void under the joint of an existing pavement. Figure 14 shows the gap in the Fabcel measured with plywood and centered with a plumb bob. With the gap under the beam, subsequent shakedown tests generated reflective cracking which propagated from the bottom-up.

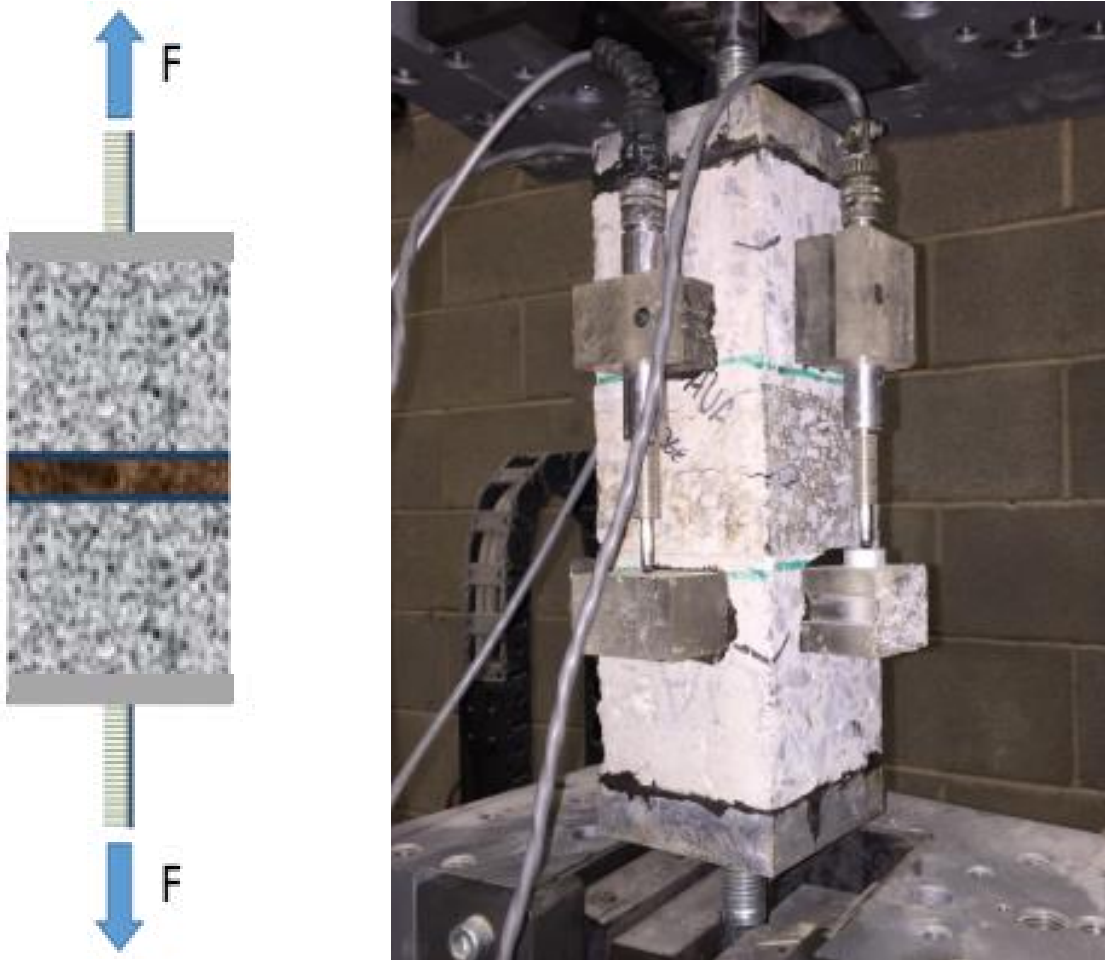
Figure 15. Schematic of direct tension test; at right, laboratory direct tension test on specimen with HMA interlayer

Bond strength of interlayers was evaluated by measuring the vertical force-displacement relationship as the concrete layers of the unbonded overlay structure are loaded in direct tension, as shown in Figure 15. This test is intended to provide insight into how debonding between the existing and overlay concrete layers develops in the field and to determine if curling can result in debonding between the interlayer and the concrete layers.

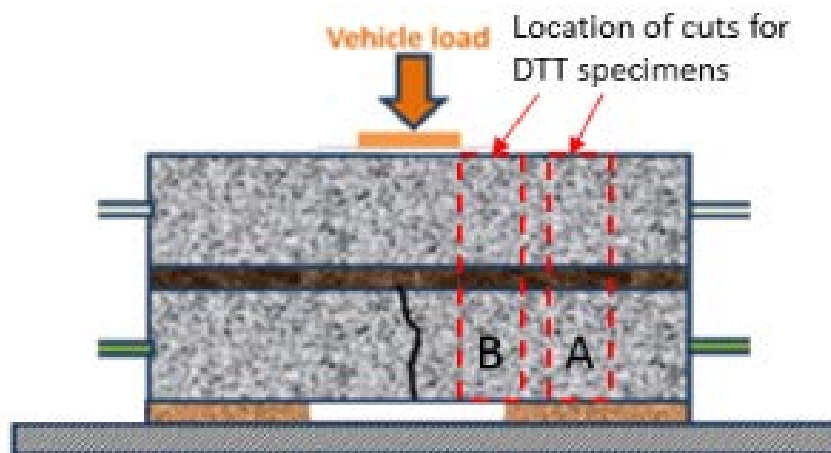
Figure 16. Location of asphalt direct tension specimens

Each direct tension specimen was either cut from one of the already tested Mechanism 3 specimens (asphalt interlayers) or cast in cylindrical molds (fabric interlayers). It was assumed that little to no damage was experienced where the direct tension specimens were sawn from the Mechanism 3 specimens and would therefore not affect the results of the direct tension test. The direct tension specimens required very precise preparation. The location of the specimens in the direct tension beams is provided in Figure 16.

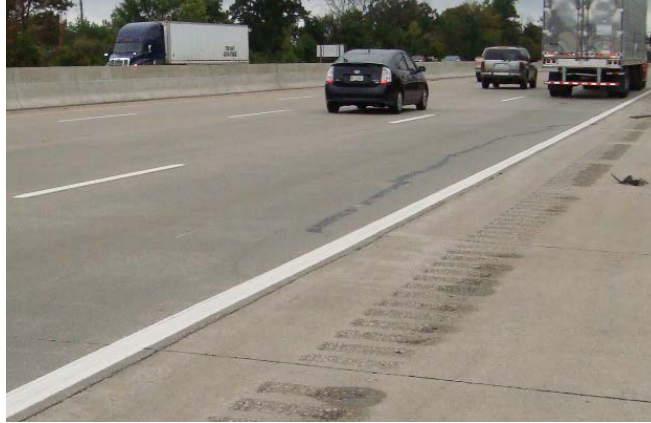
Figure 20. Longitudinal cracking due to erosion of the HMA interlayer in surveyed Michigan sections

Erosion longitudinal cracks. A contributing cause to the development of some of the longitudinal cracks is erosion of the interlayer between the lane shoulder joint and the wheelpath, as shown in Figure 20.

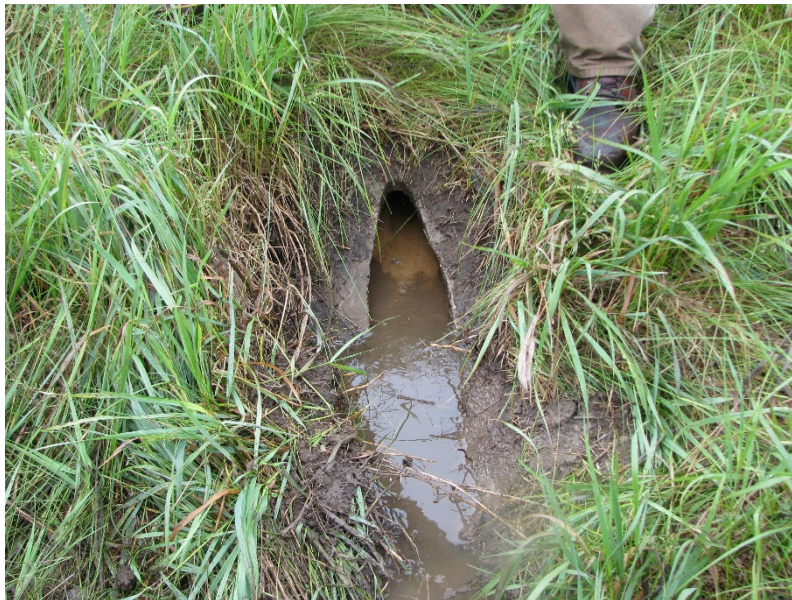
Figure 21. Plugged edge drain near surveyed Michigan sections

These longitudinal cracks tend to gradually meander towards the lane/shoulder joint. For example, on I-96, drainage was not included as part of the overlay. This resulted in water build up in the interlayer and longitudinal cracking in the overlay. MIDOT has found that ensuring adequate drainage as well as maintaining edge drains is therefore significantly important to these structures where the interlayer is susceptible to erosion. If the drainage system backs up, then water will remain trapped in the interlayer, as shown in Figure 21.

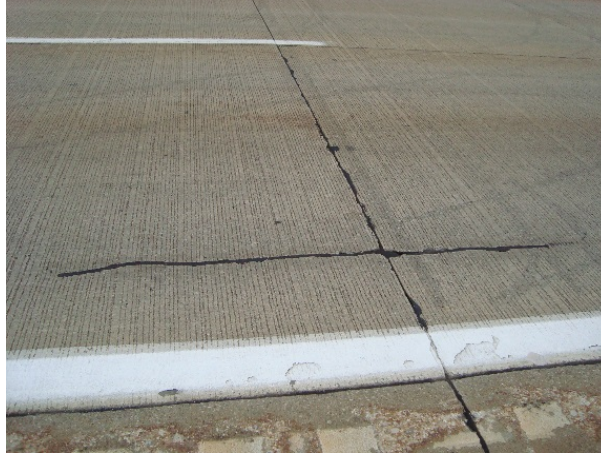
Figure 22. Longitudinal (or diagonal) cracking in the wheelpath in sections surveyed in Michigan

Longitudinal cracks in the wheel path. Longitudinal fatigue cracking can also develop along the wheel path. This may propagate from one transverse joint to the next along the wheel path or begin propagating along a diagonal to the lane/shoulder joint, as illustrated in Figure 22.

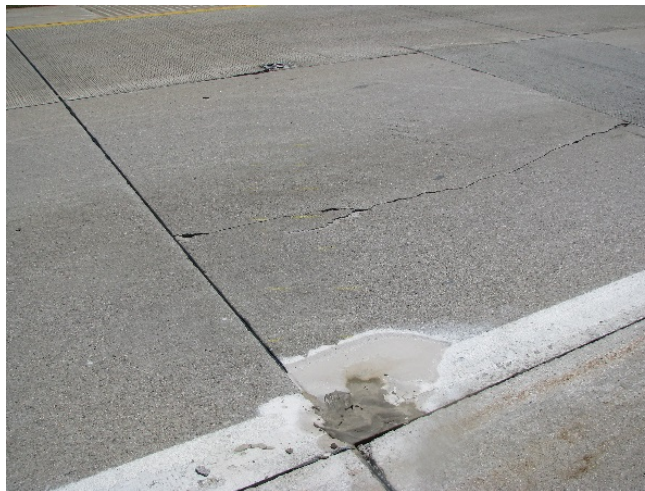
Figure 23. Midslab longitudinal cracking in surveyed Michigan sections

Midslab longitudinal cracks. Midslab longitudinal cracking was also observed, as shown in Figure 23. This appears to be top-down cracking related to fatigue. The shorter joint spacings of 10 or 12 ft can result in fatigue cracking preferentially occurring in the longitudinal direction in lieu of the transverse direction.

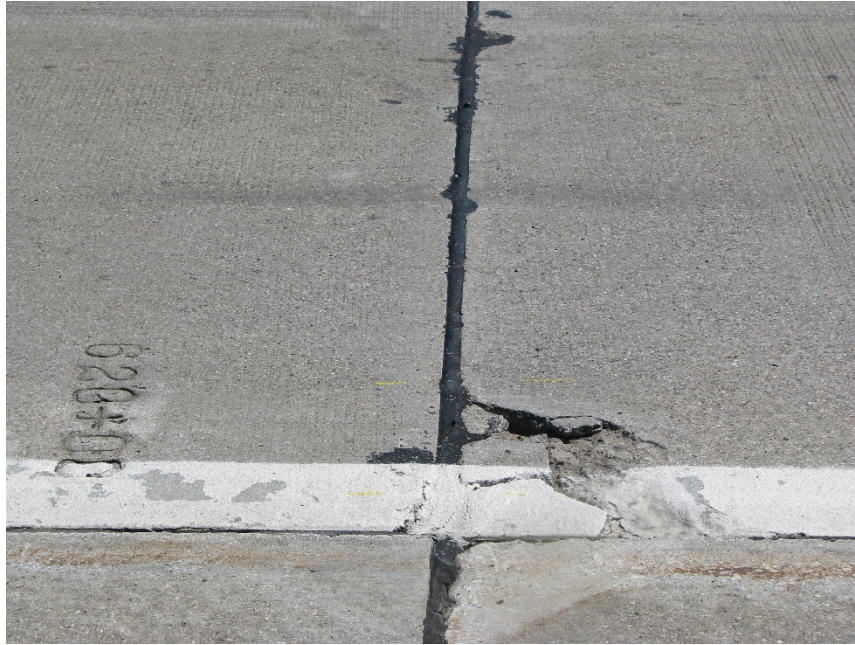
Figure 24. Wider working joint exhibiting distress in Michigan sections surveyed for Task 2

One of these wider distressed working joint is shown in Figure 24.

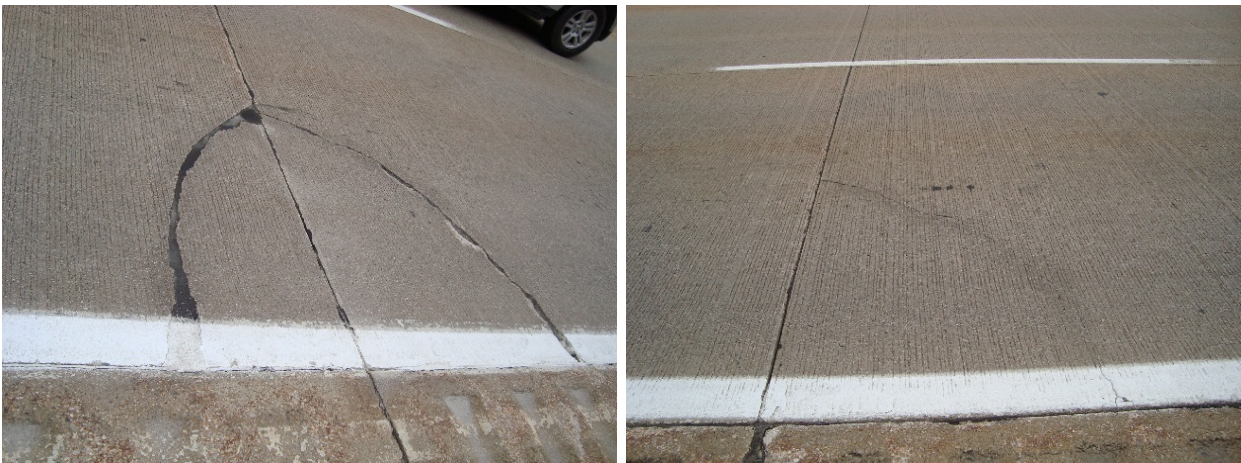
Figure 25. Corner breaks observed in Michigan**2.3.1.4. Transverse cracking**

Corner breaks were also observed in many sections. A few instances of the corner breaks observed are illustrated in Figure 25. The observed corner breaks could be the result of drainage issues. If water only enters on part of the lane, and becomes trapped at the edge, a corner break may develop. This water will cause an asphalt interlayer to strip and ravel, leading to loss of support. MIDOT now installs edge drain systems when constructing unbonded overlays.

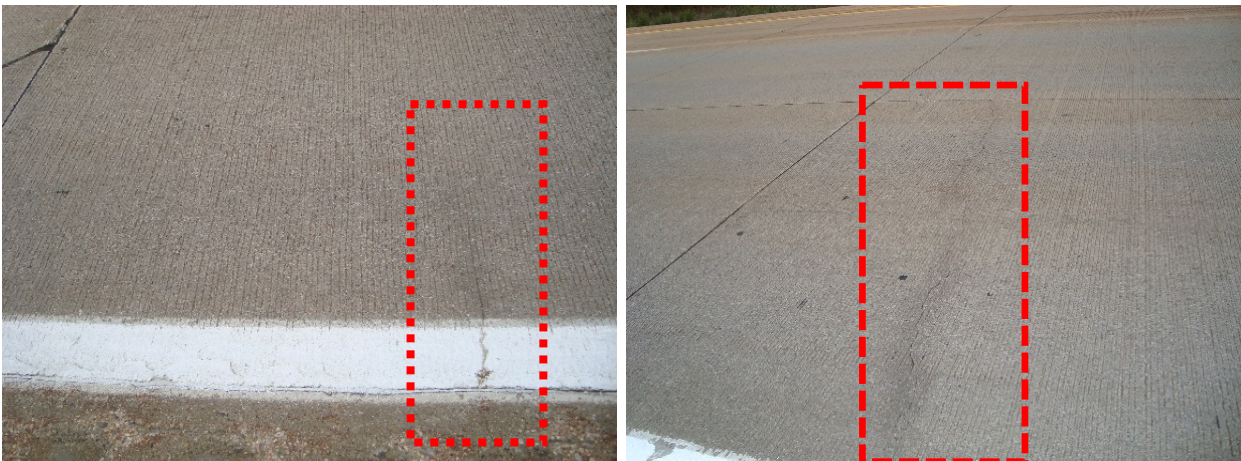
**Figure 26. Transverse cracking on leave side of joint****2.3.1.5. Joint faulting**

Transverse cracking near joints. Transverse cracking just on the leave side of the joint also appears to be common and does not appear to be a reflective crack. Examples of this can be seen in Figure 26. Further investigation is needed to determine the cause of these cracks.

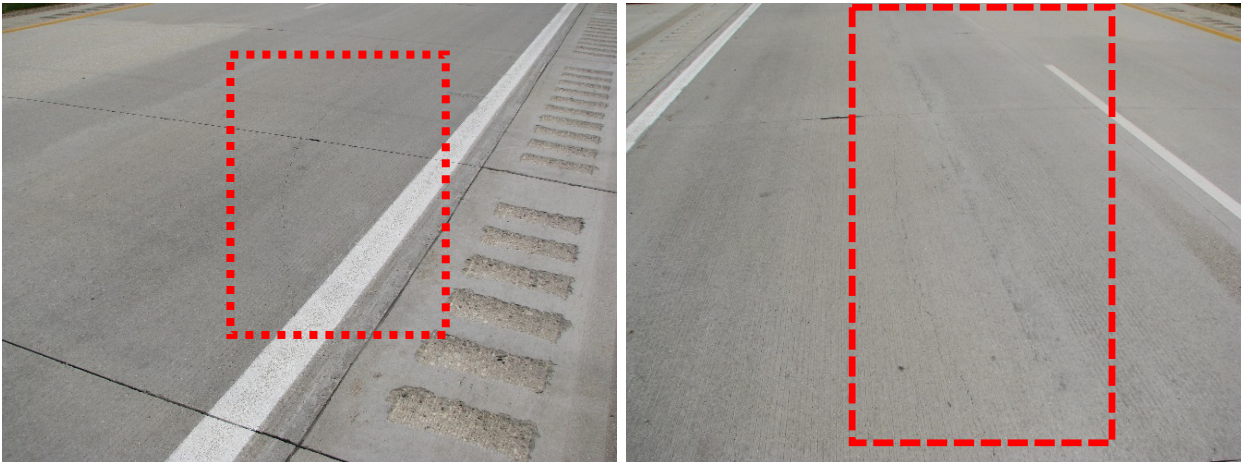
Figure 27. Longitudinal cracks on US-10 near Coleman, MI

One nonwoven geotextile fabric was constructed in Michigan as part of a test section within a project where an UBOL was constructed with a 1 in open graded HMA interlayer. This project is along US 10 near Coleman. The structure is a 6 in doweled JPCP with a 12 ft joint spacing and a tied shoulder. Early age longitudinal cracking was observed near the location where the fabric meets the asphalt. This could be due to a backup of water at the interface of the two interlayers leading to the crack initiation. The water could become trapped at the interface between the fabric and HMA resulting in a buildup of pressure resulting in the observed cracking. Additionally, the abrupt change in support condition between the asphalt and fabric could have resulted in additional stresses leading to the crack development. This longitudinal crack continued to develop in adjacent panels down the roadway, as would be expected without isolating the adjacent panels. Figures depicting this cracking are shown in Figure 27 below.

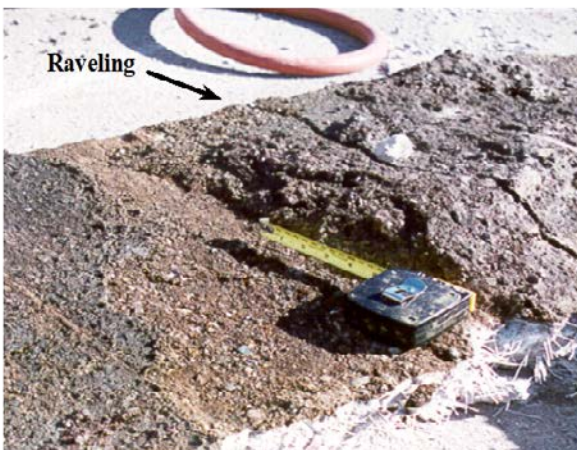
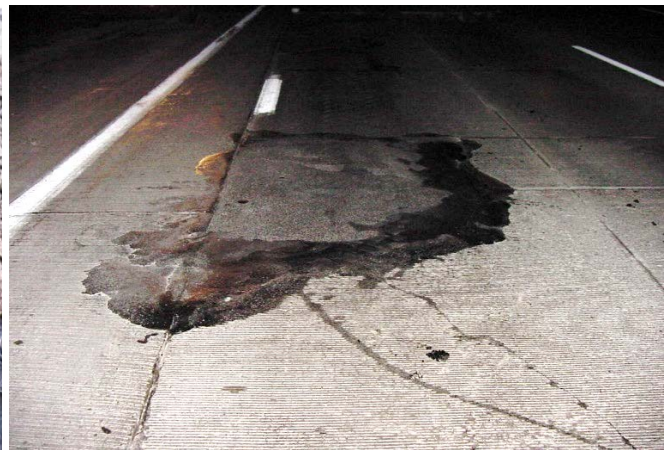
Figure 28. Photo of asphalt stripping/raveling under concrete overlay (left) and overlay damage resulting from loss of support (right)

Asphalt-based materials have been used as UBOL separation layers for many years. Asphalt stripping problems have occasionally developed within these interlayers under repetitive heavy loading in the presence of water, typically over the course of several years, causing a loss of support for the unbonded concrete overlay (see Figure 28). This loss of overlay support has led to the premature failure of some UBOLs. This type of problem may be more likely with relatively thin concrete overlays where higher load-related slab deflections are more likely to induce stripping, erosion and asphalt deformation problems.

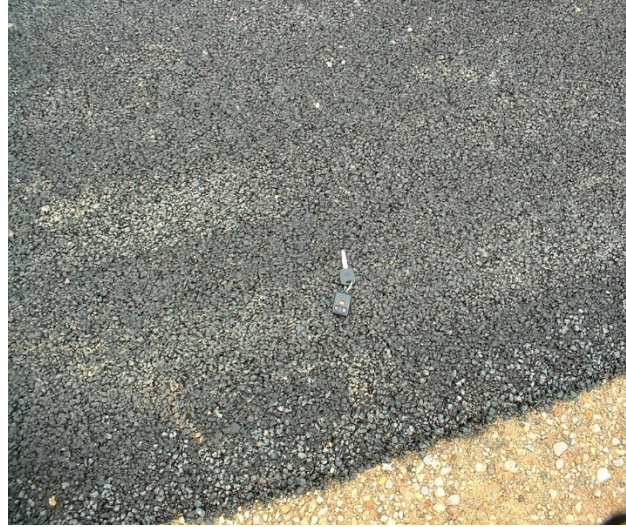
Figure 29. Photo of Michigan DOT Drainable HMA Separation Layer

The development of a drainable (but structurally stable) asphalt-based interlayer can be accomplished by decreasing the amount of fine aggregate and increasing the amount of 3/8” aggregate in the mixture. An example aggregate gradation for a drainable asphalt interlayer is given in Table 12, and a photo of an asphalt concrete interlayer that uses this specification is shown in Figure 29.

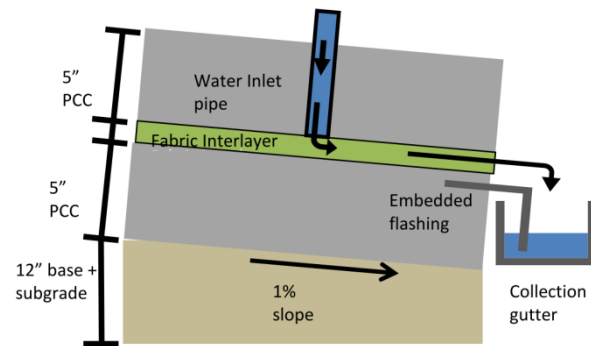
Figure 30. Schematic of apparatus used to test the effects of static and dynamic loads on the flow of water through a geotextile fabric interlayer in an unbonded concrete overlay of concrete pavement (Lederle et al, 2012)

A recent study at the University of Minnesota led by members of the research team examined the measured flow rate and velocity of water draining through an interlayer fabric in a UBOL under static and dynamic loading conditions using a laboratory-based full-scale accelerated pavement loading test stand. The objective of this work was to characterize the drainage provided by a nonwoven geotextile fabric interlayer in an unbonded concrete overlay system (Lederle et al, 2012). Figure 30 presents a schematic of the test set-up used in this study.

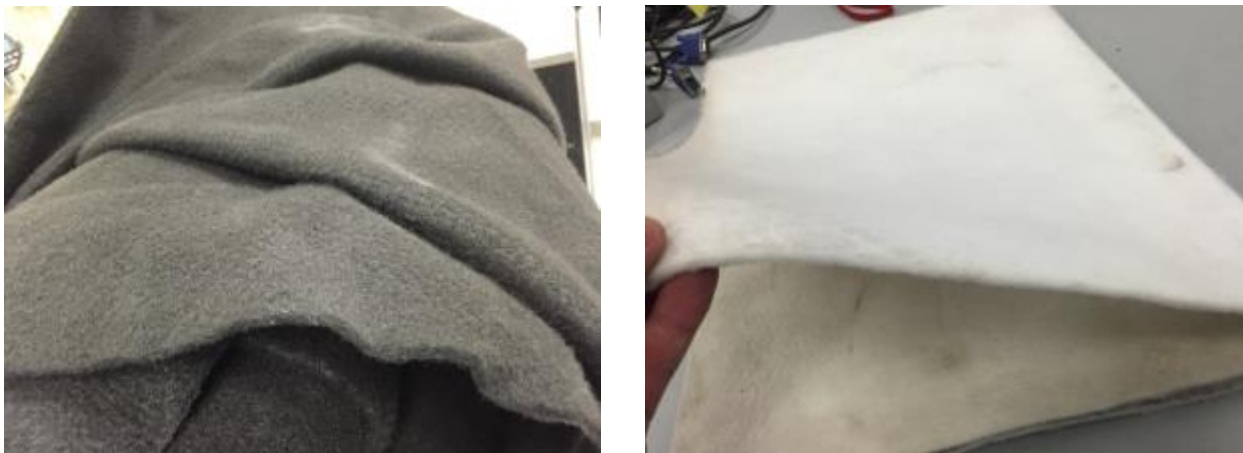
Figure A-1. F15 on the Left and F10 on the Right

The nonwoven geotextile fabrics used for this study were manufactured by Propex and consisted of a thick and a thin fabric. The thick fabric weighed 15 oz/yd² and was dark in color. The thinner white colored fabric, called Reflectex, was made specifically for this study and weighed 10 oz/yd². In this report, the fabrics will be called F15 and F10 for the thick and the thin fabrics, respectively. These fabrics can be seen in Figure A-1. For this study, the fabrics are attached to the existing concrete beams with a geotextile glue made by 3M called Scotch-Weld HoldFast 70 Adhesive.

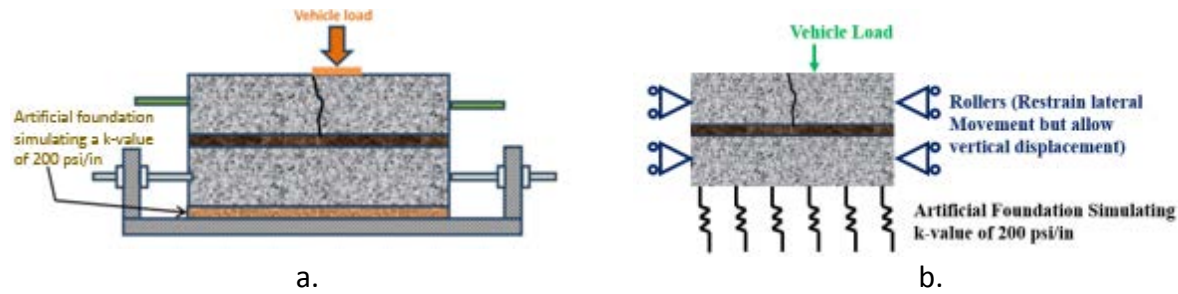
Figure A-3. a. Schematic of Deflection Characteristic Test Setup
b. Boundary Conditions of Test Setup

The deflection characteristics of the interlayer were established using the setup shown in Figure A-3. The composite section consists of a beam representing the existing slab (in strength and stiffness), the interlayer system, and a beam representing the overlay (in strength and stiffness). A load is applied to one side of a joint sawed in the overlay and deflections in the overlay and existing beams are measured by linear variable displacement transducers (LVDTs). A brief discussion of the finite element modeling performed to insure the beam test is representative of the response (deflection and rotation) of the pavement structure is provided. This is followed by a discussion of the hardware used in the setup, the loading regime, and the material properties for the beams tested.

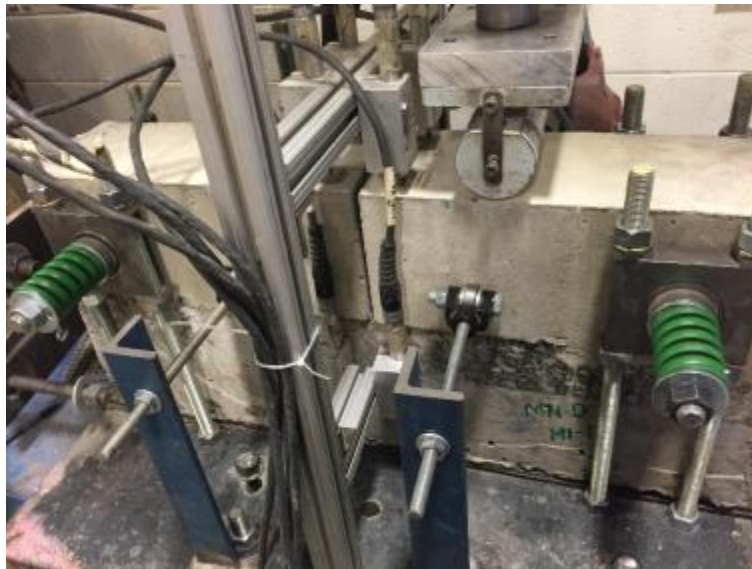
Figure A-4. Mechanism 1 Setup

Figure A-4 shows a specimen in the testing frame for Mechanism 1. The loading head contains a ball joint and is the same loading head used for testing the modulus of rupture beams. The foundation support provided by the lower layers under the concrete slab in an in-service pavement was replicated by an artificial foundation of two layers of neoprene pads, known as Fabcel 25 (<http://www.fabreeka.com/Products&productId=24>). Figure A-5 shows the Fabcel 25 waffle-shaped neoprene pads. The stiffness of the two combined Fabcel layers was determined by conducting a plate load test (ASTM D1195/D1195M), and was found as 200 psi/in. The bearing assembly used to initiate points of rotation can be seen in Figure A-6. The green spring is used in conjunction with a torque wrench to apply the same compression every time. A torque of 40 inch-pounds was applied to the bearings for all specimens. Additional restraint was provided by vertical rollers on both the loaded and unloaded sides of the beam on the front and back to prevent horizontal displacement of the specimen. Figure A-7 shows the components of this assembly.

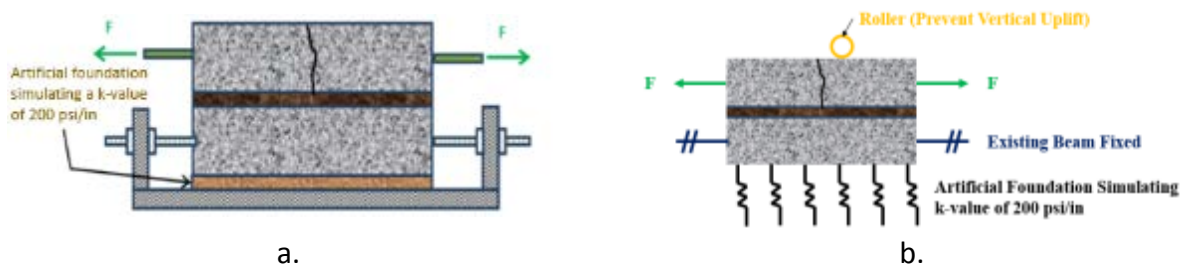
Figure A-9. a. Schematic of Modified Push Off Test Setup
b. Boundary Conditions of Modified Push Off Test Setup

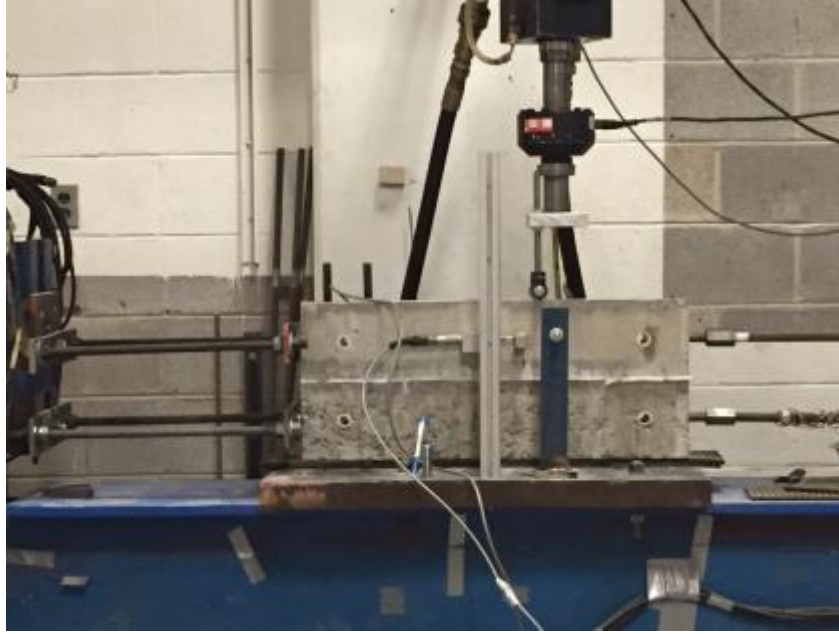
Figure A-10. Picture of Mechanism 2 Test Setup

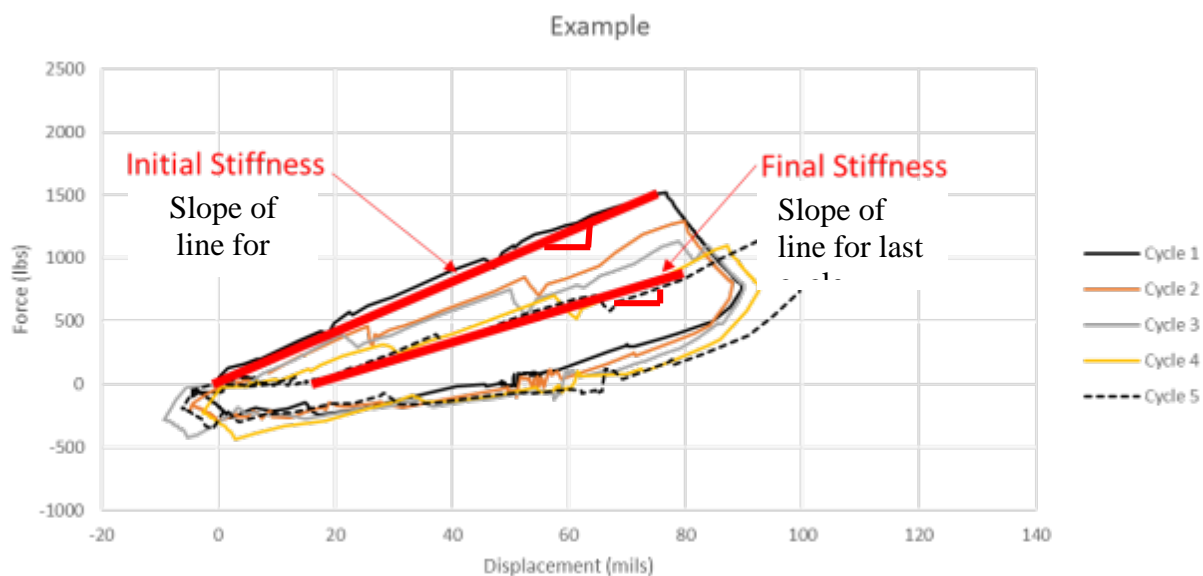
Figure A-11. Example of how Initial and Final Stiffness are Defined

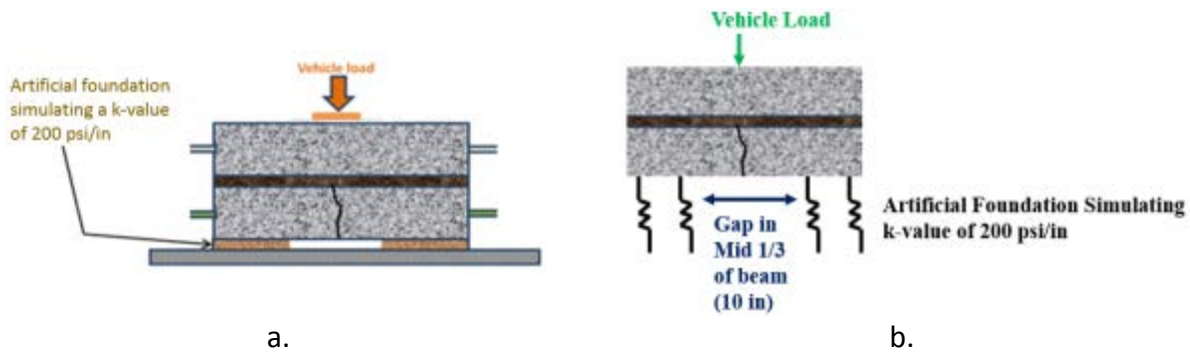
Figure A-11. a. Schematic of Reflective Cracking Test Setup
b. Boundary Conditions of Reflective Cracking Test Setup

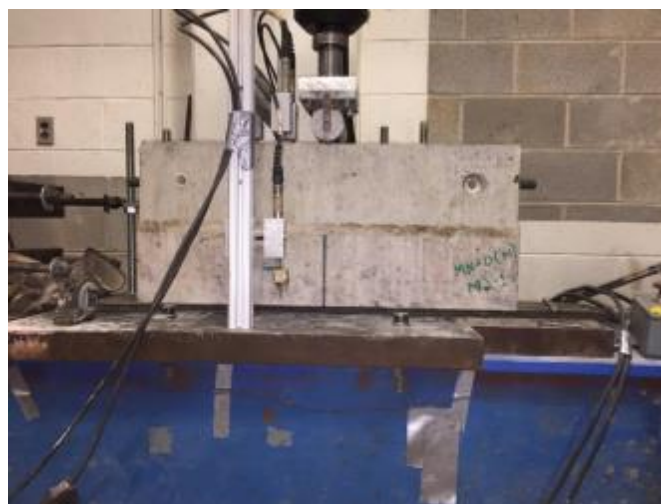
Figure A-12. Specimen in Mechanism 3 Test Frame for Assessing Reflective Cracking

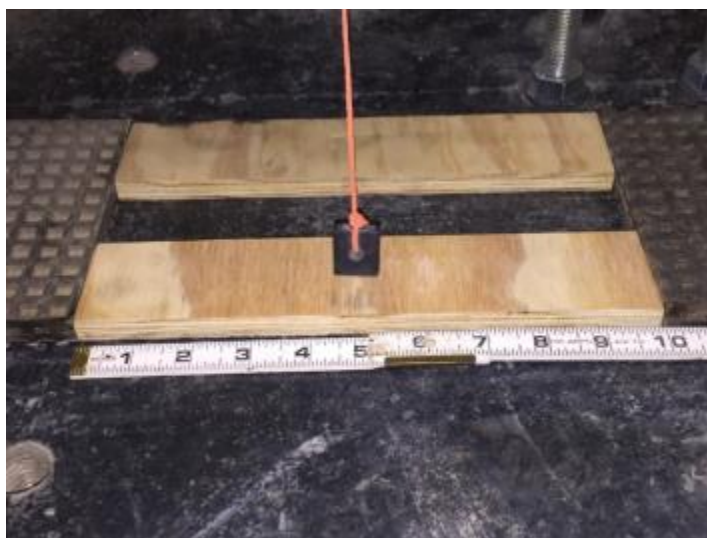
Figure A-13. 10 inch Gap in Fabcel with Plumb Bob to Center the Gap

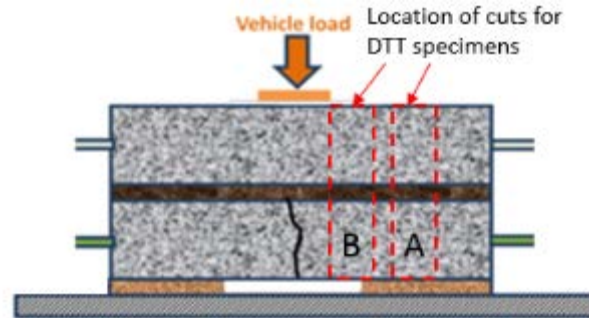
Figure A-15. Location of asphalt direct tension specimens

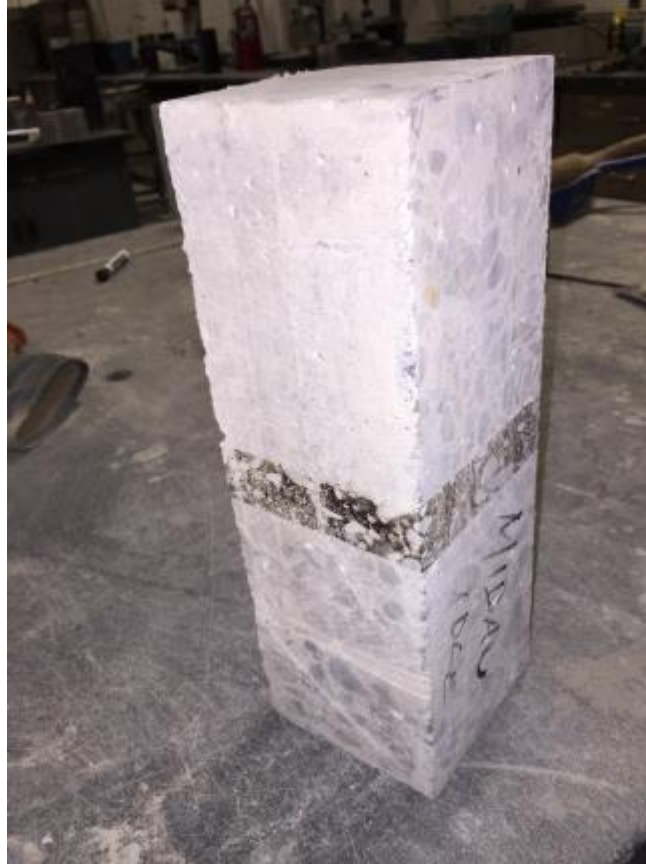
Figure A-16. Direct Tension Specimen with Asphalt Interlayer

The asphalt interlayer specimens were 4-inches on each side and approximately 12 inches tall. An asphalt interlayer direct tension specimen is shown in Figure A-16. The fabric interlayer specimens were 4-inch diameter and approximately 8 inches tall cylinders. The fabric specimens were made in two steps. First, the bottom of the specimen was cast using a 0.36 w/cm. Next, the fabric was glued to the top of the specimen bottom and the top of the specimen was cast using a 0.42 w/cm overlay mixture.

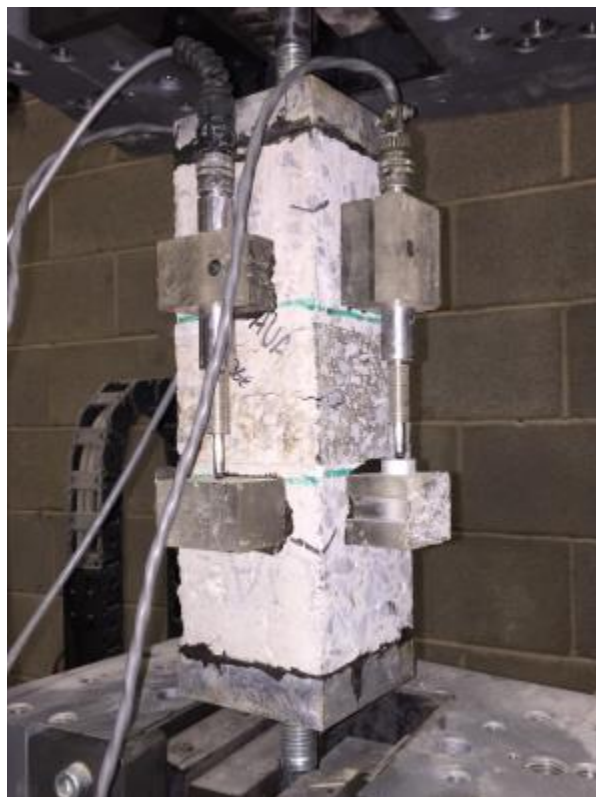
Figure A-17. Mechanism 4 Test Setup (HMA interlayer)

An Instron loading machine was used to apply a direct tensile load. A photo of the test setup is shown in Figure A-17. The test is run in displacement control mode at a rate of 1 mil/sec and the force is recorded by the load machine. Displacement is also recorded with two LVDTs attached to opposite sides of the specimen. The relative displacement between the concrete above and below the fabric is measured, which can be seen in Figure A-17. Table A-8 summarizes the specimens tested and the peak load and displacement at the peak load. Force vs displacement for each Mechanism 4 specimen is plotted in Appendix 5.

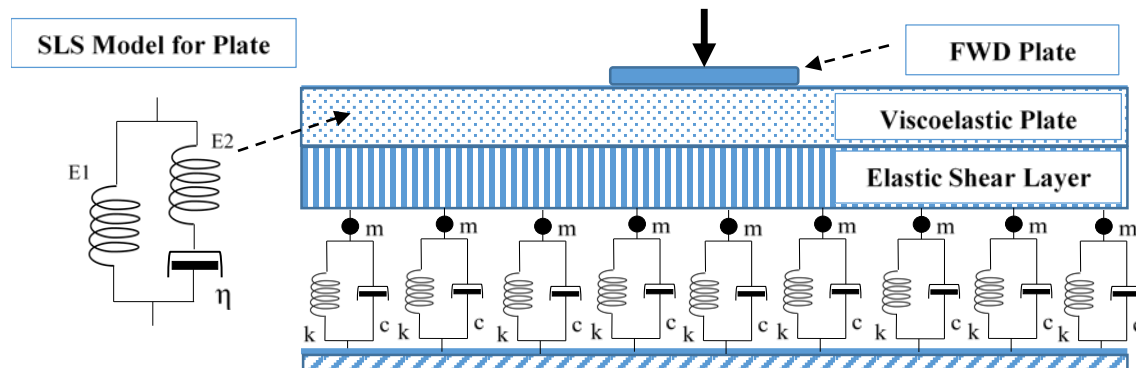
FIGURE B-1 Generalized Pasternak Model

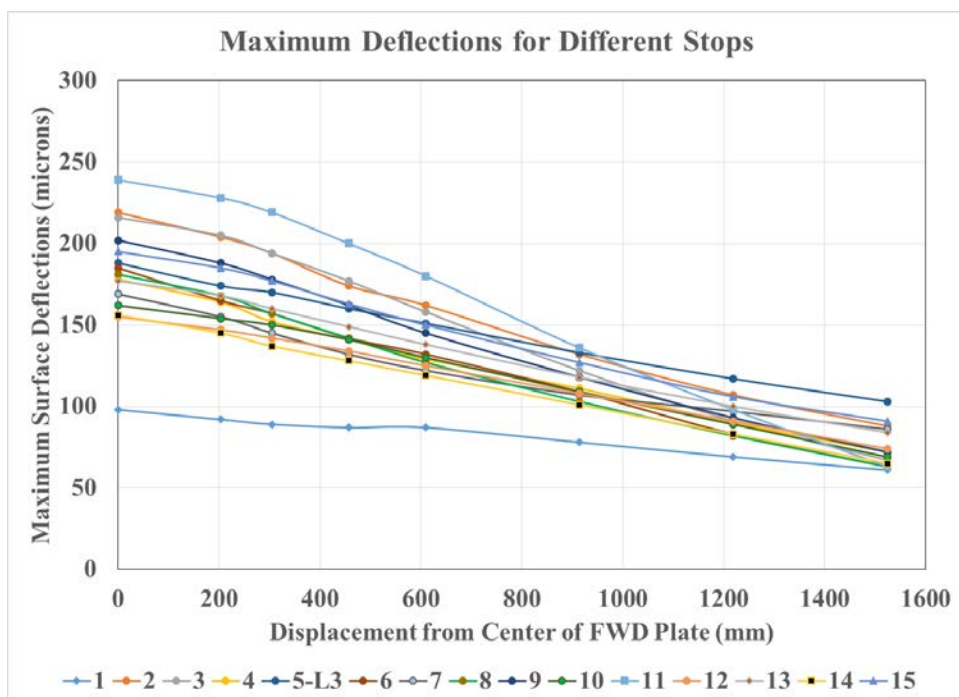
FIGURE B-5 Peak Recorded Deflections at each FWD Sensor Location for Different Stops
