DEVELOPMENT OF AN IMPROVED DESIGN PROCEDURE FOR UNBONDED CONCRETE OVERLAYS

TPF-5(269)

Task 2 Report

Interlayer Characterization, Field Performance Assessment,
and Guidelines on Drainage

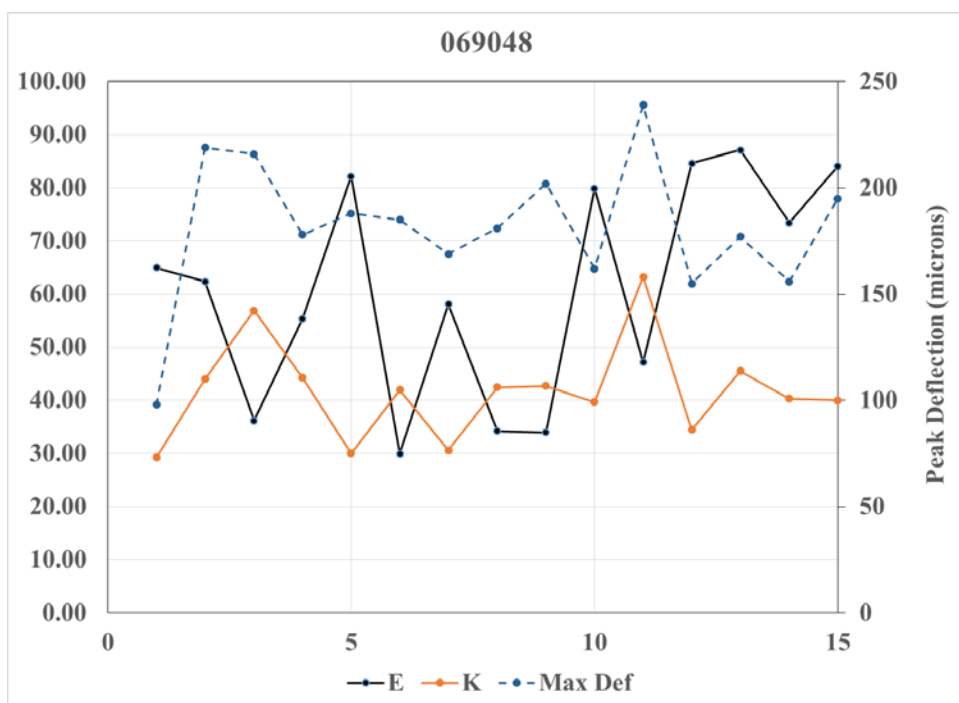
FIGURE B-6 Backcalculated E- and k-Values and Peak Deflections for Different Stops
