## June 30, 2009 Progress Report on Pooled Fund Study TPF-5(189): "Enhancement of Welded Steel Bridge Girders Susceptible to Distortion-Induced Fatigue"

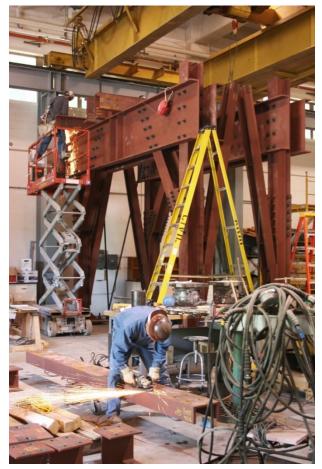
Fig. 1. Test frame under construction

The test frame was erected in mid-May, 2009 in the University of Kansas Structures Lab, and is pictured in Figures 1 and 2. The 400-kip MTS actuator and hydraulic pump also arrived in May, and are in the process of being installed.

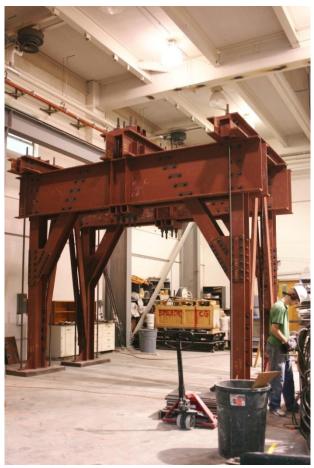
Fig. 2. Completed test frame in KU structures lab
