EVALUATION OF ALTERNATIVE DOWEL BAR MATERIALS

Draft Interim Report

March 2005

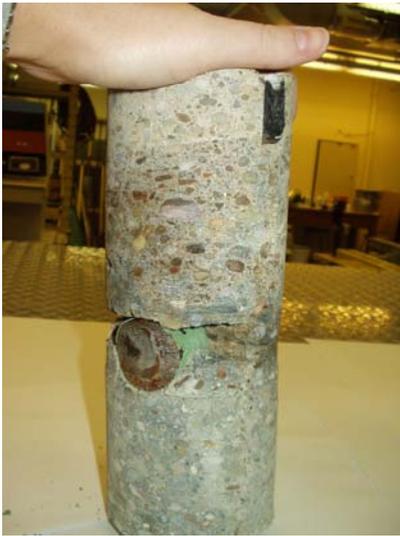
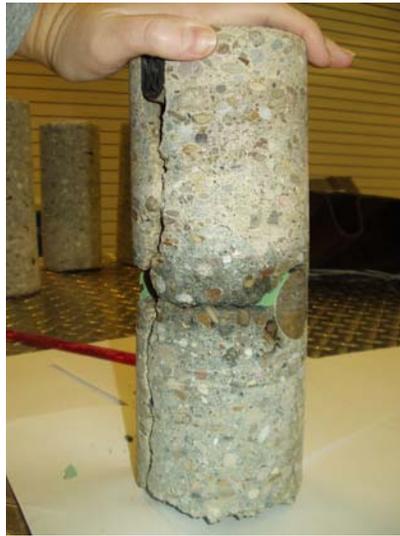
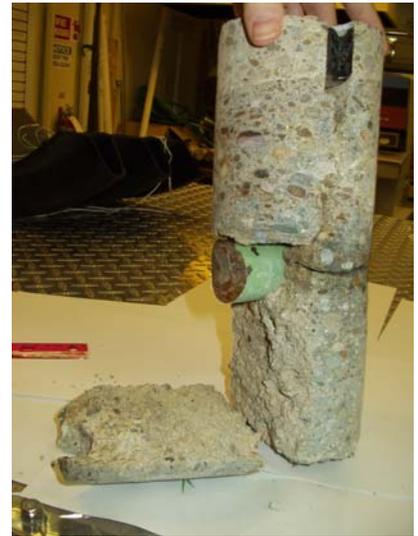
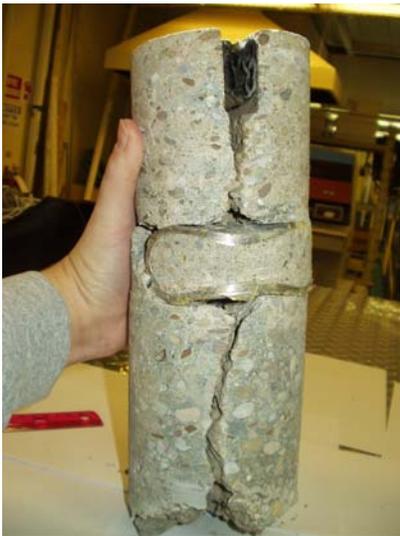
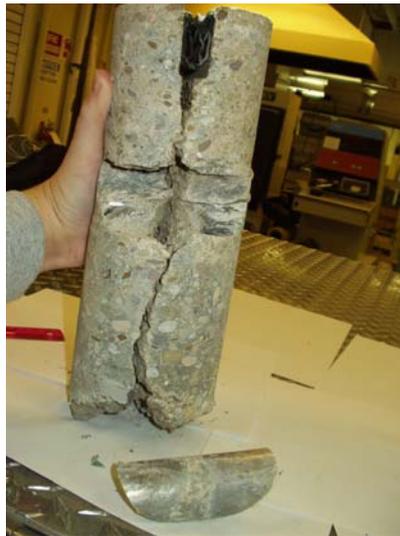
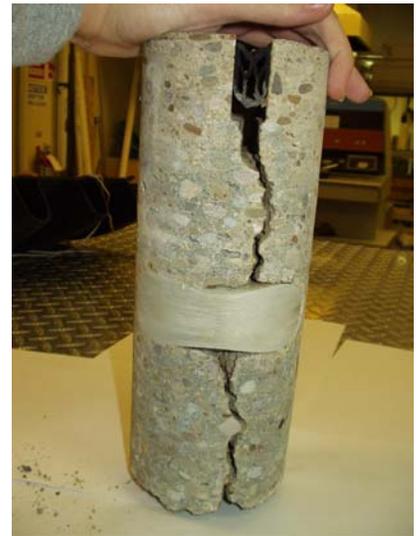
Appendix C—OH 2 Core Photos and 2001 and 2004 FWD Data

Additional FWD testing and coring was performed on this project in 2004 (Roger Green, personal communications, November 17 and December 28, 2004). Photos of the cores and the FWD data are included in Appendix C. FWD testing in 2001 and 2004 was performed during relatively high temperatures, which significantly affects the conclusions that can be made from the data. Load history data was collected but not analyzed. The 4-in diameter cores taken of the epoxy-coated dowels and the concrete filled Type 304 stainless steel showed delaminations of the concrete at the dowel bar level. As corrosion of the stainless steel dowel at this age is unlikely, the cause of the cracking is most likely due to the high early environmental stresses noted during construction and/or the poor support provided by the New Jersey unstabilized permeable base combined with the more rigid steel dowel bar properties. Further evaluation of this issue, including additional FWD testing at lower temperatures and additional 6-in diameter cores, is planned in 2005.

Recently (November 2004), the results of coring on the OH 2 project (located on U.S. 50 near Athens, Ohio, and built in 1997) have become available. The coring of the FRP materials showed no significant distress. However, the coring (4-in diameter) of the epoxy-coated dowels and the concrete-filled Type 304 stainless steel tubes or pipes showed significant distress in the adjacent concrete (although the core was not centered on the dowels). Further investigation by the Ohio DOT using 6-in diameter cores is planned to determine if the coring contributed to the distress observed. FWD data collected in both 2001 and again in 2004 was also made available. Load history data was collected but not analyzed. Appendix C contains photos of the cores taken from the U.S. 50 project in Athens, Ohio, along with the most recent FWD data.
