# Evaluation of Non-Intrusive Technologies for Traffic Detection

Minnesota  
Department of  
Transportation

Research Project  
Final Report #2010-36

**EVALUATION OF NON-INTRUSIVE TECHNOLOGIES  
FOR TRAFFIC DETECTION  
TPF-5[171]**

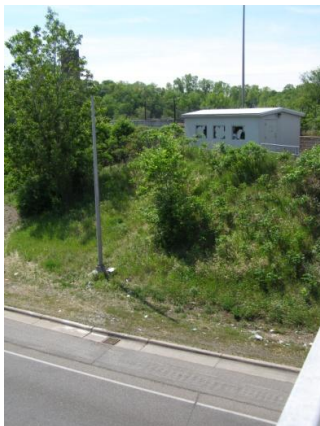
Figure 1. NIT Test Site

The NIT Test Site is equipped with dual loop detectors in each of the three eastbound lanes of I-394 (one of which was used in the PLP array). Six 11-foot piezoelectric sensors were installed at the beginning of this project to provide an accurate axle-based classification baseline, providing a piezo-loop-piezo configuration. Photographs of the test sites are provided in Figures 1 to 4.

The freeway test site features a variety of side mounting locations. The active infrared devices were mounted on a guard rail on a base as recommended by the manufacturer. All other devices were mounted on sidfire poles or railings. Mounting heights ranged from 10 to 40 feet. One pole is approximately 19 feet from the edge of the closest travelled lane. Another pole was installed 30 feet from the nearest travelled lane.

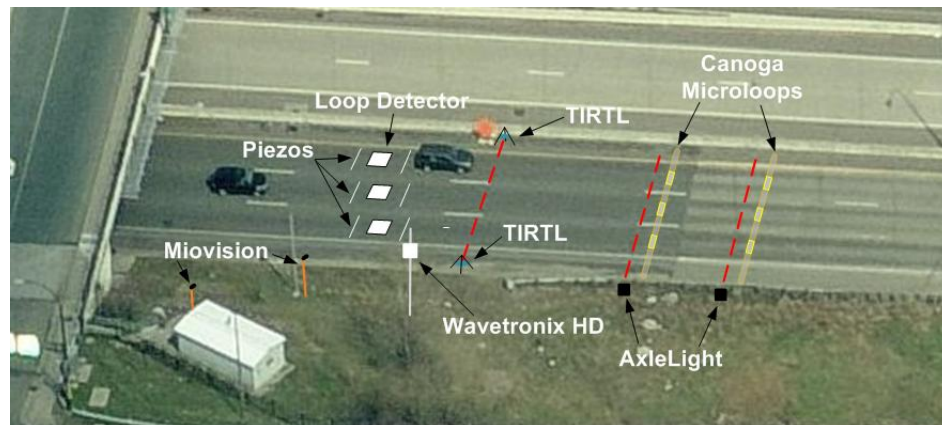
Figure 2. NIT Test Site Showing Approximate Sensor Locations

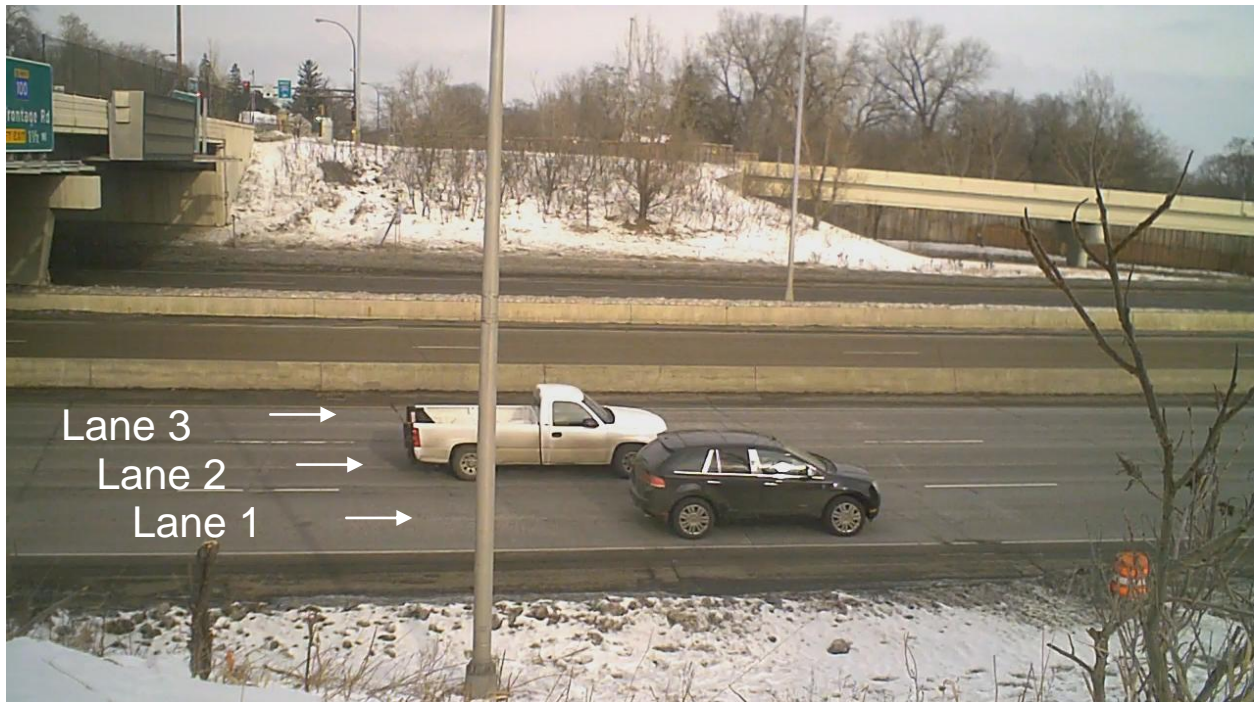
**Figure 3. NIT Test Site Showing Three Eastbound I-394 Test Lanes**

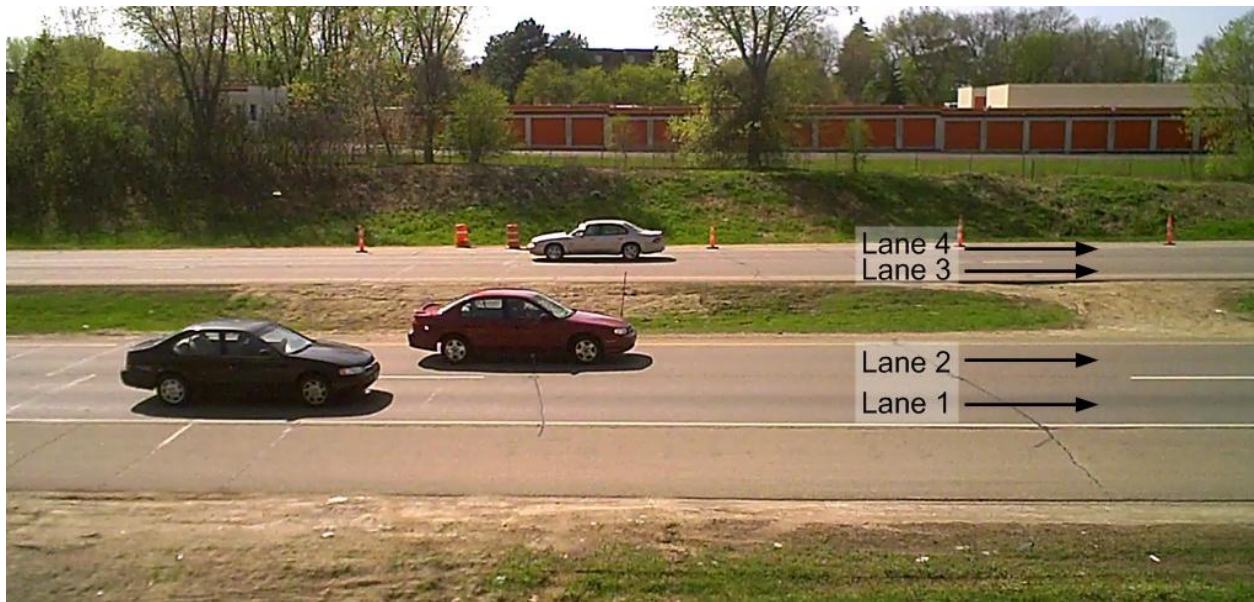
**Figure 4. TH 52 Test Site**

In addition, testing was conducted at Mn/DOT's TH 52 weigh-in-motion (WIM) station to obtain long term data from sensors that could not be installed in long term deployments at the NIT Test Site, such as the TIRTL. This site features significant truck traffic and already had a Piezo-Loop-Piezo (PLP) baseline. The roadway at this site is shown in Figure 4.

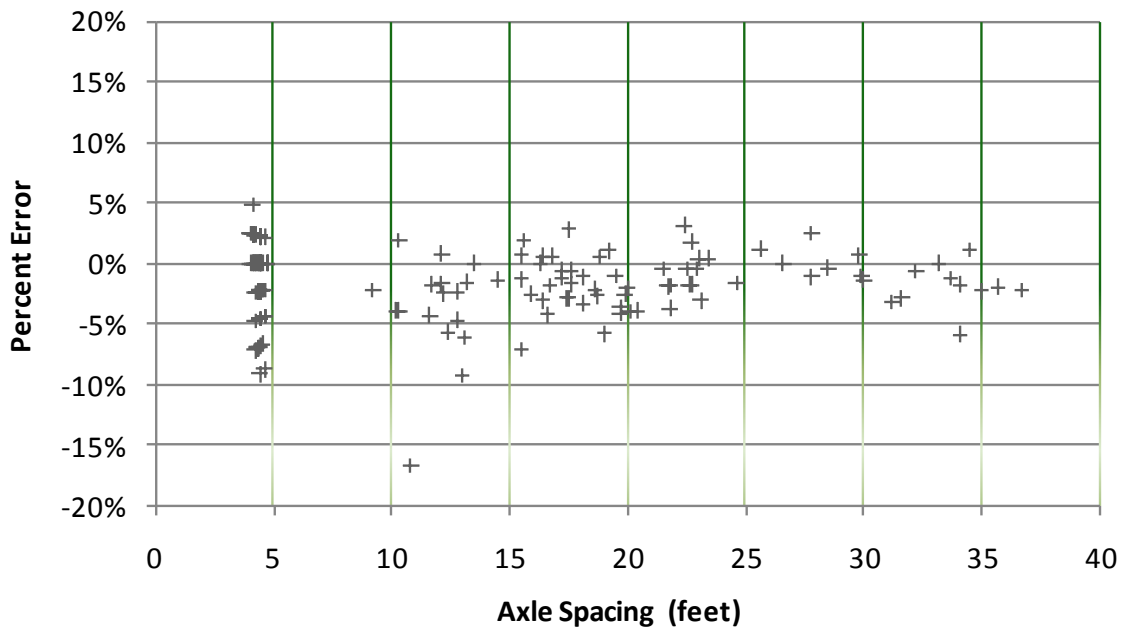
**Figure 5. Percent Error of Various Axle Spacings: Video Compared to PLP Baseline**

A simple analysis was conducted to validate the video measurement process by comparing the video measurements to the ground-truthed PLP baseline. The data presented in Figure 5 shows that across the range of axle spacings, most axle spacing measurements were within three percent error. Table 6 shows more detail about this finding.

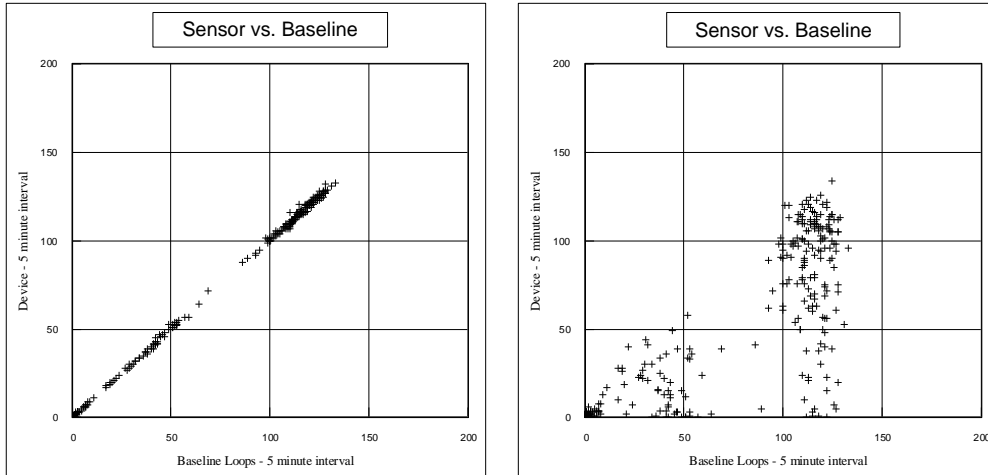
**Figure 6. Examples of Volume Scatter Plots**

Scatter plots show the relationship between two sets of numbers as one series of x-y coordinates. Each point on a scatter plot represents traffic data for a given sampling interval (i.e., 15 minutes) as measured by the baseline on the horizontal axis and the sensor on the vertical axis. Data points falling on a linear 45-degree line represent perfect agreement between the two compared data sets. This approach provides a straightforward visual representation of variation between each sensor and the baseline data. Figure 6 provides examples of volume scatter plots. The one on the left shows that the sensor correlates closely with the baseline data. The one on the right has some problems with undercounting vehicles.

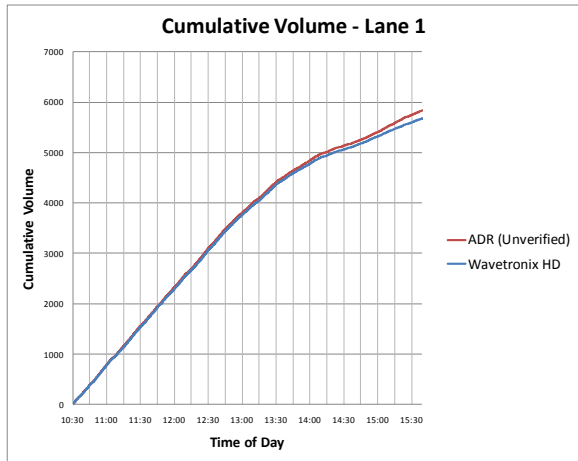
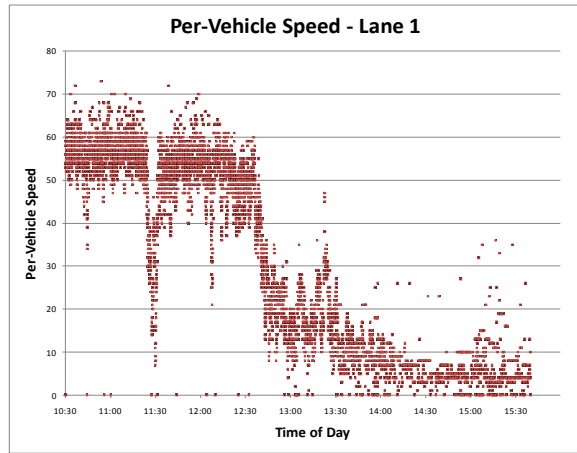
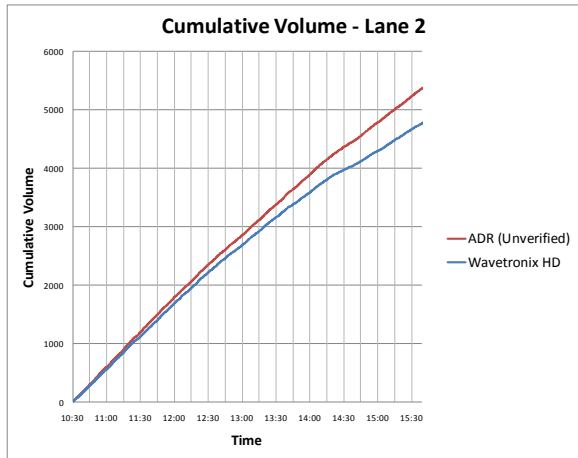
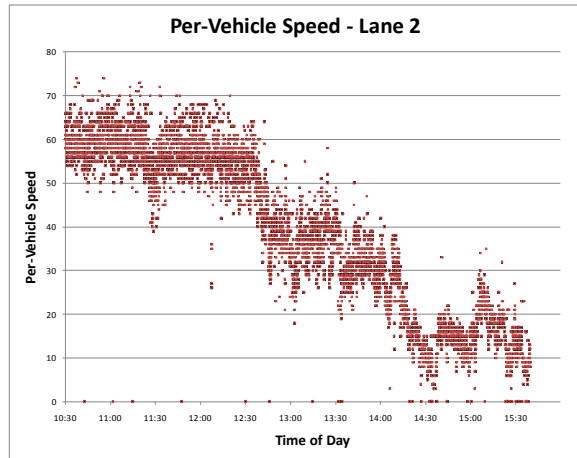
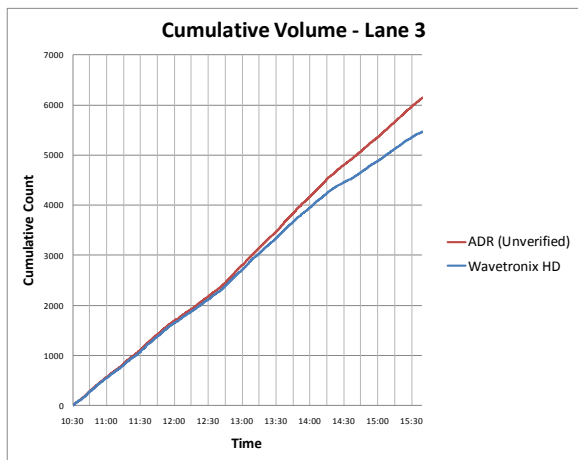
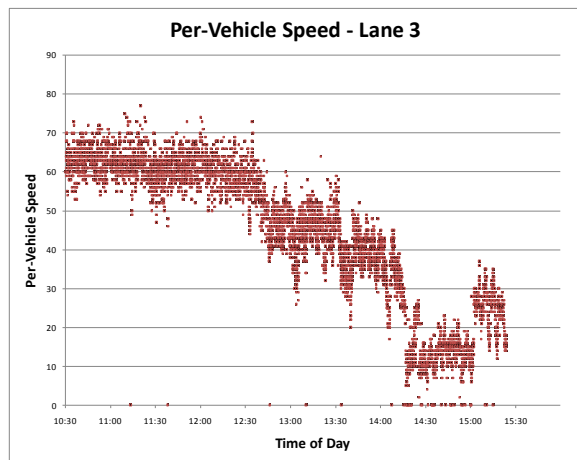
**Figure 7. Wavetronix SmartSensor HD data captured on December 8, 2009**  
 Traffic was unusually slow due to light snow conditions. Traffic undercounting in Lanes 2-3 (far two lanes) is attributed to occlusion from Lane 1 (lane nearest sensor).

Figure 7 illustrates the effect slow traffic in the first lane has on adjacent lane volume accuracy. While Lane 1 volumes are consistently accurate, even when speeds drop, Lane 2 and Lane 3 volumes drop off due to occlusion from Lane 1. From 14:30 to 15:30, the sensor missed 20.0 percent of the vehicles in Lane 2 and 22.6 percent of vehicles in Lane 3. During the same period of slow moving traffic, it only undercounted 12.2 percent of vehicles in Lane 1. During this period, vehicles in Lane 1 were travelling 0-10 miles per hour.

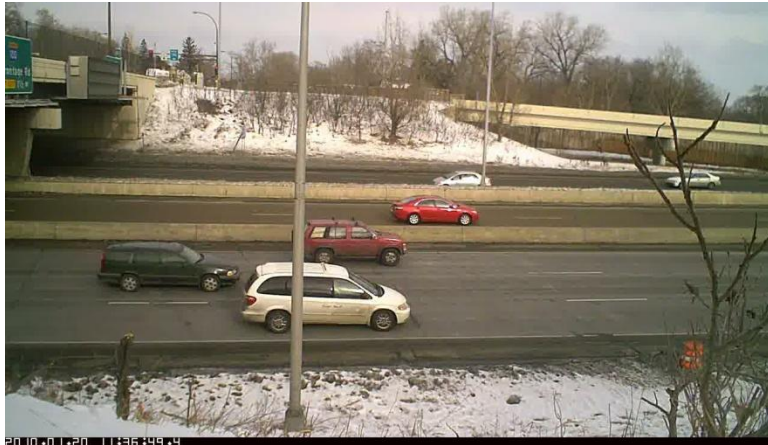
**SUV in Lane 3 (far lane) detected as a 25 foot vehicle.**

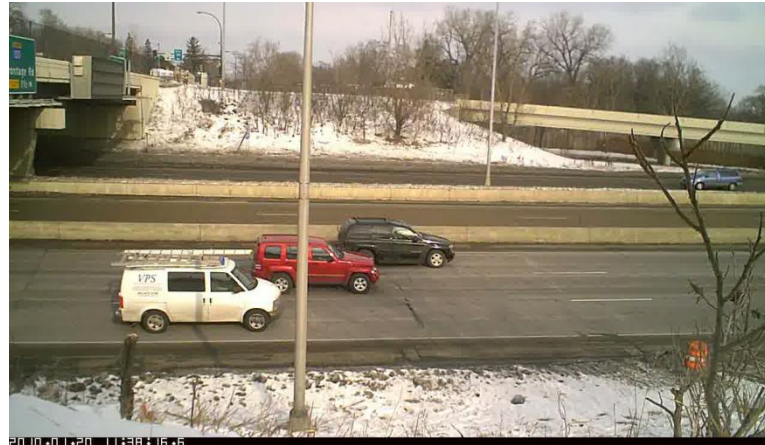
**SUV in Lane 3 (far lane) detected as a 24-foot vehicle.**

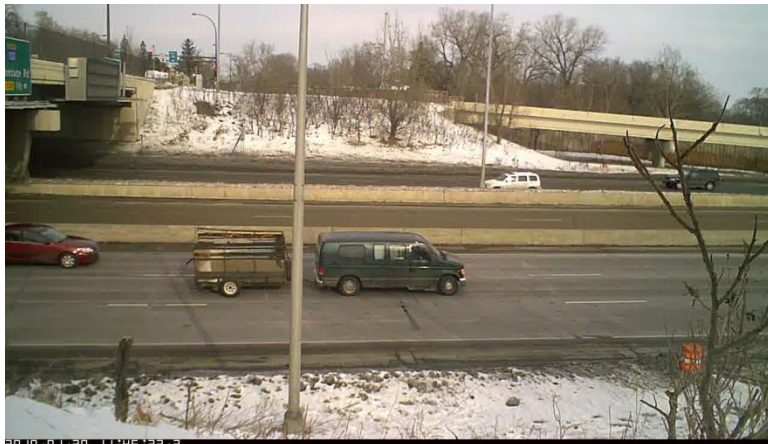
**Van in Lane 2 pulling a trailer that was classified as a truck.**

Another source of error was when trucks were hauling a trailer. The Wavetronix SmartSensor HD generally does not detect a trailer as being separate from the primary vehicle. In this case, the sensor is accurately reporting the entire length of the vehicle/trailer combination. However, depending on how the data is used, it is often important to differentiate trucks from passenger vehicles. Even when hauling a trailer, the passenger vehicle does not load the pavement as significantly as a truck and some agencies would want to separate these vehicles from trucks. Figure 8 shows examples of passenger vehicles that were detected as long trucks. A summary of

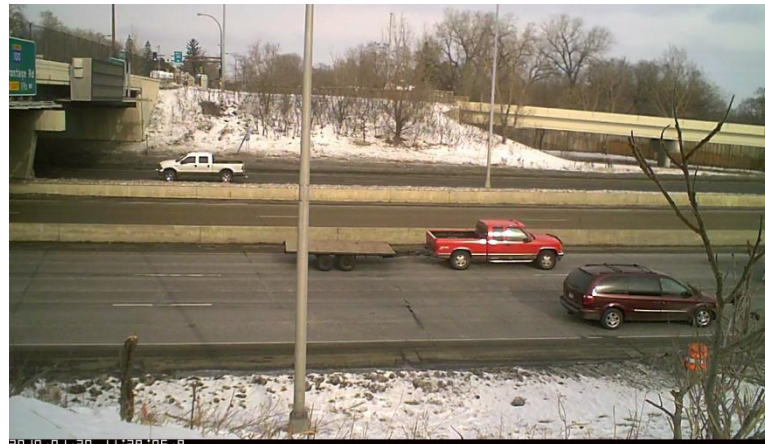
**Pickup truck in Lane 3 hauling a trailer that was detected as a large truck.**

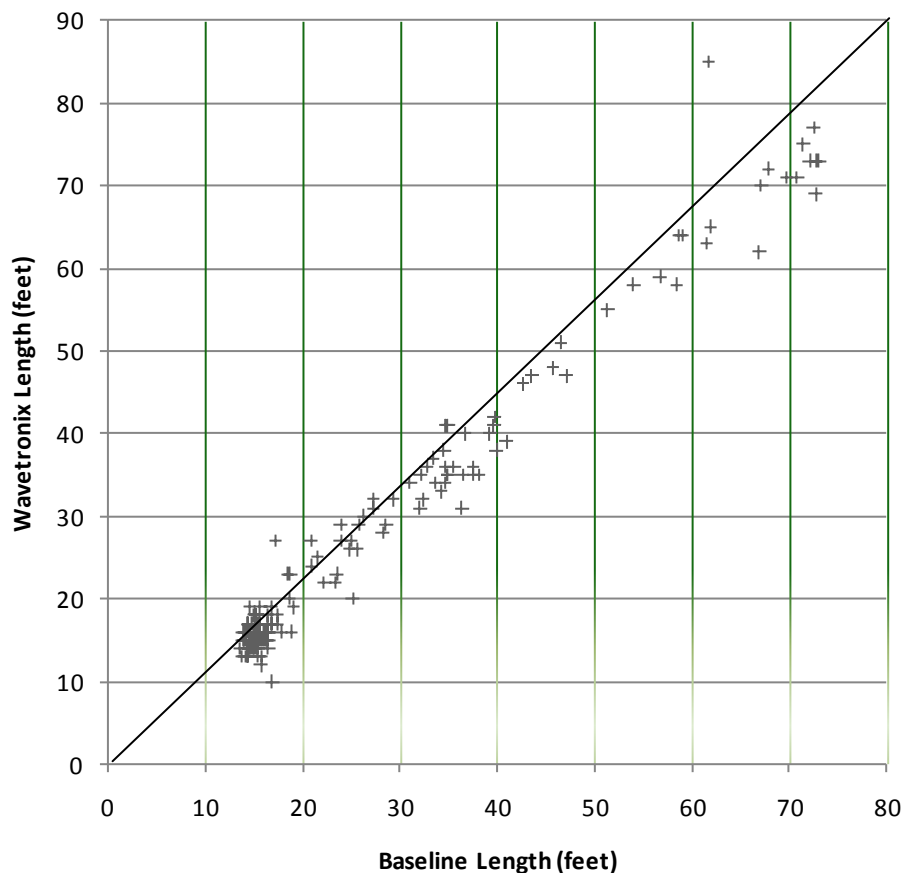
**Figure 9. Baseline Length Compared to Wavetronix SmartSensor HD Length**

In contrast to the axle-based classification, a test was run to compare Wavetronix SmartSensor HD length data to manually-measured vehicle lengths. This test was only conducted during free-flow traffic. This analysis disregards the type of vehicle and instead simply compares the length of the vehicle. It was found that for most vehicles, the Wavetronix SmartSensor HD reported a very accurate length. One outlier was a large Class 9 truck that the Wavetronix SmartSensor HD reported was 85 feet long due to grouping the truck (in the middle lane) with a passenger vehicle in the near lane, see Figure 9 with a following car in Lane 1. The Wavetronix records show that this vehicle did not appear on the Wavetronix PVR. As shown in the data, these cases were few. Because passenger vehicles tend to be similar sizes, emphasis was placed on manually observing additional trucks to develop a more even distribution of vehicle lengths.

The average error among passenger vehicles was 0.6 feet with an absolute average error of 1.6 feet. The average error for trucks was 1.7 feet with an absolute average error of 2.8 feet. These findings demonstrate that the Wavetronix can accurately determine vehicle length in free-flow traffic. The most significant error with length measurement is shown in Figure 10. The “outlier” point in Figure 9 (Wavetronix SmartSensor HD recorded it as an 85-foot long truck).

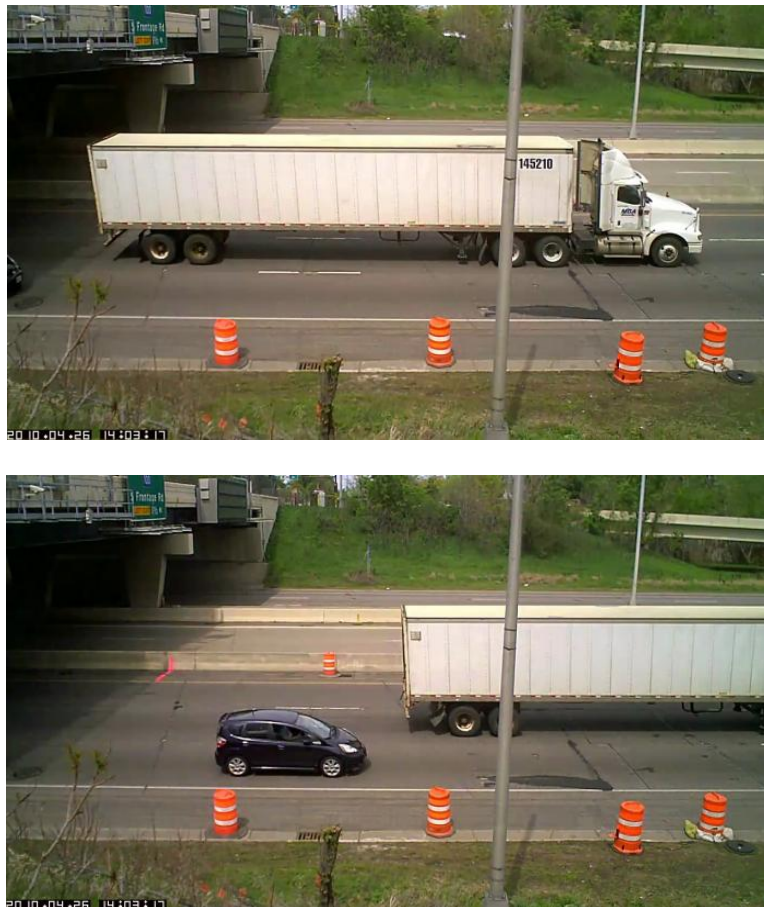
**Figure 10. Screenshots of a Truck Grouped with a Following Car by the Wavetronix SmartSensor HD**

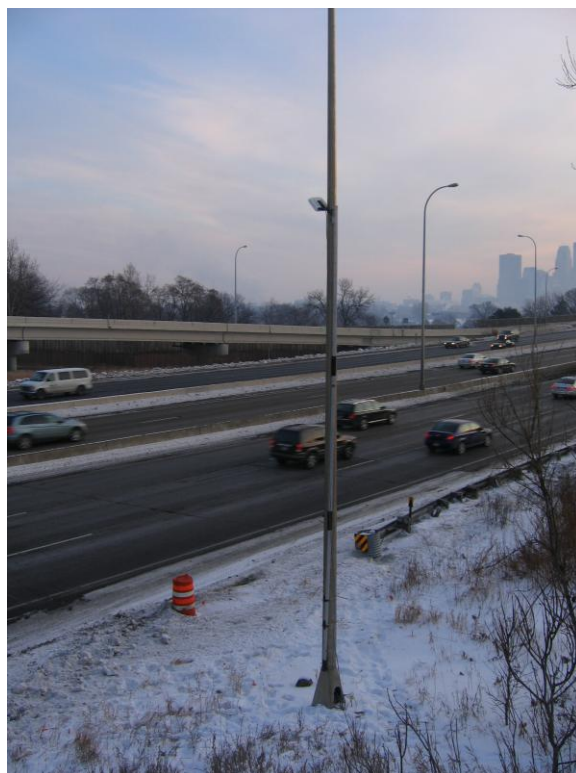
**Figure 11. Wavetronix SmartSensor HD Mounted on Lighting Pole at NIT Test Site**

The Wavetronix SmartSensor HD has a relatively simple setup procedure. For the testing, the sensor was mounted at the recommended height of 28 feet at a 30-foot offset. This height was too high for an installer to install with a ladder, so the PNITDS (Portable Non-Intrusive Traffic Detection System) system was used. This system is a series of aluminum poles that can be attached at the bottom of an in-place pole and tipped up against the pole. To reach a height of 28 feet, three 8-foot poles were used in addition to the pole being mounted on a gradual slope. The PNITDS pole was secured with hose clamps. The installation is shown in Figure 11.

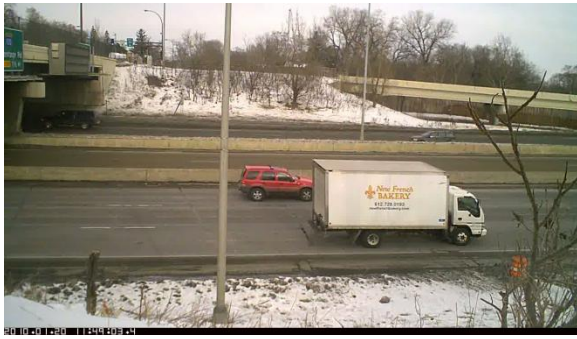
**Small Class 5 truck classified as PV by the GTT Canoga Microloops.**

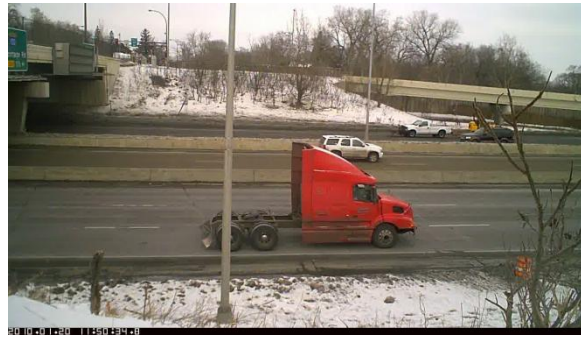
**Class 6 truck classified as PV by the GTT Canoga Microloops.**

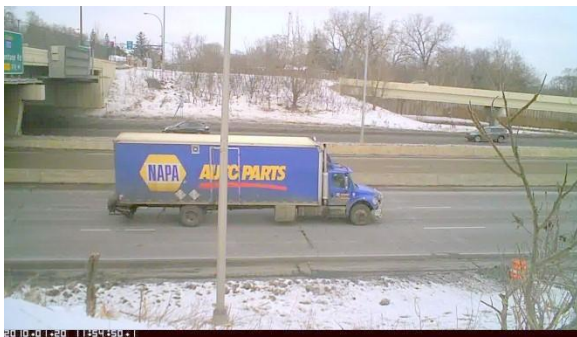
**Long Class 5 truck classified as a MU Truck by the GTT Canoga Microloops.**

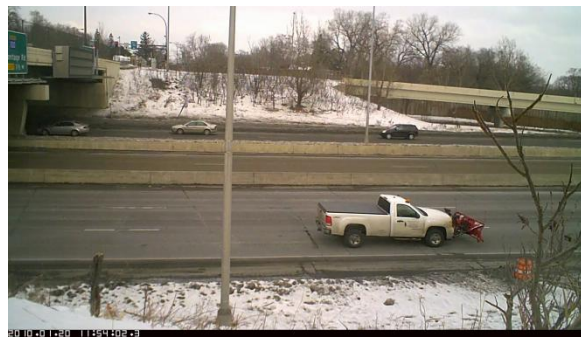
**Class 3 pickup truck classified as a SU Truck by the GTT Canoga Microloops because of the plow mounted on the front of the truck.**

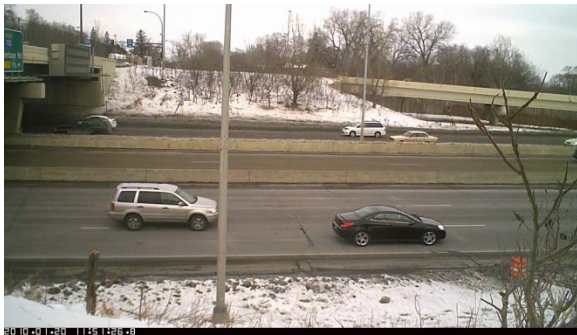
**Tailgating passenger cars classified as a MU truck.**

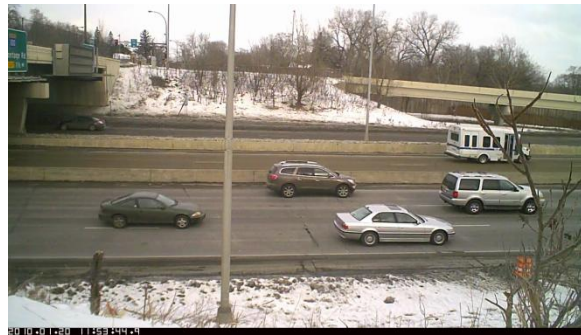
**Tailgating passenger cars classified as a MU truck (Lane 1).**

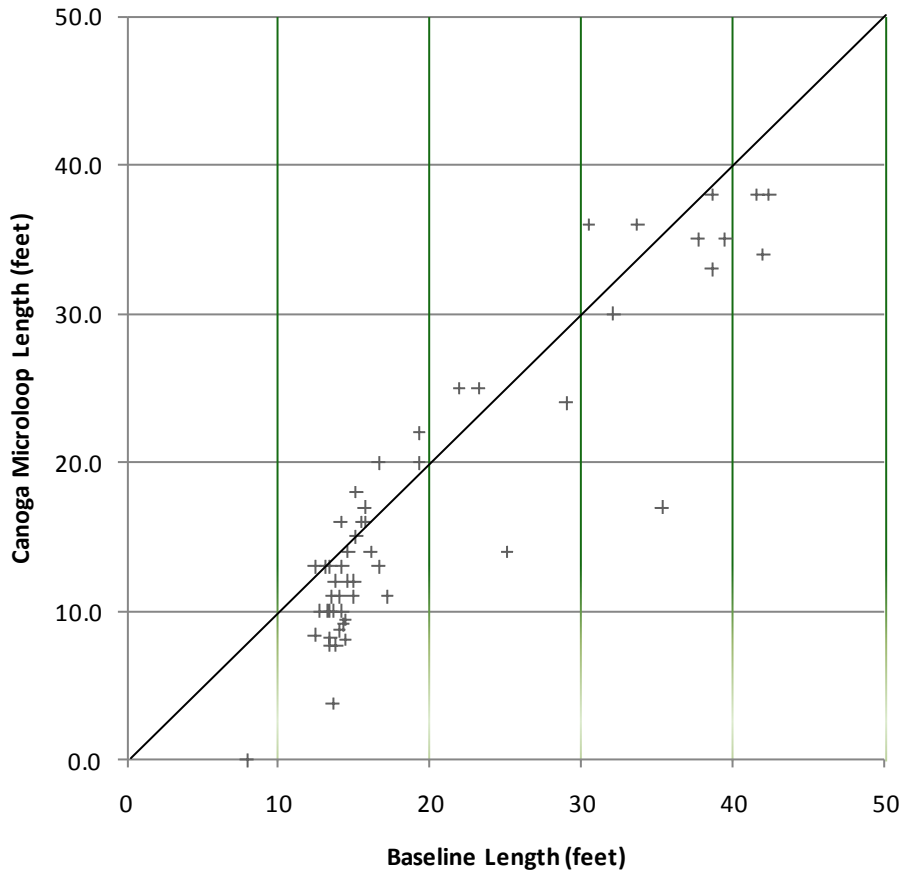
**Figure 13. Comparison of Baseline Length to Canoga Microloops**

In contrast to the axle-based classification, a test was run to determine how close the Canoga Microloops would report to manually measured vehicle lengths. This test was only conducted during free-flow traffic. This analysis disregards the type of vehicle and instead simply compares the length of the vehicle. Because passenger vehicles tend to be similar sizes, additional trucks were examined to develop a more even distribution of vehicle lengths. Figure 13 shows a graphical representation of the baseline and sensor length comparison.

The average error among passenger vehicles was -3.1 feet with an absolute average error of 3.7 feet. The average error for trucks was -2.0 feet with an absolute average error of 4.0 feet. The Canoga Microloops were reasonably accurate among a wide varied of different vehicle sizes, but there was significantly more variation when compared to the Wavetronix SmartSensor HD sensor. It is interesting to note that although there is a relatively tight distribution of passenger vehicles, the Canoga Microloops reported a rather large distribution of these vehicles. There were also some obvious outliers where the sensor vastly underreported vehicle length. A few examples are shown in Figure 14.

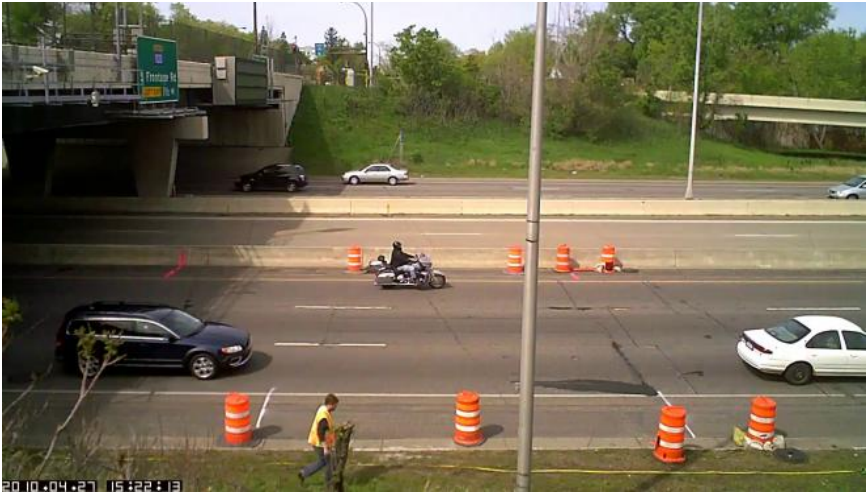
**7.9-foot motorcycle measured at 0 feet long by Canoga Microloops.**

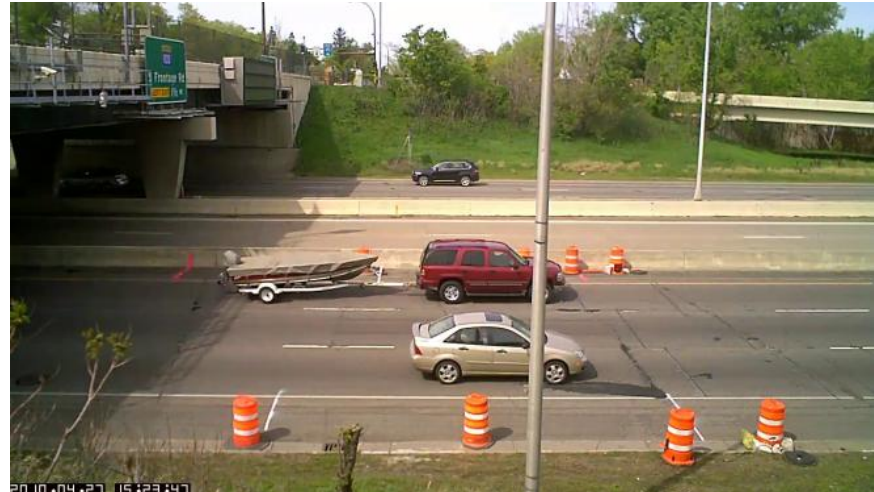
**35.3-foot SUV pulling trailer measured at 17 feet long by Canoga Microloops.**

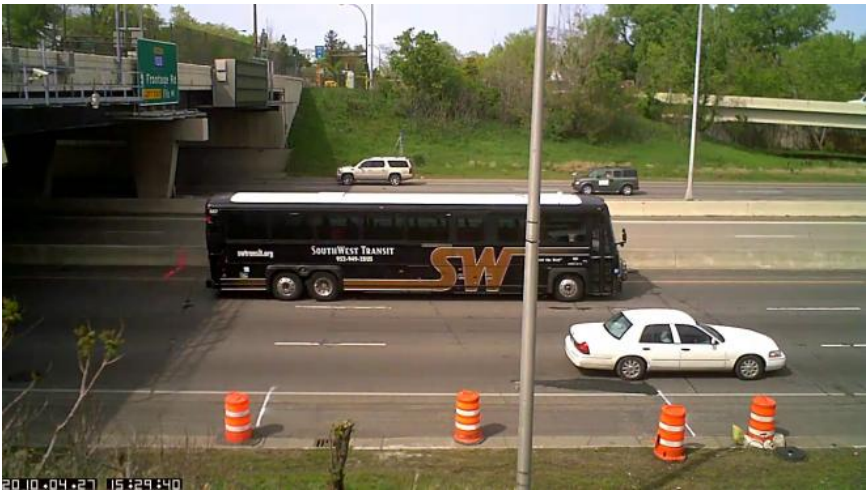
**42-foot bus measured at 34 feet long by Canoga Microloops.**

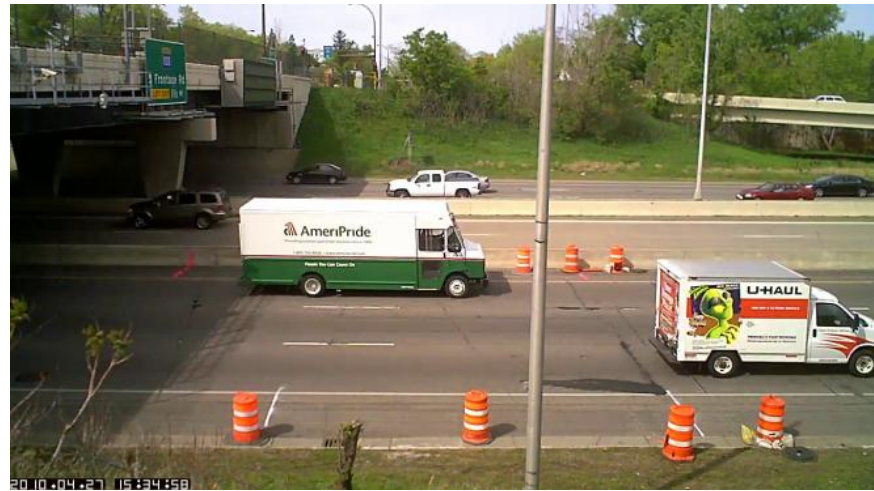
**25.1 foot truck measured at 14 feet long by Canoga Microloops**

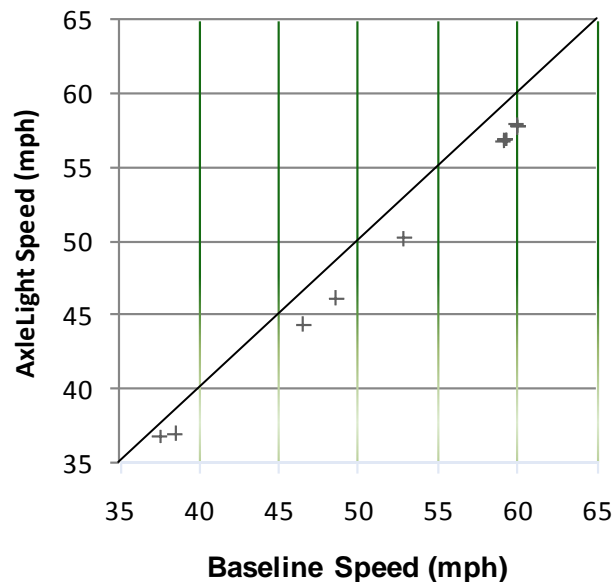
**Figure 15. Baseline Speed vs. AxleLight Speed, Average Speed for 15 Minute Intervals**

The PEEK AxleLight demonstrated very consistent speed data at a wide range of average speeds in 15 minute intervals. The graph in Figure 15 shows that the AxleLight consistently underreported speeds for the test examined. Note that the axes start at 35 mph and go to 65 mph. One caveat to this data is that the sensor was placed downstream of the baseline and it is possible that vehicles slow as they begin to climb the hill. The speed trap method that the sensor uses to determine vehicle speed should produce accurate results, but some unknown parameter caused it to underreport the data. The sensor spacing (distance from sensor to sensor) was set at 12.5 feet. This value was entered into the ADR 1000 during configuration. This error indicates that the sensors were about 4 percent farther apart than configured or about 1/2 foot.

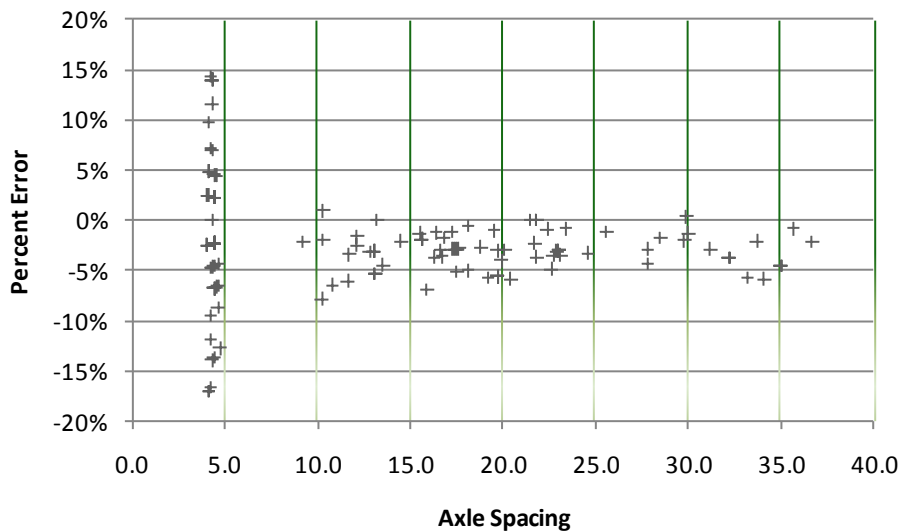
**Figure 16. Percent Error of AxleLight at Various Axle Spacings**

Axle-based sensor performance is based on detecting axle spacings. The axle spacings from individual PVR for several trucks were compared to the PLP baseline. This showed that the trend was toward the axle spacings being within 0 to 5 percent error for a wide range of axle spacings. However, there was significantly more variability with the detected axle spacings of a truck's tandem axles. This is due in large part to the smaller spacings leading to small errors being reflected as larger percent errors. Also, the resolution of the reported data was to the nearest tenth of a foot which explains the clusters of data points lower than 5.0 feet. Figure 16 shows the percent error for various axle spacings of selected trucks. Note that there is a wide distribution in percent error of axle spacings lower than 5 feet (tandem axles).

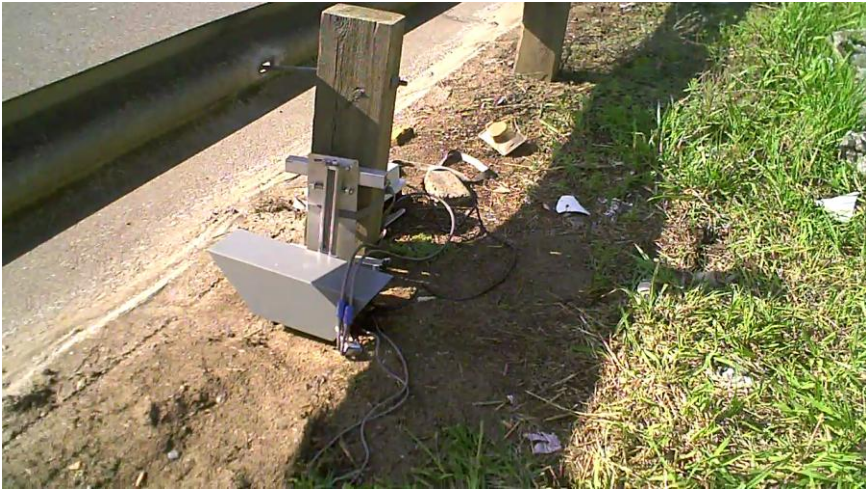
**AxleLight mounted to guard rail at TH 52 Test Site.**

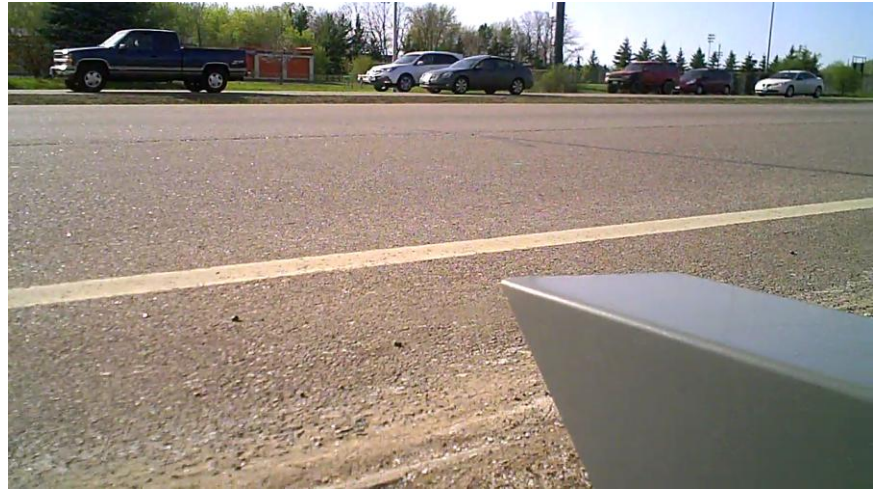
**View from AxleLight sensor.**

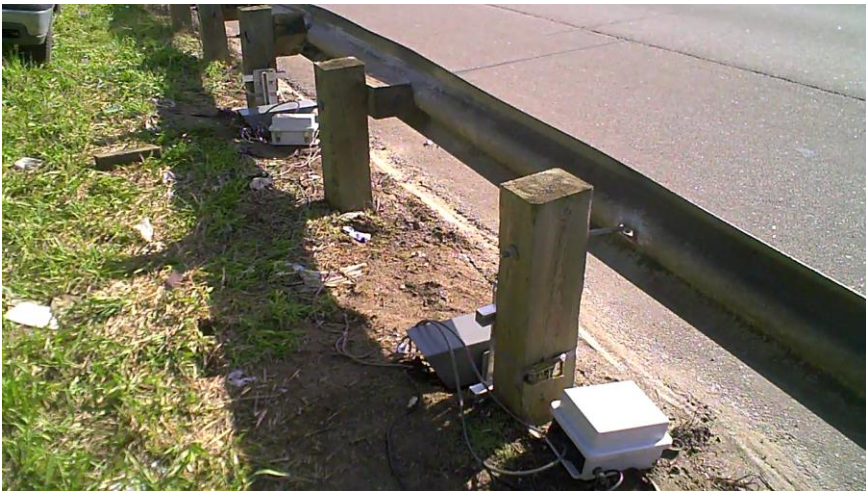
**Two AxleLight sensors set up in a speed trap configuration.**

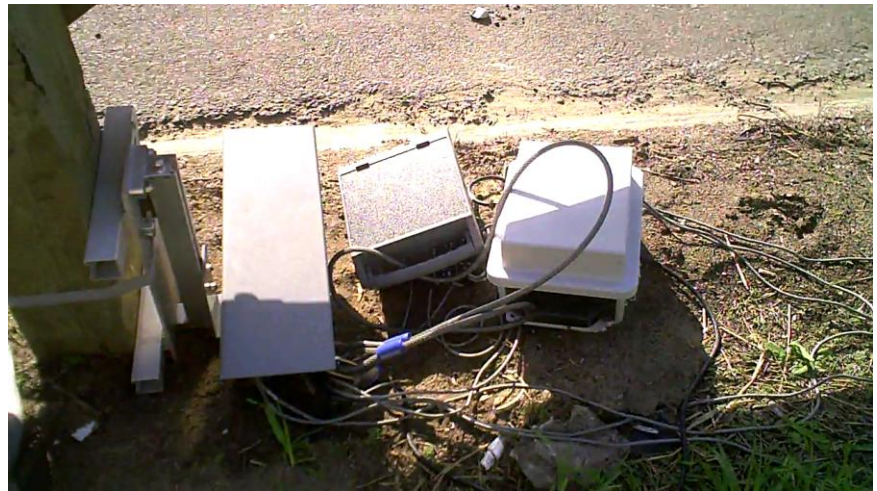
**AxleLight, PEEK ADR 1000 and battery module.**

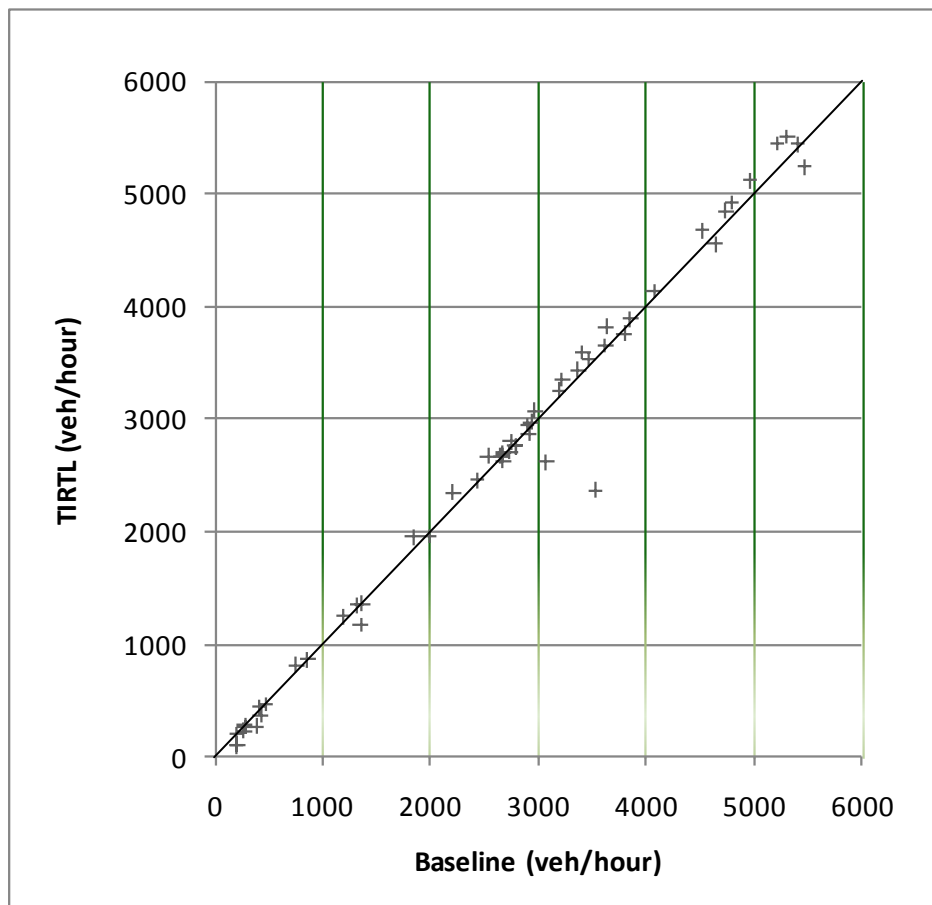
**Figure 18. Baseline Compared to TIRTL Volume  
All Lanes, LOS A-B, TH 52 Test Site**

The TIRTL performed consistently in volume data collection, but at slow speeds, and especially if the sensor is covering several lanes, there is a possibility that vehicles with large wheels will occlude other lanes. The scatter plot in Figure 18 shows that across many volume levels, the sensor generally accurately reports volume. Among the entire test duration, sensor undercounting and overcounting balanced to give a final percent error of 0.4 percent. There was a general trend of overcounting with a median overcount of 2 percent per hour period. A few periods of undercounting balanced this overcounting, but no specific cause of this undercounting could be identified. The periods were from 1:00 pm to 3:00 pm and 12:00 am to 6:00 am. No environmental cause could be linked to these times. All percent error for other time periods were within one standard deviation. The system has an alarm system that could be used to diagnose volume issues in future deployments. The finding from this test was that the TIRTL generally reports volume within 2 percent of the baseline, but a few outliers of unknown cause produced errors.

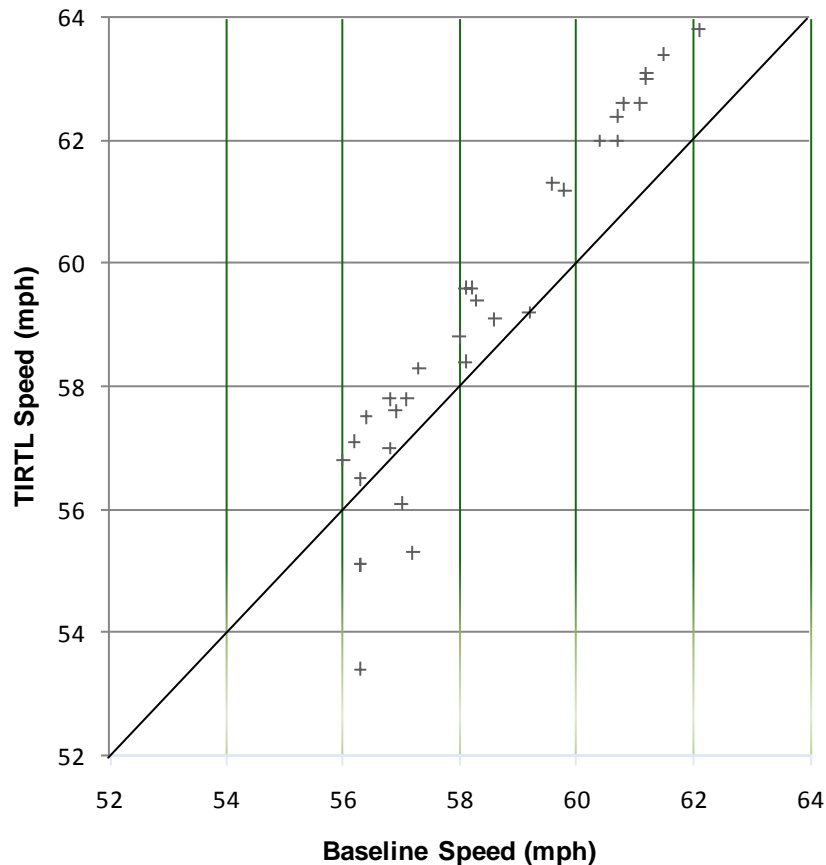
**Figure 19. Baseline Speed vs. TIRTL Speed, Average Speed for 15 Minute Intervals**

At both free-flow and speeds, the TIRTL is capable of measuring accurate speeds. Average speeds for 15 minute intervals were compared to baseline speeds measured by the TH 52 WIM site. The comparison of these aggregate speeds are shown in Figure 19. Note that the axes in this graph are centered around the average free flow speeds. The average error throughout the entire tested period was 0.7 mph higher than the baseline speed. The absolute average error was found to be 1.2 mph. This shows that the TIRTL can consistently report accurate speed in free flow traffic. The manufacturer claims that TIRTL can provide accurate data at speeds as low as 5 mph.

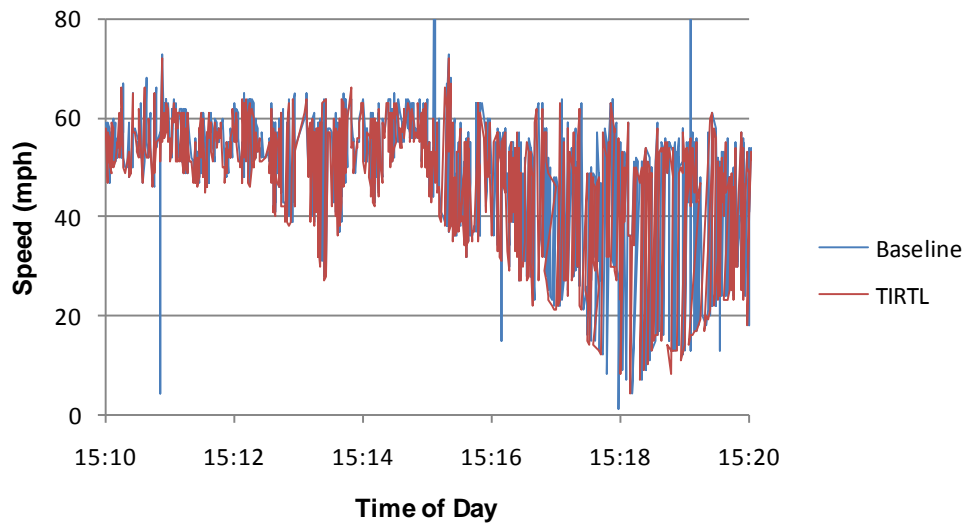
**Figure 20. Comparison of Baseline Speed to TIRTL Speed, Congested Traffic All Lanes at the NIT Test Site**

A separate test was done to determine how well the TIRTL matched the baseline speeds at the NIT Test Site in congested traffic. The graph in Figure 20 shows that the TIRTL speed matched the baseline speed well in both free flow and congested traffic conditions. Note that the baseline data (shown in blue) has some outlier points that are shown in the graph (spikes with high or low values). These points are where the baseline inaccurately measured a vehicle due to multiple vehicles being over the sensors. The TIRTL sensor had fewer of these types of errors than the baseline presumably because it does not use a traditional speed trap method to determine vehicle speeds.

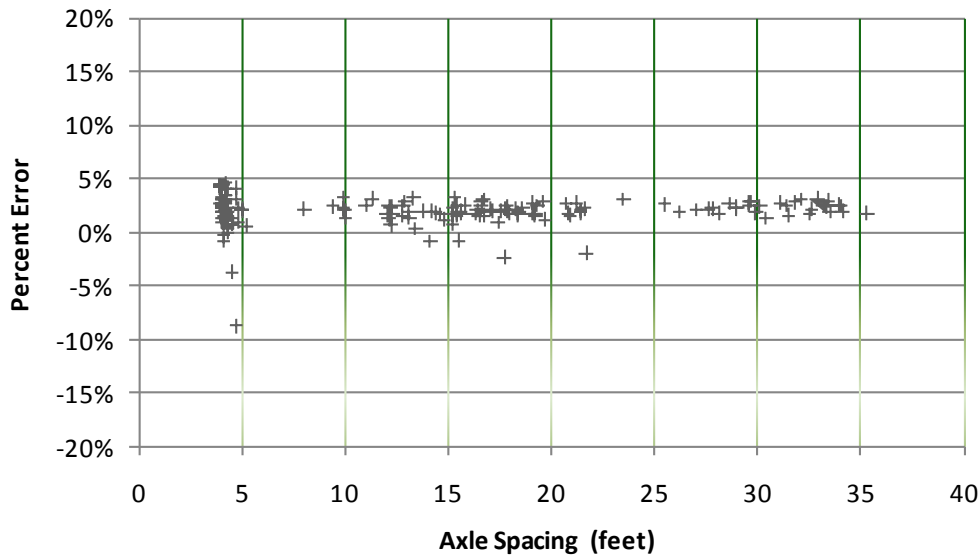
**Figure 21. TIRTL Axle Spacing Percent Error**

The sensor reported axle spacings within about 2 percent of the actual axle spacing measured by the baseline. This performance did not vary significantly across various axle spacing lengths. The measurements were taken on large trucks passing at free flow speeds. Figure 21 shows the distribution of axle spacing percent error. Table 19 shows a summary of the percent error.

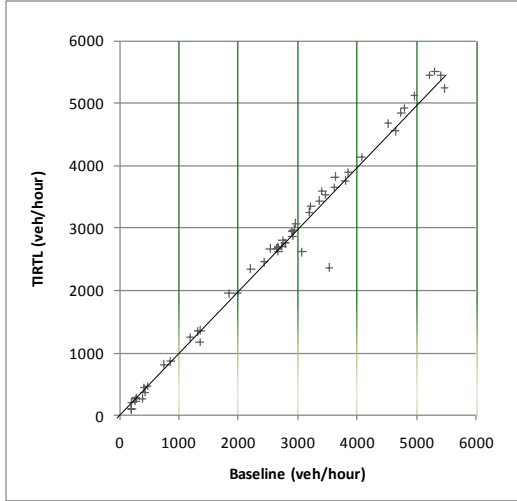
**2-axle vehicles.  $r^2=0.985$ .**

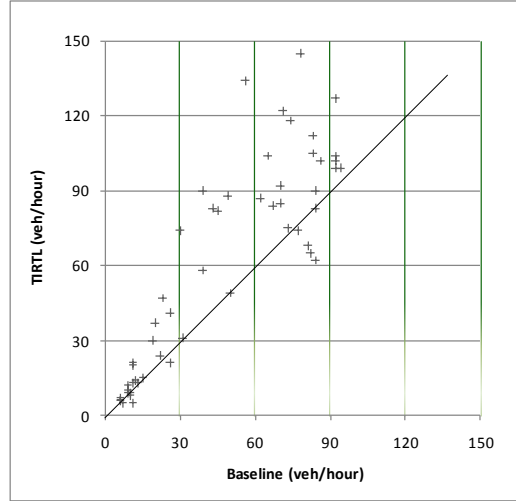
**3-axle vehicles.  $r^2=0.767$ .**

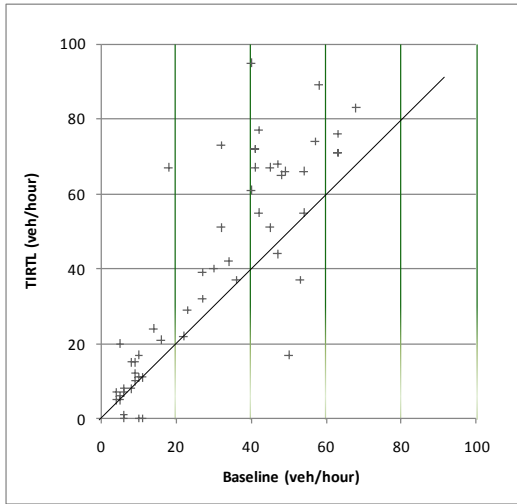
**4-axle vehicles.  $r^2=0.734$ .**

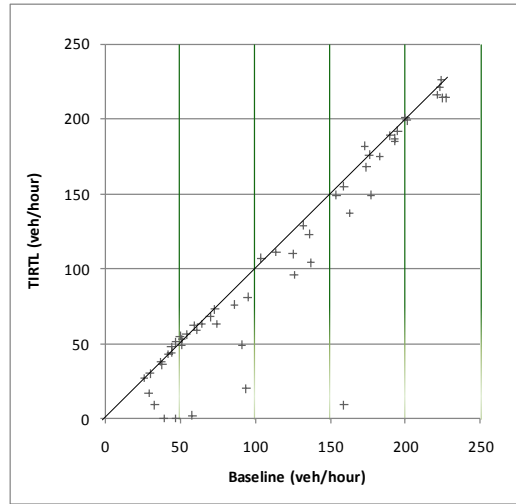
**5-axle vehicles.  $r^2=0.871$ .**

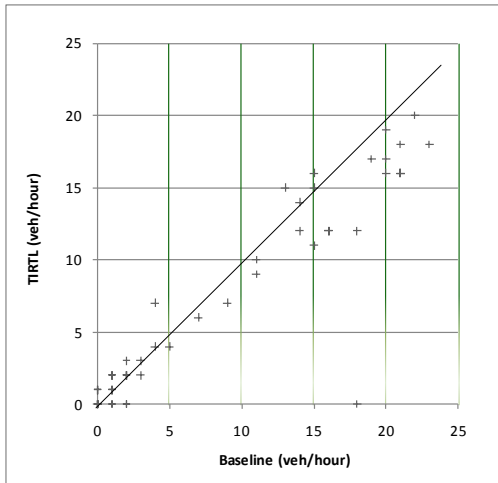
**6+ axle vehicles.  $r^2=0.872$ .**
