# Evaluation of Non-Intrusive Technologies for Traffic Detection

Minnesota  
Department of  
Transportation

Research Project  
Final Report #2010-36

**EVALUATION OF NON-INTRUSIVE TECHNOLOGIES  
FOR TRAFFIC DETECTION  
TPF-5[171]**

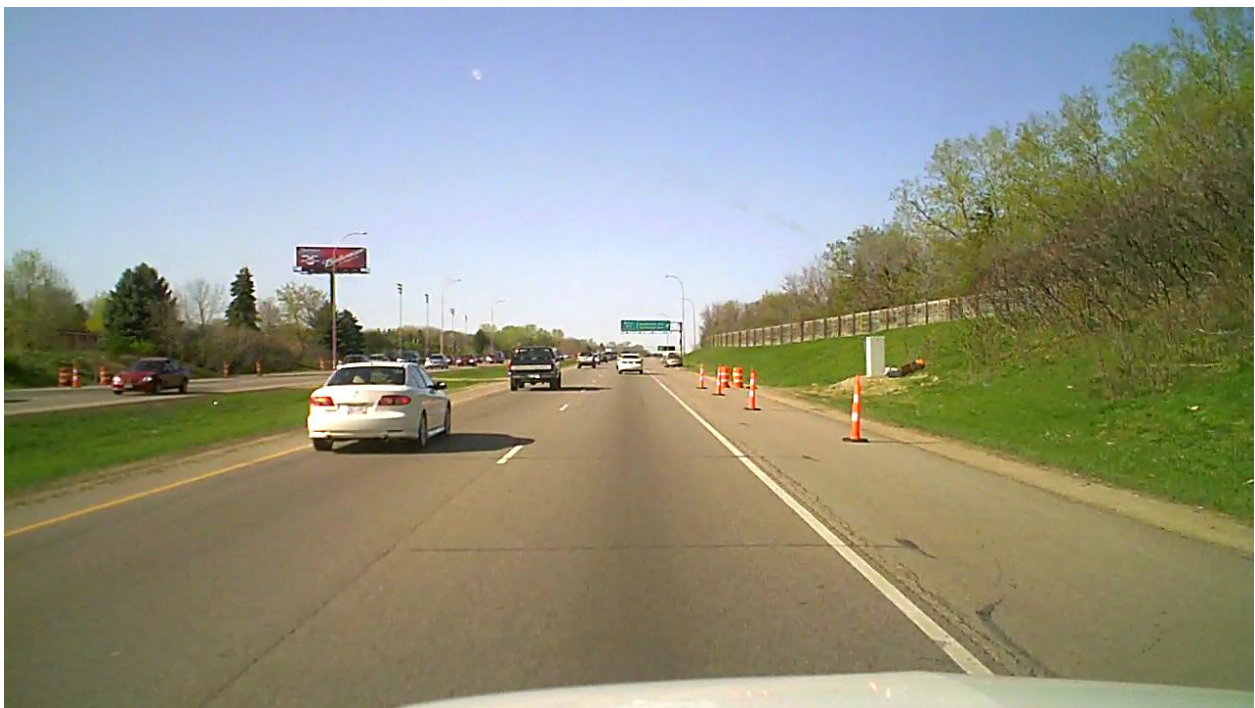
**Figure 23. Traffic Control for TIRTL Mounted on the Roadway Shoulder**

Because the TIRTL system was used in temporary deployments, traffic delineators and barrels were used to house the system, provide some traffic control and protect the sensors from traffic. At the TH 52 Test Site, a series of five delineator cones were set on each side to taper the

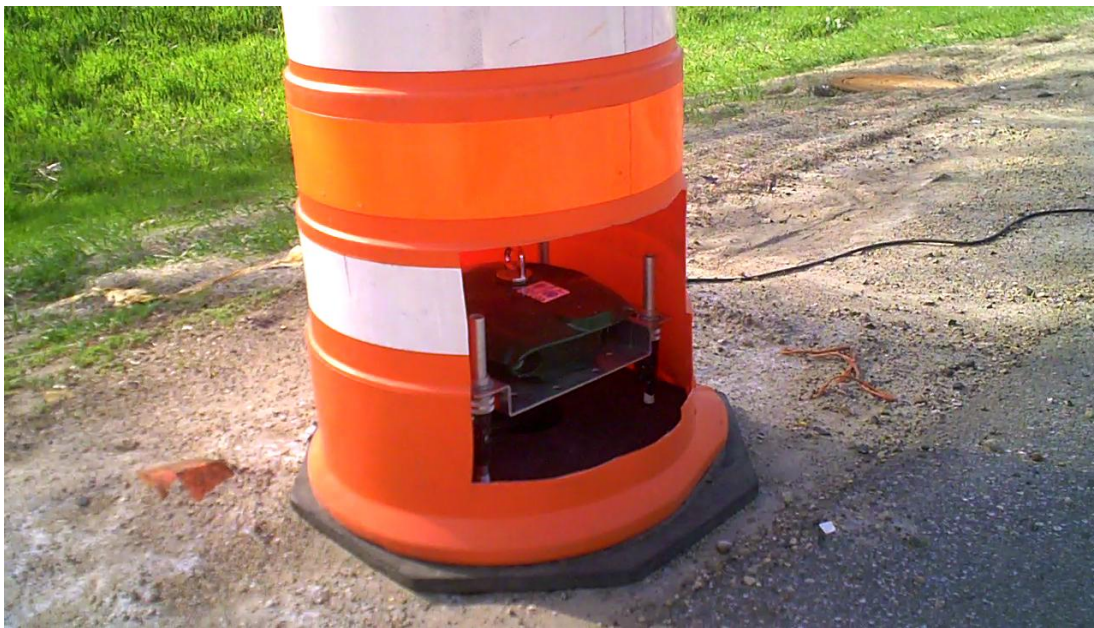
**Figure 24. Traffic Barrel with Cutout for TIRTL Sensor.**

Setup of the traffic control equipment took approximately 30 minutes with another 20 to 30 minutes to take the traffic control equipment and sensor down after testing. Figures 24 and 25 show the traffic barrel and TIRTL base.

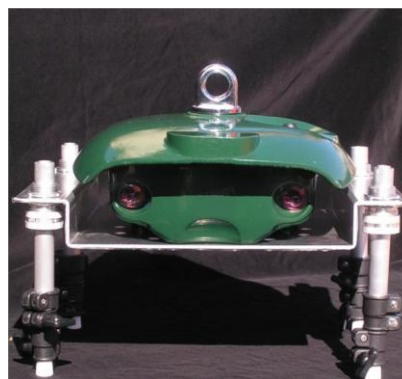
**Figure 25. TIRTL Base**

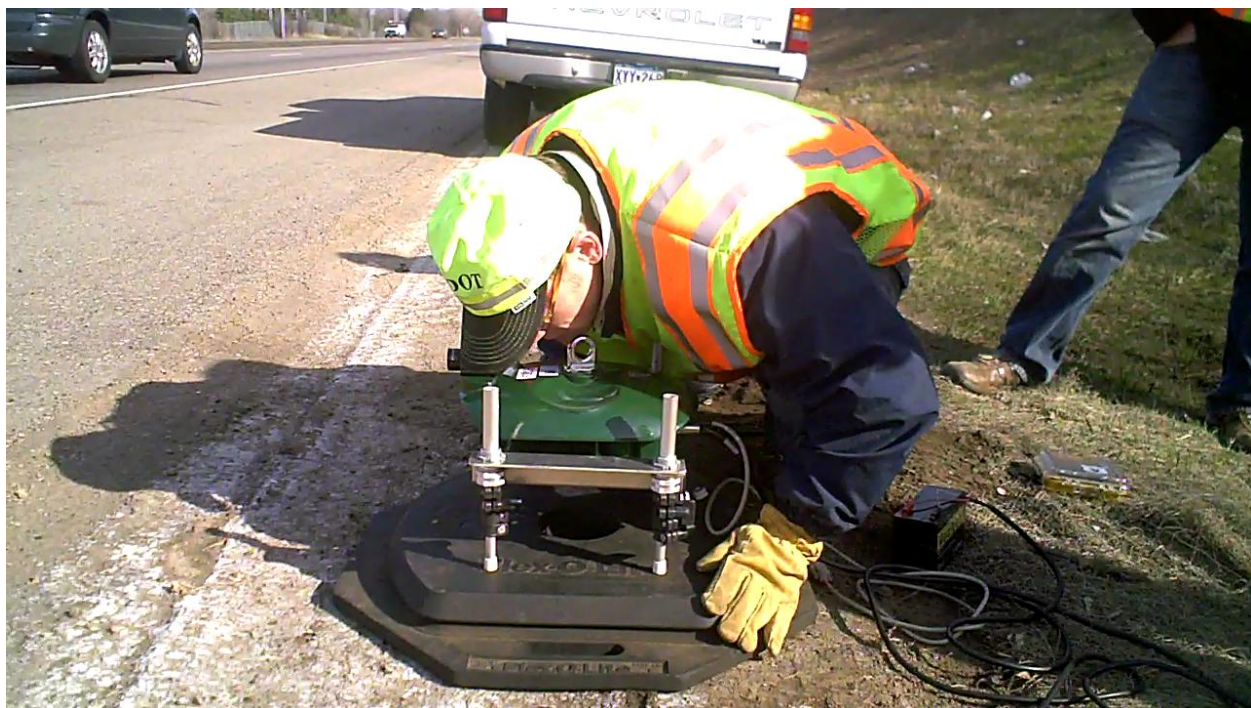
**Figure 26. TIRTL Setup--Aiming With Scope**

Additionally, the sensors each needed to be set up and aimed as shown in Figure 26. Mn/DOT's system was purchased in 2004 when the system came with optical scopes. A person could look through the scope (from the top of the sensor) to sight in the TIRTL on the other side of the roadway. Small adjustments could be made to the aiming, although over a long distance, such as 80 feet, a small adjustment in the TIRTL base skewed the sensor significantly. It was sometimes more effective to shim the traffic barrel base that the sensor was set on. A laser aiming tool is available now. This tool has a laser that is mounted to a machined piece that fits in the two mounting holes on the top of the sensor. Someone would hold a target, such as a piece of paper, on the other TIRTL to show where the laser is hitting. This method has proven to be more effective than the optical scope method. Also, the laser method allows for the sensor to be mounted inside a cabinet where there is not enough room for a person to use the optical scope. The manufacturer claims that setup with the laser aiming system and the new portable cabinets can be done in ten to 20 minutes.

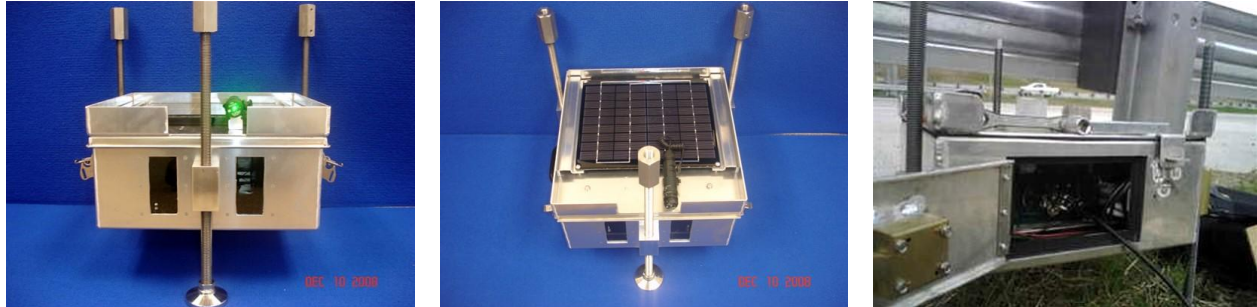
**Figure 27. TIRTL with Portable Enclosure**

Figure 27. This system uses two 12-volt rechargeable batteries which are charged with a 12-watt solar panel integrated with the cabinet. The threaded legs can be cut to specified length. The threads allow for fine adjustments to the height and tilt. The visible green laser recommended for sensor aiming is shown in the leftmost image.

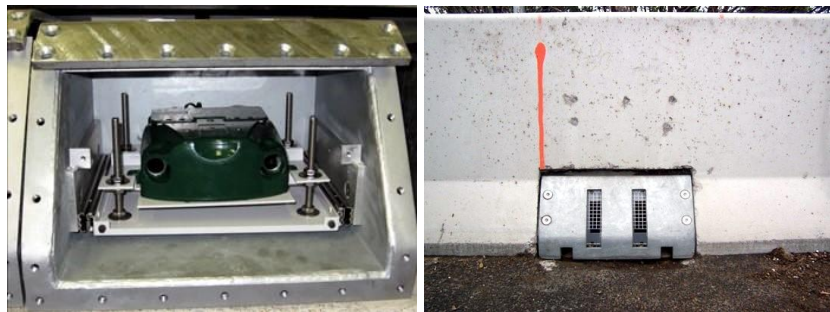
**Figure 28. Barrier-Mounted TIRTL Sensors (Permanent Installation)**

During the course of the project, two solutions for permanent or semi-permanent were suggested. The first was to mount the TIRTL in a small cabinet placed on the side of the road. This cabinet protects the TIRTL and could provide additional capacity for batteries. These cabinets should be installed outside the clear zone or otherwise be protected. The TIRTL vendor supplied photos of other permanent installations of both barrier-mounted units (Figure 28) and roadside mount units (Figure 29).

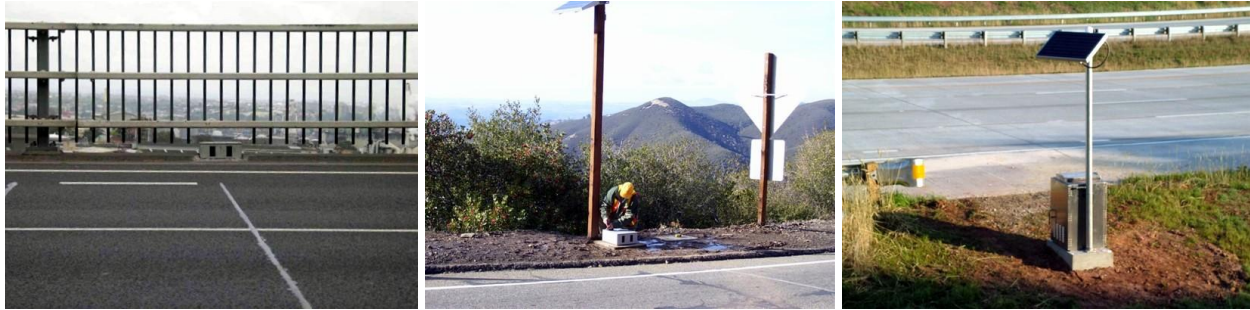
**Figure 29. Roadside/Pad-Mounted TIRTL Sensors (Permanent Installation)**

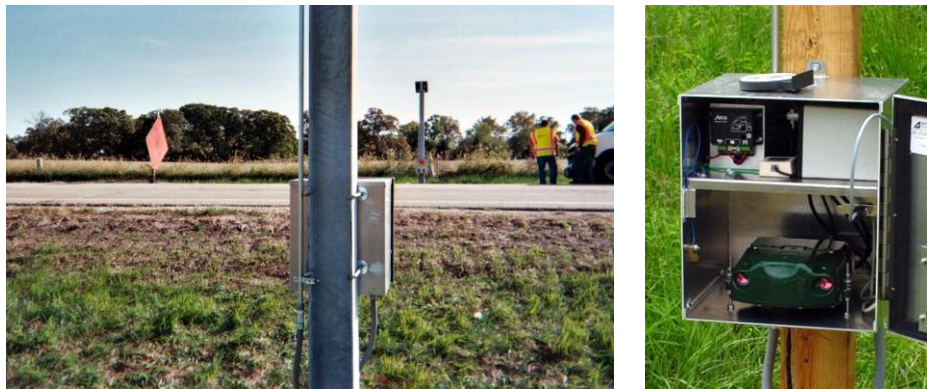
**Figure 30. TIRTL Pole Mount Examples (Permanent Installation)**

Another suggested method is to mount the sensors to poles located outside the roadway as shown in Figure 30. It is reported that a pole-mount configuration has worked for Illinois DOT, although it was not tested for this project.

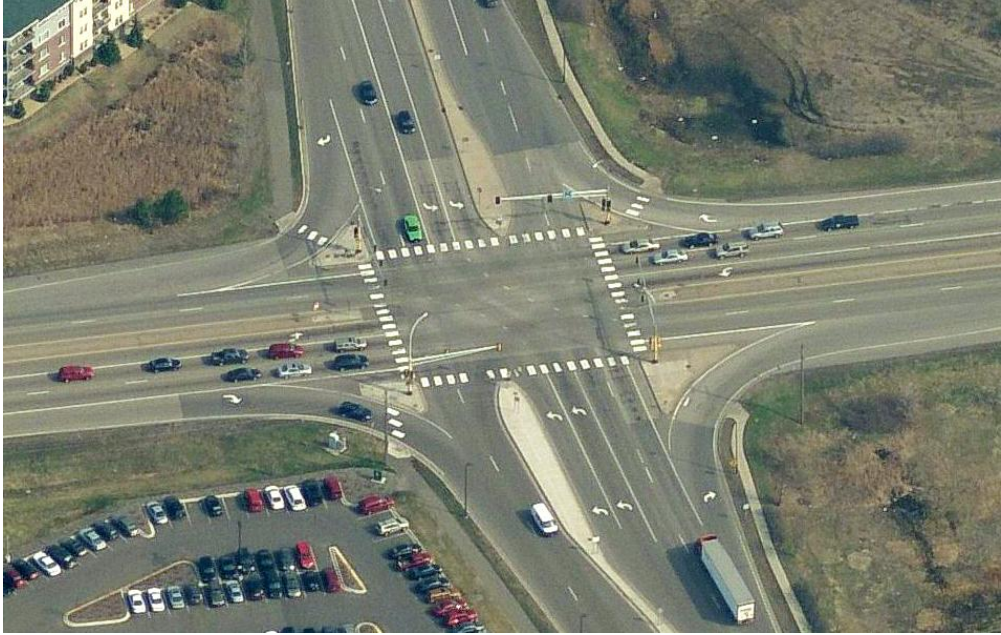
**Figure 32. Aerial view, TH 7 and Louisiana Ave, St. Louis Park, MN**

Aerial images of the two intersections are shown in Figures 32 and 33.

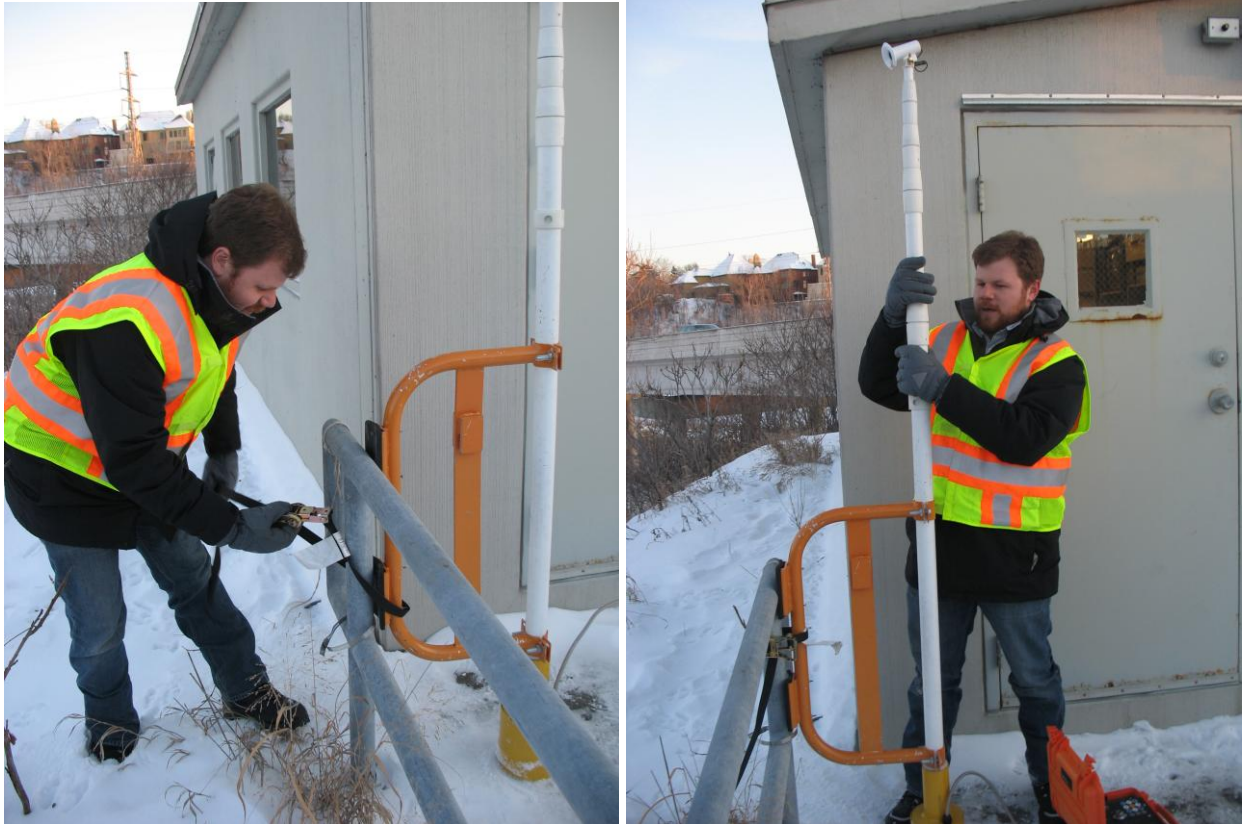
**Figure 34. Miovision Setup at NIT Test Site (Railing Mount)**

The telescoping mast is attached to the pole mount. The pole mount and mast assembly can be mounted on various types of poles or similar structures with tie straps. Rubber pads on the two places the pole mount contacts the pole protect the pole from scratching the pole. However, care must be taken to not scratch a painted pole with the tie strap clasp. Images of the pole mount system being installed are shown in Figure 34.

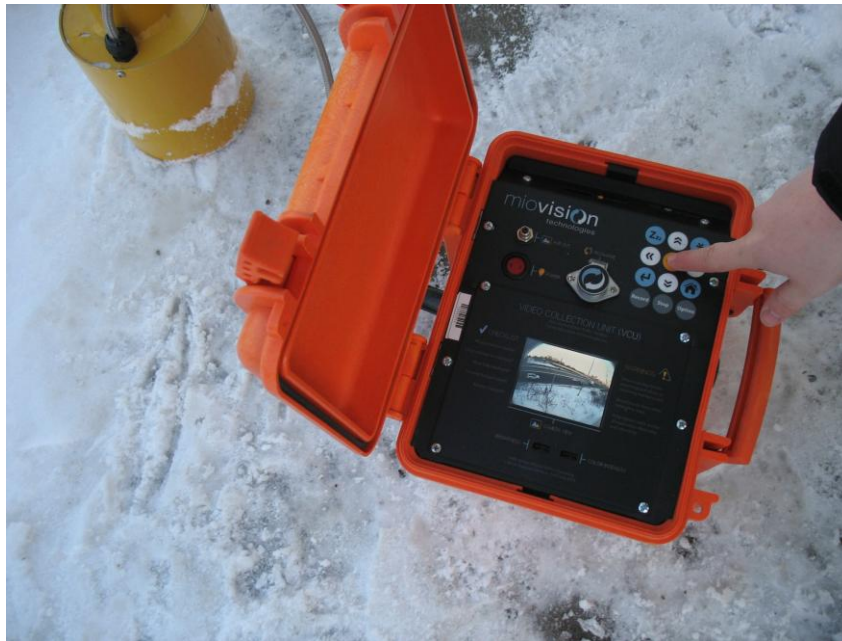
**Figure 35. Miovision VCU with Video Display**

The physical setup of the sensor is relatively easy with some practice. It is easy to elevate the camera into position once the pole mount is securely mounted to the pole. Rotating the camera into place is easy to do and the camera view can be seen on the VCU. It is important to adjust the camera so that it can see all relevant lanes. On a large intersection, this can be difficult. For example, on the turning movement count at TH 7 and Louisiana Ave, Miovision recommended that two units be used to cover all movements. Because only one unit was available for this test, the sensor was set up to collect as many movements as possible and was able to observe ten of twelve movements.

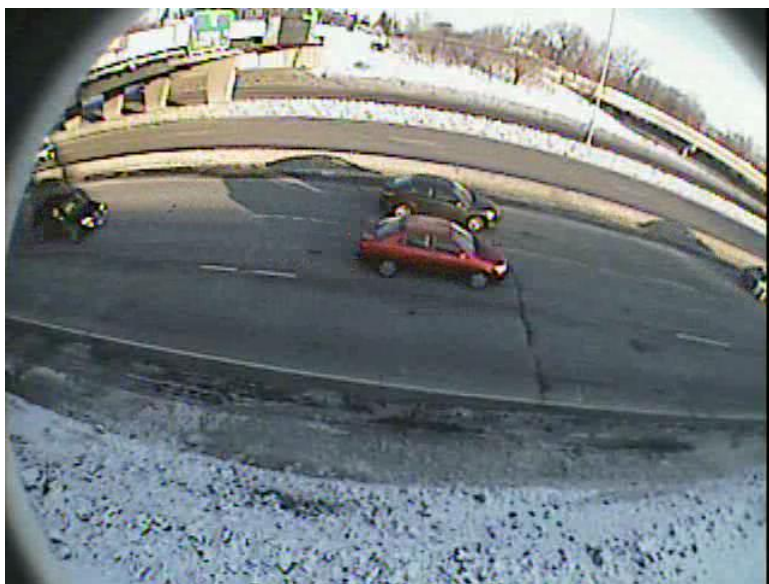
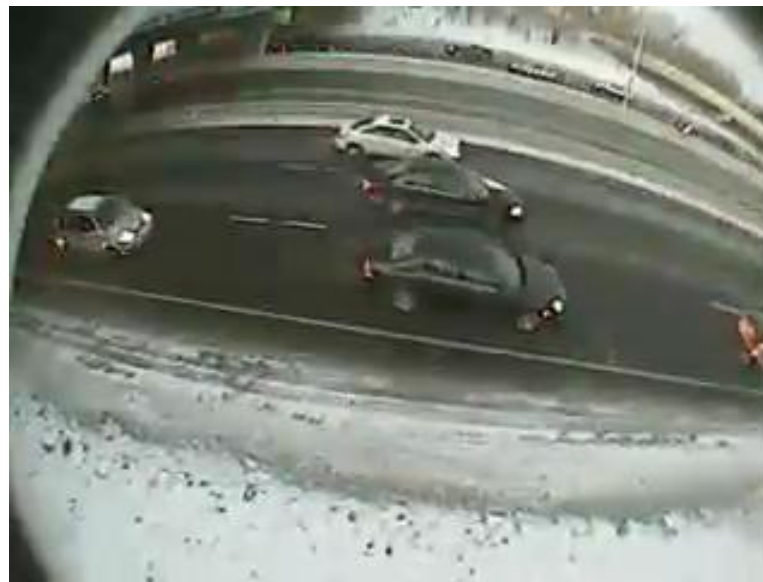
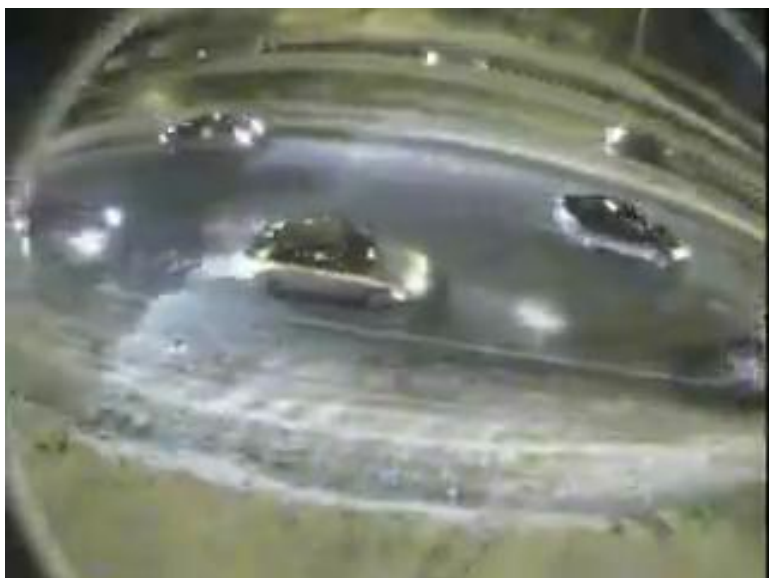
**Daytime, High Resolution**

**Daytime, Downloadable Resolution**

**Nighttime, Downloadable Resolution**

**Figure 36. Miovision Screenshots**

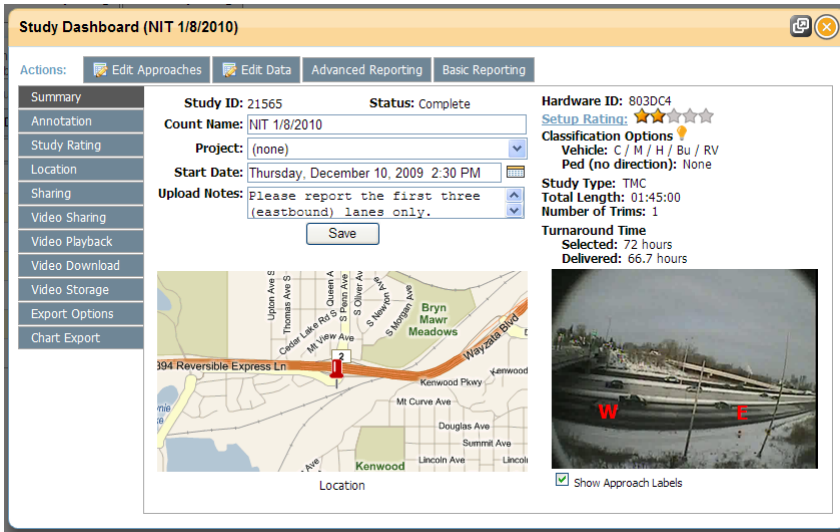
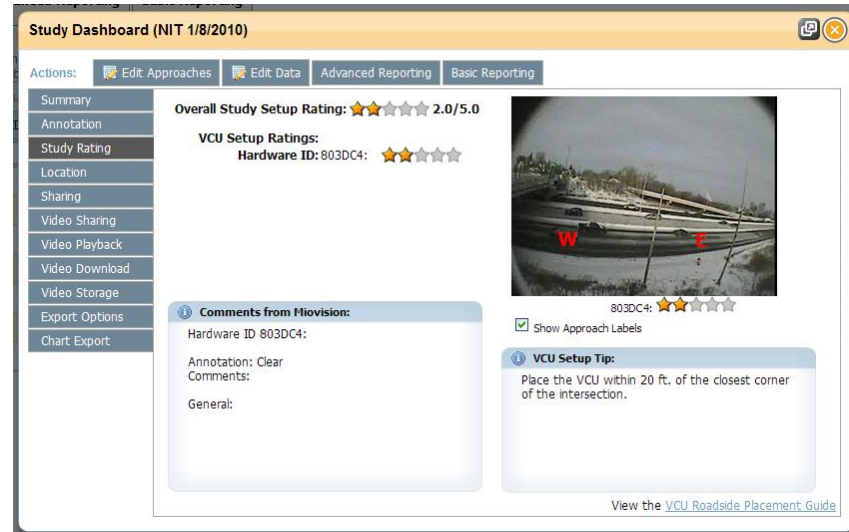
Online Interface - Setup on railing at NIT Test Site

Setup Evaluation - Railing-Mount Setup Evaluation (Two Stars)

Also, the website organizes and stores the traffic data and supports downloading in a variety of standard formats. Miovision gives a rating to each installation. In Figure 37 (top), the sensor was mounted far from the roadway and Miovision gave the feedback that the sensor should be mounted within 20 feet of the roadway. As shown the bottom images of Figure 37, the setup on the lighting pole near the roadway was given a perfect score.

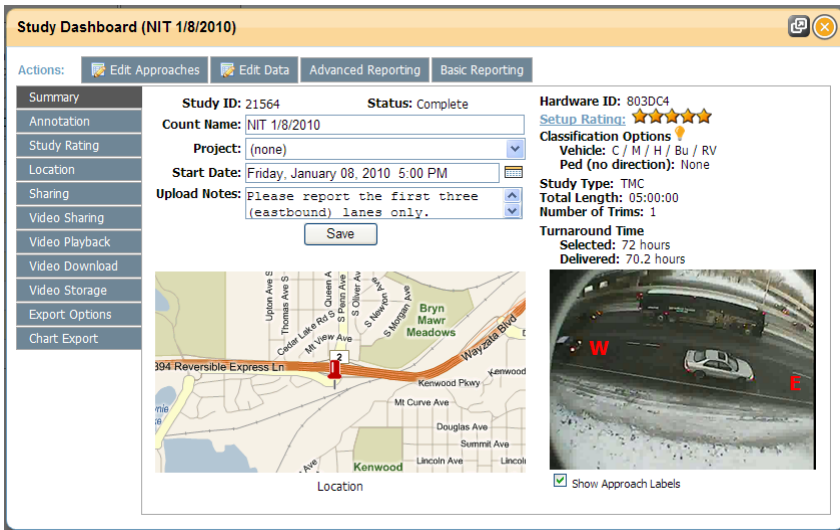
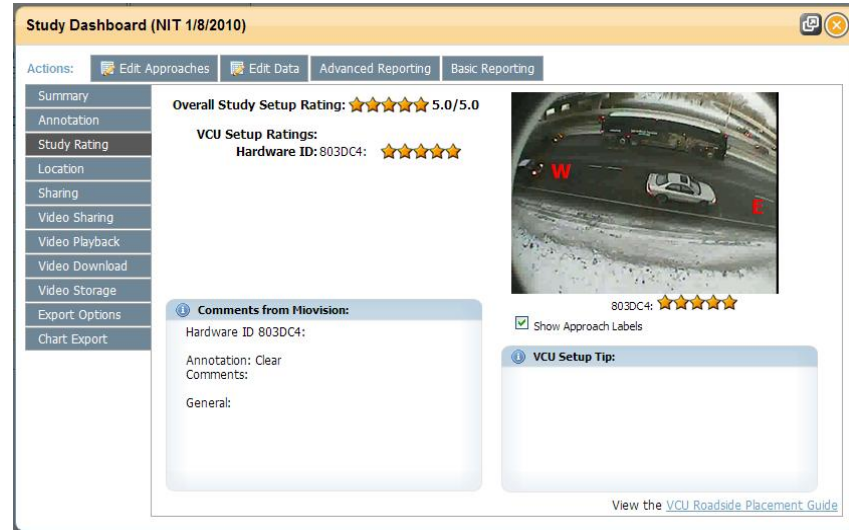
Online Interface - Setup on Lighting Pole Near Roadway

Setup Evaluation - Pole-Mount Setup Evaluation (Five Stars)
