DEVELOPMENT OF A NEW GUARDRAIL END TREATMENT: SELF-RESTORING IMPACT ATTENUATOR

FHWA REGIONAL POOLED FUND STUDY SPR-3(043)

STATE OF CALIFORNIA DEPARTMENT OF TRANSPORTATION DIVISION OF RESEARCH AND INNOVATION OFFICE OF SAFETY INNOVATION AND COOPERATIVE RESEARCH

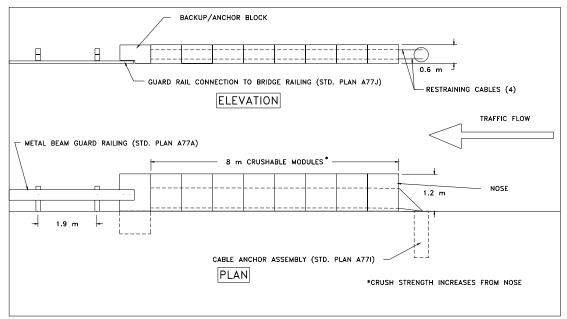
Figure 2-2 Initial Design for Concept A

Initially, this concept was to use inexpensive, crushable modules that are easy to replace. Cables would tie the modules together and be anchored at both ends of the terminal (see Figure 2-2). The final design for this concept was to use two different sized HDPE pipe sections as the energy absorbing crushable modules. Each module would have an inner and outer HDPE pipe section oriented vertically. The terminal would have a concrete foundation and the entire system would be detached from the guardrail. During a designed head-on impact the modules would collapse, absorbing the kinetic energy of the vehicle and bring it to a stop. During a lateral impact the tension in the cables tying the modules together would redirect the impacting vehicle. Some module deformation will occur during this type of impact. See Figure 2-3.

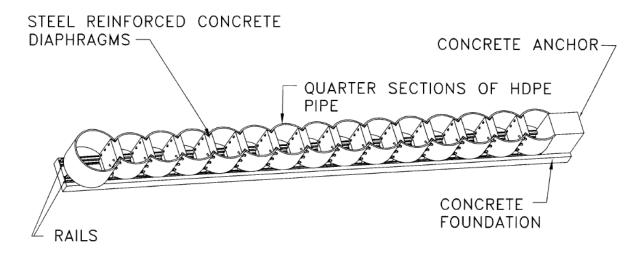
Figure 2-4 Design Concept D

Concept D used steel-reinforced concrete diaphragms that were to be connected by HDPE pipe quarter sections. It was to have a concrete foundation with steel rails that the diaphragms slide on. During a head-on impact the kinetic energy would be absorbed by the HDPE pipe quarters as the diaphragms are pushed back and collapse. A concrete anchor block would provide a wall that the pipe quarters can push on. During a designed lateral impact the vehicle would be redirected by hitting on the pipe quarters. This concept was abandoned because it was deemed too expensive to build and because it would require an excessive amount of time to install. Also, the system could have had patent infringement issues since it was similar in design to the Hybrid Energy Absorbing Reusable Terminal (HEARTTM, Section 4.2.5), that was being developed by the Texas Transportation Institute at the time.

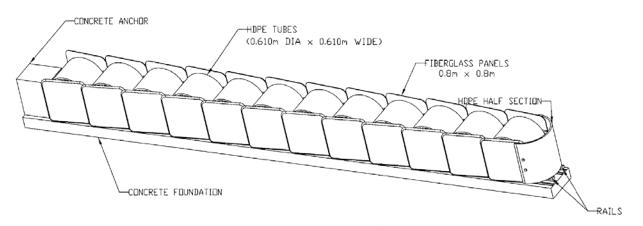
Figure 2-5 Design Concept E

This concept is similar to concept A in that it uses HDPE pipe sections as the primary energy absorber but with the pipe oriented horizontally. To protect the open ends of the pipe and provide a way to reflect lateral impacts, overlapping fiberglass panels were added. The pipe sections and panels slide on a pair of steel rails that are fastened to a concrete foundation. In a design head-on impact, the pipe sections would be pushed back against each other, causing them to collapse. The overlapping panels would allow for the system to telescope and thereby absorb the kinetic energy.

This design was heavily pursued until the first project manager left. However, this concept was later dropped due to possible patent infringement issues since it resembles the QuadGuard[®] Elite (Section 4.2.4) and the QuadGuard[®] LMC (Low Maintenance Cushion, Section 4.2.3), both manufactured by Energy Absorption Systems, Inc.

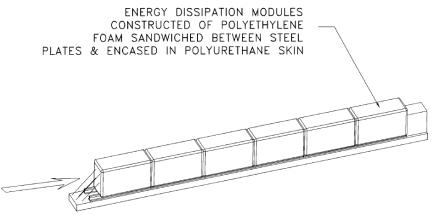
Figure 2-7 Design Concept F

This design concept was to use marine foam rectangular modules as the primary energy absorber. Initially, the modules were to be used for both head-on and lateral impacts without protection. The modules were placed between steel plates and would ride on a pair of rails that were fastened to a concrete foundation. Steel cables would hold the modules in place and provide tension for redirecting a vehicle during a lateral impact. During material testing, the modules were able to withstand head-on impacts, but they would rip and tear in lateral impacts. This established the need for overlapping side panels to protect the modules

Before material testing, the estimated cost of an installation using marine foam modules was \$16,000. This cost was acceptable because it was cheaper than the REACT 350 and the LMA. Also, it was assumed that these modules would have less rebound compared to the other two systems. Testing not only revealed the need for protective side paneling but also for a means for retarding the significant, post-impact rebound of the system. These two additions would increase the installation cost and make the system cost prohibitive. Therefore the concept was abandoned.

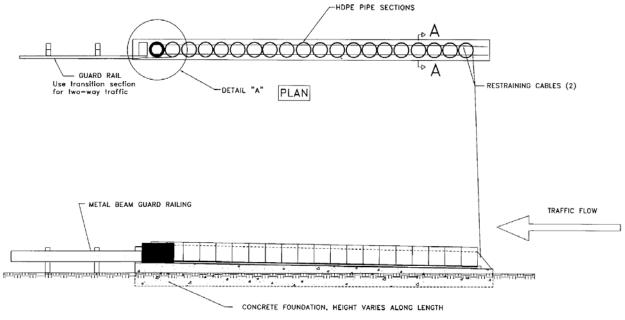
Figure 2-8 Design Concept G

Concept G is similar to Concept A except that the cable that holds the pipe sections is anchored to the last pipe that is much thicker than the other sections and is restricted from traveling upstream. A fender panel is bolted to the last two pipes that overlaps the guardrail and is a form of transition. Even with these changes it was apparent that the system would still have issues with patent infringement and was consequently abandoned.

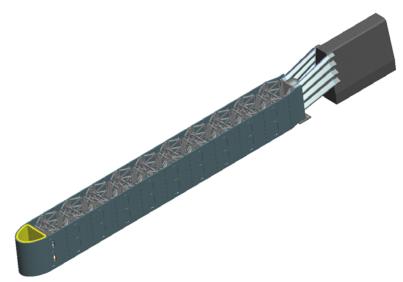
Figure 2-12 Isometric View of Design Concept L

Concept L used steel frame diaphragms that would collapse in an accordion fashion with extension springs to absorb the impact energy. Since the primary material in this design was steel the cost of the system would be low. Computer simulations showed that the diaphragms were too stiff. Efforts were made to soften the system with little success. Researchers requested information from manufacturers on the cost and availability of the necessary springs, but no information was received. This concept was abandoned shortly thereafter.

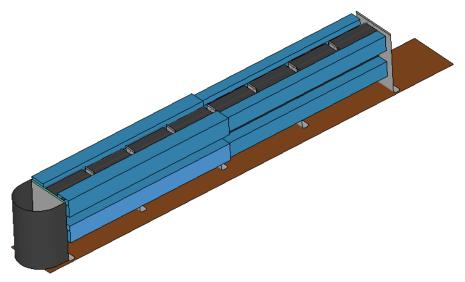
Figure 2-15 Design Concept N

Concept N used the foam modules that were in concept F with the addition of telescoping steel box beams. During a design head-on impact the beams would telescope back and the foam modules would collapse, absorbing the kinetic energy and bring the vehicle to a stop. During a lateral impact the box beams would redirect the vehicle. Computer simulations were run but the project manager left before they were evaluated. No further work was done on this concept.

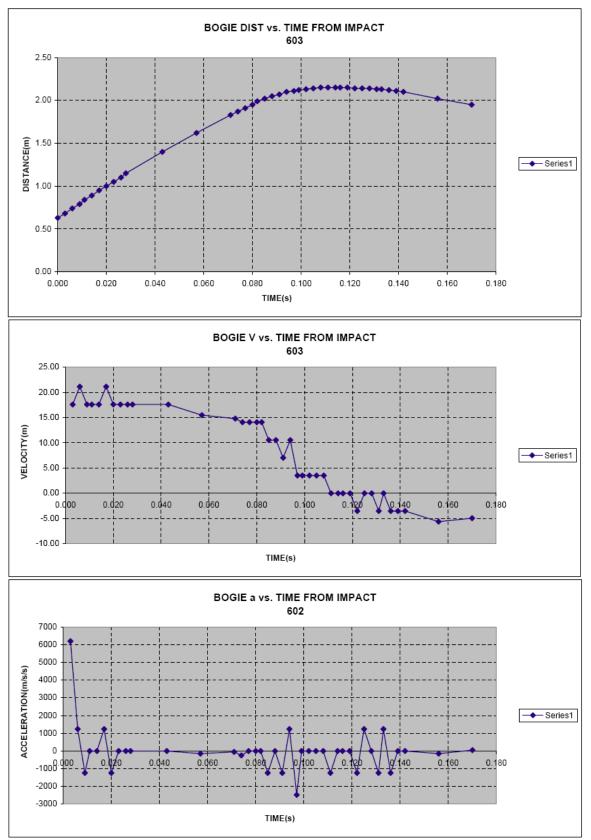
Figure 6-6 ET-603 Film Analysis Graphs

the very high forces, which rocked the reaction wall. No damage to the reaction wall was observed. The right front wheel stop on the bogie was bent, however. The peak dynamic force was about 178 kips (792 kN). The reaction wall was designed for a static loading of 110 kips (489 kN).

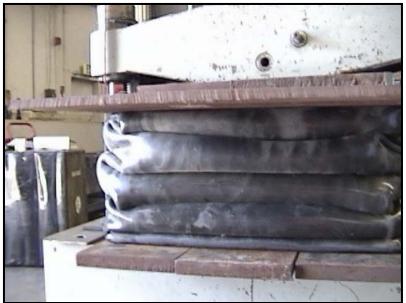
Figure 6-10 Fully Compressed Module, About 10" Deep

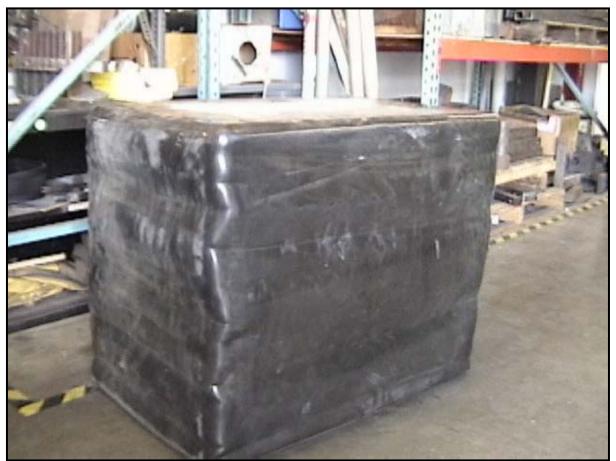
Figure 6-11 Test Sample 10 Minutes After Unloading 30" Dimension Now Almost 29"

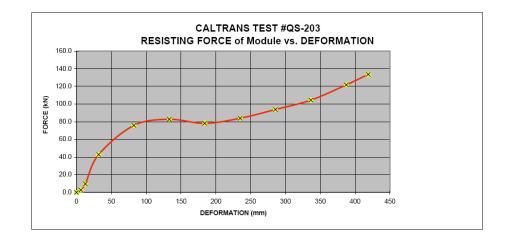
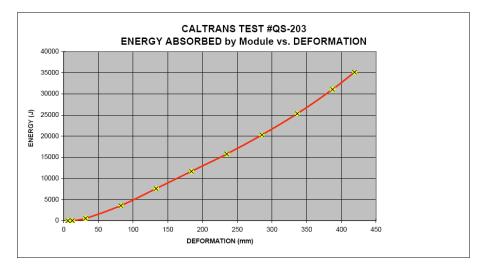
Figure 6-12 Test No. QS-203 Data Sheet and Graphs

PRE-TEST DIMENSIONS Press, area: 864 Height: 36 Width: 24 Impact depth: 30	"	CALTRANS TEST QS-203 QUASI-STATIC LOADING TESTS PROMAR FOAM MODULE SAMPLE CCM4-203-0499 MC3800 FOAM (4 pcf) with Polyurethane skin								
PRESS.	LOAD (Ibs)	DEFLECT.	1				AREA	DEFLECT.	LOAD (kN)	ENERGY
(psi)		(in)					(trap. avg.	(mm)		(kN-mm)
	0	0.00						0	0.0	
0.7	600	0.25					8.5	6	2.7	8.5
2.5	2150	0.50					39	13	9.6	47
11.1	9600	1.25					498		42.7	545
19.7		3.25					3012		75.9	3558
21.5	18600	5.25					4030	133	82.8	7587
20.3	17550	7.25					4086	6 184	78.1	11673
21.8	18850	9.25					4114	235	83.9	15787
24.4	21050	11.25					4510	286	93.7	20297
27.1	23450	13.25					5030	337	104.4	25327
31.7	27350		ENERGY	. ,		35121	5742	2 387	121.7	31069
34.7	30000	16.50	ENERGY	(kip-ft):		25.9	4051	419	133.5	35121

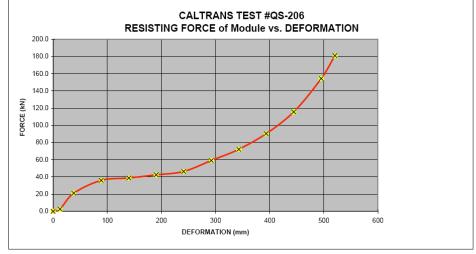
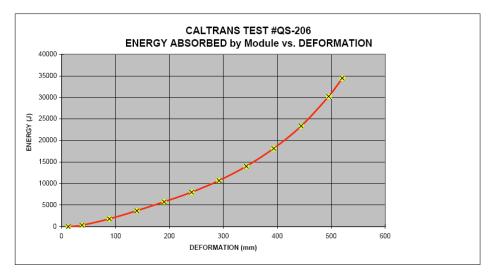
Figure 6-15 Test No. QS-206 Data Sheet and Graphs

23.5	20300	15.50			4126	394	90.3	18127	18.13
	30.1	26000	17.50			5233	445	115.7	23360	23.36
	40.2	34700	19.50			6861	495	154.4	30221	30.22
	47.1	40700	20.50			4261	521	181.1	34483	34.48
r				ENERGY (kN-mm): ENERGY (kip-ft):	34483 25.4

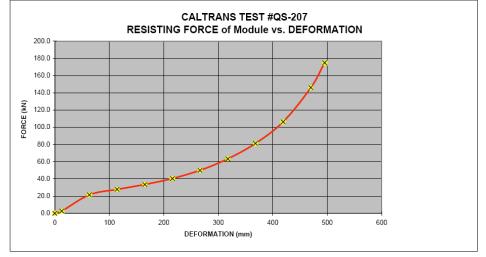
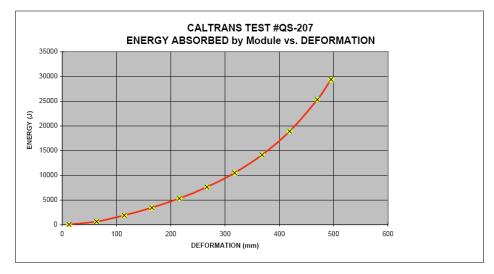
Figure 6-16 Test No. QS-207 Data Sheet and Graphs

PRE-TEST DIME Press. area: Height: Width: Impact depth:	864 sq.in. 36 "			CALTRANS TEST QS-207 QUASI-STATIC LOADING TESTS DMAR FOAM MODULE SAMPLE CCM3-202-0499 MC2900 FOAM (3 pcf) with Polyurethane skin			
-						RGY	
F	PRESS.	LOAD	DEFLECT.	AREA DEFLECT. LOAD		/ CCM3	
	(psi)	(lbs)	(in)		(kN-mm)	(kJ)	
F		0	0.00	0 0.0	17.0		
F	0.7	600	0.50	17.0 13 2.7	17.0	0.02	
F	5.6	4800	2.50	610 64 21.4	627	0.63	
F	7.2	6250	4.50	1249 114 27.8	1876	1.88	
-	8.7	7500	6.50	1554 165 33.4	3430	3.43	
	10.5	9100	8.50	1876 216 40.5	5307	5.31	
L	13.0	11200	10.50	2295 267 49.8	7601	7.60	
	16.4	14200	12.50	2871 318 63.2	10472	10.47	
L	21.1	18250	14.50	3668 368 81.2	14140	14.14	
	27.7	23900	16.50	4764 419 106.4	18904	18.90	
	38.0	32800	18.50	6409 470 146.0	25313	25.31	
	45.5	39300	19.50	4075 495 174.9	29388	29.39	
				NERGY (kN-mm): 29388 NERGY (kip-ft): 21.7

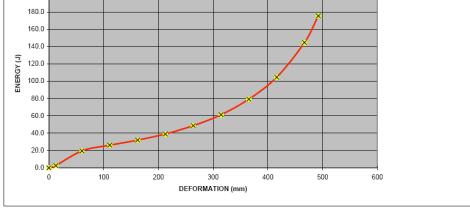
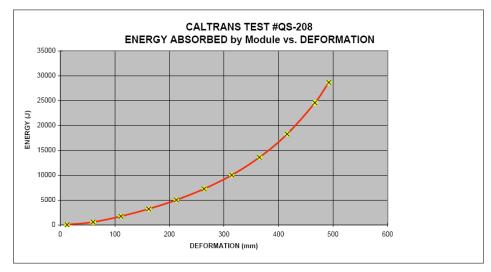
Figure 6-17 Test No. QS-208 Data Sheet and Graphs

20.6	23500	14.38				4668	416	104.6	13592	13.59
	37.6	32500	18.38				6330	467	144.6	24590	24.59
	45.6	39400	19.38				4063	492	175.3	28653	28.65
	200.0 - 180.0 - 160 0 -		t	ENERGY (kN-mm ENERGY (kip-ft): CALTR ISTING FORCE	ANS TEST #	QS-208		_

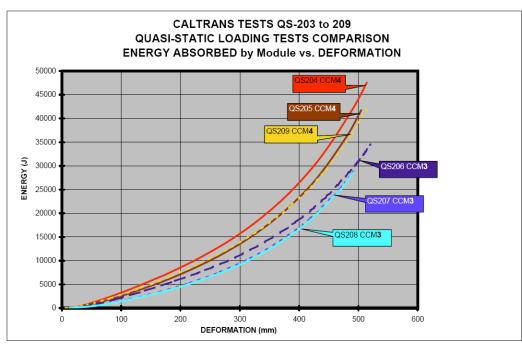
Figure 6-19 Tests QS-203 -209 Summary Graph

CALTRANS TESTS QS-203 to 209 QUASI-STATIC LOADING TESTS COMPARISON

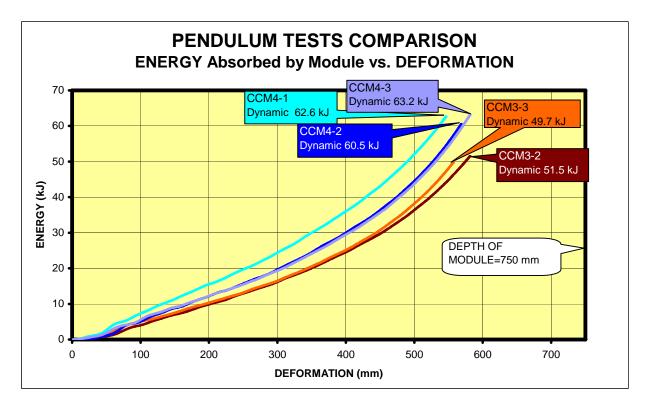
Figure 6-22 Pendulum Tests Comparison

The impact mass was 915 kg (2017 lbs) and impact speed was 11.7 m/s (28.4 ft/s). The initial impact depth of 749 mm (29.5") was restored to 749 mm (29.5") after impact. No damage in module detected. The overhead camera was not installed for this test, to avoid risk of damage from oscillating swing mass.
