TPF-5(433) Behavior of Reinforced and Unreinforced Lightweight Cellular  
Concrete (LCC) For Retaining Walls

**Interim Report on Second Unreinforced Lightweight Cellular Concrete Test**

June 27, 2020

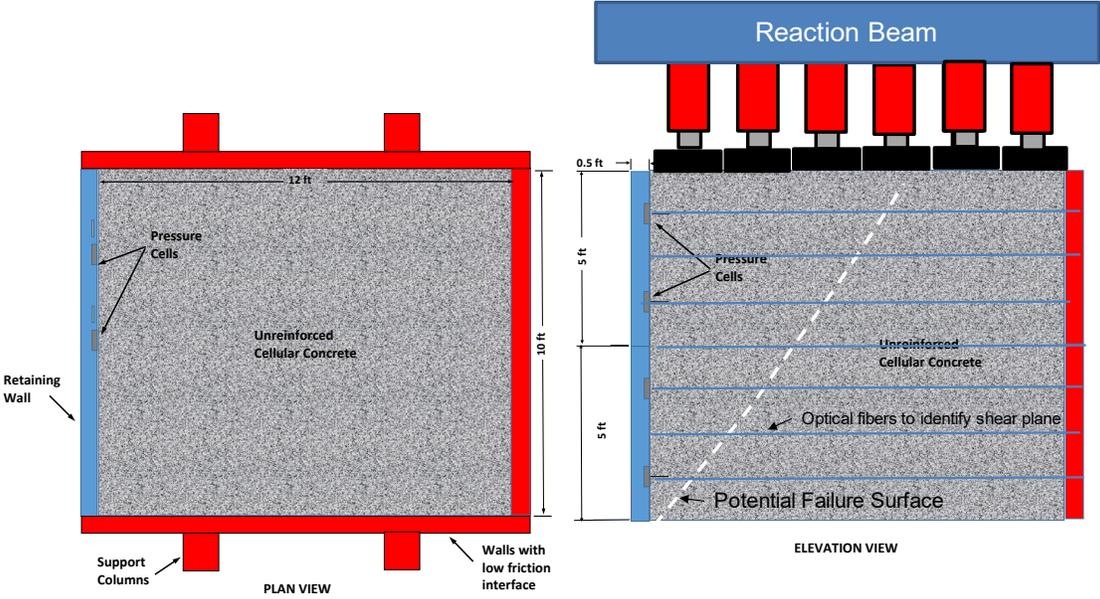
Fig. 1. Schematic plan and profile drawings of the test with unreinforced LCC behind reinforced concrete cantilever retaining wall.

Schematic plan and profile drawings for the unreinforced LCC test are shown in Fig. 1. The test box is 10 ft tall x 12 ft long x 10 ft wide. The reinforced concrete (RC) cantilever wall had a 1-foot thick slab that was six feet long and a 1-foot thick stem wall extending to a height of 10 ft. The cellular concrete had a unit weight of 27 lbs/ft<sup>3</sup> and an unconfined compressive strength (UCS) of about 100 psi at the time of the load test. The cellular concrete was placed in 2.5-foot thick lifts to a height of 10 feet behind the RC cantilever retaining wall over a four-day period (one pour per day). The three steel braced walls (shown in red) were stiff enough to constrain lateral movements to less than 0.1 inch at the maximum expected surcharge load of about 64 psi (7200 psf) based on SAP2000 analyses of the steel frame. The test box was designed so that we could apply load independently to six stiff concrete beams (2 ft wide by 10 ft long) using independently activated hydraulic jacks with load cells.

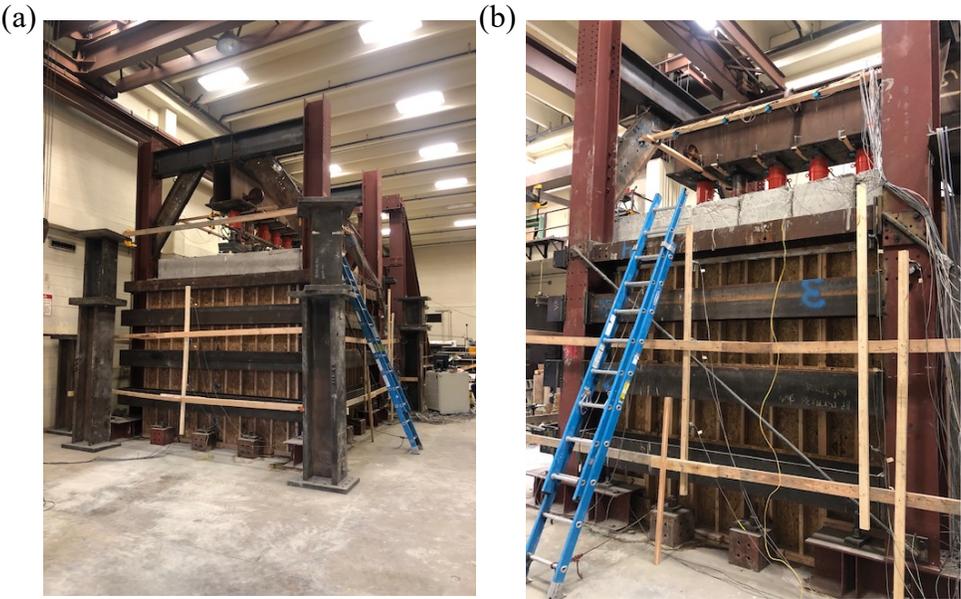
Fig. 2 Photographs showing: (a) the test box from the short side opposite from the retaining wall and (b) the test box from the long side with the concrete surcharge blocks and hydraulic jacks reacting against a longitudinal T-beam.

Photographs of the test box just prior to testing the RC retaining wall are provided in Fig. 2. For each test, we applied the surcharge load incrementally at 25,000 lbs to 50,000 lbs load increments or 2.75 to 5.5 psi pressure increments. For the test on the RC retaining wall, load was applied to the first three surcharge blocks (6 ft) adjacent to the retaining wall as illustrated

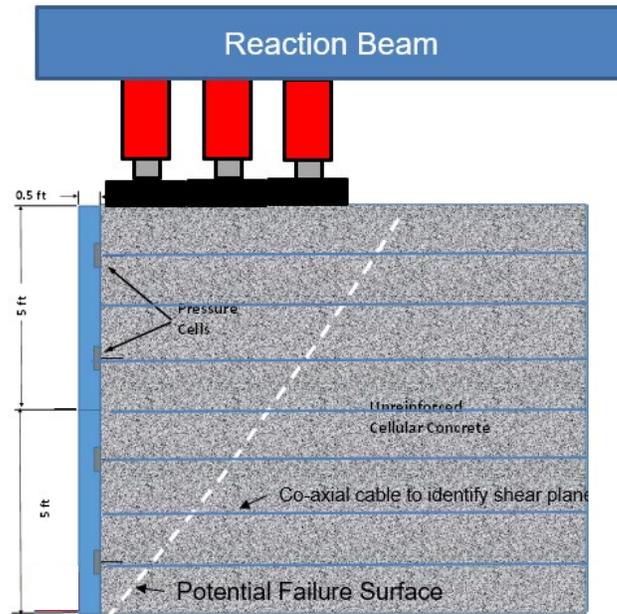
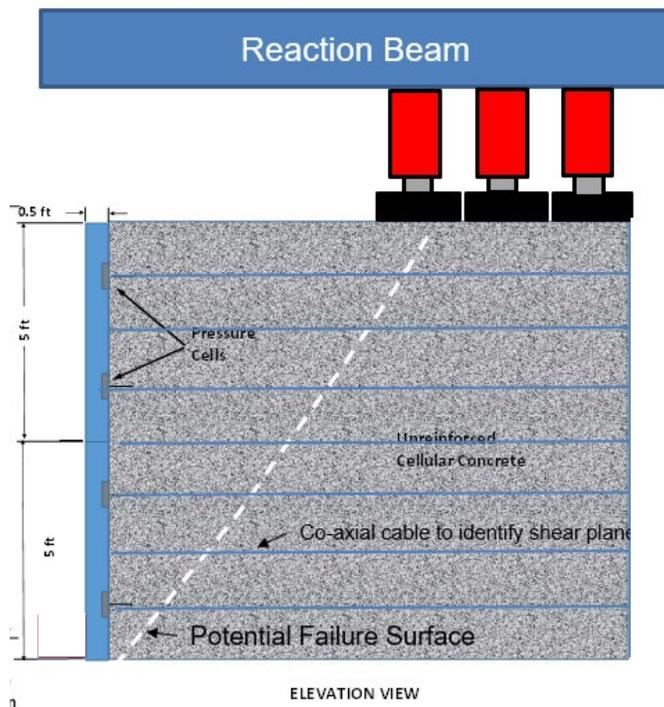
Fig. 3. Schematic drawings illustrating the surcharge load application for (a) the RC cantilever wall test and (b) the free face wall test.

schematically in Fig. 3(a). For the test against the free face, with no retaining wall, load was applied to the first three surcharge blocks (6 ft) adjacent to the free face as illustrated schematically in Fig. 3(b). The load was quite uniformly distributed over the three blocks in each case, but settlement under the load could be different. Displacement of each block was monitored with three string potentiometers attached to an independent reference frame.

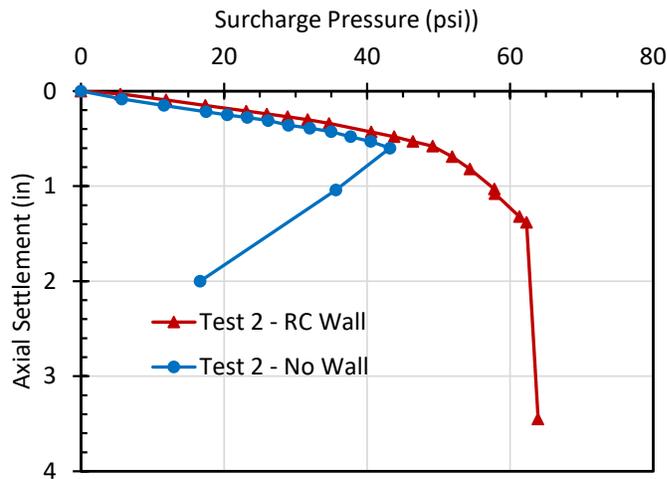
Fig. 4. Applied surcharge pressure versus axial displacement in the LCC for tests with and without RC cantilever wall.

A plot of the applied surcharge pressure versus axial displacement is provided in Fig. 4. The stiffness of the curve near the RC wall is somewhat higher than that for the free face, but the difference is not large. However, at a surcharge pressure of about 44 psi, the axial settlement near the wall increases rapidly and the surcharge pressure decreases as the LCC loses strength after reaching its peak strength. In contrast, the test near the RC wall continues to carry higher surcharge pressures up to a value of about 63 psi, where settlement increases to over 3 inches at constant pressure. Failure of the RC cantilever wall exhibits ductile behavior, while the free face does not.

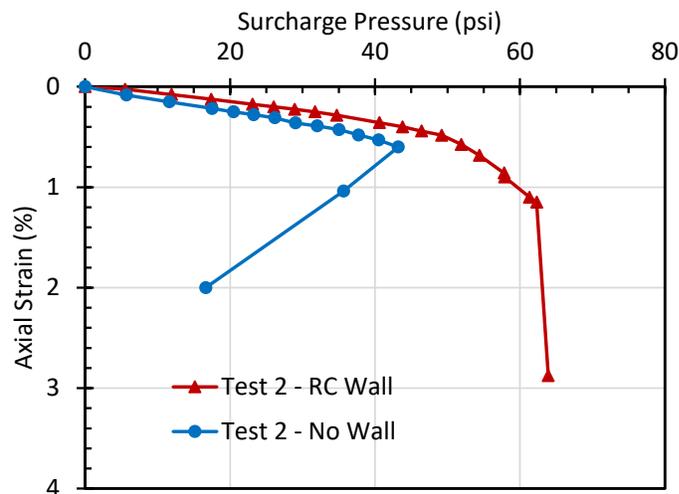
Fig. 5 Applied surcharge pressure versus axial strain in the LCC for tests with and without RC cantilever wall.

Fig. 5 shows plots of surcharge pressure vs. axial strain for both wall tests. The curves show that failure occurred at axial strains of 0.6% and 1.2% for the free face and RC wall tests, respectively.

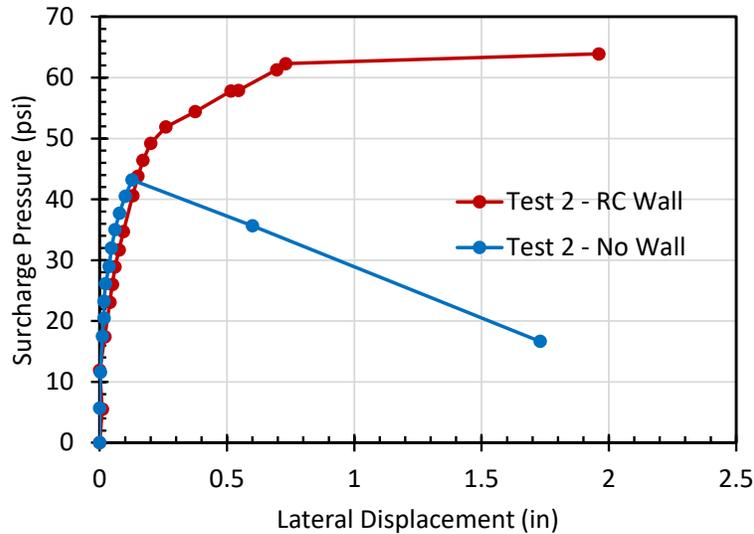
Fig. 6. Applied surcharge pressure vs. lateral wall displacement in the LCC for tests with and without RC cantilever retaining wall for unreinforced LLC test 2.

A plot of applied surcharge pressure vs. lateral wall displacement is provided in Fig. 6 for both walls. The pressure vs. displacement curves are very similar until a pressure of 44 psi suggesting that the strength of the LCC provided most of the resistance to this point. At higher pressures, the curve for the free face experiences significant lateral displacement as surcharge pressure decreases. In contrast, the pressure vs. lateral displacement curve near the RC wall continues to show an increase in resistance that must come primarily from the strength of the retaining wall. There is a significant reduction in stiffness at a surcharge pressure of about 50 psi and failure of the retaining wall occurs at a surcharge pressure of about 63 psi when the wall begins to deform without an increase in applied pressure.

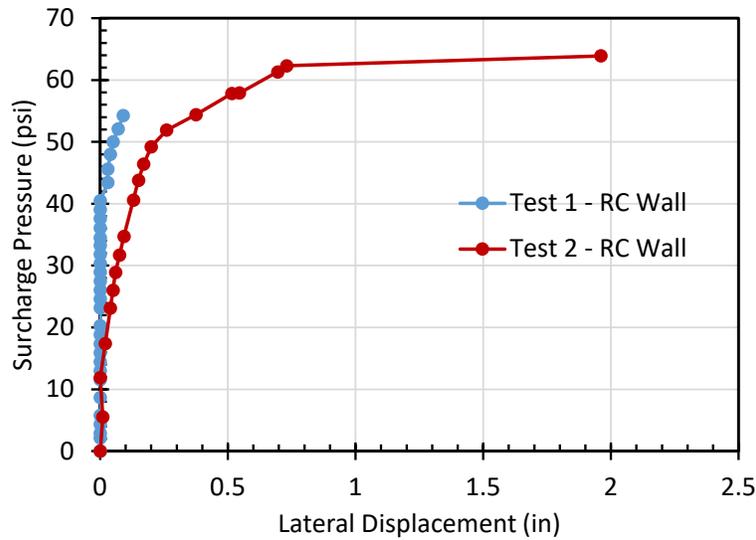
Fig. 7. Applied surcharge pressure vs. lateral wall displacement with RC cantilever retaining wall for unreinforced LCC tests 1 and 2.

Fig. 7 provides a comparison of the surcharge pressure vs. lateral wall displacement for the first and second unreinforced LCC tests with the RC cantilever retaining wall. The unconfined compressive strength of the LCC during the first test was approximately 40 psi, relative to about 100 psi in the second test. In contrast with the second set of unreinforced LLC tests described in this report, the surcharge pressure for the first test was applied uniformly across the entire surface area of the LCC block. For the uniform pressure in test 1, the plot in Fig. 7 indicates that there was absolutely no lateral movement of the top of the wall up to a pressure of 40 psi. In an effort to induce some lateral displacement, the surcharge pressure was entirely removed, and pressure was only re-applied to the first four surcharge blocks (8 feet behind the RC wall). For this loading scheme, the wall began to move laterally beyond a pressure of 40 psi, although movements were small. It should be noted; however, that this was after the entire LCC block had already been pre-compressed to 40 psi under a

uniform pressure that could have increased strength and stiffness. Despite the higher compressive strength of the LCC for test 2 (UCS=100 psi), significantly more displacement occurred at surcharge pressures less than 40 psi than for test 1 (UCS=40 psi). In addition, failure occurred at 63 psi, which is much smaller than the compressive strength of the LCC. These results indicate that the partial loading condition, which induces a shear plane, is more critical for retaining wall performance than a uniform surface pressure over the entire surface which primarily induces compressive strain.

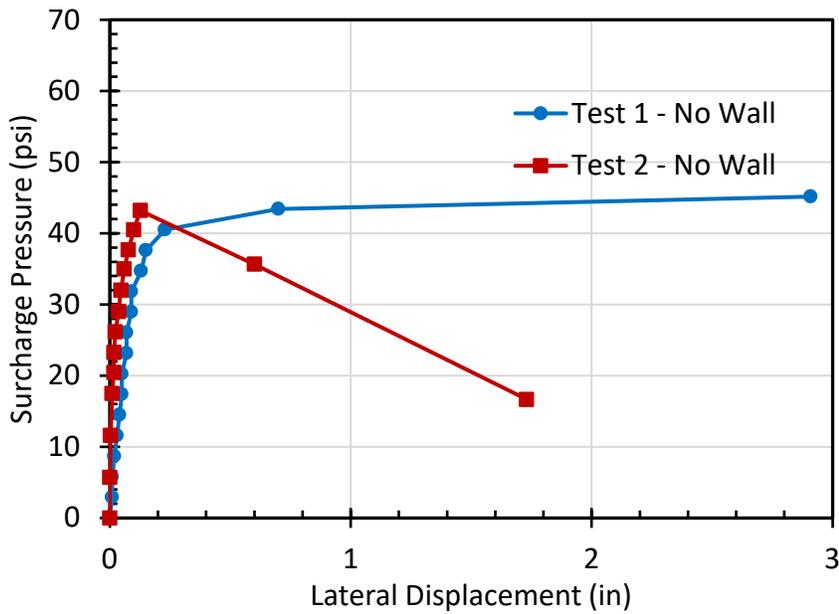
Fig. 8. Applied surcharge pressure vs. lateral wall displacement with no retaining wall (free face) for unreinforced LCC tests 1 and 2.

Fig. 8 provides a comparison of the surcharge pressure vs. lateral wall displacement for the first and second unreinforced LCC tests adjacent to free face (no retaining wall). For these two tests the surcharge pressure was applied over an area 6 feet back from the wall face. Despite the higher compressive strength of the LCC for test 2 (UCS=100 psi), both tests reached a failure condition at about 45 psi. The lower strength LCC had a much more ductile failure than the higher strength LCC. Once again, it must be noted that prior to test 1 adjacent to the free face, the entire LCC block had already been pre-compressed to 40 psi under a uniform pressure that could have increased strength and stiffness. As a result, further comparisons are difficult to interpret.

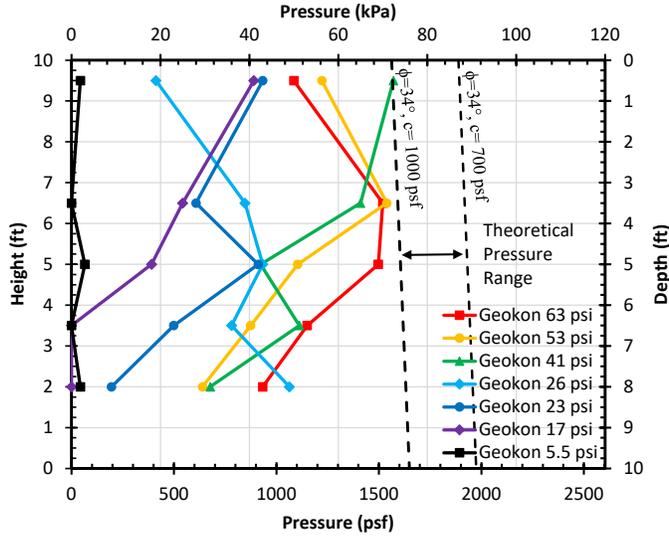
Fig. 9. Horizontal pressure on the RC wall versus depth curves for selected applied surcharge pressure values near the wall during test 2 as measured by Geokon pressure plates.

Fig. 9 provides plots of horizontal pressure on the RC wall versus depth for selected applied surcharge pressures during loading as measured by the Geokon pressure plates. As the surcharge pressure increases, the pressure on the wall progressively increases with higher pressures developing in the top half of the wall, followed by increased pressures in the bottom half.

where  $K_a = \tan^2(45 - \phi/2)$ ,  $\phi = 34^\circ$ ,  $c = 700$  to  $1000$  psf,  $\gamma = 27$  lbs/ft<sup>3</sup>,  $q$  = surcharge pressure, and  $z$  = depth below the ground surface. The range of theoretical horizontal pressures ( $c = 700$  to  $1000$  psf) on the cantilever wall computed using Equation 1 is plotted relative to the measured horizontal pressures in Fig. 9. In this case, the theoretical horizontal pressure range provides a reasonable upper boundary for the measured horizontal pressures.

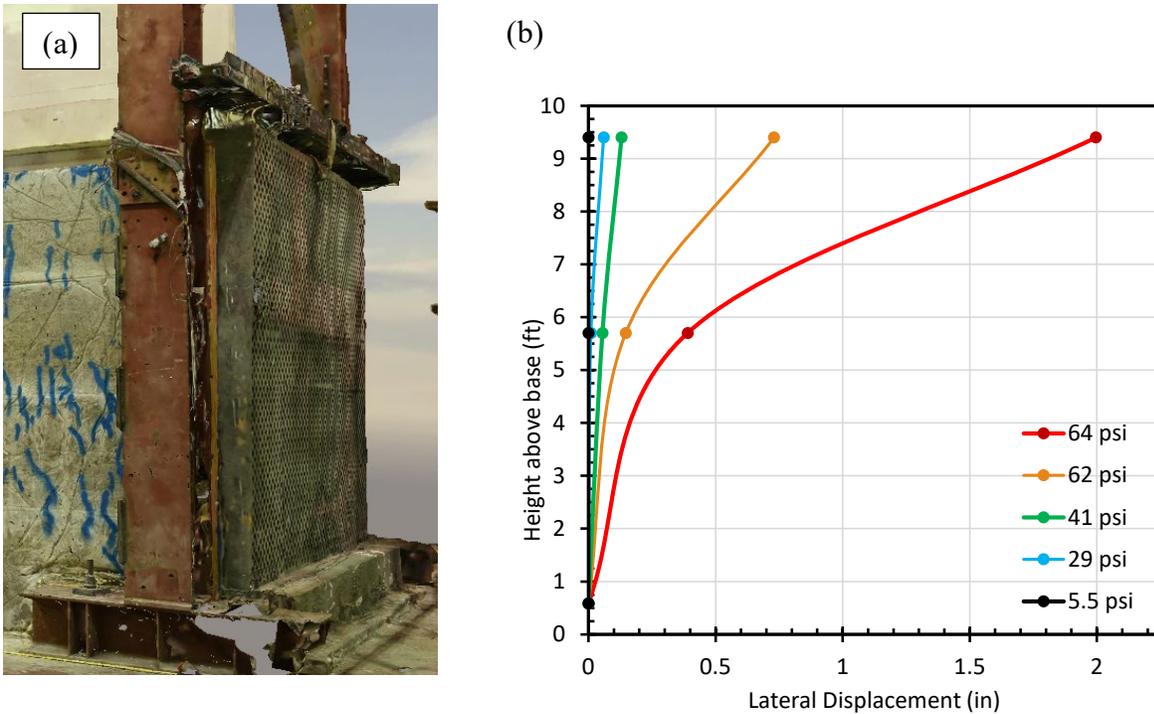
Fig. 10 (a) 3D point cloud of cantilever wall deflection at failure, and (b) measured horizontal deflection of the wall versus height above the base of the wall for selected surcharge pressures.

Based on the string potentiometer measurements on the front face of the cantilever retaining wall, horizontal wall deflection has been plotted as a function of height above the base of the wall for selected surcharge pressures in Fig. 10. The deflection curves are close to zero at the base indicating that the wall was bending, not sliding during the surcharge loading. The horizontal deflection profile is typical of what would be expected for a cantilever wall under lateral loading.

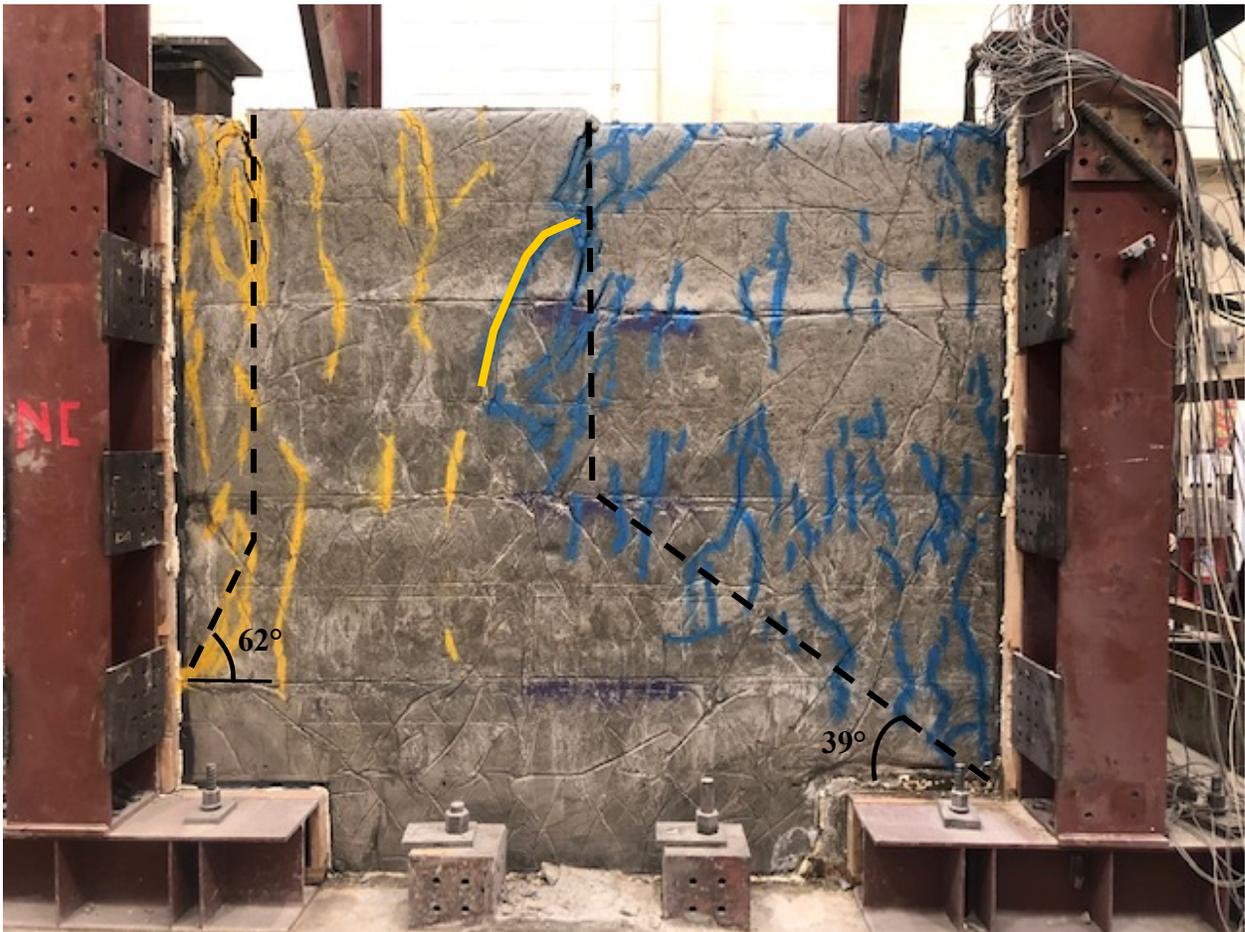
Fig. 11. Photo showing the blue crack patterns adjacent to the cantilever wall with the six-foot wide surcharge load at the surface. Yellow crack patterns are for a second test with six-foot wide surcharge adjacent to free-face without retaining wall.

At the completion of the test, one side wall and the back wall (free face) were both removed to provide a view of the crack patterns produced by the load testing. Drones were also used to photograph the LCC block from multiple angles to produce a 3D point cloud model of the deformed geometry using structure from motion software. Fig. 11 provides a photograph from the side of the LLC block while Fig. 12 provides 3D point cloud representations of the crack patterns in the LCC block. The cracks painted in blue likely developed during loading near the RC cantilever wall, while the cracks painted in yellow likely developed during

loading near the free face with no wall. The blue cracks suggest that a nearly vertical shear plane developed at the back side of the third surcharge block (6 feet behind the wall), due to the 3 inch offset at the top of the LCC block (see Fig. 12 (b)), and propagated to a depth of about 5 feet (mid-height). The failure plane then appears to move to the base of the stem wall at an angle of  $39^\circ$  as shown in Fig. 11.

In the absence of a retaining wall, the pattern of shear planes and cracks develops much closer to the wall face than was observed near the cantilever wall. Although a relatively uniform surcharge pressure was applied to a distance of six feet from the wall, a shear plane developed in the LCC just behind the first surcharge block at a distance of two feet behind the wall. A significant vertical offset is observed across the top of the LCC block in Fig. 12 (a). The shear crack propagates nearly vertically to a depth of about 5 ft (mid-height of the wall), then slopes down to the base of the wall at an angle of  $62^\circ$  from the horizontal as shown in Fig. 11. This failure angle is obviously much steeper than was observed in the LCC behind the cantilever wall.

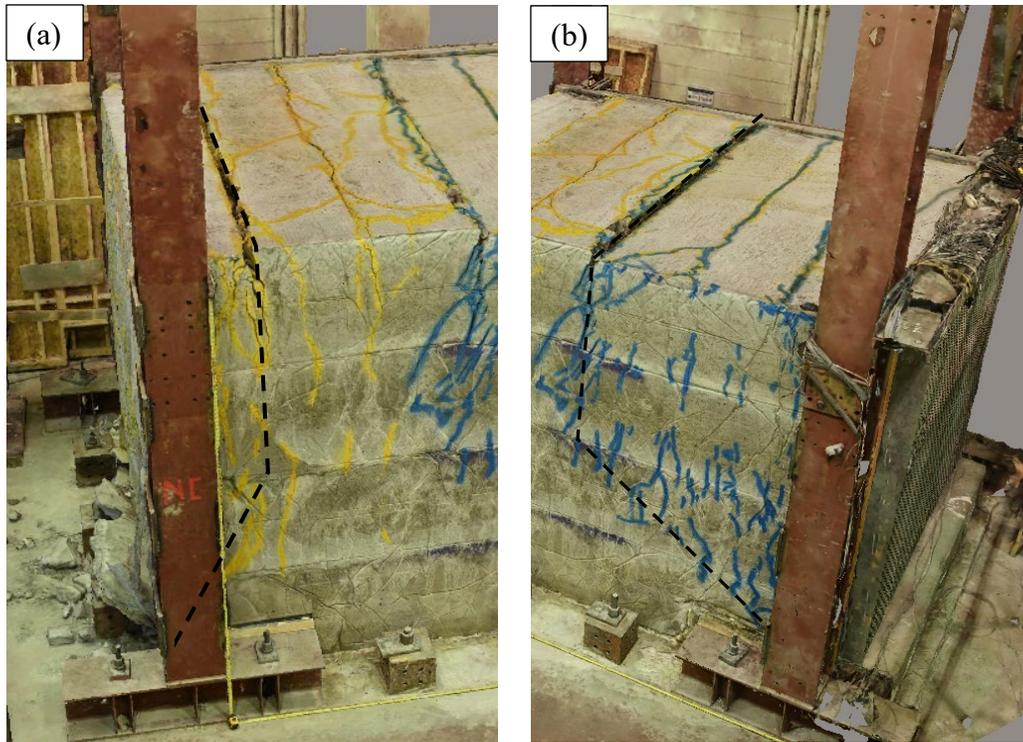
Fig. 12. Three-dimensional point cloud models of (a) crack patterns due to surcharge loading near the free face without a wall and (b) crack patterns due to surcharge loading near the RC retaining wall. (URL for interactive 3D point cloud models)

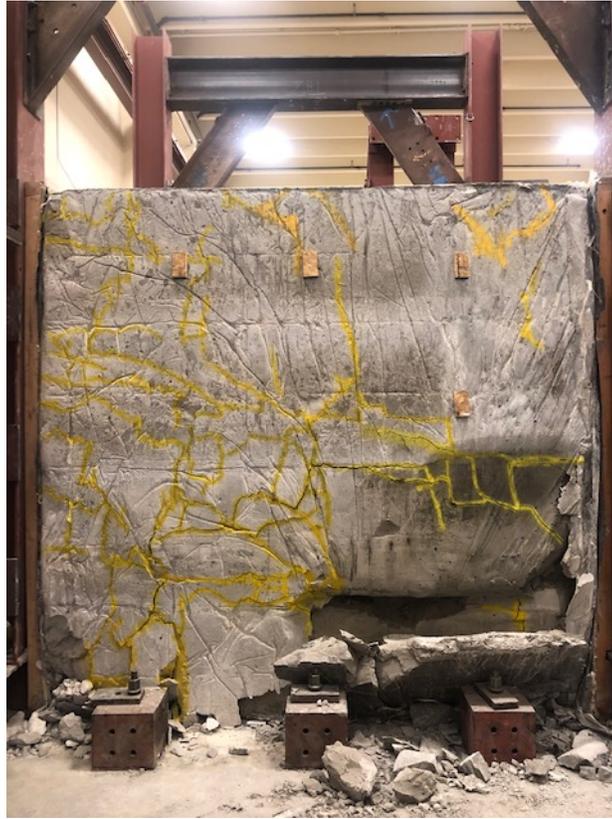
Fig. 13. Photograph of the crack pattern in the LCC on the free face opposite to the cantilever retaining wall side.

When the wood panel was removed on the back face of the box after completion of the load test on the RC cantilever wall side of the box, no vertical cracks were observed in the free face. This result suggest that the wall was relatively unaffected by the loading on the other side of the box. During the first set of unreinforced LLC tests, when a surcharge was placed over the entire LCC surface, many vertical cracks were observed in the free face. A photograph of the free face at the completion of the surcharge loading adjacent to the free face is shown in Fig. 13. The cracks were spray-painted with yellow paint to highlight their locations. The cracks consist of both vertical and horizontal or inclined cracks. The maximum crack width on one crack was 0.125 inch while the majority are less than 0.06 inch or hairline cracks. There appear to be more cracks in the lower half of the wall than in the top half. Visual observations at the time that the wall was failing indicated that the top half of the wall appeared to be moving as an intact block that was sliding downward on top of the underlying shear planes.
