Assessment, Repair, and Replacement of Bridges Subjected to Fire

PROPOSAL

Organization/Institution: Iowa State University
Institute for Transportation
Bridge Engineering Center
2711 South Loop Drive, Suite 4700
Ames, IA 50010

Submission Date: January 31, 2020

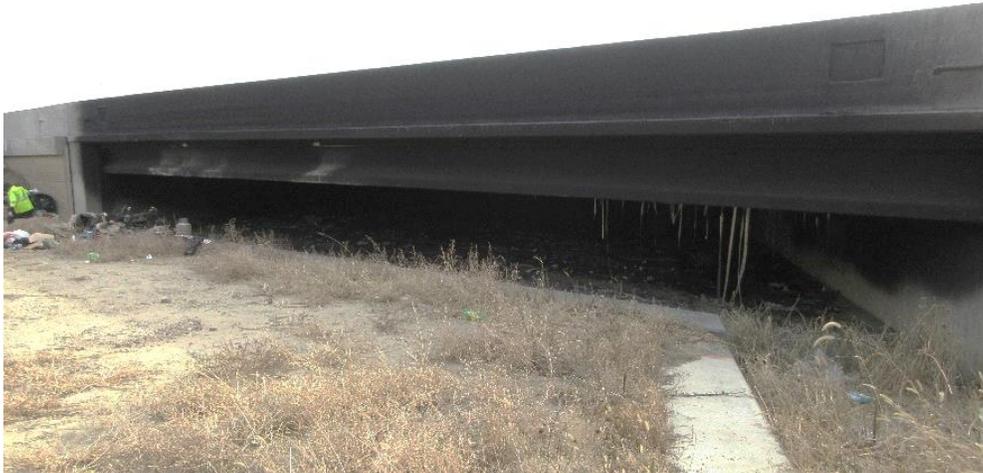
Figure 1 Bridge Fire on I-29 near Sioux City, IA

Recently, a bridge on I-29 near Sioux City, IA caught fire causing various levels of damage to multiple pre-stressed girders. Visual inspection and load testing of the bridge were completed to aid in the development of a response. However, the lack of available information on fire damage created a situation where the decision makers were left without many tools or guidelines to follow for such cases. Research to develop guidelines is needed. This research will assess the condition and structural behavior of precast pre-stressed concrete fire-damaged bridge girders. Additionally, repair, and replacement options will be explored.

There is very little technical information available on "what to do" following a bridge fire. As such, bridge owners do not have much guidance as to how to assess the amount of damage resulting from a fire nor do they have information as to how to repair or replace structures identified as "too damaged". Recently, a bridge on I-29 near Sioux City caught fire causing various levels of damage to multiple pre-stressed concrete girders. Visual inspection and load testing of the bridge were completed to aid in the development of a response. However, the lack of available information on reacting to bridge fire damage leaves more questions than answers.
