A Full-Scale, Single-Column Bridge Bent Tested by Shake-Table Excitation

Matthew J. Schoettler
José I. Restrepo
Gabriele Guerrini
David E. Duck
Francesco Carrea

Center for Civil Engineering Earthquake Research
Department of Civil Engineering/258
University of Nevada
Reno, NV 89557

August 2012

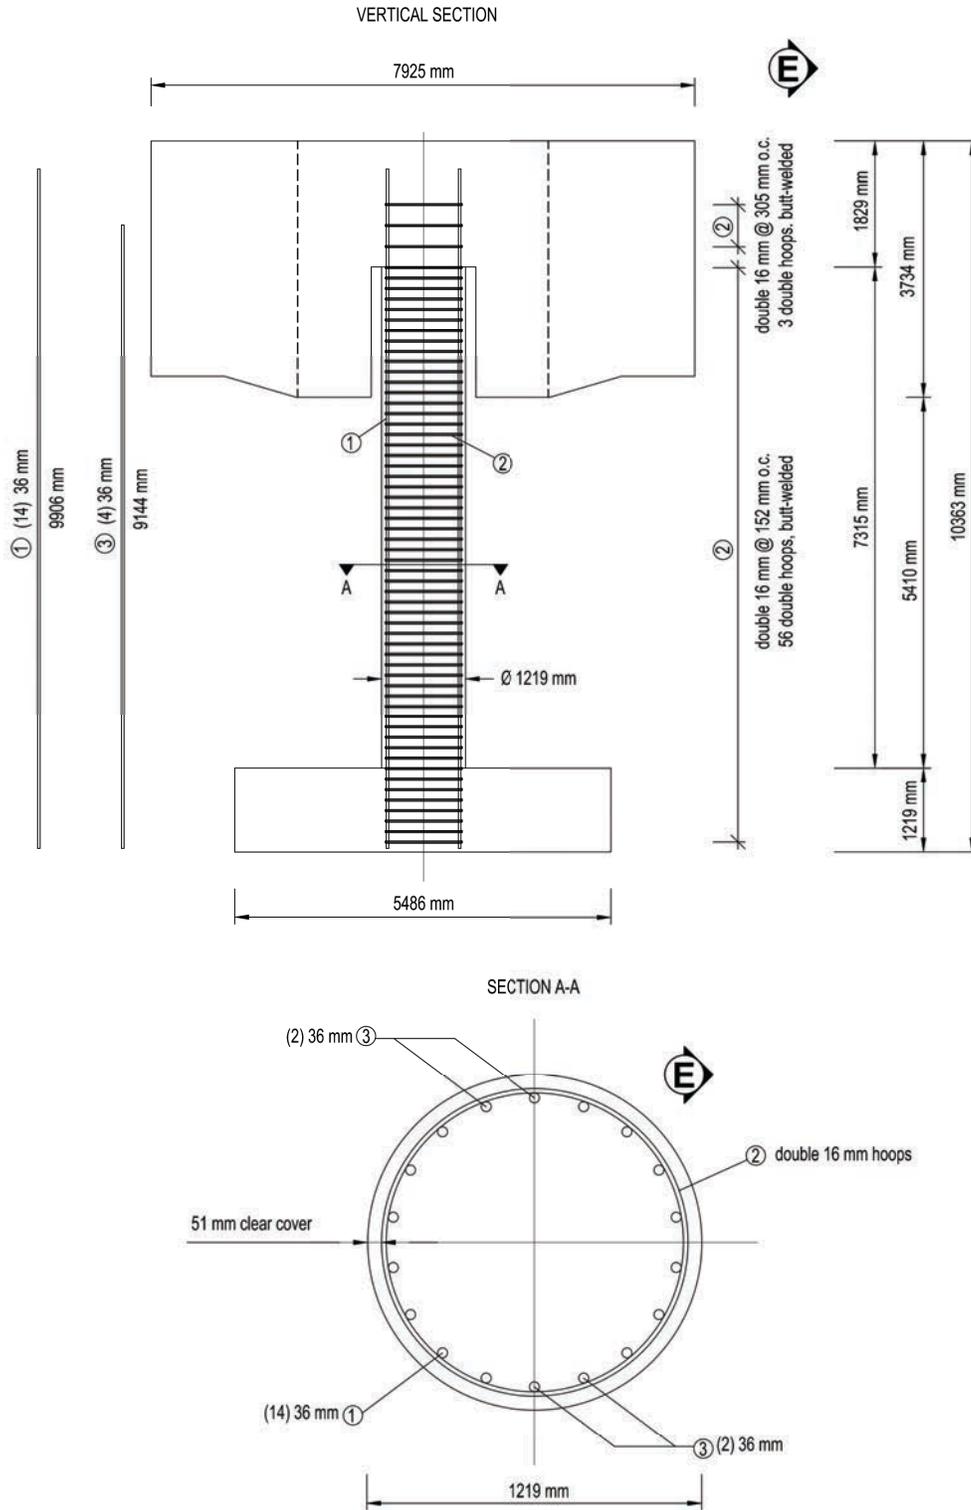
Figure 3.1 Column reinforcing details.

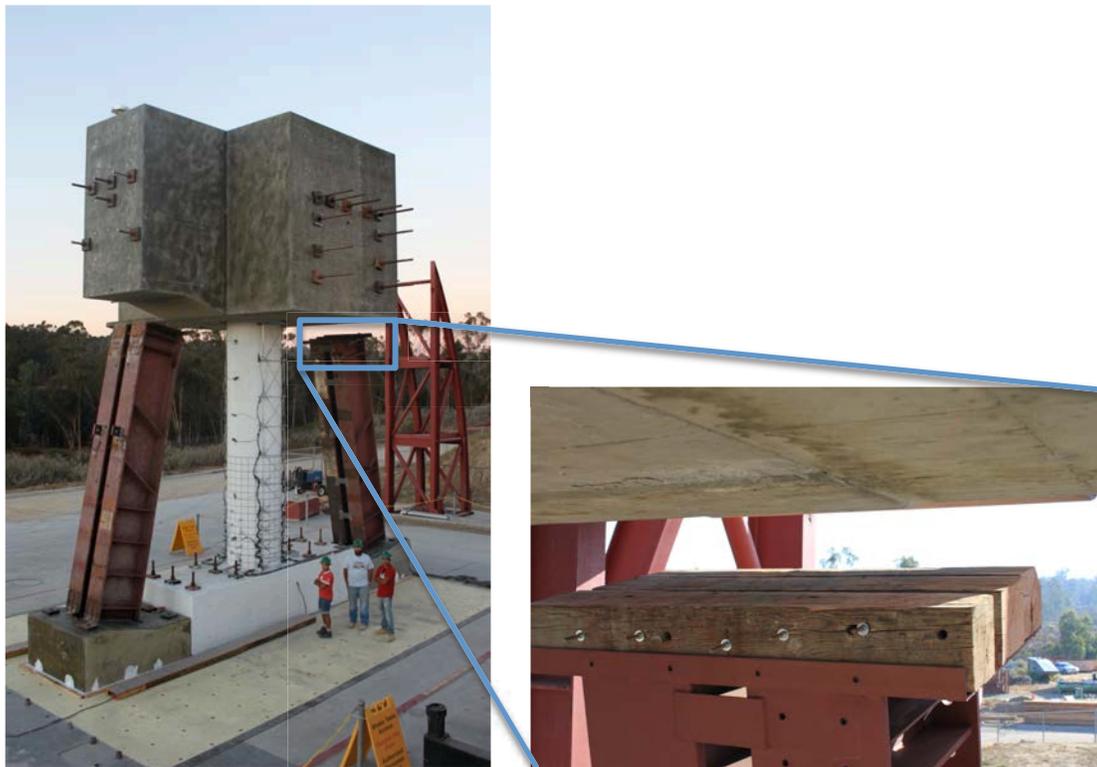
Figure 4.2 Inclined safety columns.

Column displacement was limited to a 10% drift ratio. This restriction was imposed by inclined safety columns placed on either side of the column in the direction of shaking, see Figure 4.2. These also provided gravity load restraint in the event of collapse. They were inclined 11.6° off vertical and were designed to contact the angled portion on the underside of the superstructure block at the limiting drift ratio. Safety columns consisted of dual W32x302 sections connected by stiffener plates. Headed reinforcing bars were welded to the flanges of the W-sections and anchored in a concrete footing. The W-sections were also embedded 38 mm (1.5 in.) in the footing. These footings were post-tensioned to the shake table, but were independent from the column's footing. Large timbers were secured to the top of the safety columns for energy dissipation at impact between the concrete block and safety column.

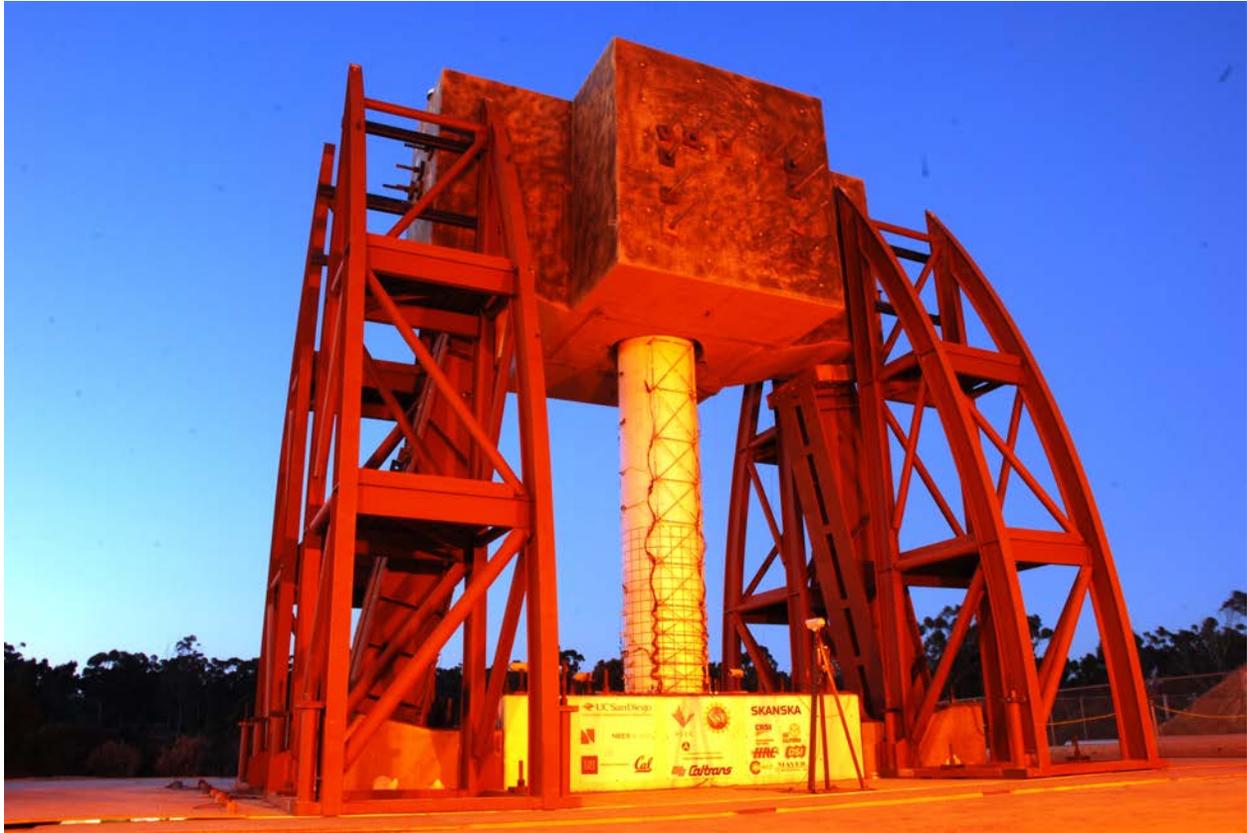
Figure 4.3 Pre-test setup.

To preclude out-of-plane motion, the arched safety restraints located at the corners of the specimen were fitted with guides. Pairs of steel tubes were aligned in the direction of shaking and welded to the arched safety towers. A clear 6.4 mm (0.25 in.) gap between the guide and concrete block was greased to reduce friction should contact initiate during testing. The final test setup including the arched safety restraints is shown in Figure 4.3.

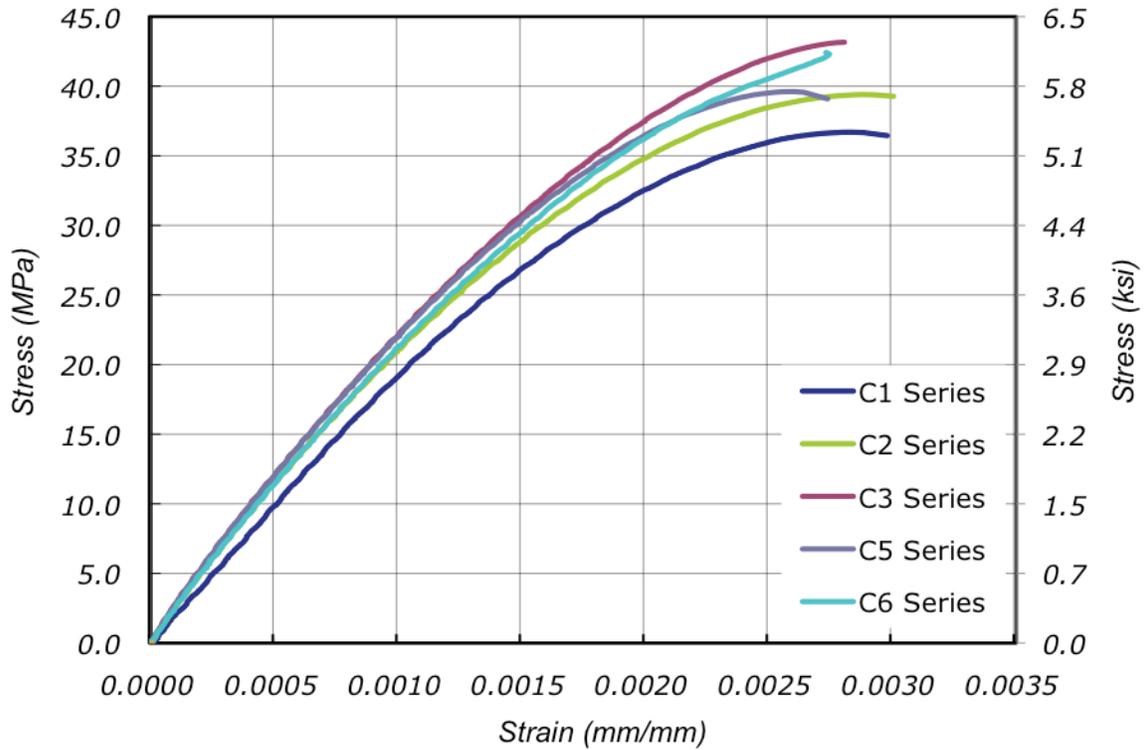
Figure 5.1 Column concrete stress-strain relationship.

The modulus of elasticity of the concrete, E_c defined here as the slope of the secant line from the origin to the point at $0.5f'_c$, was obtained from the stress-strain curves in Figure 5.1 as 22877 MPa (3317 ksi). This was found as the average value of three concrete breaks. This modulus of elasticity is only 79% of the anticipated modulus calculated from equation 3.11 [Caltrans 2006a] based expected concrete compressive strength and unit weight.

The unconfined concrete compressive strain at maximum compressive stress, ϵ_{co} , was obtained from Figure 5.1 and found to be 0.0026. This was based on an average strain from three samples at 42 or 43 days, where the maximum compressive stress was based on the average from five or six samples, respectively, rather than the maximum compressive stress of the single sample shown in Figure 5.1. This unconfined concrete compressive strain at maximum compressive stress was 30% greater than the 0.002 value specified for design [Caltrans 2006a].

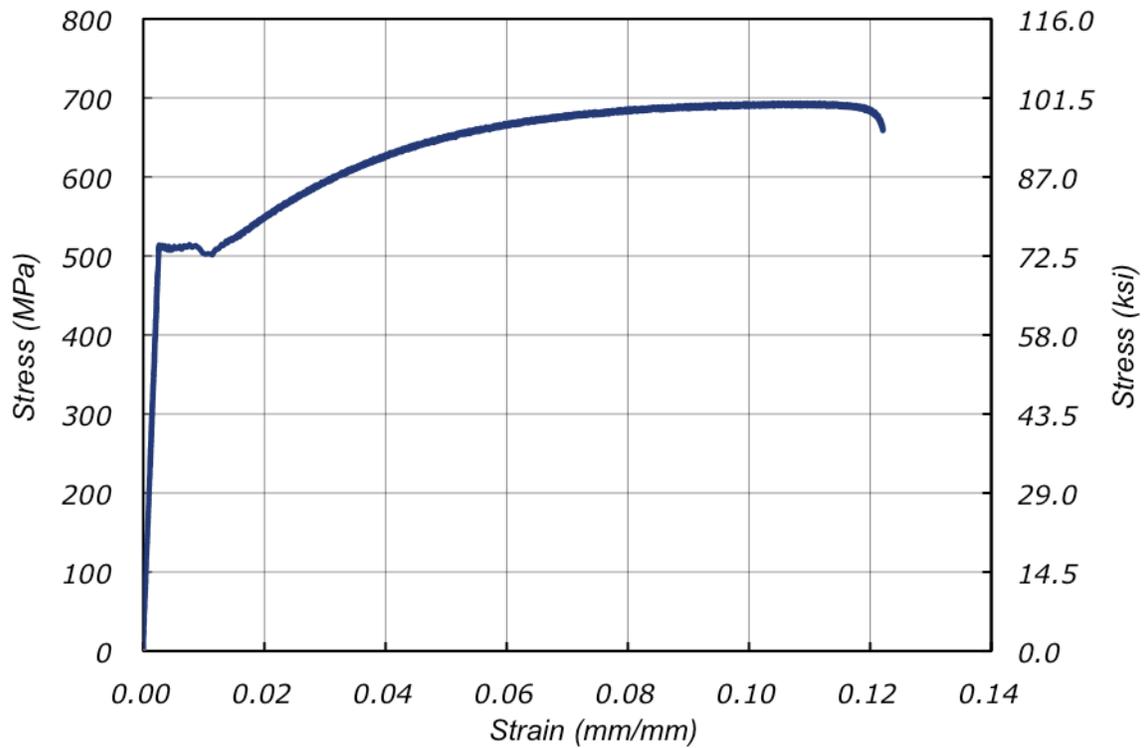
Figure 5.2 Column longitudinal reinforcement stress-strain relationship.

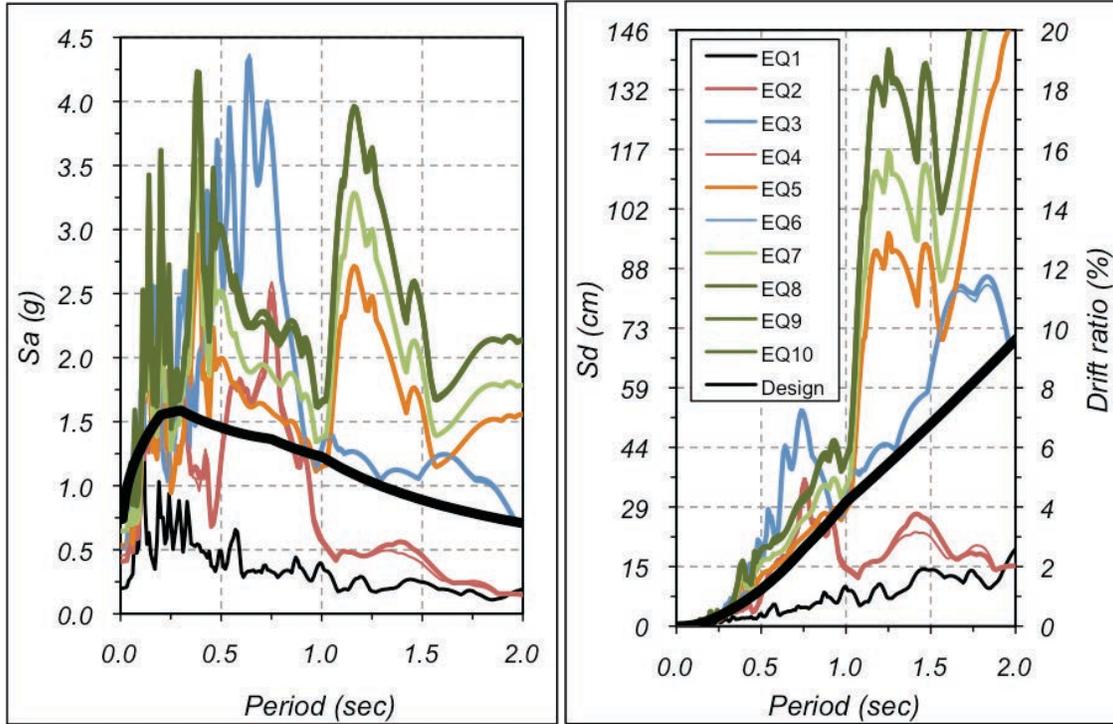
Figure 6.1 Desired ground motions in terms of (a) pseudo-acceleration and (b) displacement response spectra at 1% damping ratio.

For comparison with these input motions, the 975 year return period probabilistic seismic hazard for the San Francisco site is provided with their response spectra in Figure 6.1. Obtained through ARS Online [Caltrans 2010b], the 5% damped design response spectra was transformed to 1% damping with a 1/0.8 amplification across the entire period range [FEMA-273 1997]. The site considered, latitude 37.77 and longitude -122.42, had stiff soil with an average small strain shear wave velocity, V_{s30} , of 350 m/s (1,148 ft/s) in the upper 30 m (98 ft) of the soil column.

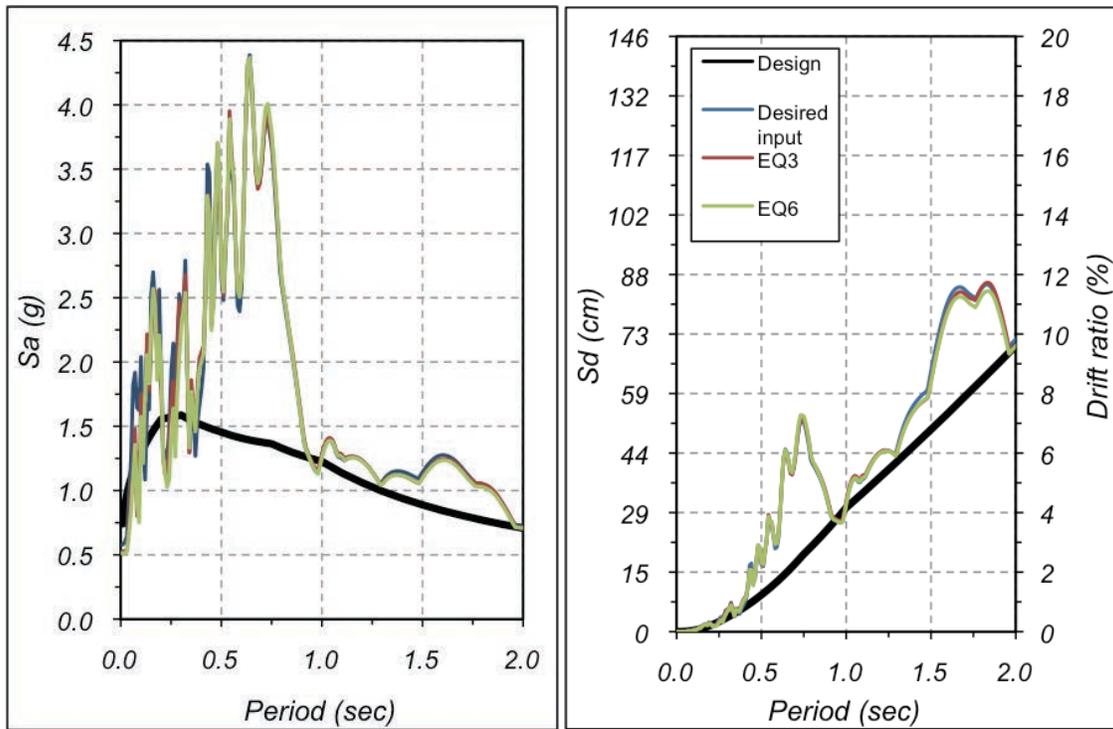
Figure 6.4 EQ3 and EQ6 (a) pseudo-acceleration and (b) displacement response spectra at 1% damping ratio.

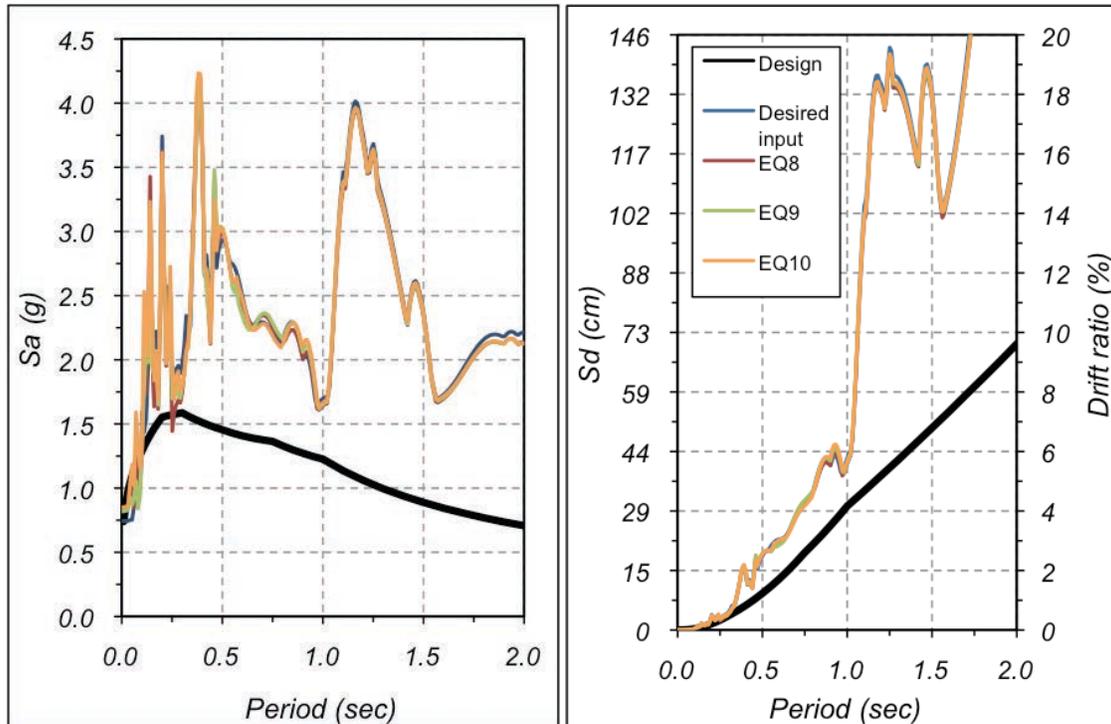
Figure 6.7 EQ8, EQ9, and EQ10 (a) pseudo-acceleration and (b) displacement response spectra at 1% damping ratio.

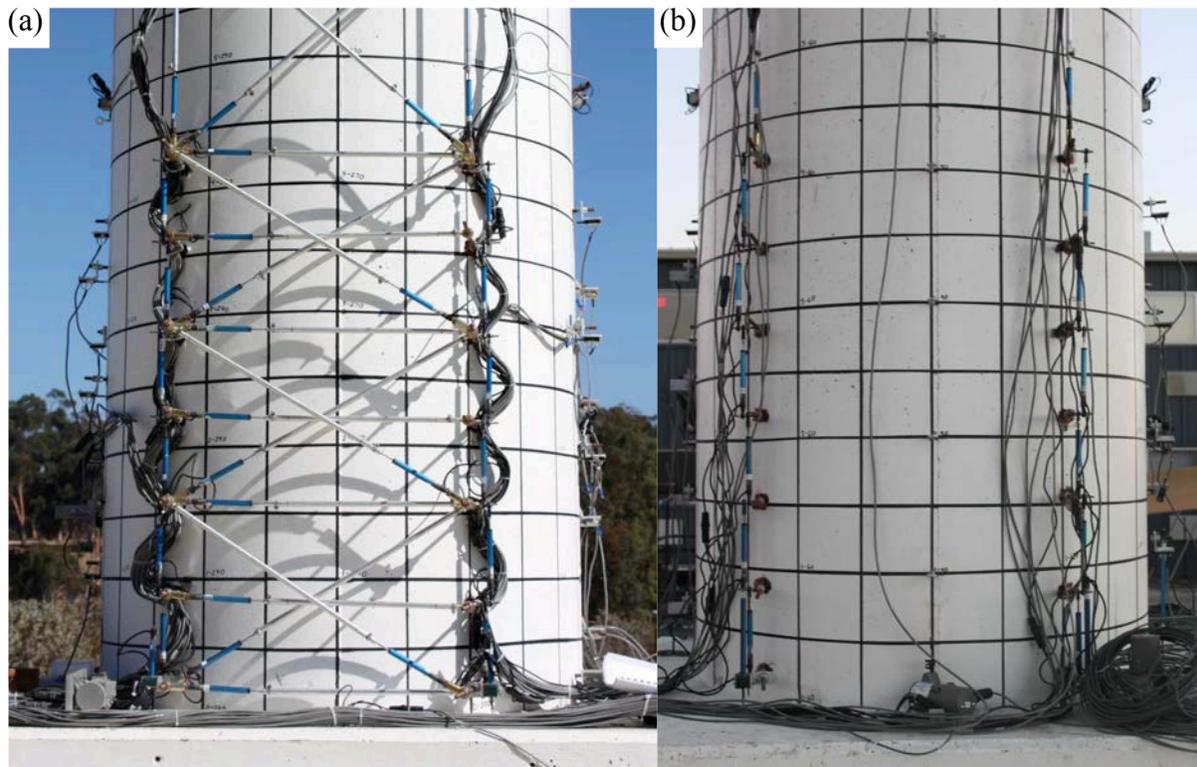
Figure 7.1 Curvature, shear, and fixed-end rotation LVDTs and the (a) South and (b) North faces.

A 203-mm (8-in.) vertical spacing of the rods was used starting 50.8 mm (2 in.) above the column base and extending one column diameter, whereas 610-mm (24-in.) and 787-mm (31-in.) spacings were used outside of that area. Both curvature and shear LVDTs were installed on the South face of the column, whereas only curvature LVDTs were mounted on the North face, see Figure 7.1. Four vertical spring LVDTs were installed to determine the fix-end rotation of the column. They were mounted on the four curvature rods located 51mm (2 in.) above the column-footing interface and they targeted the top of the footing as shown in Figure 7.1.

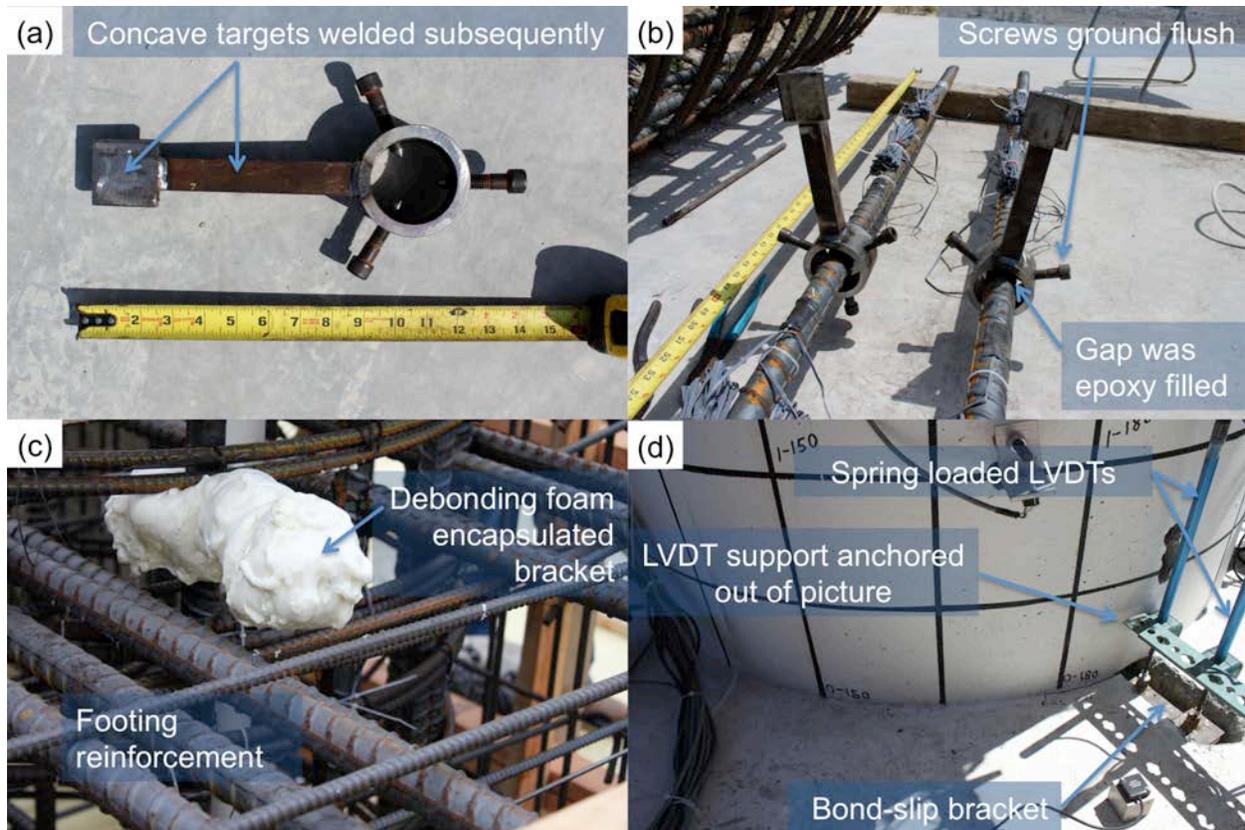
Figure 7.3 Bond slip bracket installation: (a) assembly, (b) placed on longitudinal bars, (c) encapsulated with debonding foam, and (d) final installation.

Vertical LVDTs were installed to measure bond slip between the longitudinal bars and the concrete of the footing. One bar on both East and West faces of the column was monitored. Steel brackets, see Figure 7.3, were clamped on these bars using three sharpen screws and they were placed just below the column-footing interface. Two concave steel targets were welded to each brace to prevent slip of the spring LVDTs. The distances from the center of the bar to the center of each target were 119 mm (4.7 in.) and 208 mm (8.2 in.). Epoxy filled the gap between the collar and the longitudinal bar and the screws were ground flush to the exterior of the collar. The assembly was then encapsulated in expansive foam to debond it from and allow movement within the surrounding footing concrete, see Figure 7.3(c). The LVDTs were placed on a rigid support bolted to the footing away from the column. Access to the bracket was made possible by removing the expansive foam after casting the footing. Two LVDTs were used to capture the rotation and vertical movement of the bracket.

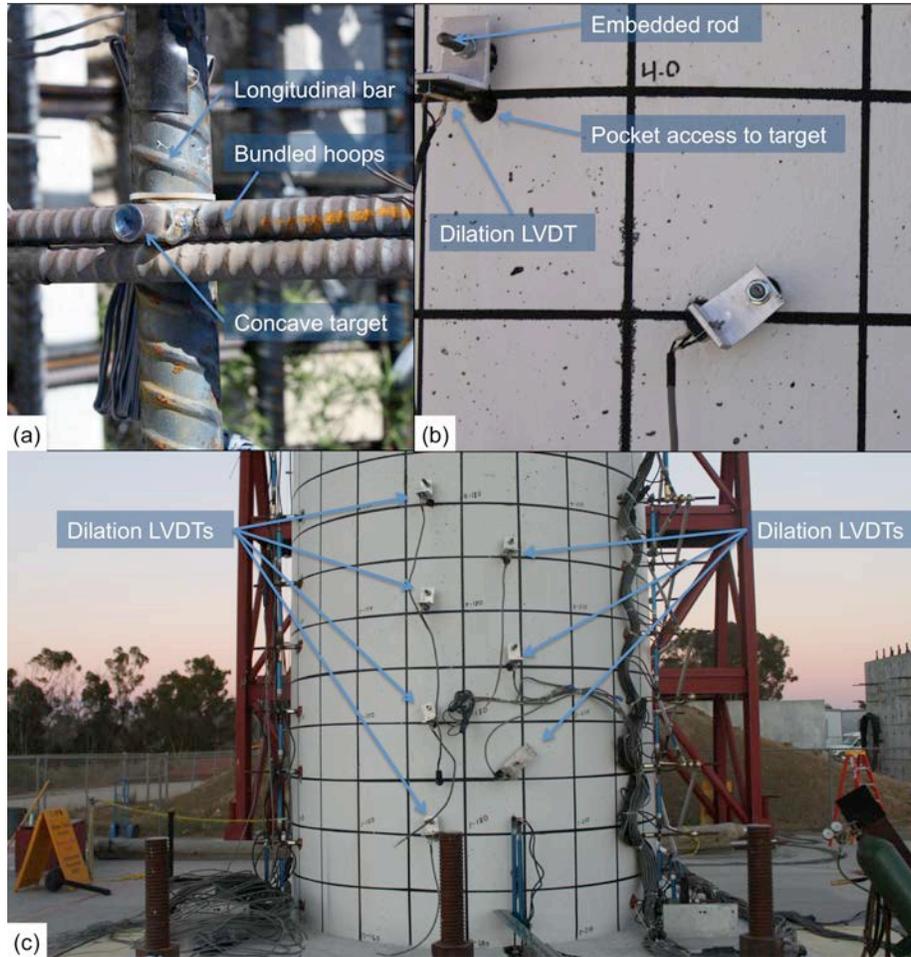
Figure 7.4 Dilation LVDT installation (a) target welded to a transverse hoop, (b) LVDT assembly, and locations on the West face.

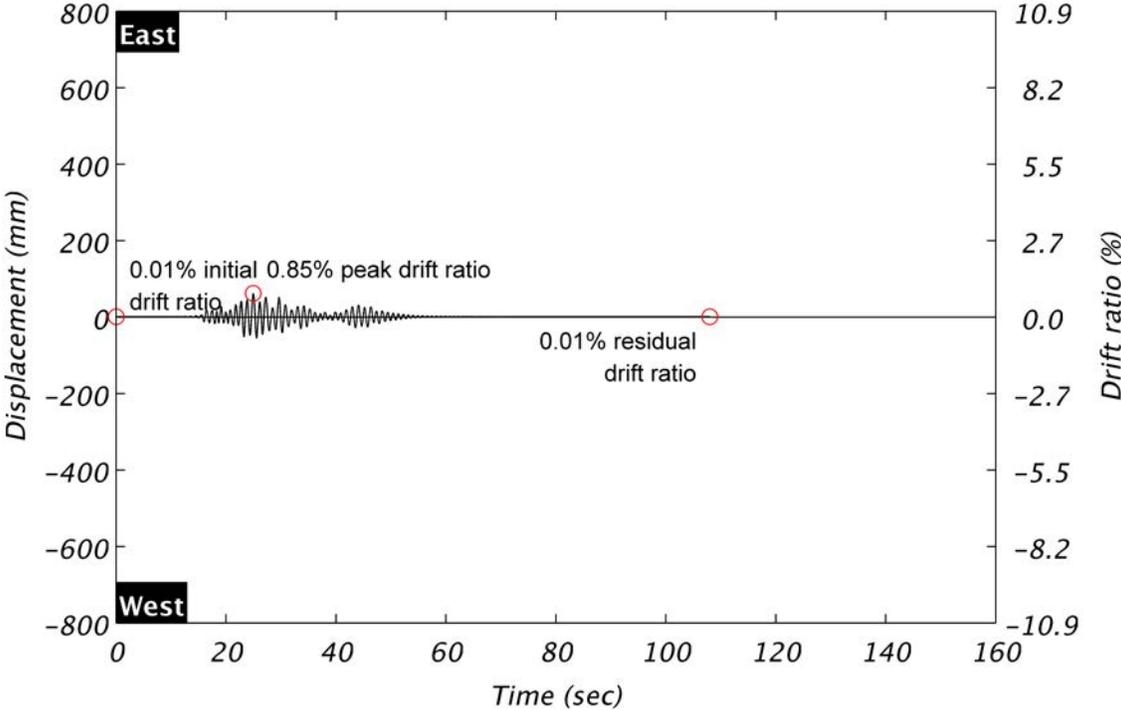
Figure 8.1 Column displacement during EQ1.

The objective of this test was to induce a displacement ductility of 1.0. The peak displacement achieved, defined as the magnitude of the maximum displacement in the East or West direction, was 62 mm (2.44 in.) corresponding to a 0.85% drift ratio and there was no plastic deformation. Figure 8.1 shows the displacement time history with initial, peak, and residual quantities indicated. The residual displacement was 1 mm (0.03 in.) or a 0.01% residual drift ratio. Figure 8.2 (a) and (b) show the East face of the column base at maximum displacement in the West and East directions, respectively.

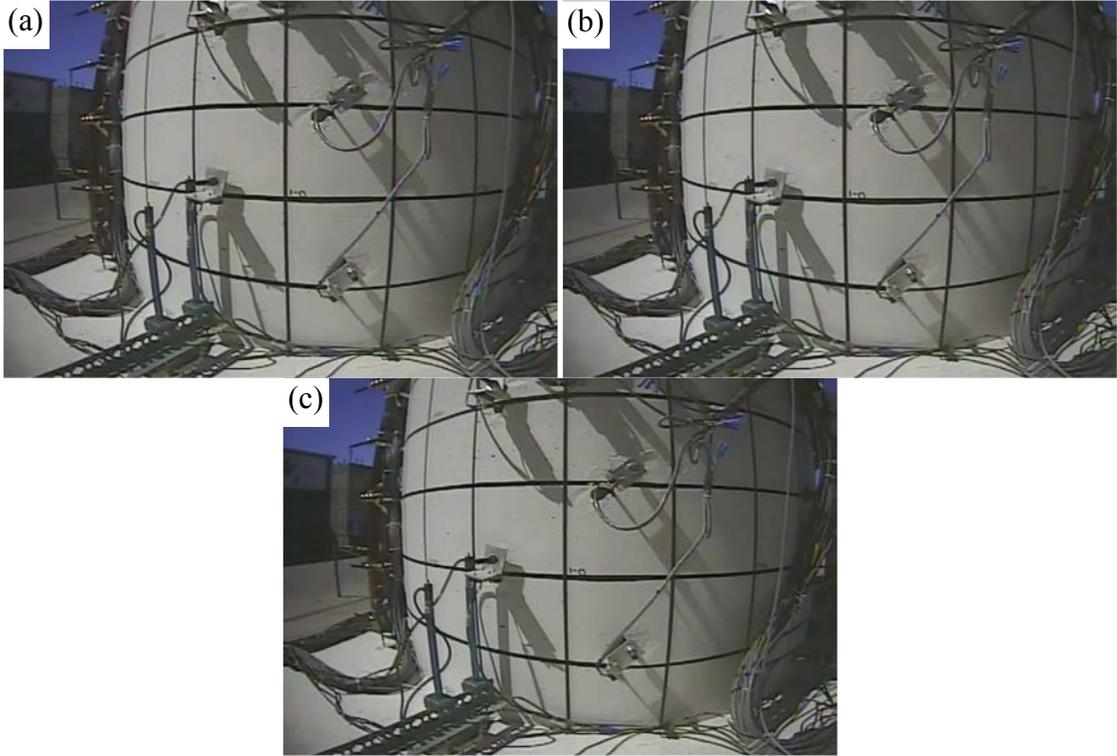
Figure 8.2 Column base East face during EQ1 at (a) peak West displacement, (b) peak East displacement, and (c) post-test.

There was no observable damage in the column post-test. Hairline cracks, defined here as less than 0.1 mm (0.004-in), were found at the column to footing interface. The cracks were

discontinuous on the East and West sides of the column. No other cracks were observed in the test specimen. A post-test view of the East face of the column base is shown in Figure 8.2 (c).

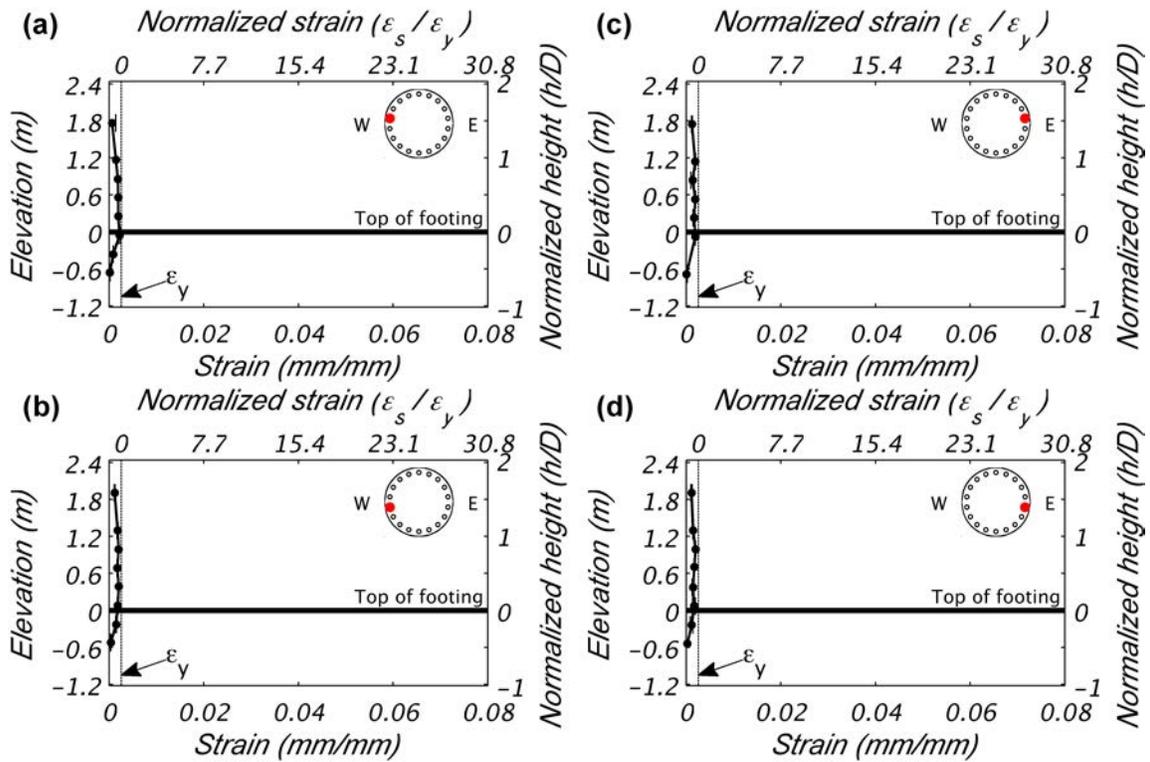
Figure 8.5 Longitudinal reinforcement tensile strain demand during EQ1.

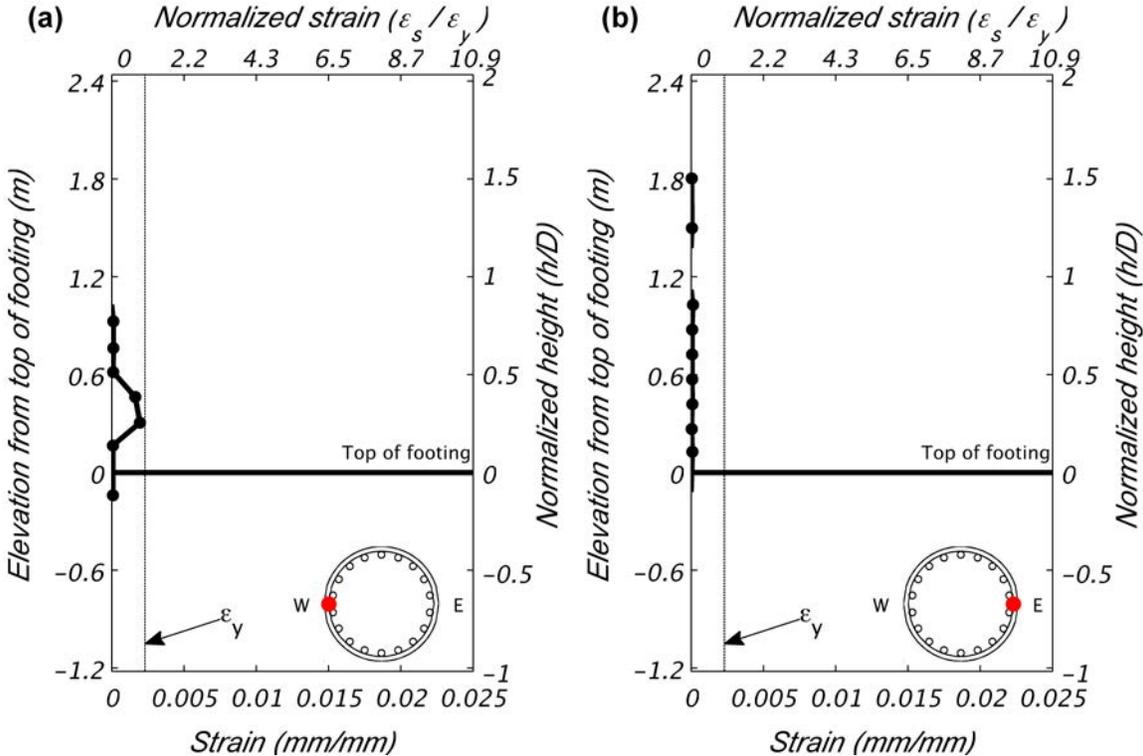
Figure 8.6 Transverse hoop reinforcement tensile strain demand during EQ1.

Transverse hoop strains on the East and West faces of the column remained elastic. A single strain gauge was located on the outside of one of the bundled hoops on the East and West sides of the column. Figure 8.6 shows the maximum tensile values obtained in the instrumented hoops were larger on the West face with values approaching yield between 0.25 and 0.5 times the column diameter. Negligible strain increases were recorded on the East face.

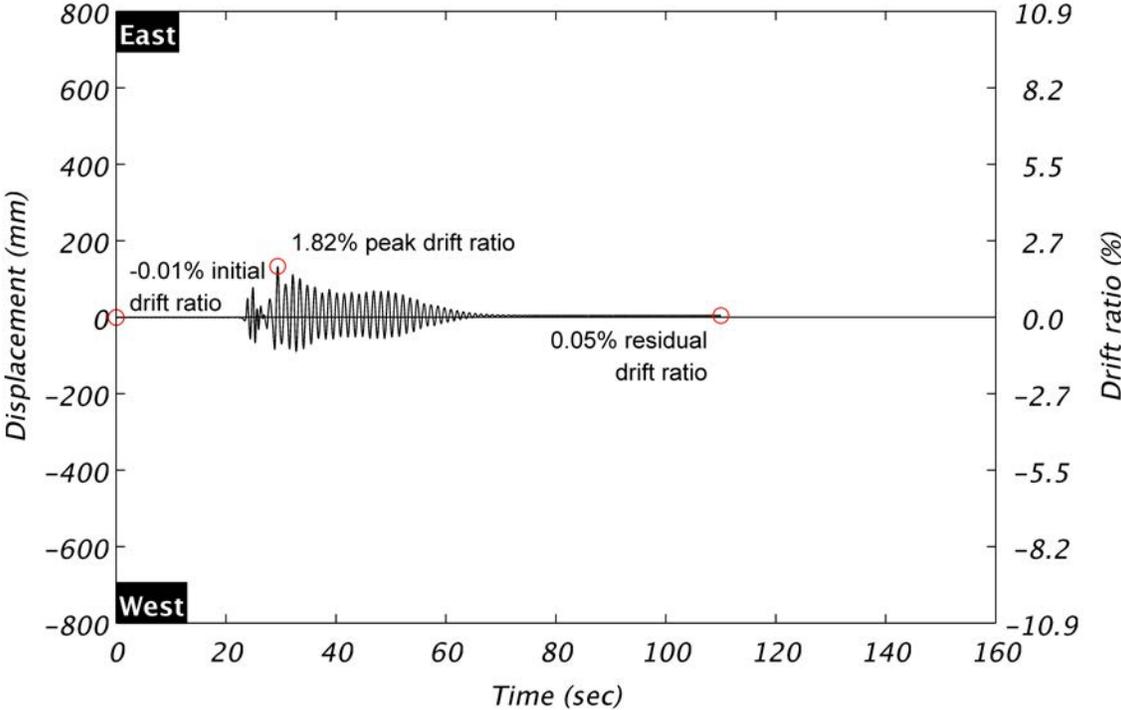
Figure 8.7 Column displacement during EQ2.

A displacement ductility of two was the target ductility for EQ2. The earthquake simulation produced a displacement ductility of 1.48 at the peak displacement of 133 mm (5.23 in.). This corresponds to a drift ratio of 1.82%. The residual displacement was a negligible 4 mm (0.16 in.) or 0.05% residual drift ratio. These values are indicated in the displacement time history of the top of the column in Figure 8.7. Figure 8.8 (a) and (b) show the East face of the column base at peak displacement in the West and East directions, respectively. A tensile crack is visible in Figure 8.8 (a) at approximately 10 in. above the footing. A post-test view of the East face of the column base is shown in Figure 8.8 (c). The video snapshot was taken before crack marking, so cracks are not visible in this figure.

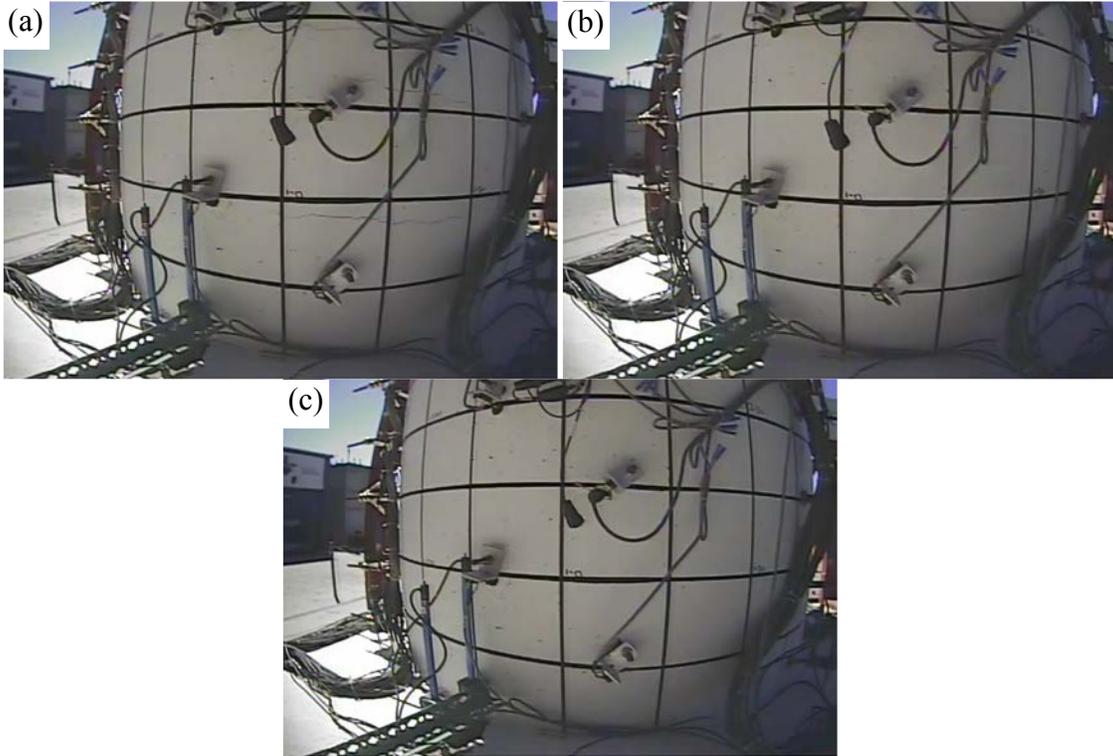
Figure 8.8 Column base East face during EQ2 at (a) peak West displacement, (b) East positive displacement, and (c) post-test.

Residual crack widths remained at hairline width after this test. Crack propagation occurred at the column to footing interface and additional cracks formed. Discontinuous hairline cracks spaced between 152 mm (6 in.) and 305 mm (12 in.) were found in the column from its

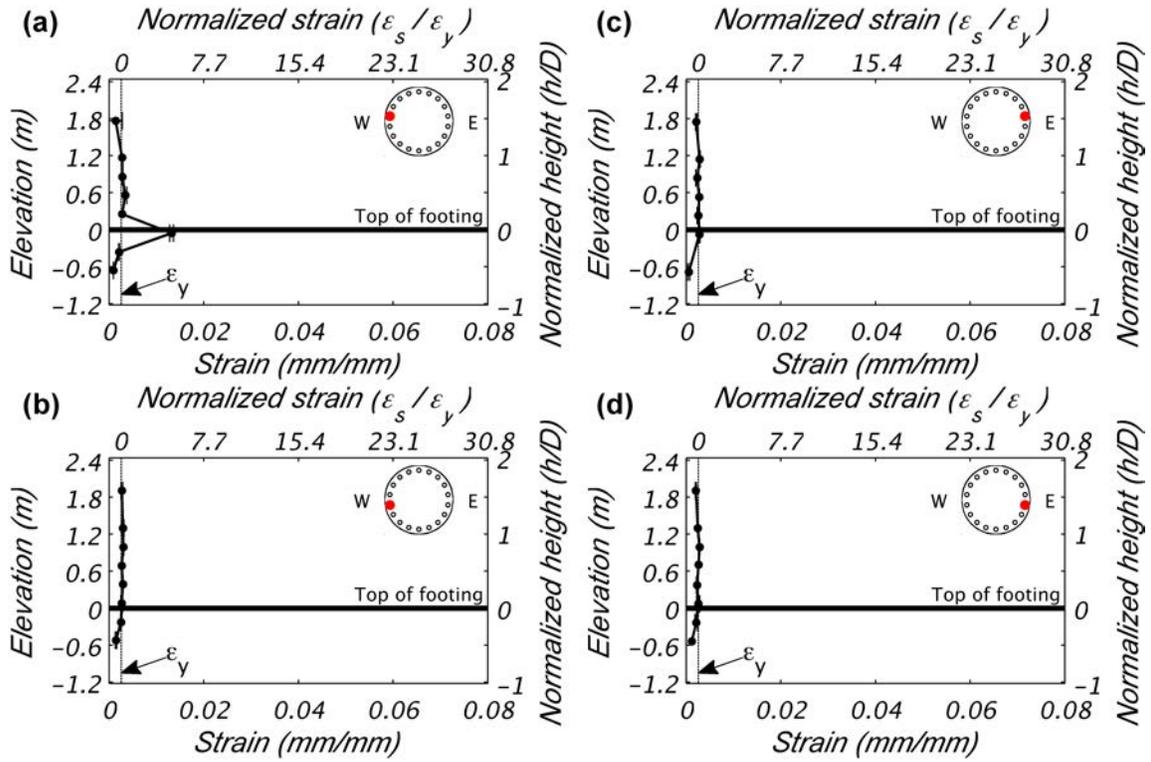
Figure 8.11 Longitudinal reinforcement tensile strain demand during EQ2.

Localized yielding was measured by strain gauges near the column-to-footing interface, see Figure 8.11. Maximum tensile strain was 0.0132 mm/mm or $5.1\varepsilon_y$. All four instrumented bars achieved peak tensile strains on the order of yielding within one column diameter from the top of the footing. Although localized yielding occurred, a plastic hinge did not form. Transverse hoops strains also exceeded their yield strain at elevations between 0.25 and 0.5 times the column diameter on the West face, see Figure 8.12. Strains demands on the opposite face were minor.

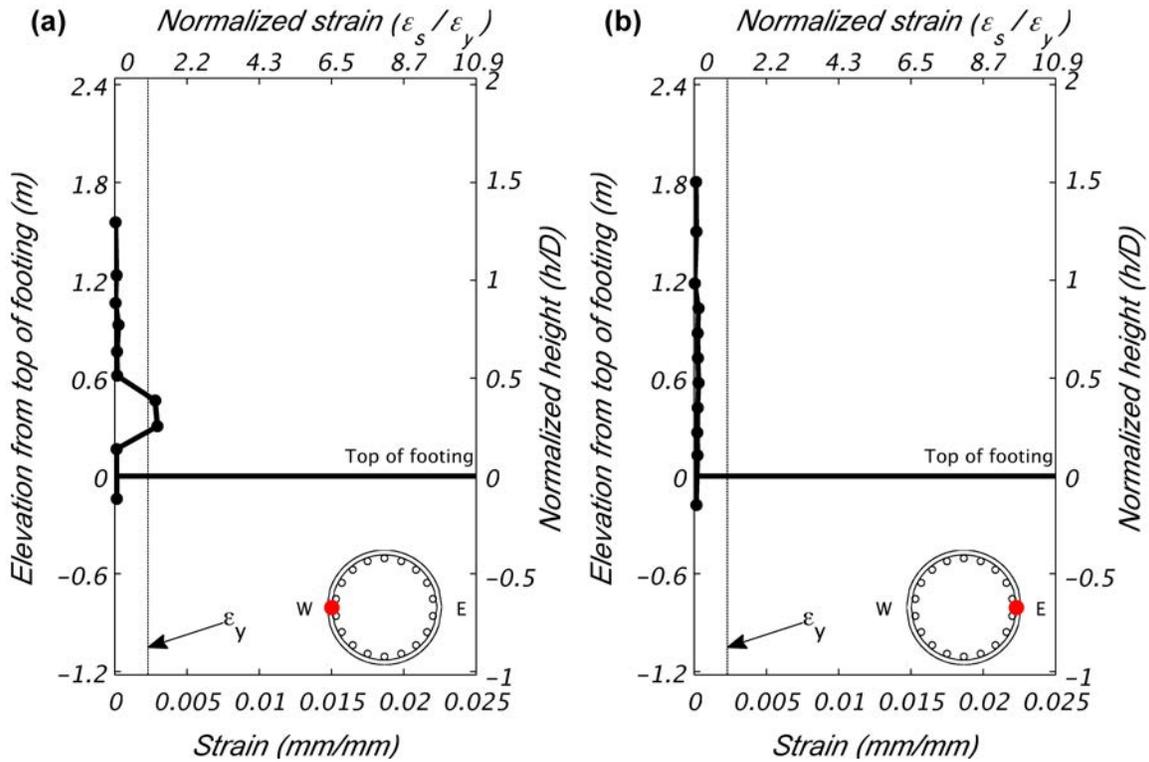
Figure 8.12 Transverse hoop reinforcement tensile strain demand during EQ2.

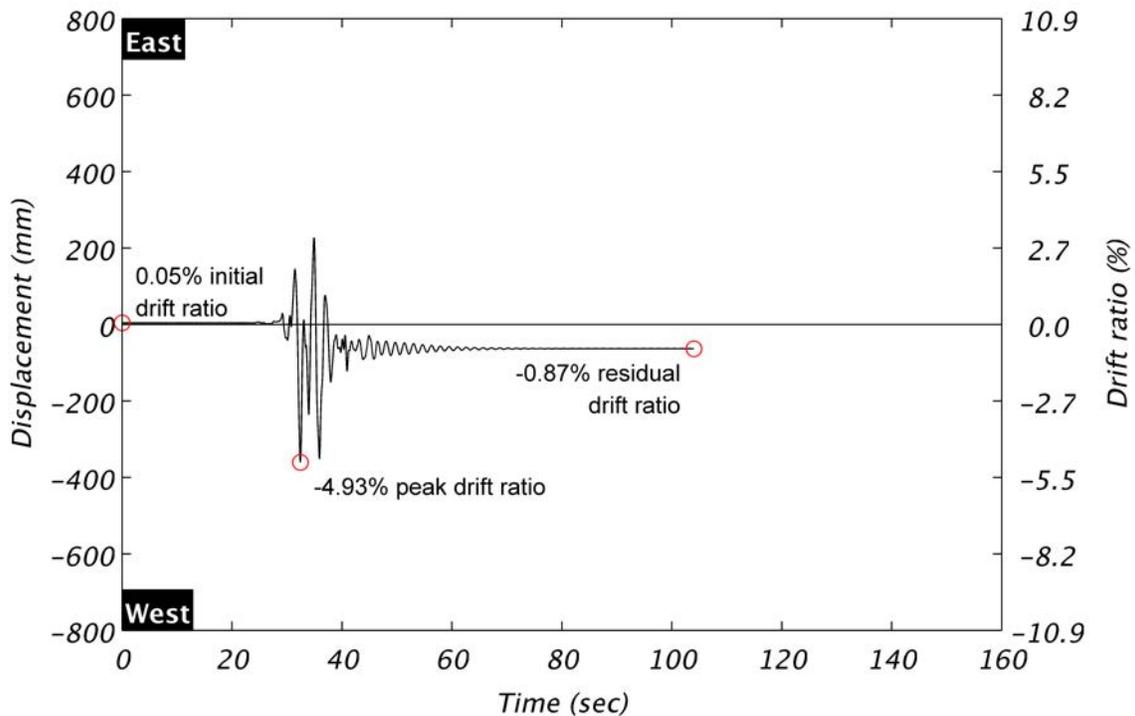
Figure 8.13 Column displacement during EQ3.

Test EQ3 represents a simulation of a design level earthquake. The target displacement ductility of four was achieved with only cosmetic damage. A peak displacement of 361 mm (14.20 in.) was measured at the top of the column. This corresponds to a displacement ductility of 4.01 or a drift ratio of 4.93%. A residual drift ratio of -0.87% or -63mm (-2.49 in.) resulted from the nonlinear response. These values are indicated in the displacement time history of Figure 8.13. This was the first instance of a residual drift. Figure 8.14 (a) and (b) show the East face of the column base at peak displacement in the West and East directions, respectively.

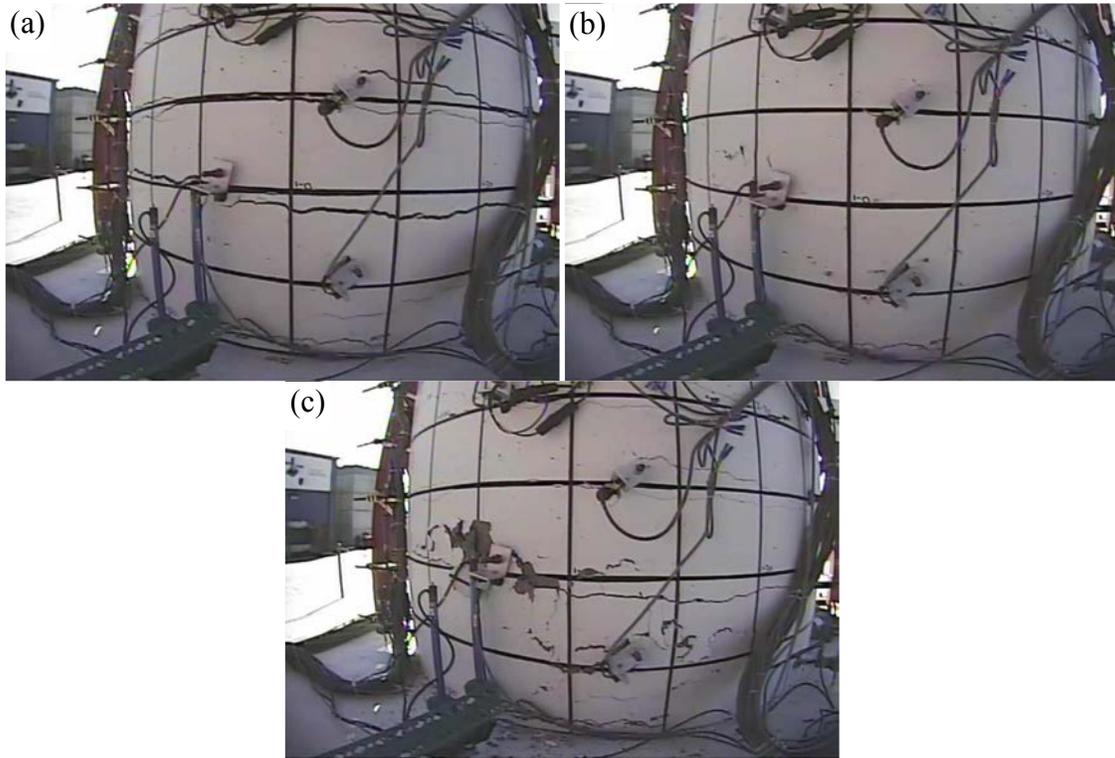
Figure 8.14 Column base East face during EQ3 at (a) peak West displacement, (b) peak East displacement, and (c) post-test.

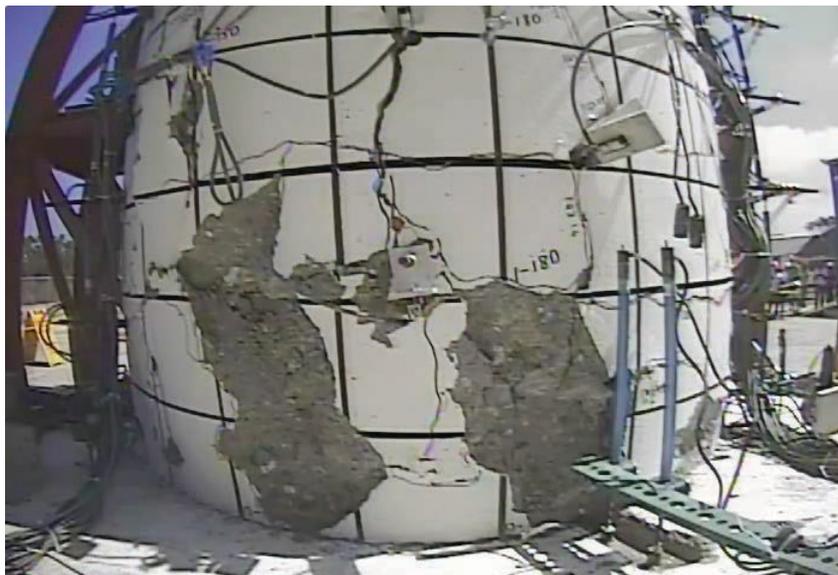
Figure 8.15 Column base West face after test EQ3.

Spalling of the concrete cover was initiated at this level of testing. Spalling occurred on the West face of the column, shown in Figure 8.15. The maximum residual crack width near the base of the column was 1.4 mm (0.055 in.). Significant cracking developed at the base of the column; see the post-test views of the East and West column faces in Figure 8.14(c) and Figure 8.15, respectively. The snapshot in this figure was taken before cracks had been marked, but the crack pattern and concrete flaking are visible.

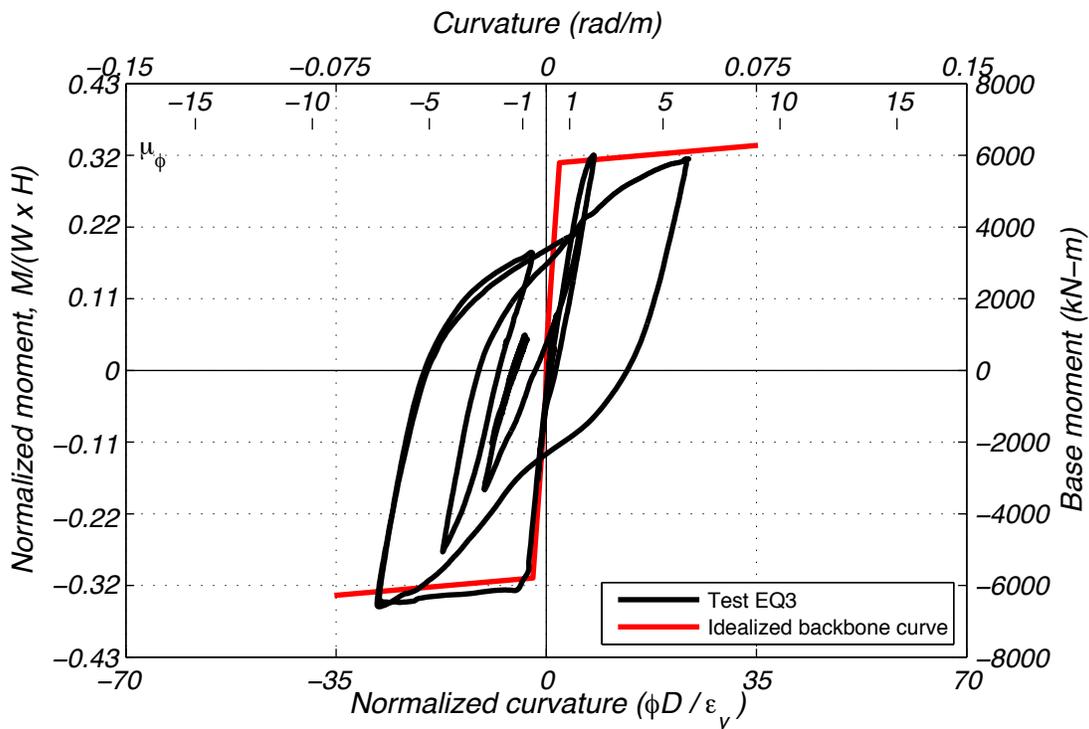
Figure 8.16 Column response during EQ3 in terms of base moment and curvature.
