A Full-Scale, Single-Column Bridge Bent Tested by Shake-Table Excitation

Matthew J. Schoettler
José I. Restrepo
Gabriele Guerrini
David E. Duck
Francesco Carrea

Center for Civil Engineering Earthquake Research
Department of Civil Engineering/258
University of Nevada
Reno, NV 89557

August 2012

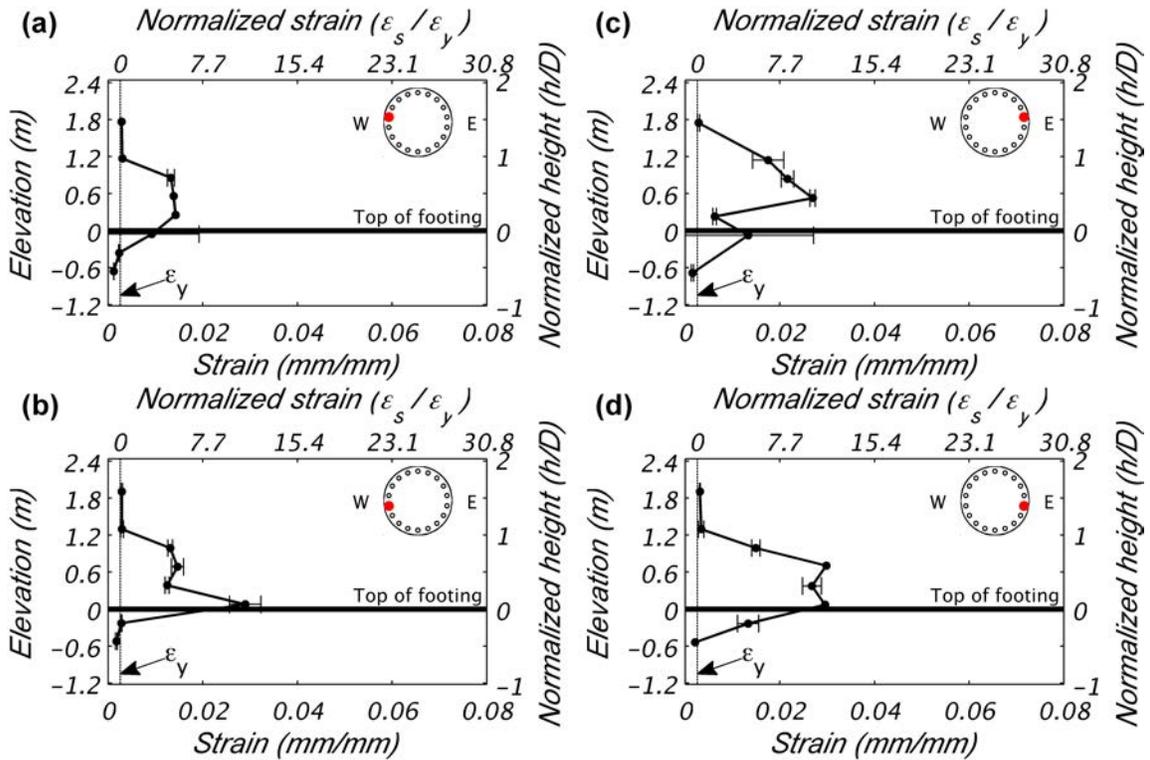
Figure 8.18 Longitudinal reinforcement tensile strain demand during EQ3.

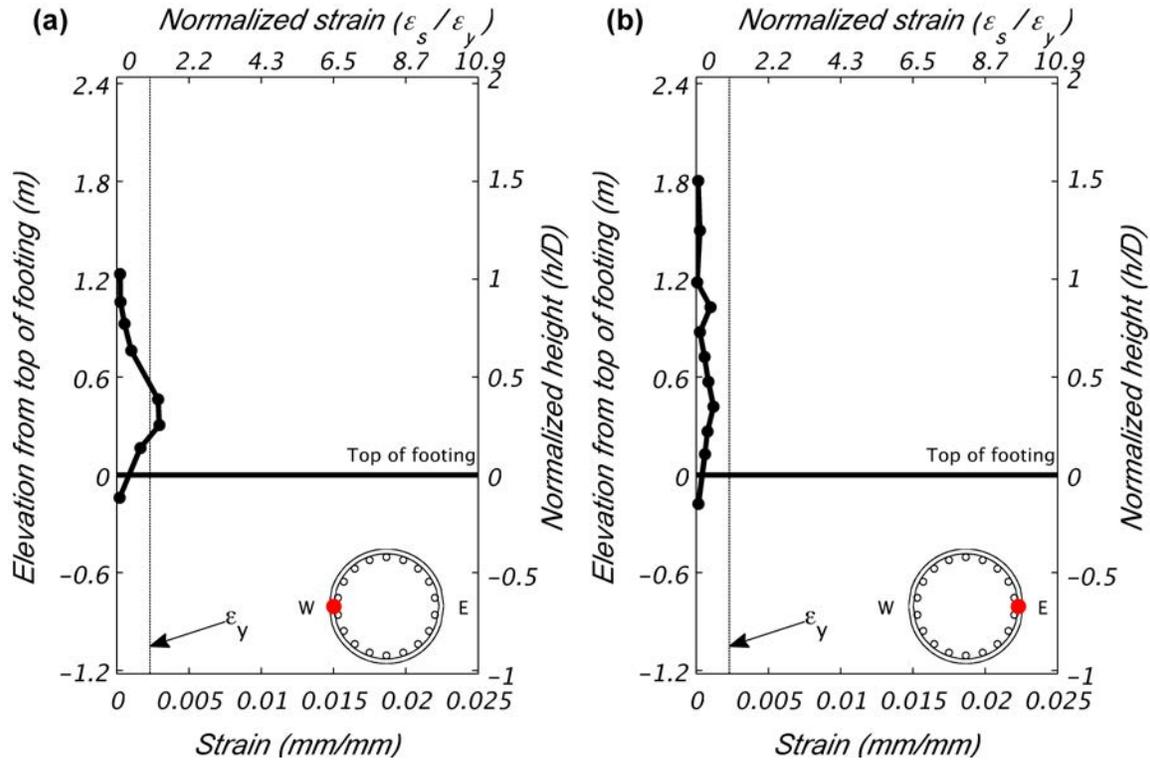
Figure 8.19 Transverse hoop reinforcement tensile strain demand during EQ3.

Peak transverse strain demands on the West face were consistent with demands from the prior test. Only two hoops on the West face of the column exceeded yield, see Figure 8.19. Hoop demands elsewhere increased, but were below yield. Despite modest transverse strain demand increases, the plastic hinge was fully formed as evident in the nonlinear moment and shear responses, longitudinal strain demands, and observed damage.

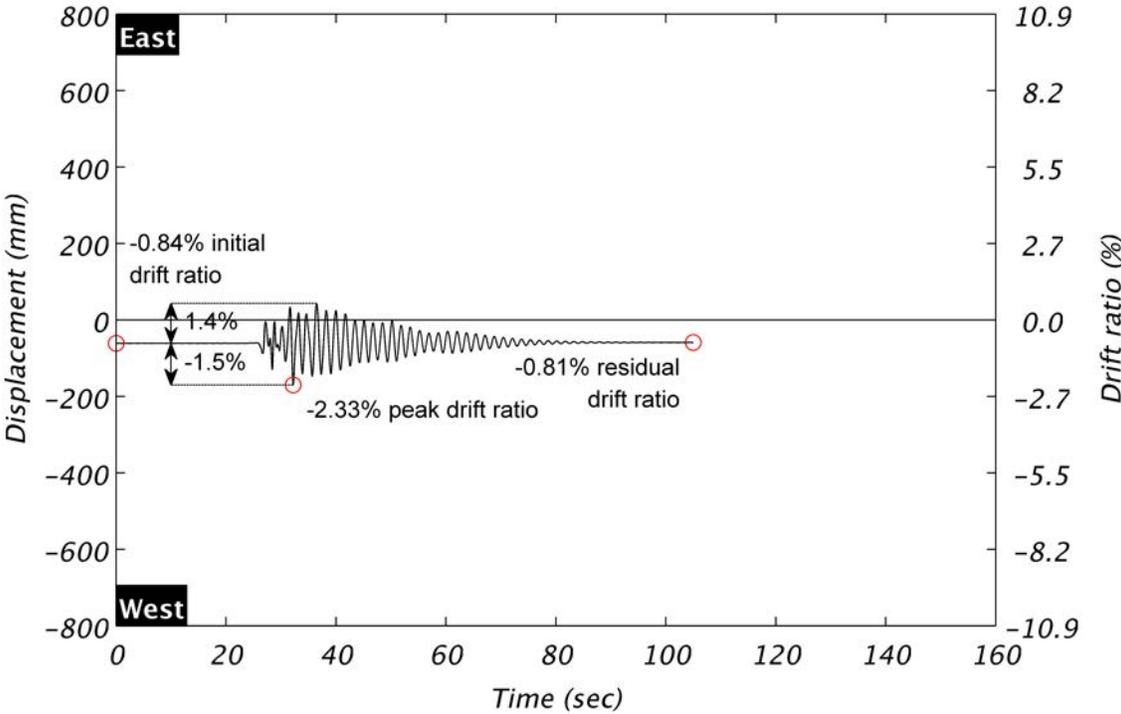
Figure 8.20 Column displacement during EQ4.

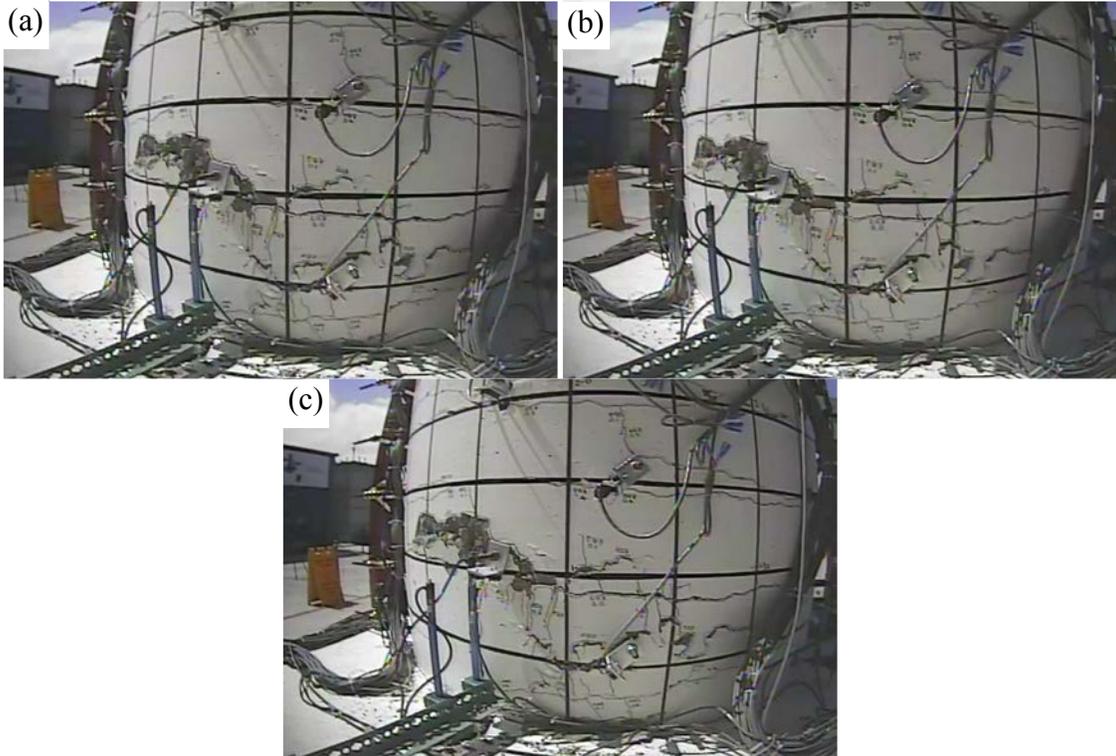
Figure 8.21 Column base East face during EQ4 at (a) peak West displacement, (b) peak East displacement, and (c) post-test.

Figure 8.21 (a) and (b) show the East face of the column base at peak displacement in the West and East directions, respectively. Residual cracks were not marked post-test due to testing time constraints. Regions with spalling caused by test EQ3 enlarged, but damage was less significant than that induced by EQ3. A post-test view of the East face of the column base is shown in Figure 8.21 (c).

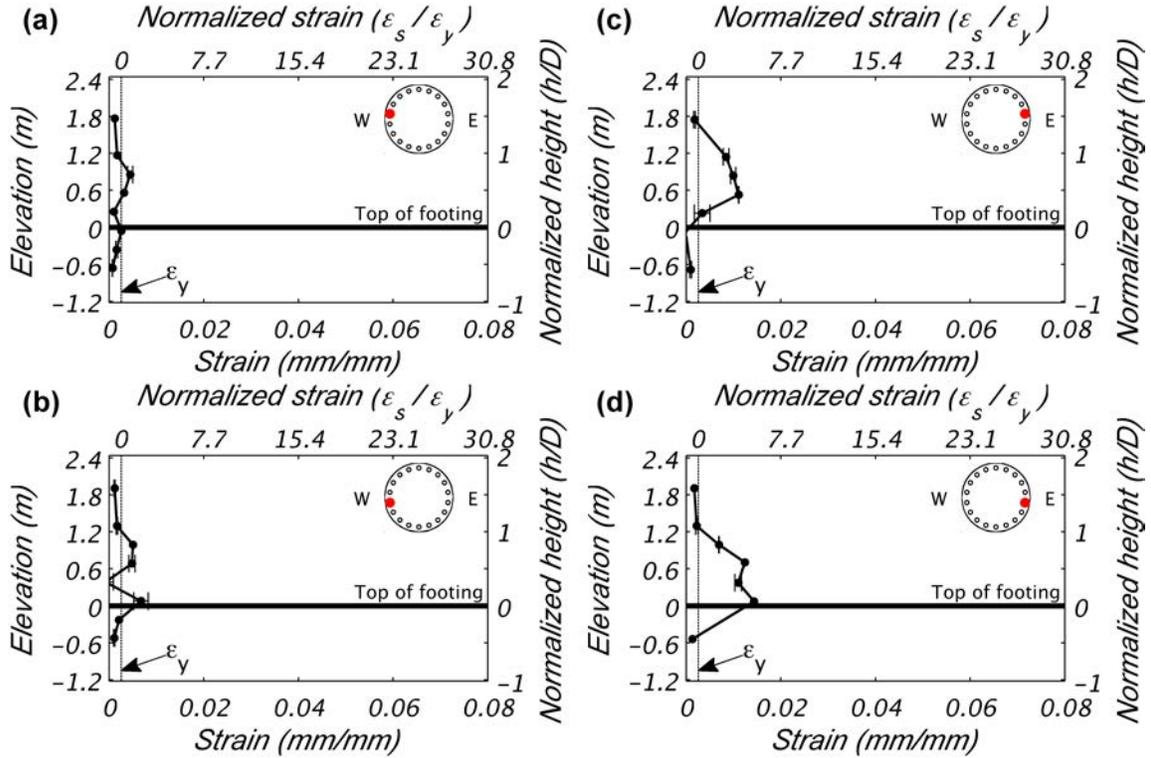
Figure 8.24 Longitudinal reinforcement tensile strain demand during EQ4.

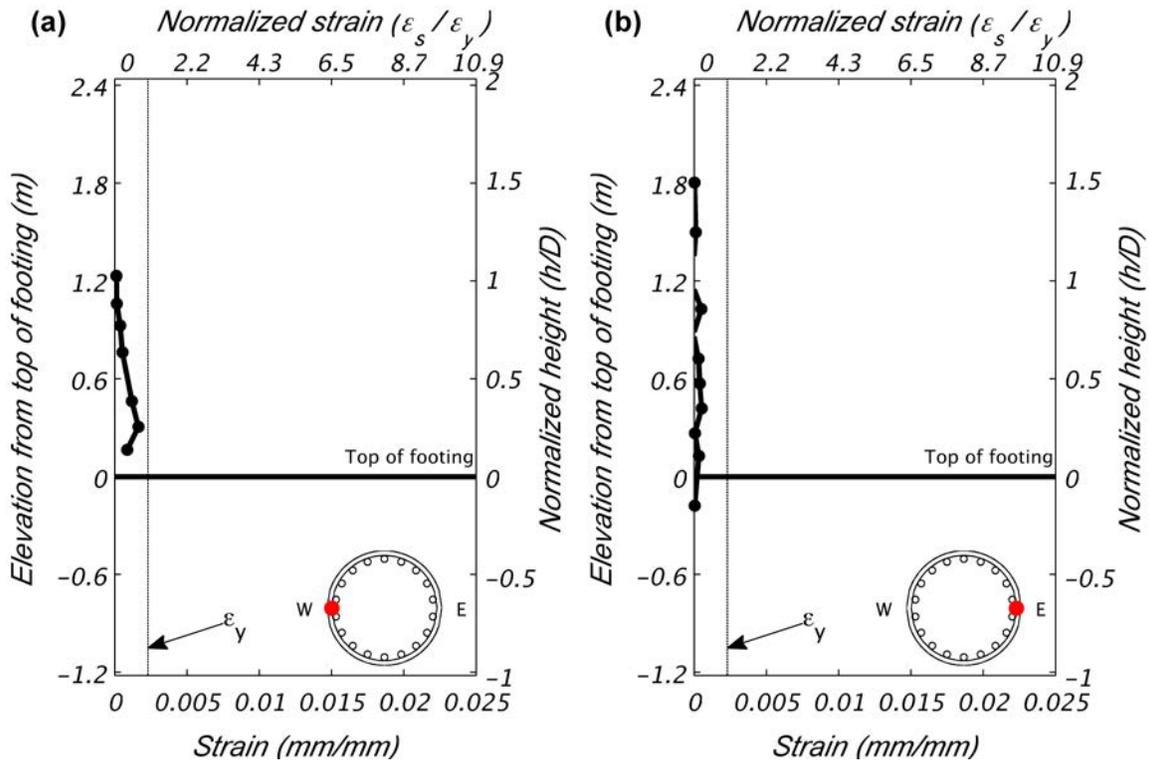
Figure 8.25 Transverse hoop reinforcement tensile strain demand during EQ4.

residual. Figure 8.25 shows transverse strain demands were below yield with larger demands on the West face where spalling initiated in the prior test.

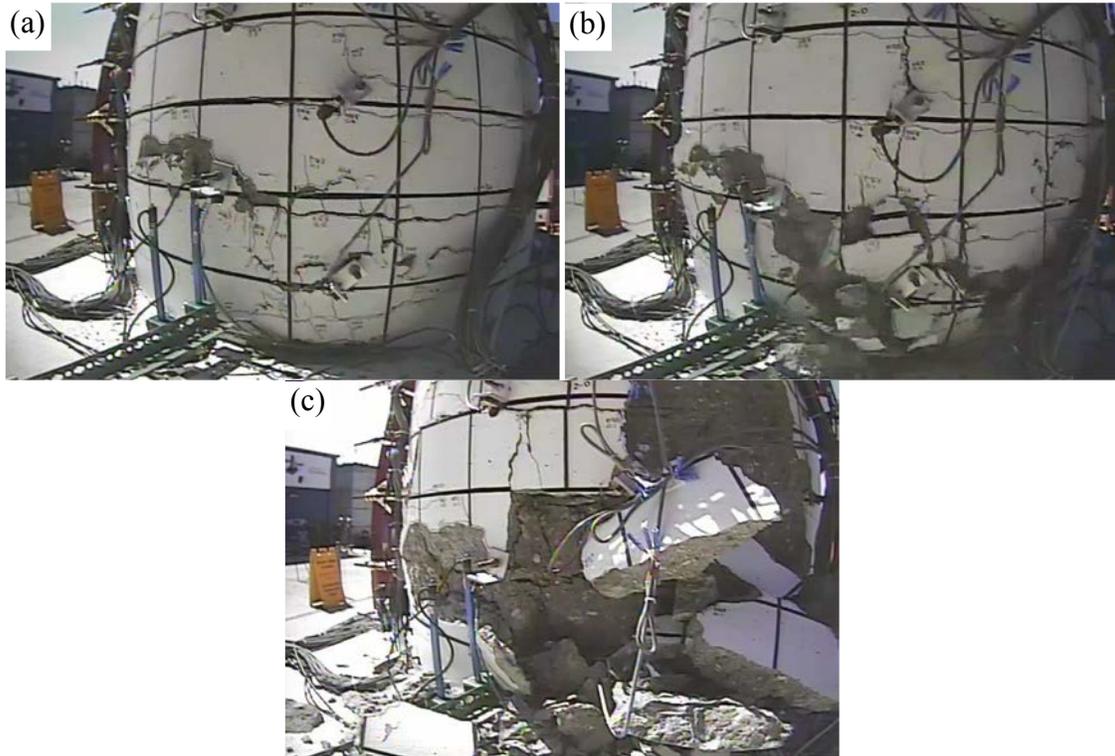
Figure 8.27 Column base East face during EQ5 at (a) peak West displacement, (b) peak East displacement, and (c) post-test.

Continued concrete spalling occurred and extended to 1.07 m (3.5 ft) above the column base. A post-test view of the East face of the column base is shown in Figure 8.27 (c). Concrete spalling is evident in this figure to a height of 0.76 m (2.5 ft), or 0.625 column diameters.

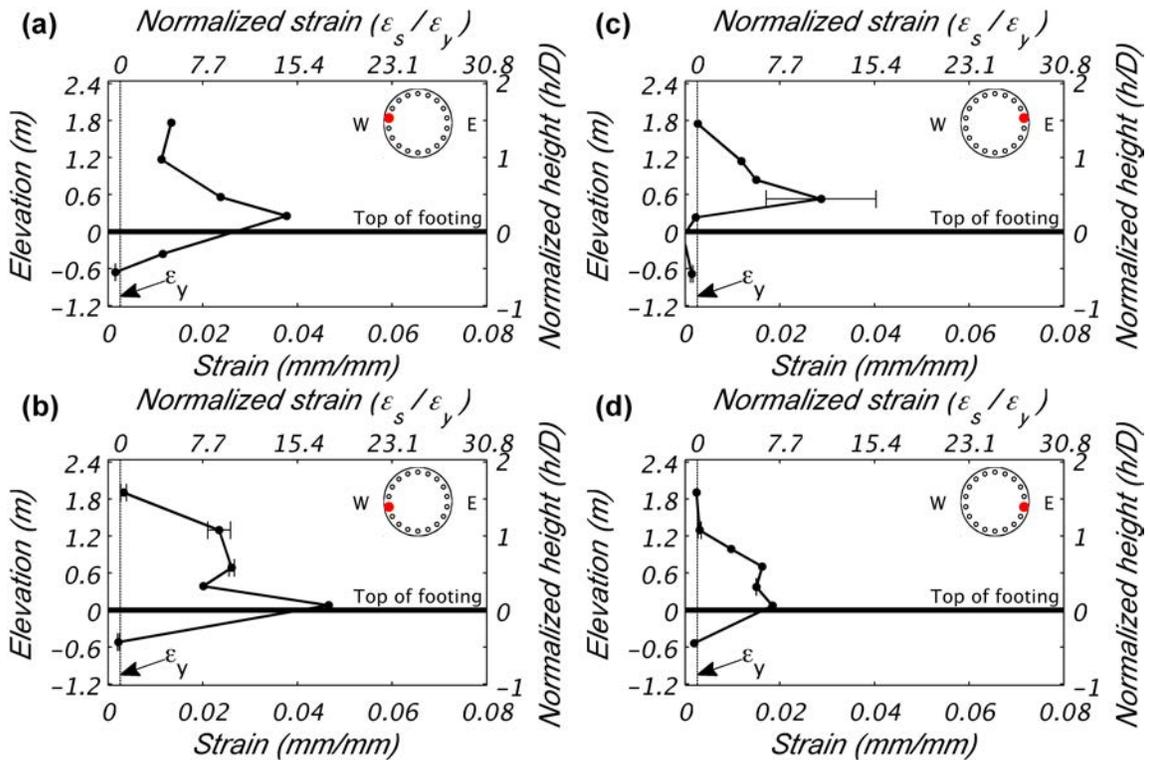
Figure 8.30 Longitudinal reinforcement tensile strain demand during EQ5.

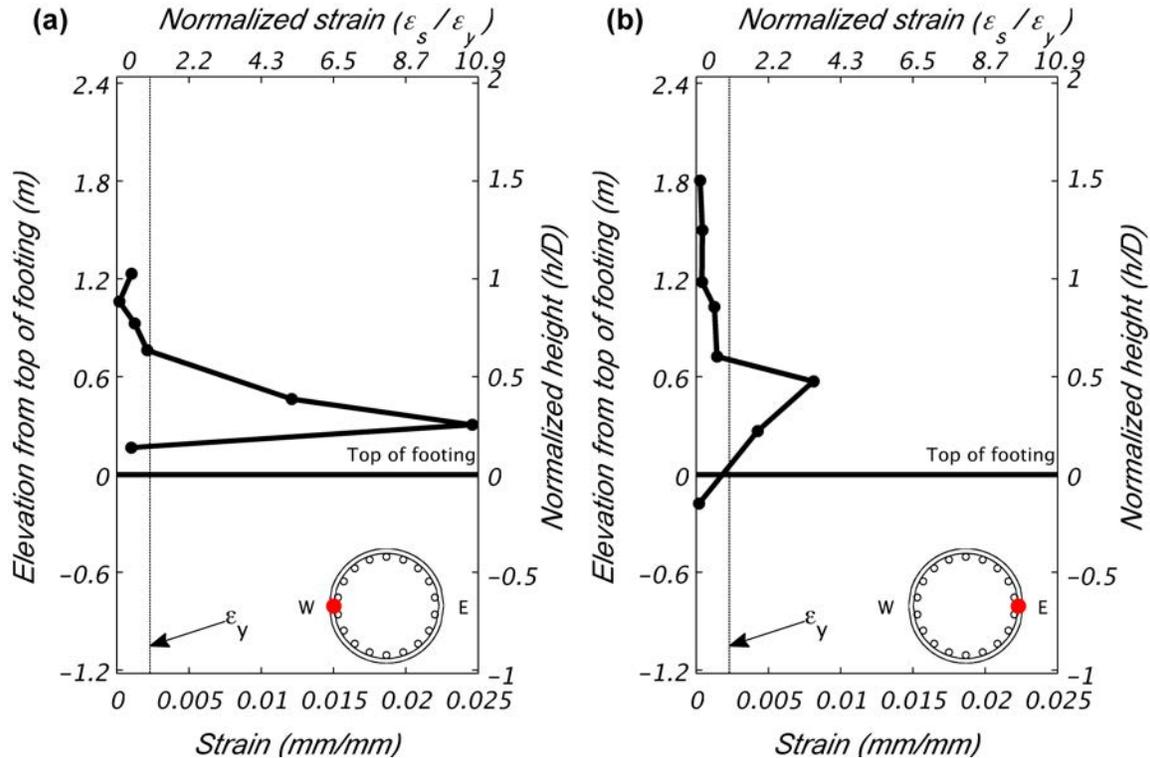
Figure 8.31 Transverse hoop reinforcement tensile strain demand during EQ5.

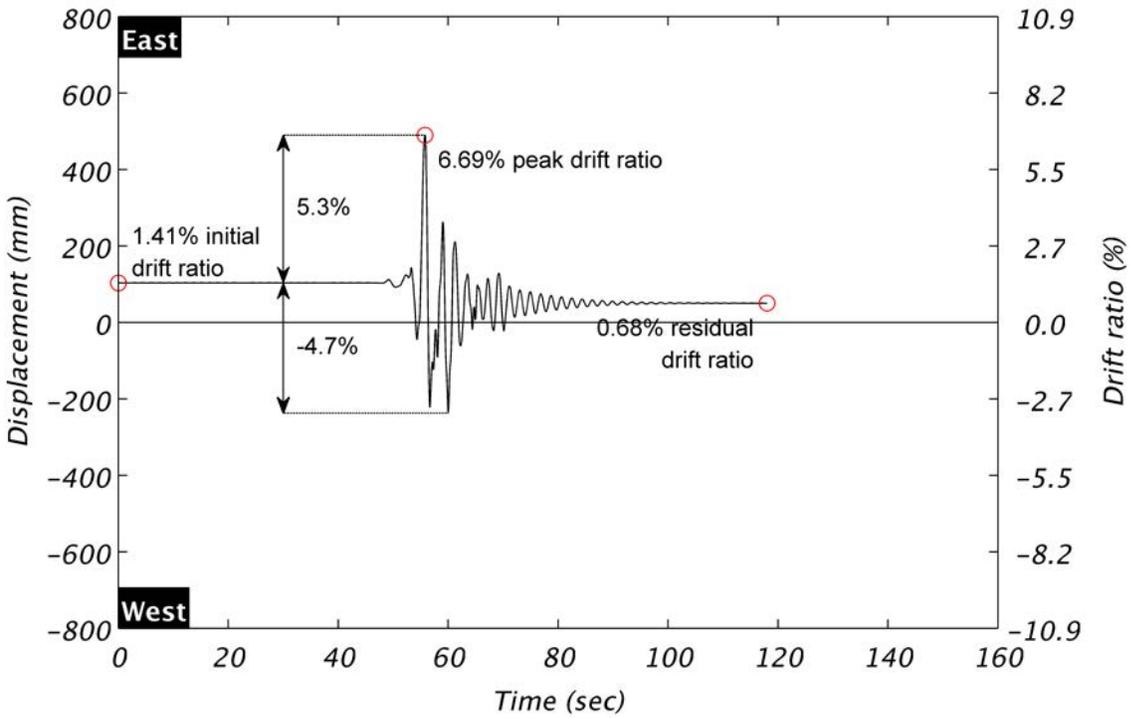
Figure 8.32 Column displacement during EQ6.

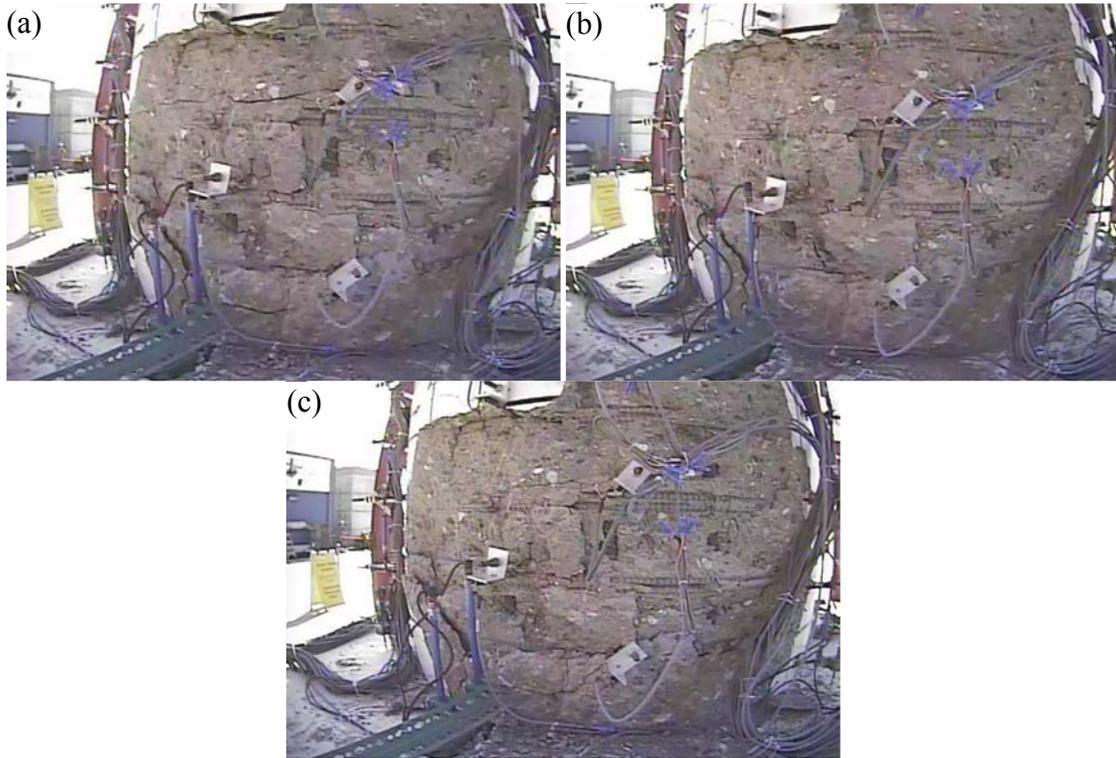
Figure 8.33 Column base East face during EQ6 at (a) peak West displacement, (b) peak East displacement, and (c) post-test.

A post-test view of the East face of the column base is shown in Figure 8.33 (c). Concrete spalling and longitudinal reinforcement are visible, but spalling did not extend beyond the damage caused by test EQ5. The primary difference between Figure 8.33 (c) and Figure 8.27 (c) is the removal of spalled and loose concrete before test EQ6. The concrete core remained intact.

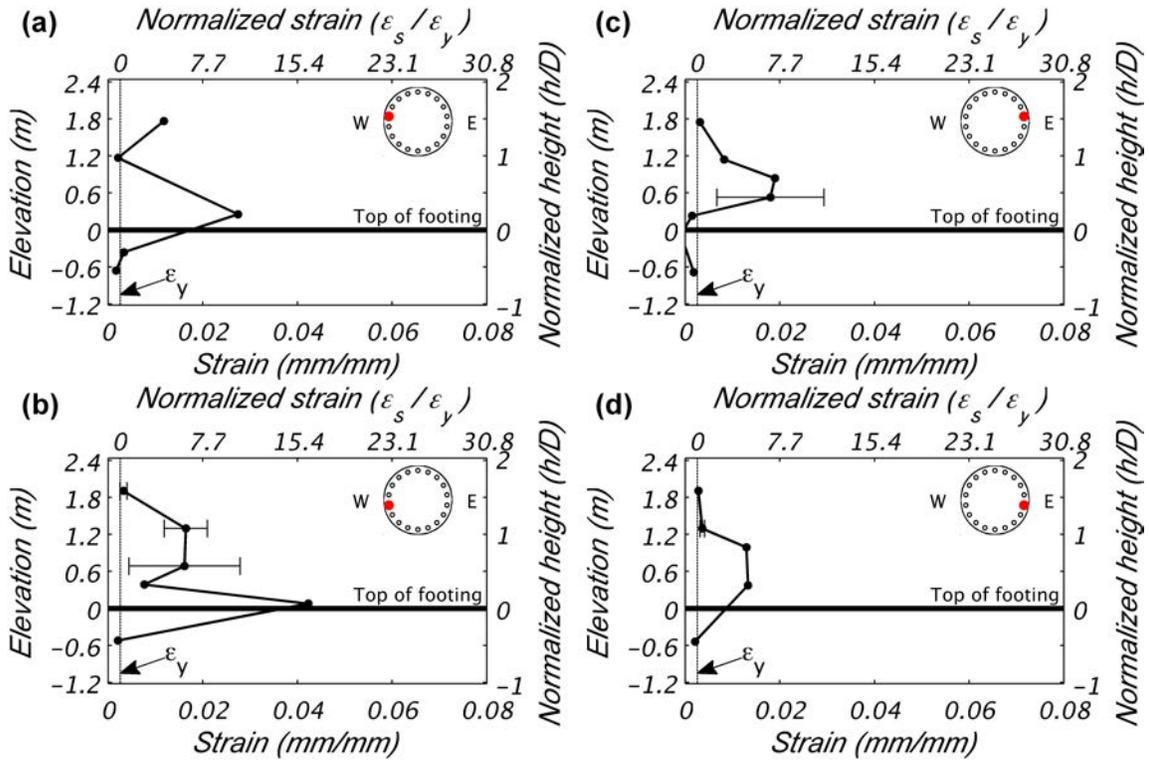
Figure 8.36 Longitudinal reinforcement tensile strain demand during EQ6.

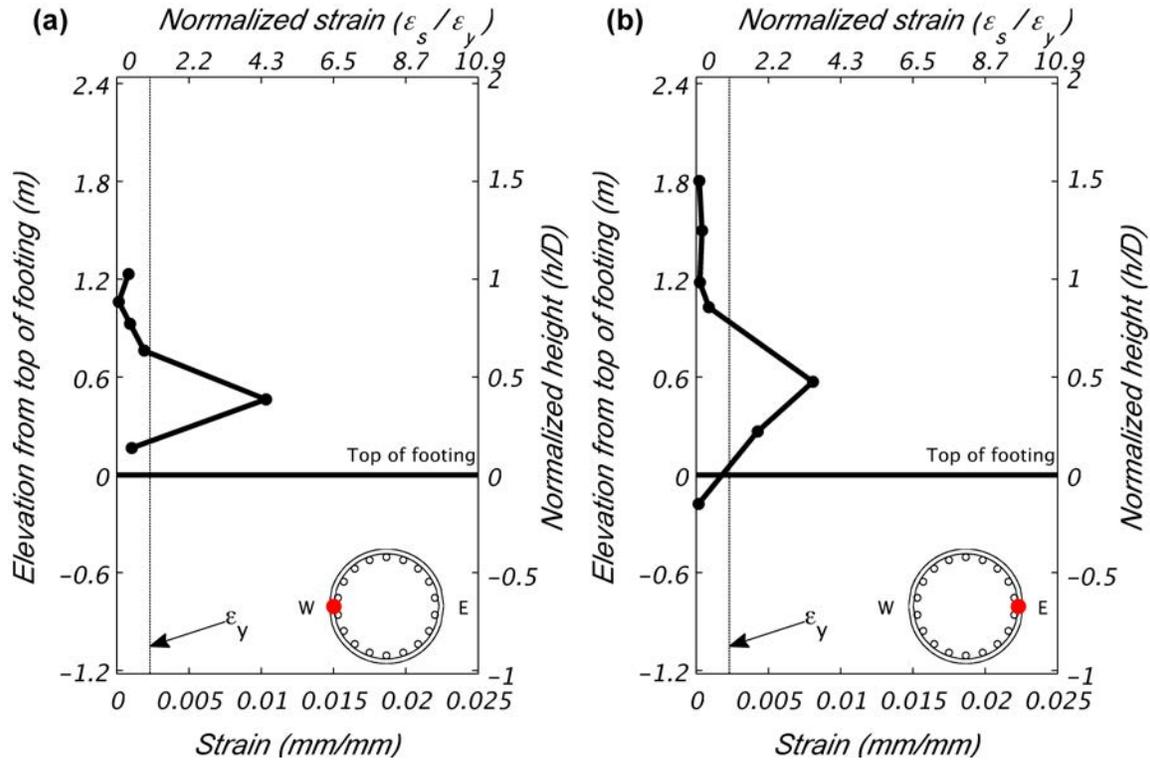
Figure 8.37 Transverse hoop reinforcement tensile strain demand during EQ6.

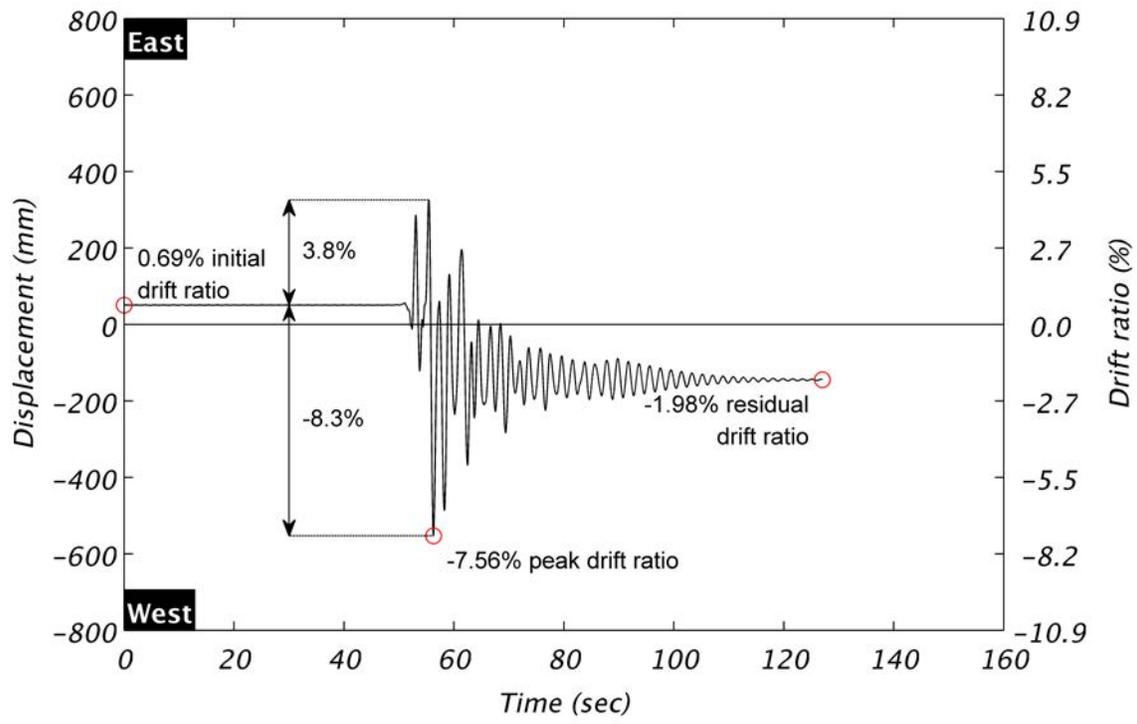
Figure 8.38 Column displacement during EQ7.

For extended testing, the Takatori record from the Kobe earthquake was utilized at different amplitudes to bring the column to a near collapse condition. In test EQ7, the Takatori motion was utilized at 100% of the original record. It resulted in a peak displacement of 553 mm (21.78 in.) or a 7.56% drift ratio. This corresponds to a displacement ductility of 6.15. A residual drift ratio of -1.98%, or -145 mm (-5.70 in.) column displacement, remained post-test, see Figure 8.38. Figure 8.39 (a) and (b) show the East face of the column base at peak displacement in the West and East directions, respectively.

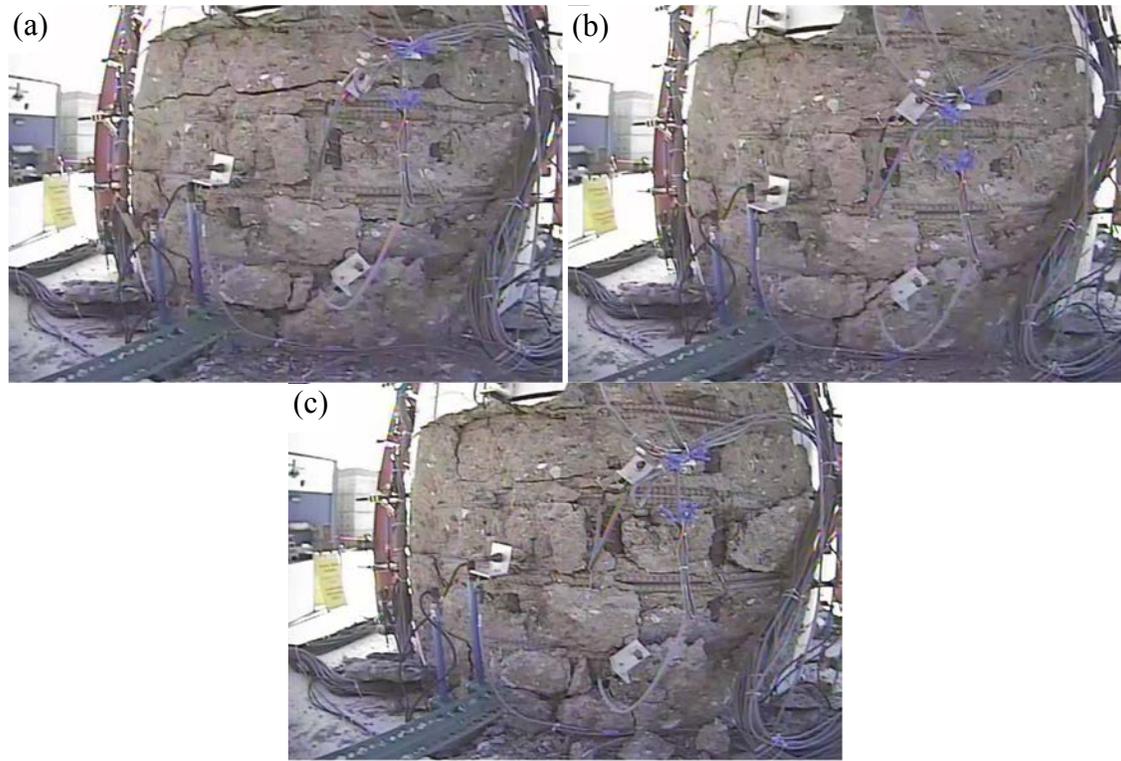
Figure 8.39 Column base East face during EQ7 at (a) peak West displacement, (b) peak East displacement, and (c) post-test.

A post-test view of the East face of the column base is shown in Figure 8.39 (c). Further spalling was induced and more of the longitudinal bars were exposed as the spalling penetrated deeper into the face of the column. The loss of bond with the longitudinal bars in this figure and video footage indicate the onset of bar buckling.

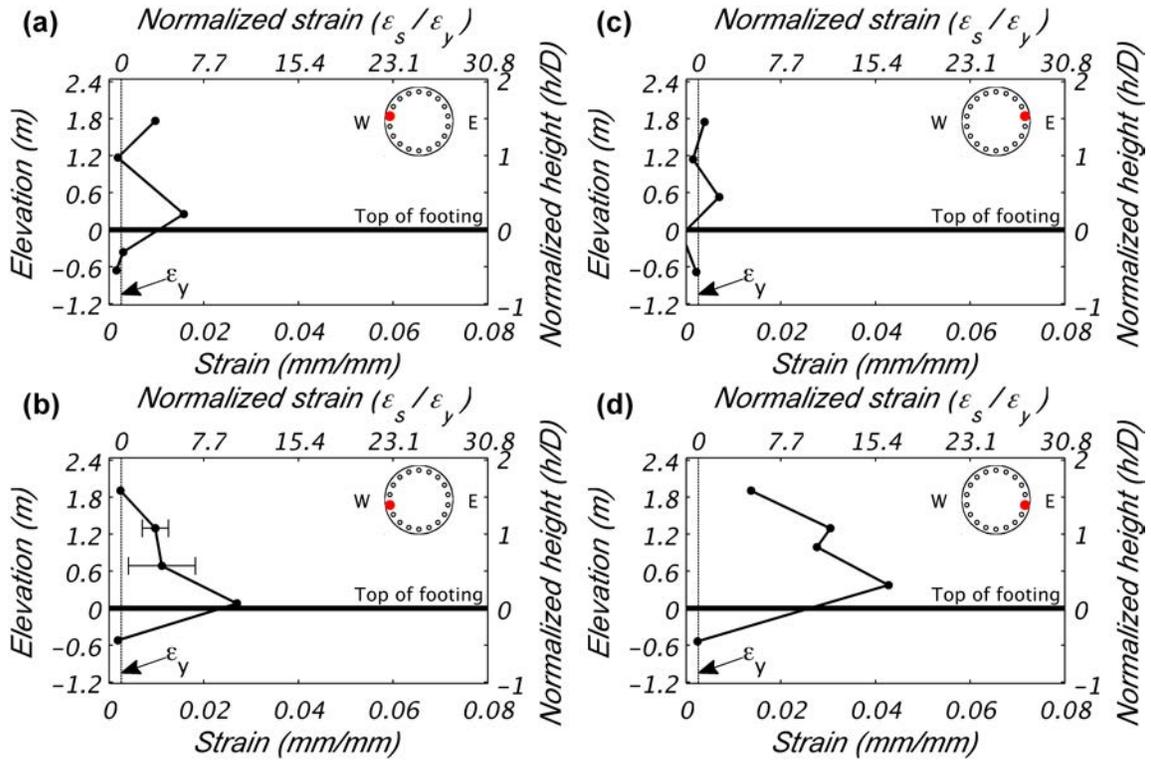
Figure 8.42 Longitudinal reinforcement tensile strain demand during EQ7.

Longitudinal strains, in terms of peak tensile demand, are shown in Figure 8.42. Unfortunately, only one gauge was reliable at each location in Figure 8.42(c), so buckling onset cannot be confirmed in this bar with these sensors. Transverse strain demands were similar to the prior test with the largest demands occurring at 0.6 m (24 in.); see Figure 8.43

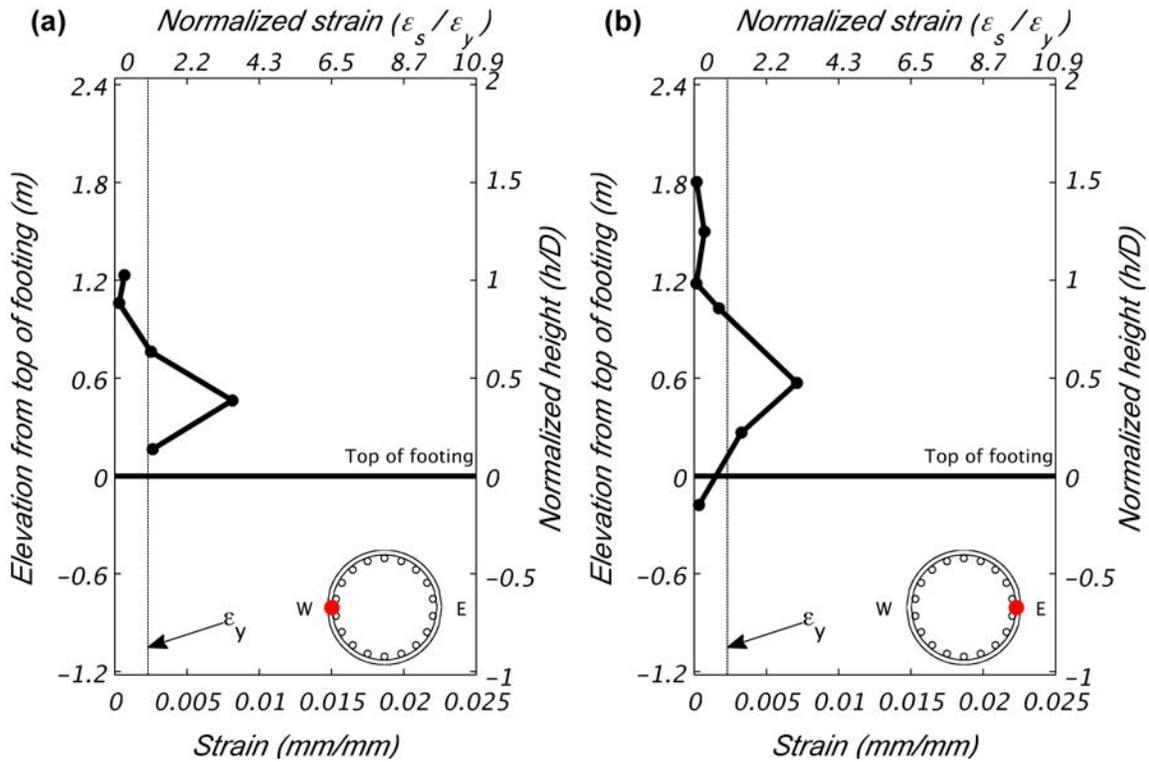
Figure 8.43 Transverse hoop reinforcement tensile strain demand during EQ7.

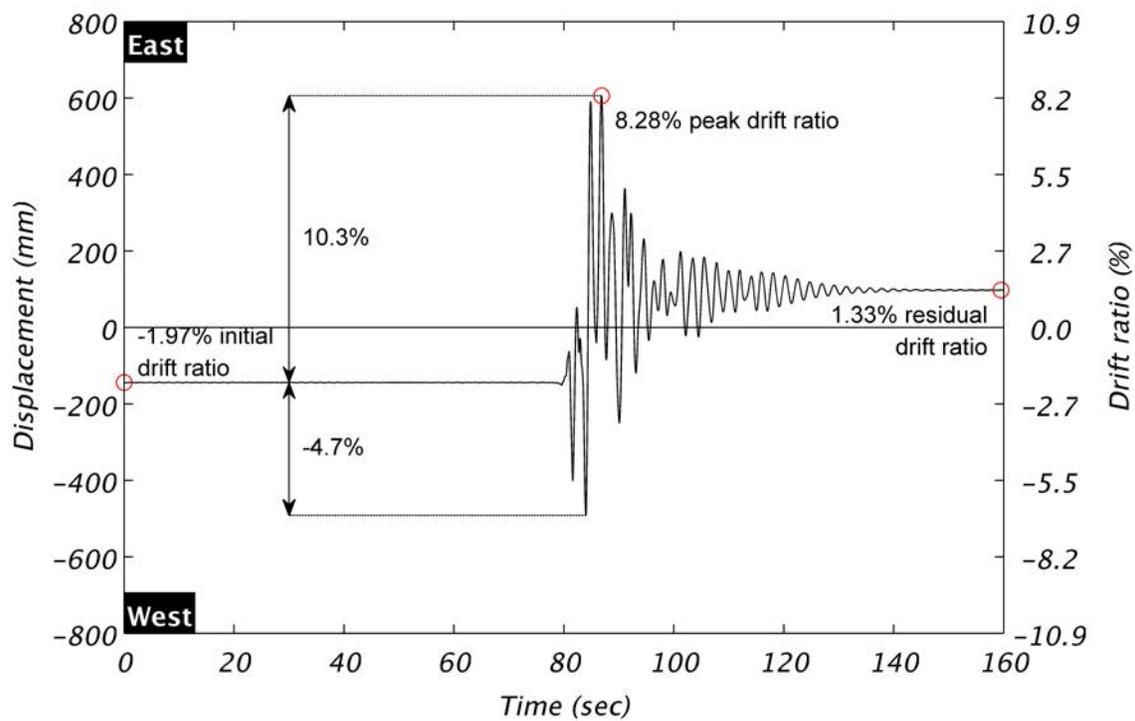
Figure 8.44 Column displacement during EQ8.

With the robustness observed in the prior test and drift demands still shy of the 10% limit, the prior signal was repeated and amplified. A scale factor of -1.2 was used with the original Takatori record. This imposed a displacement ductility of 6.73 at 606 mm (23.85 in.) of column displacement. The corresponding drift ratio was 8.28%. The residual displacement was 97 mm (3.83 in.) at the top of the column. This normalizes to 1.33% residual drift ratio and was slightly lower than the prior residual drift ratio of 1.98%. The displacement time history is shown in Figure 8.44. Figure 8.45 (a) and (b) show the East face of the column base at peak displacement in the West and East directions, respectively.

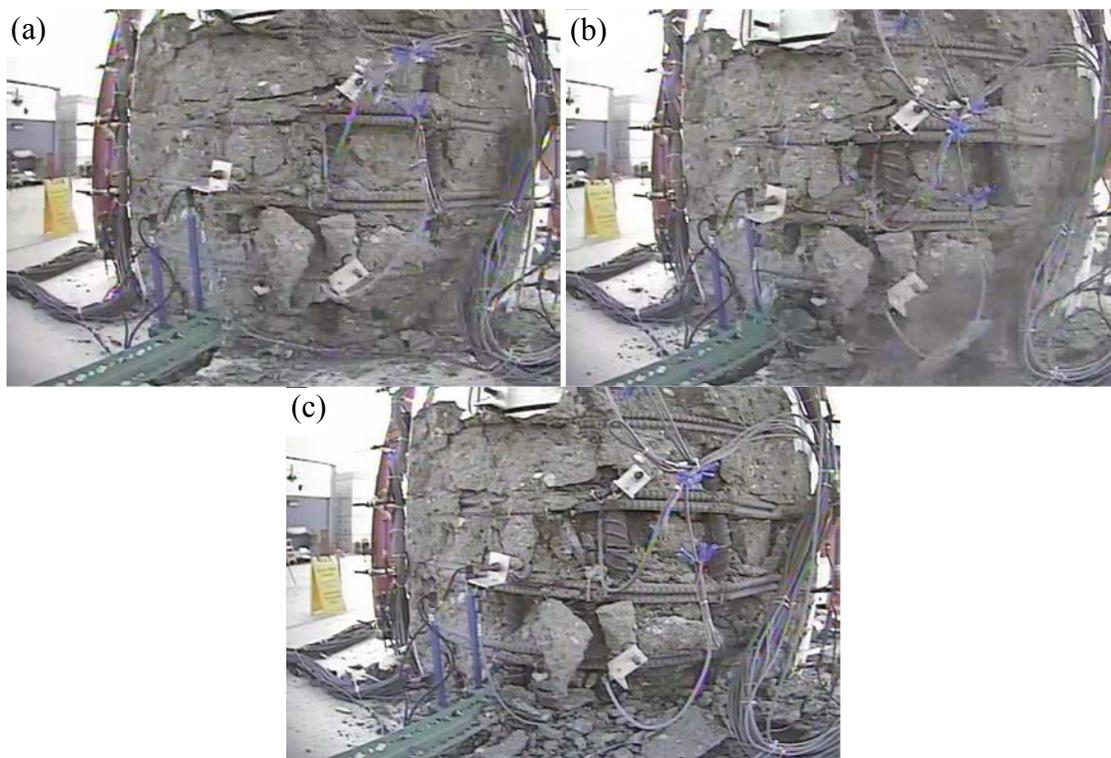
Figure 8.45 Column base East face during EQ8 at (a) peak West displacement, (b) peak East displacement, and (c) post-test.

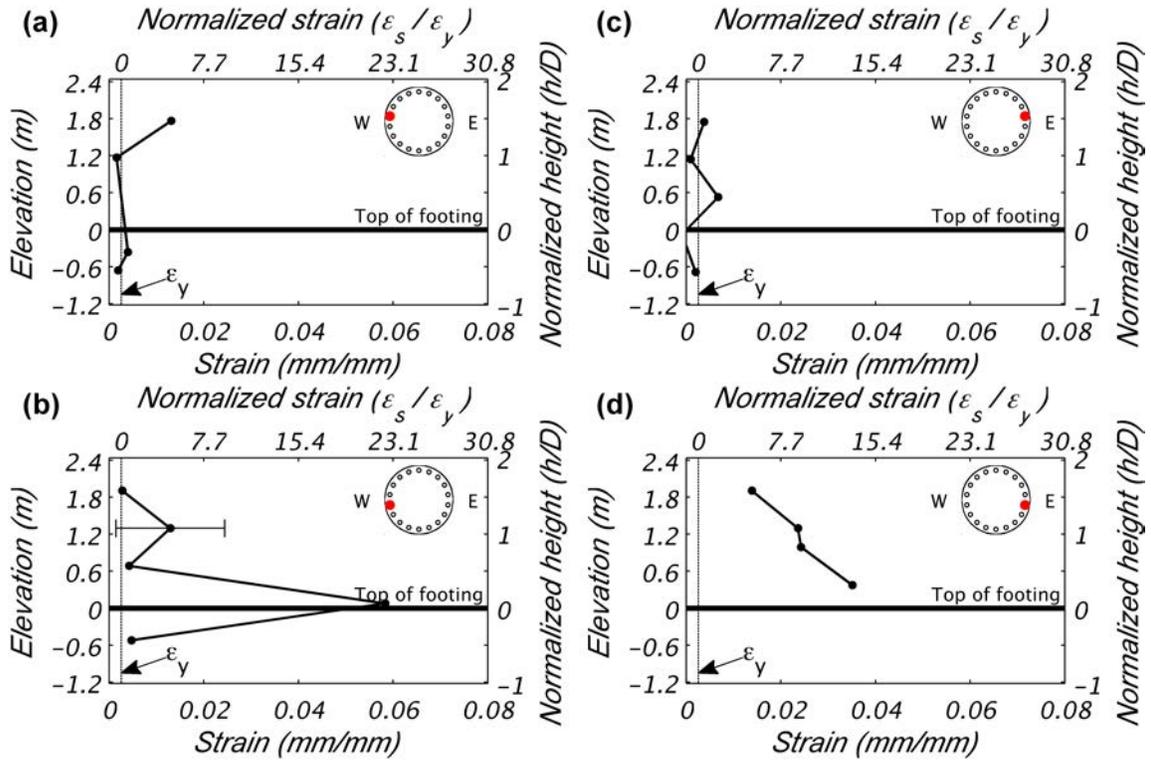
Figure 8.48 Longitudinal reinforcement tensile strain demand during EQ8.

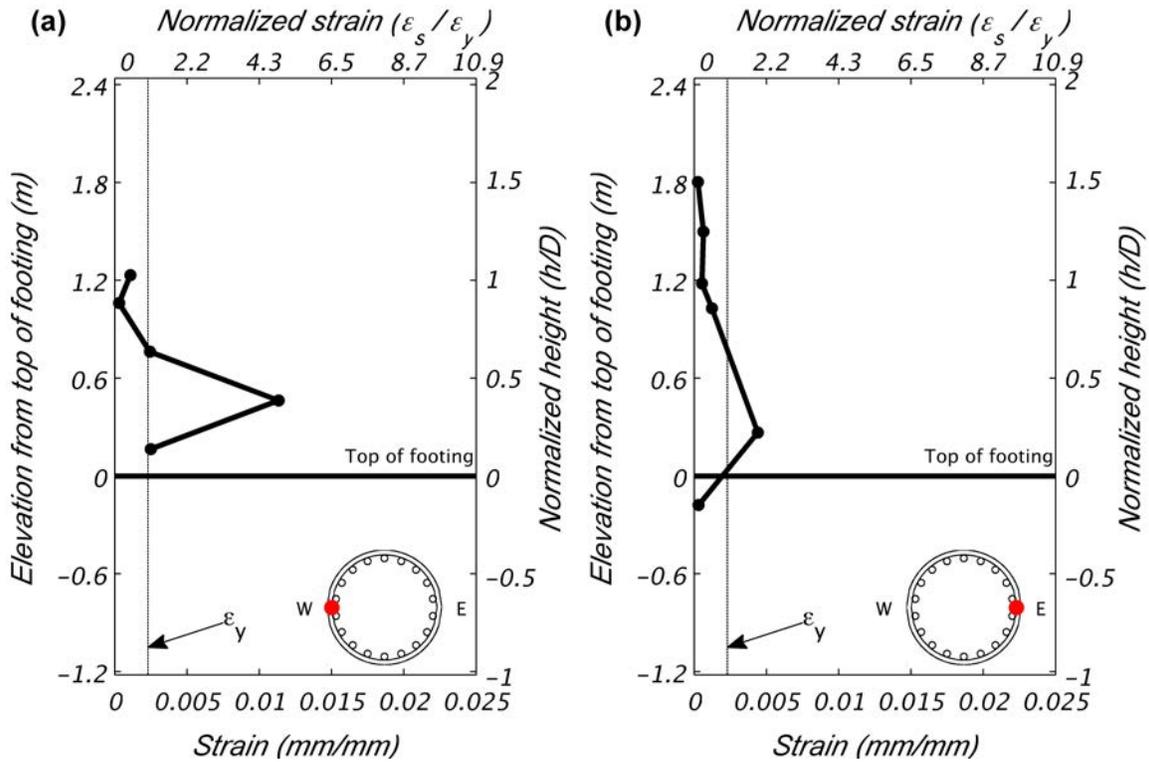
Figure 8.49 Transverse hoop reinforcement tensile strain demand during EQ8.

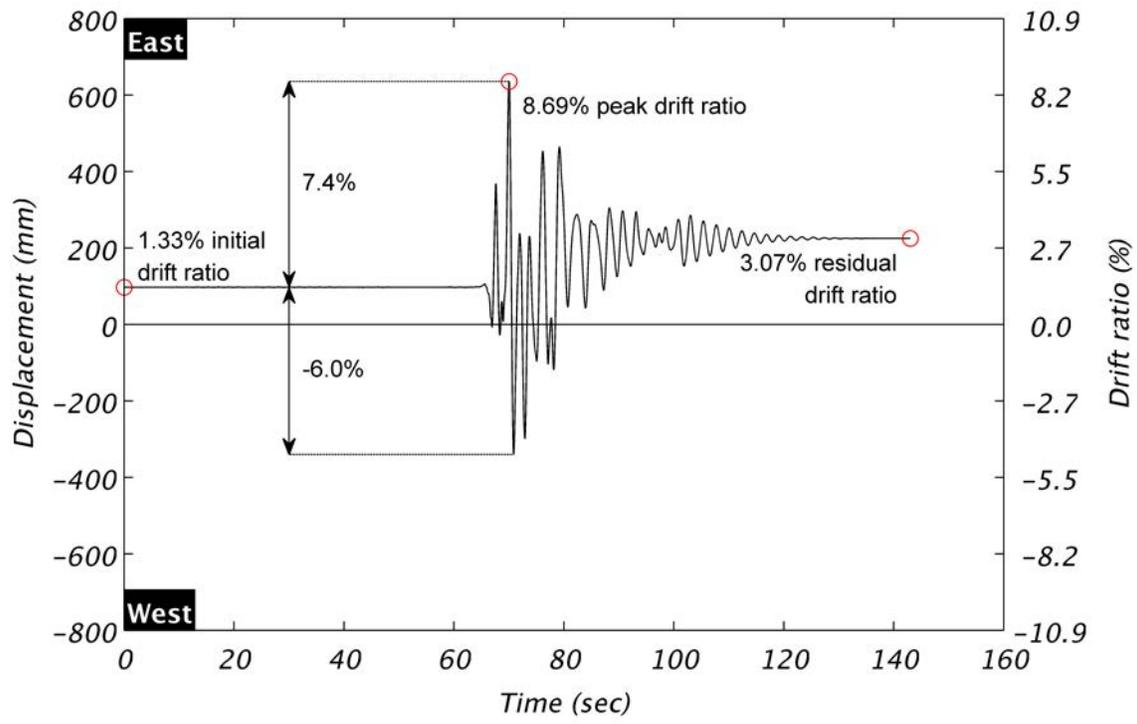
Figure 8.50 Column displacement during EQ9.

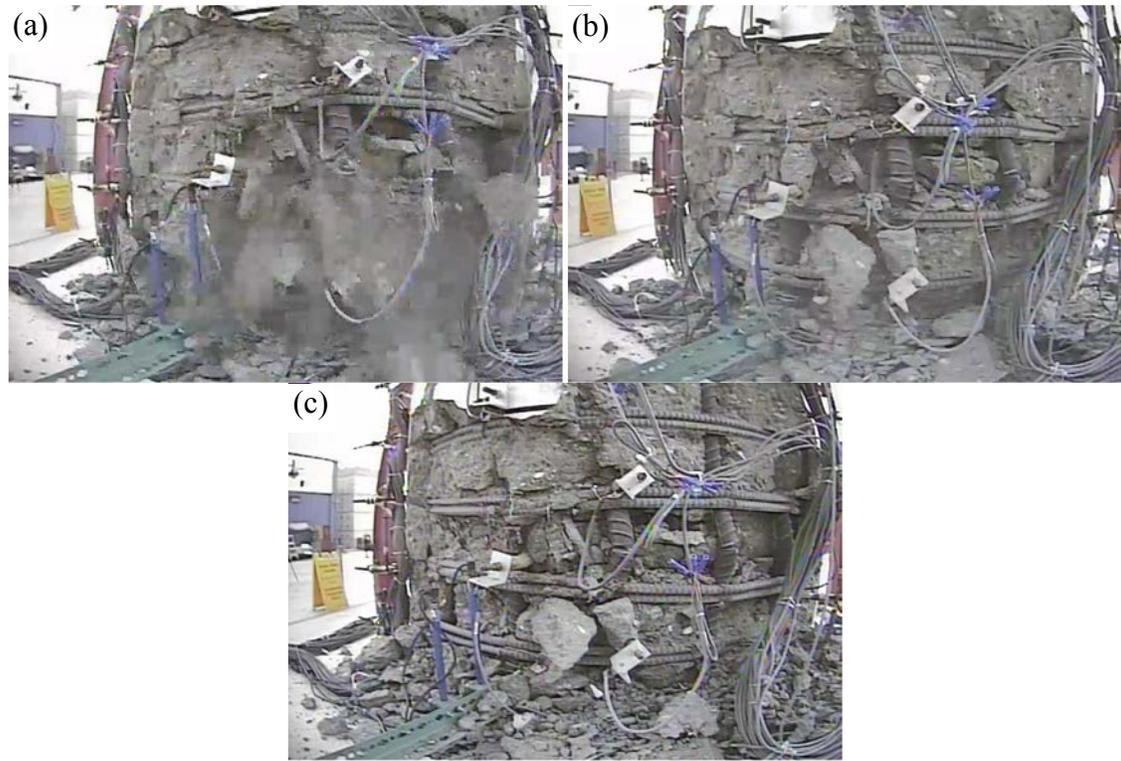
Figure 8.51 Column base East face during EQ9 at (a) peak West displacement, (b) peak East displacement, and (c) post-test.

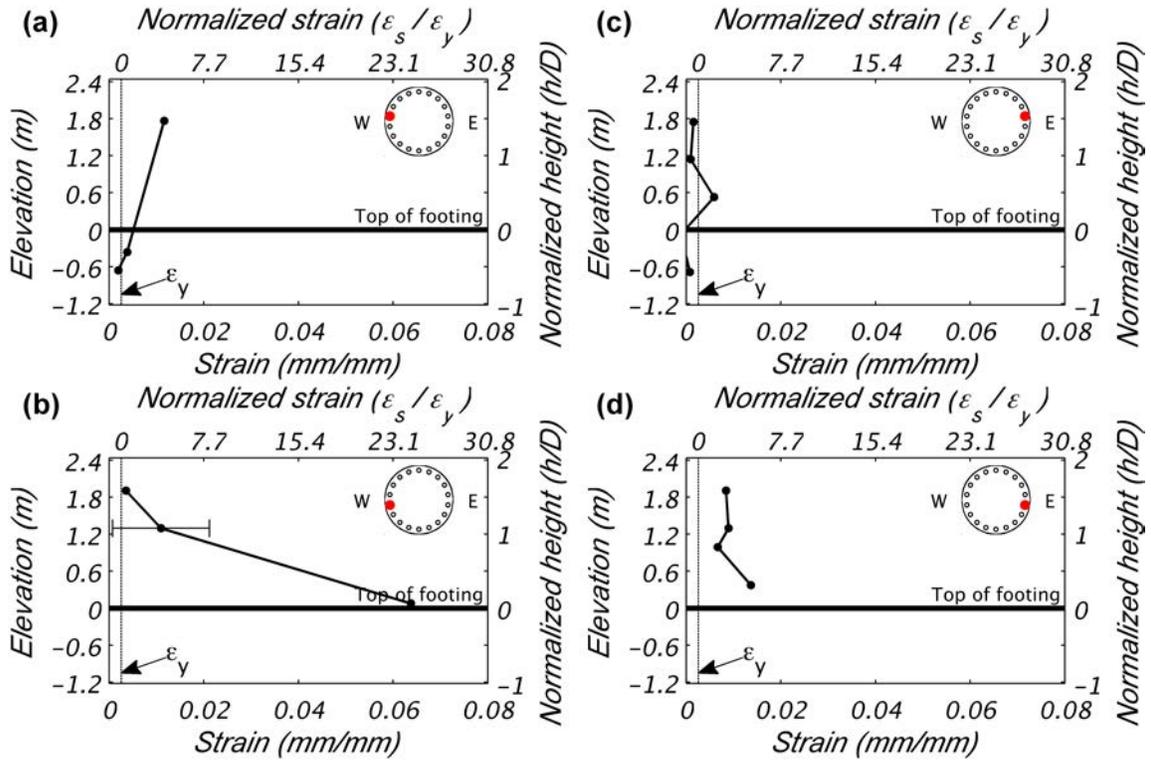
Figure 8.54 Longitudinal reinforcement tensile strain demand during EQ9.

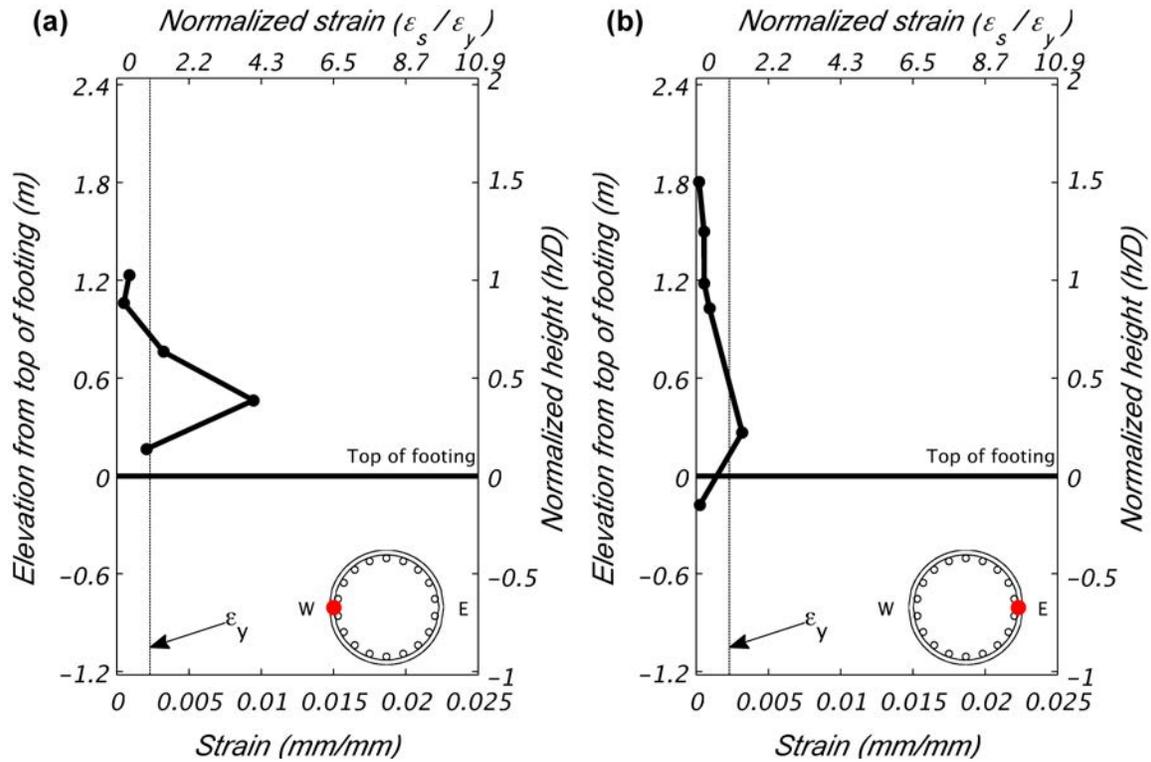
Figure 8.55 Transverse hoop reinforcement tensile strain demand during EQ9.
