A Full-Scale, Single-Column Bridge Bent Tested by Shake-Table Excitation

Matthew J. Schoettler
José I. Restrepo
Gabriele Guerrini
David E. Duck
Francesco Carrea

Center for Civil Engineering Earthquake Research
Department of Civil Engineering/258
University of Nevada
Reno, NV 89557

August 2012

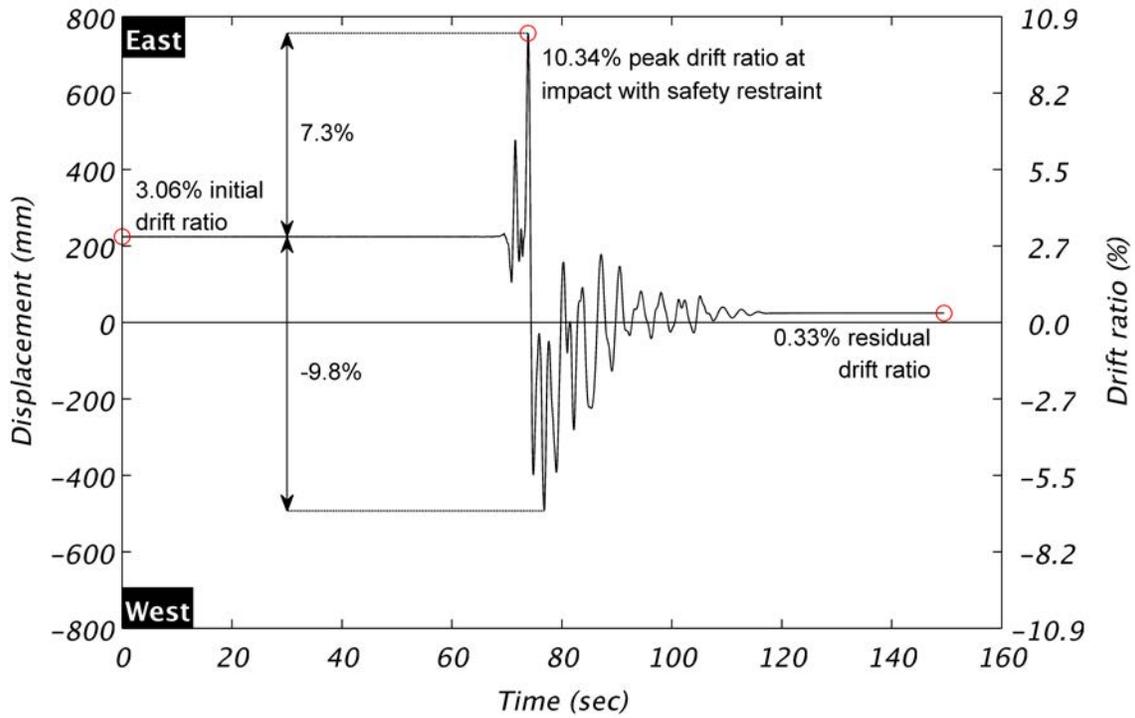
Figure 8.56 Column displacement during EQ10.

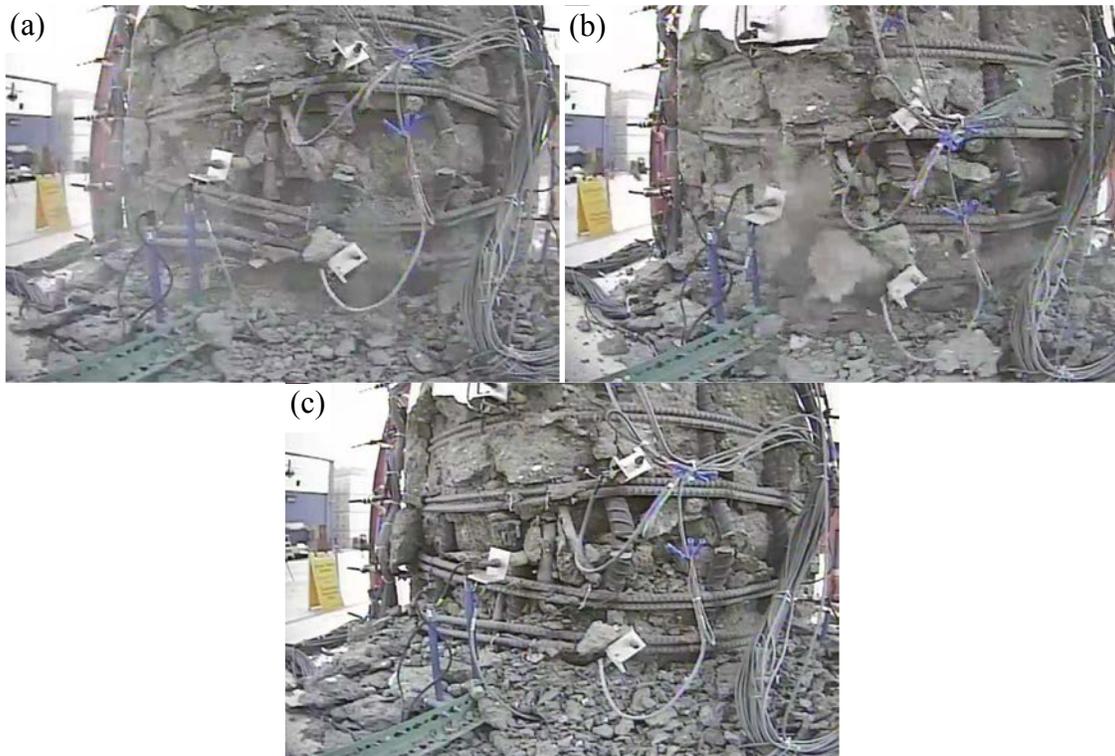
Figure 8.57 Column base East face during EQ10 at (a) peak West displacement, (b) peak East displacement, and (c) post-test.

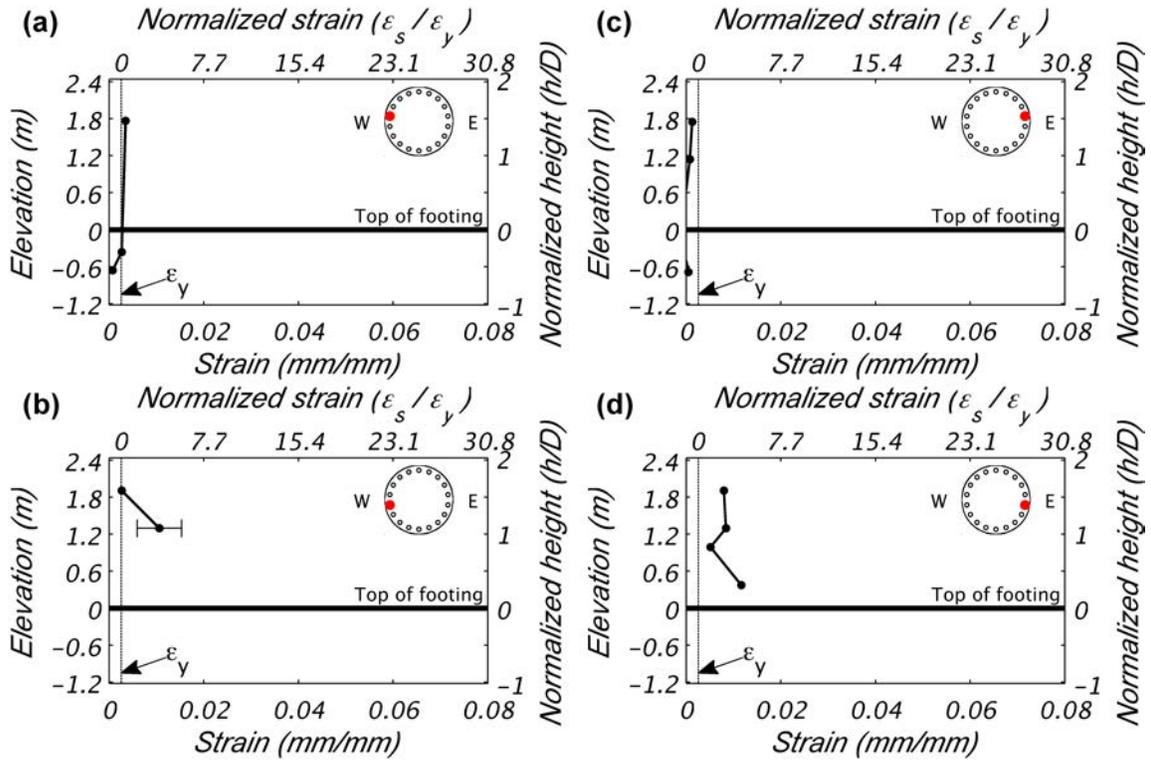
Figure 8.60 Longitudinal reinforcement strain demand during EQ10.

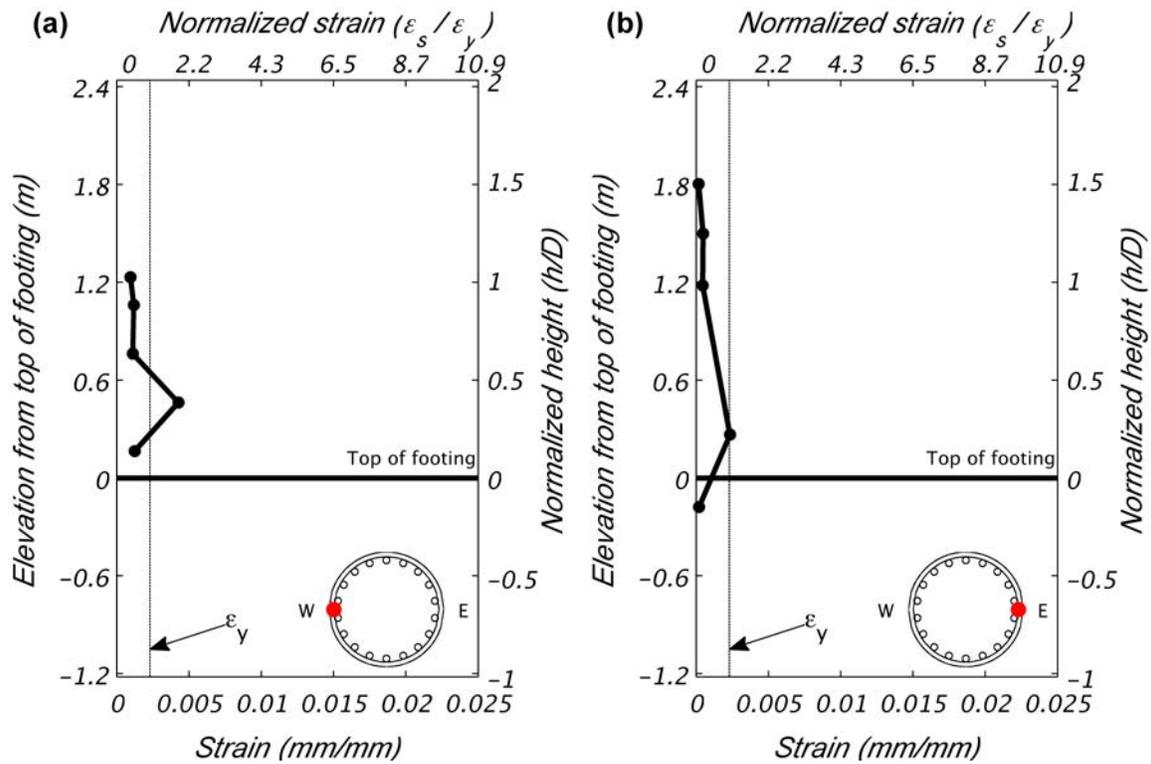
Figure 8.61 Transverse hoop reinforcement strain demand during EQ10.

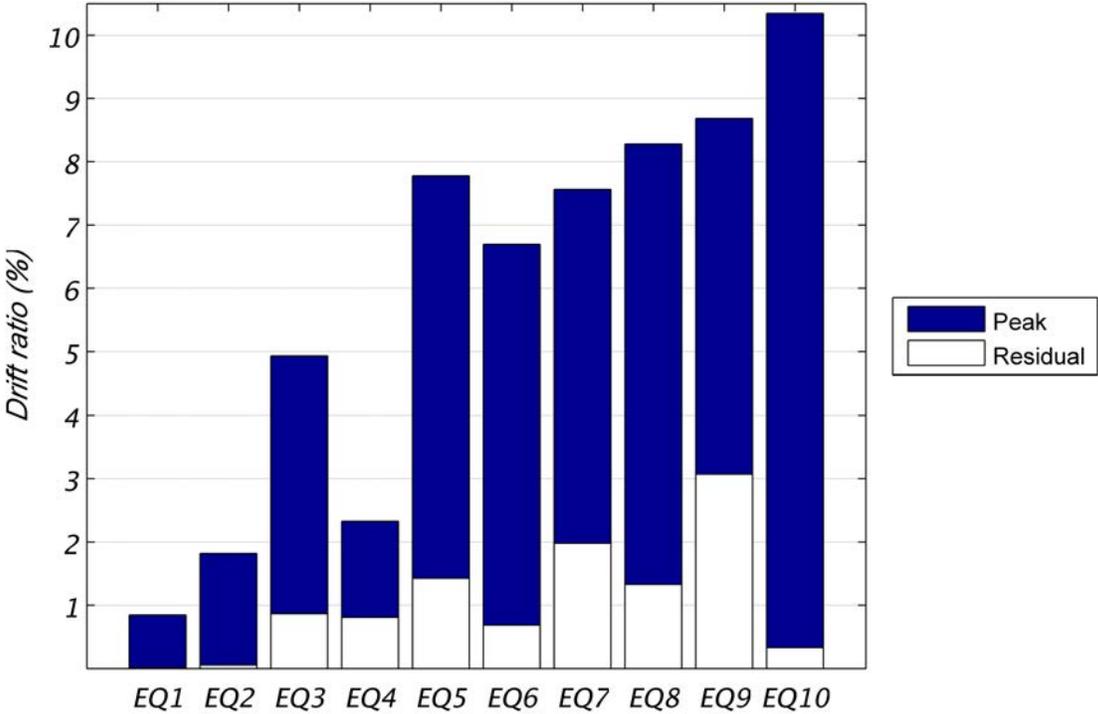
Figure 9.1 Drift ratios achieved during tests.

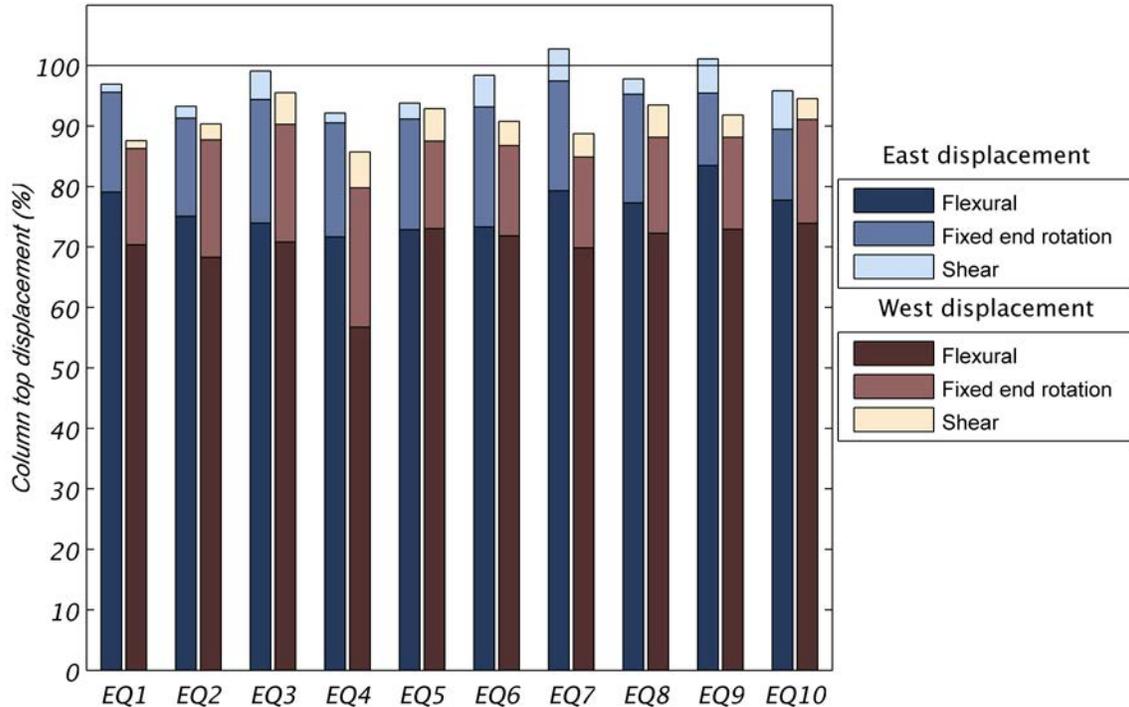
Figure 9.2 Displacement components at peak displacements.

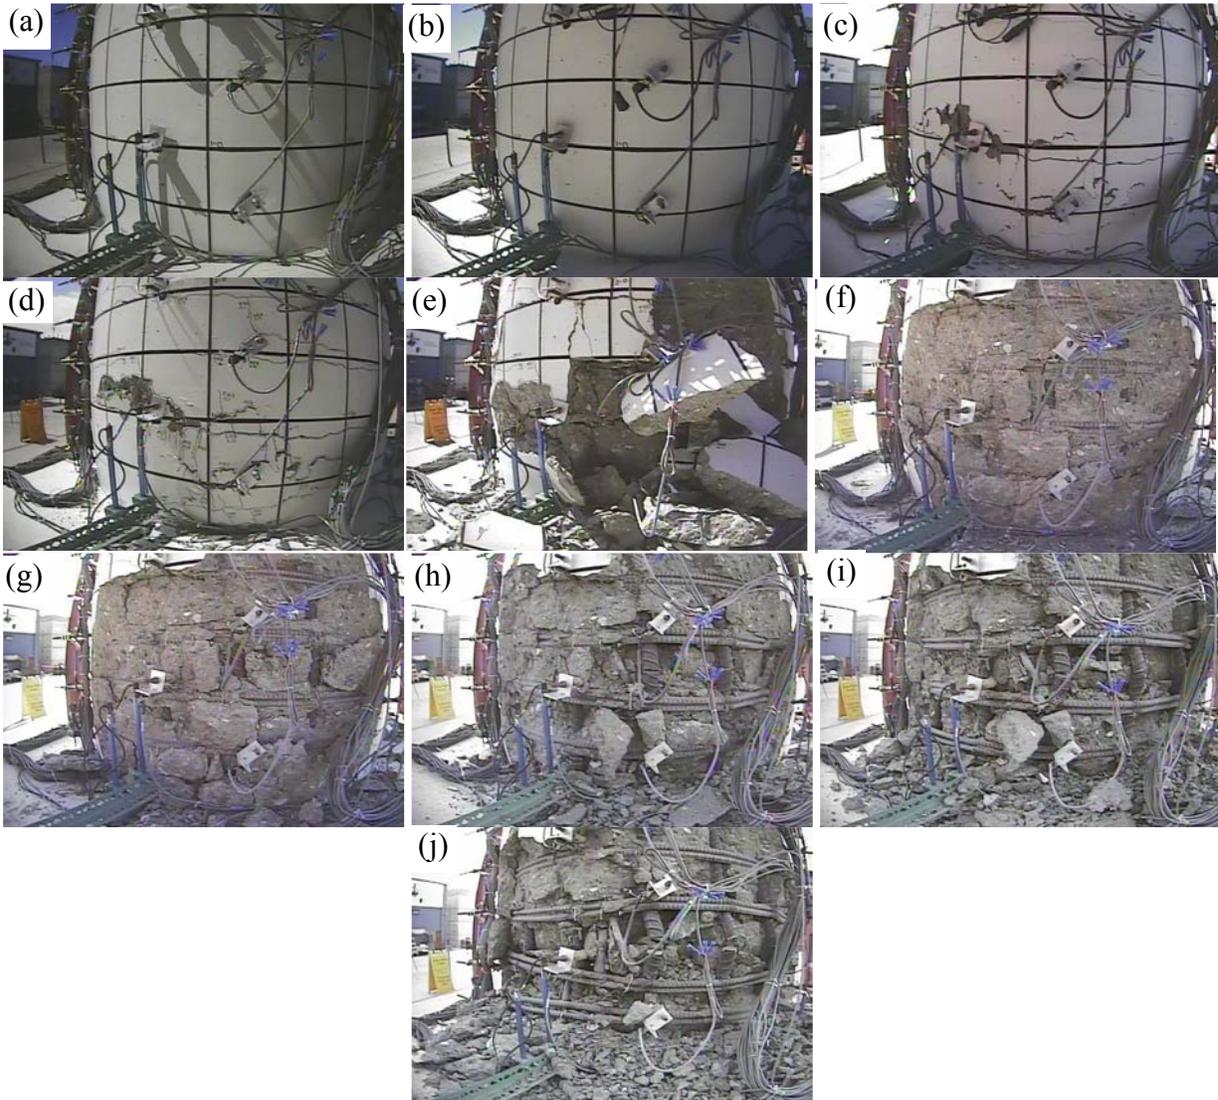
Figure 9.3 Column base East face post test (a) EQ1, (b) EQ2, (c) EQ3, (d) EQ4, (e) EQ5, (f) EQ6, (g) EQ7, (h) EQ8, (i) EQ9, and (j) EQ10

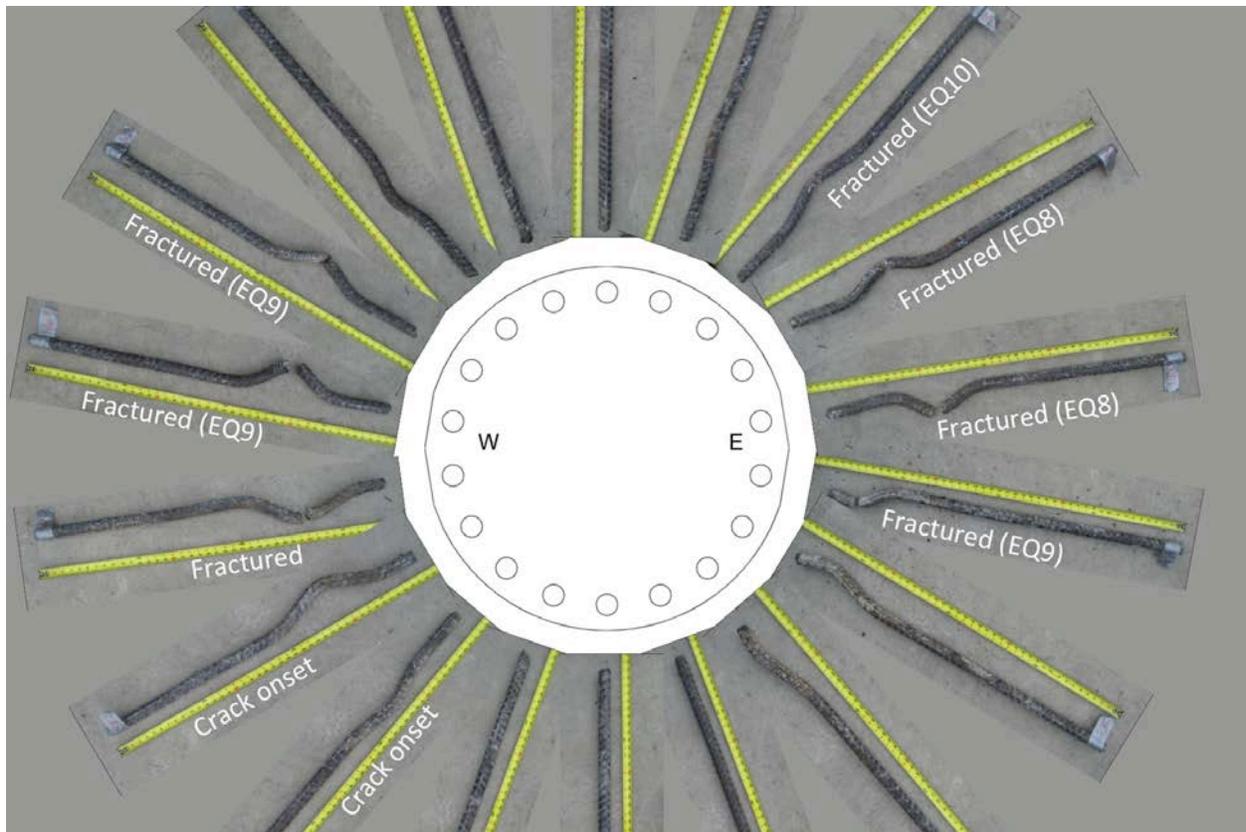
Figure 9.4 Extracted longitudinal reinforcement.

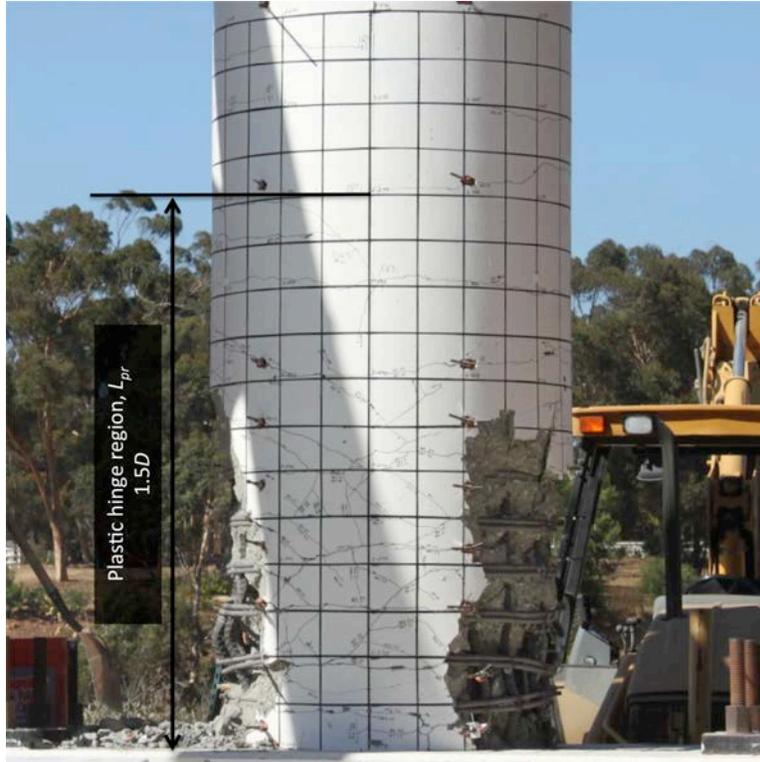
Figure 9.5 South face of the column post-test.

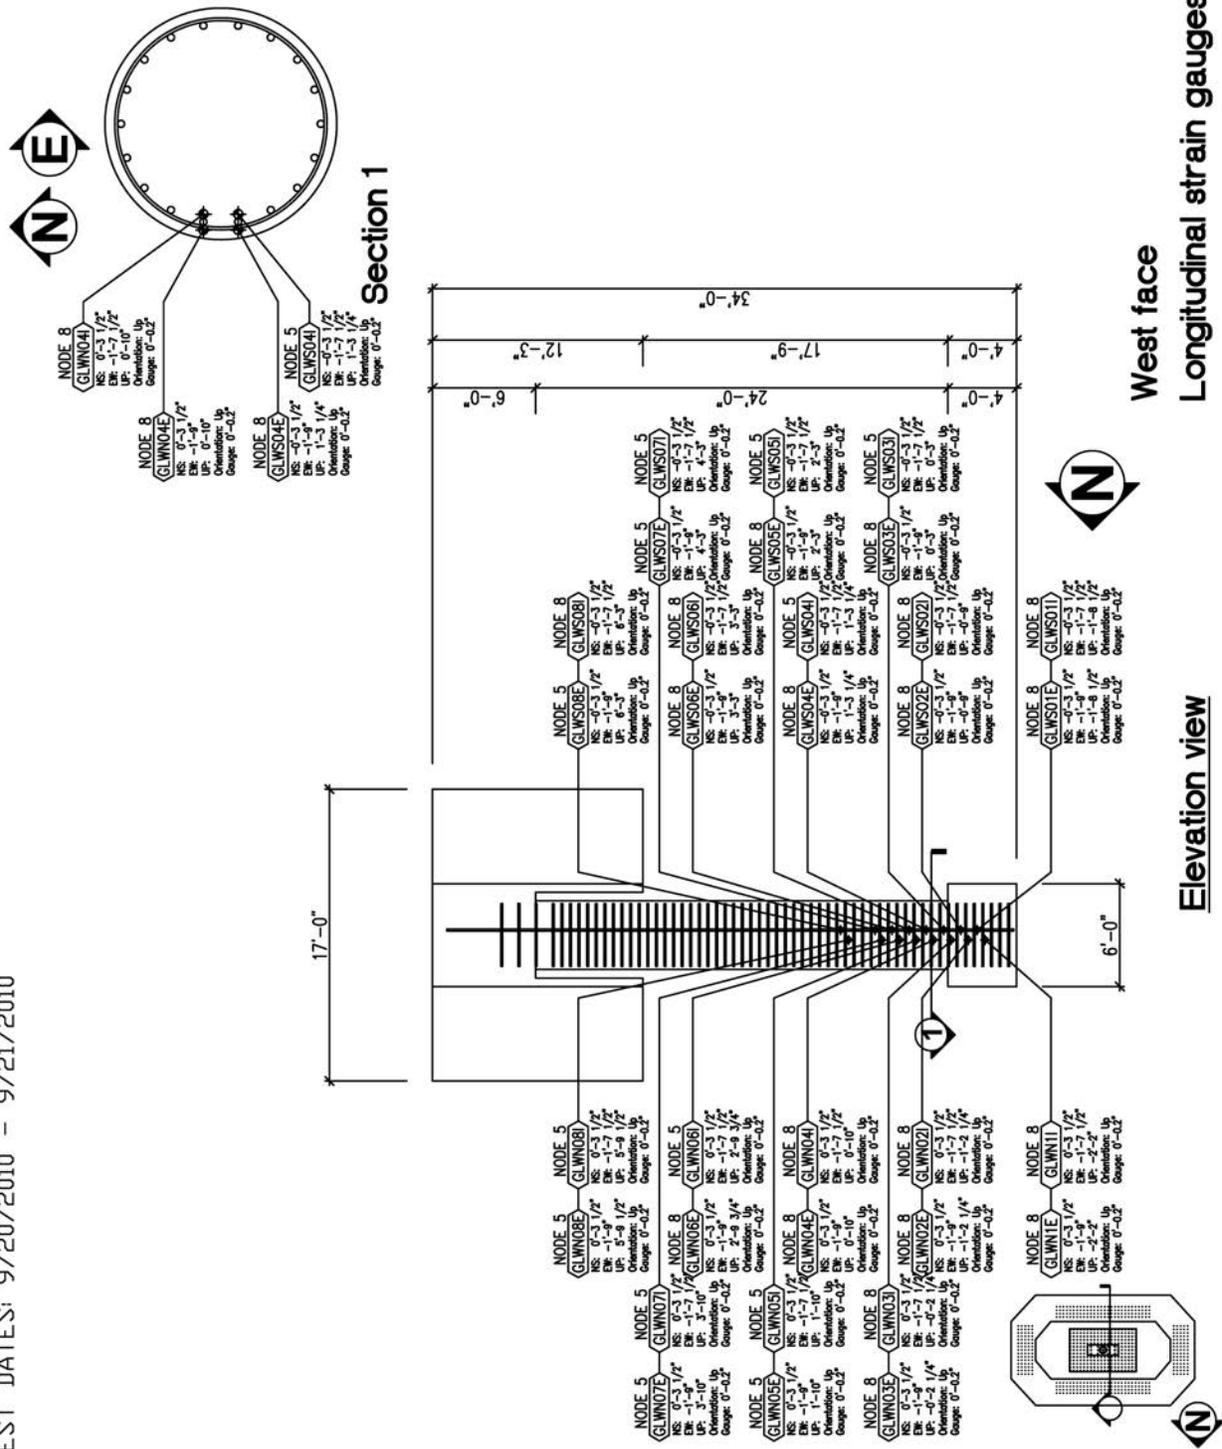
Figure A.2 Longitudinal strain gauge locations on the West face of the column.

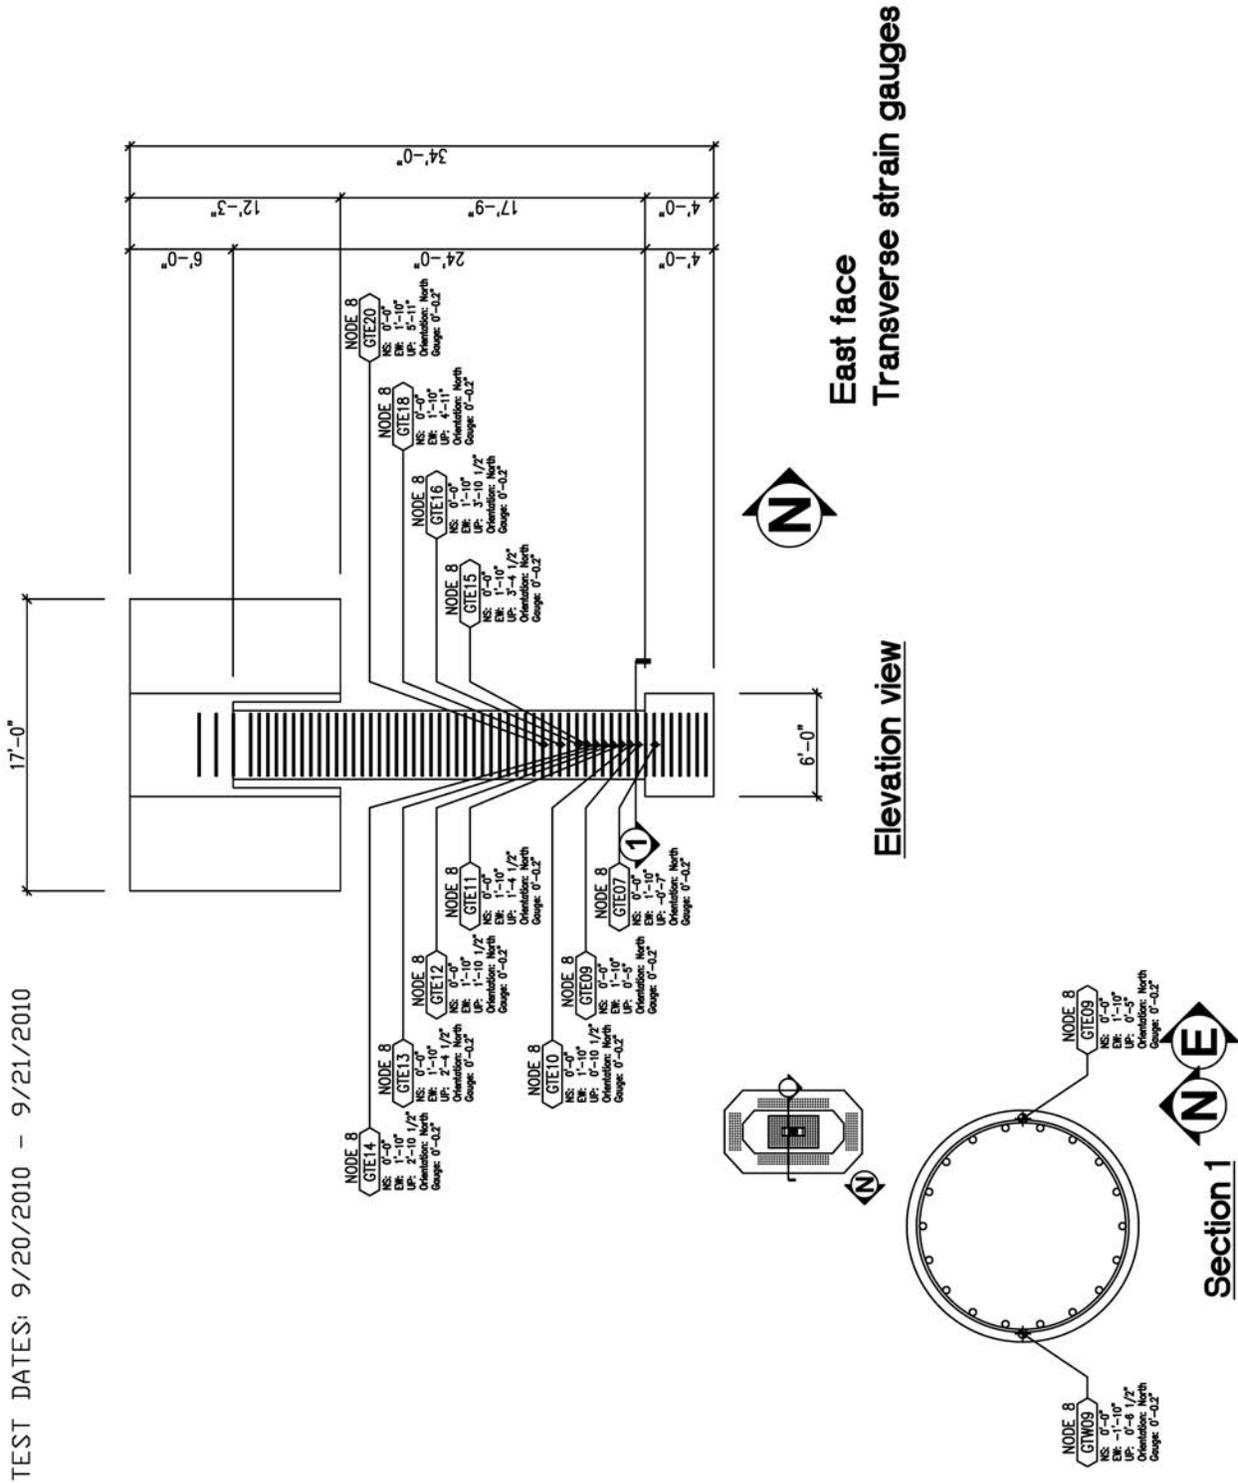
Figure A.3 Transverse strain gauge locations on the East face of the column.

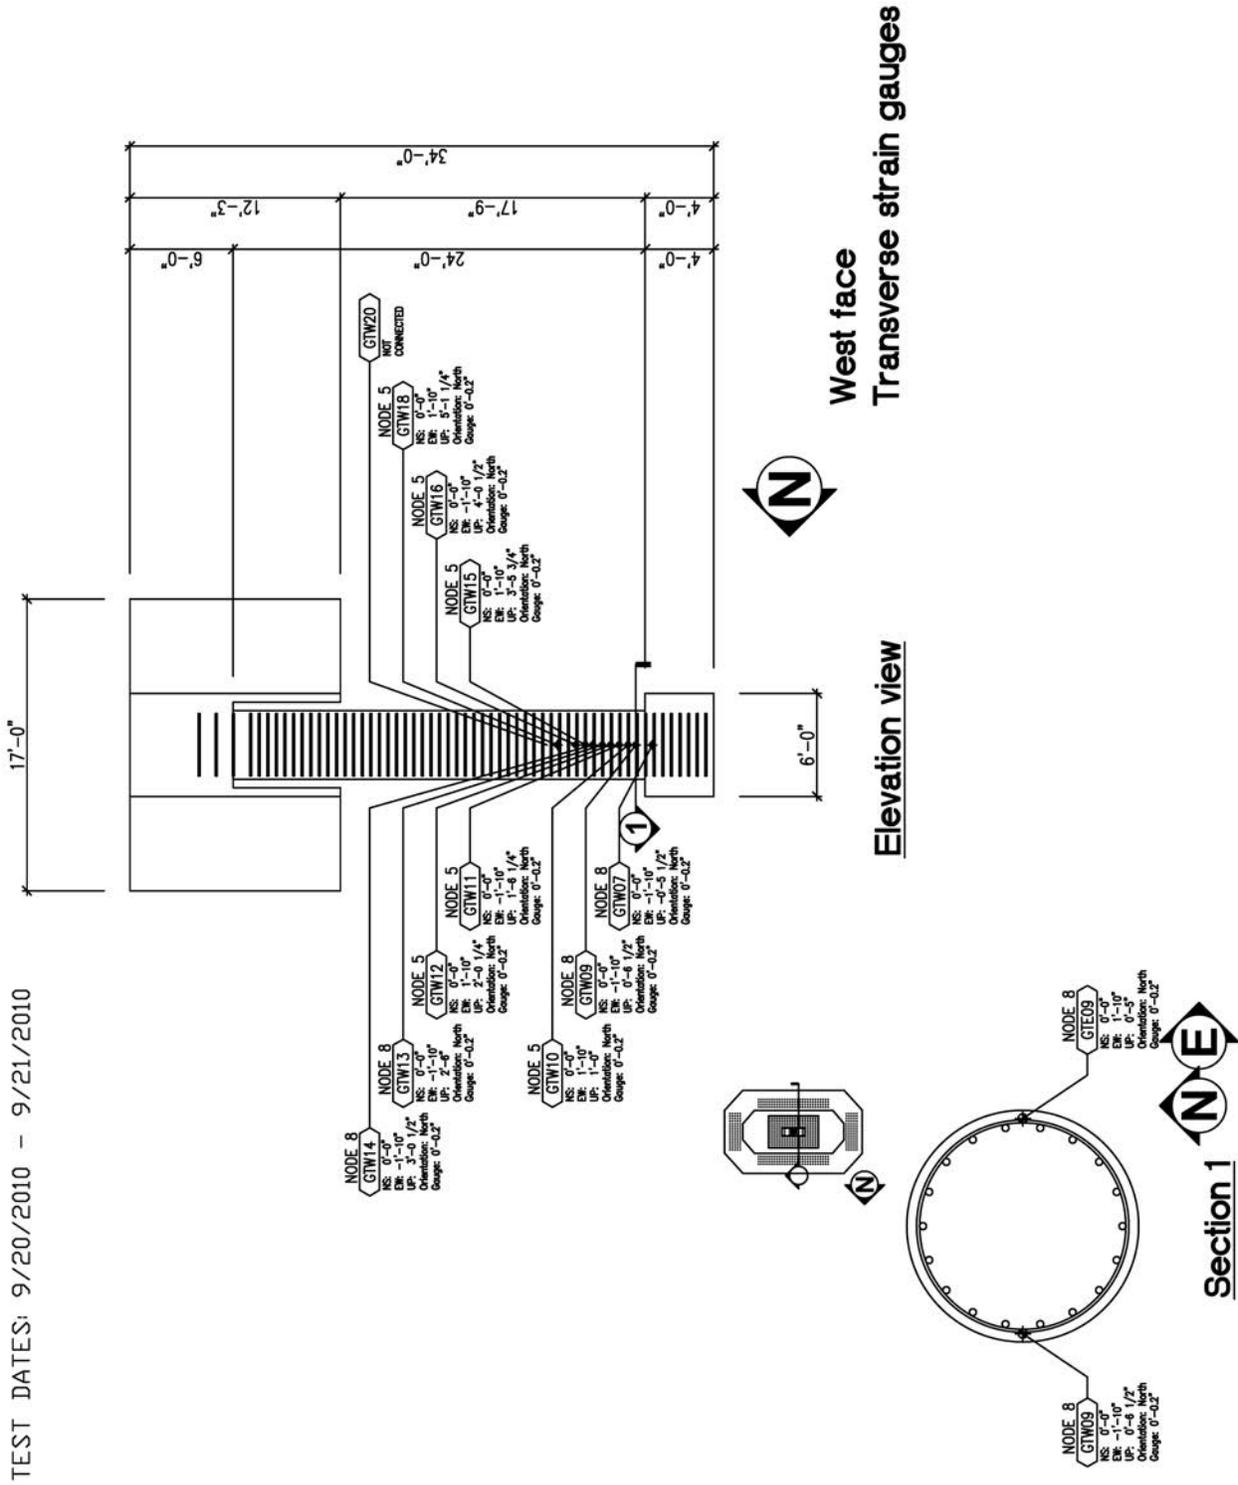
Figure A.4 Transverse strain gauge locations on the West face of the column.

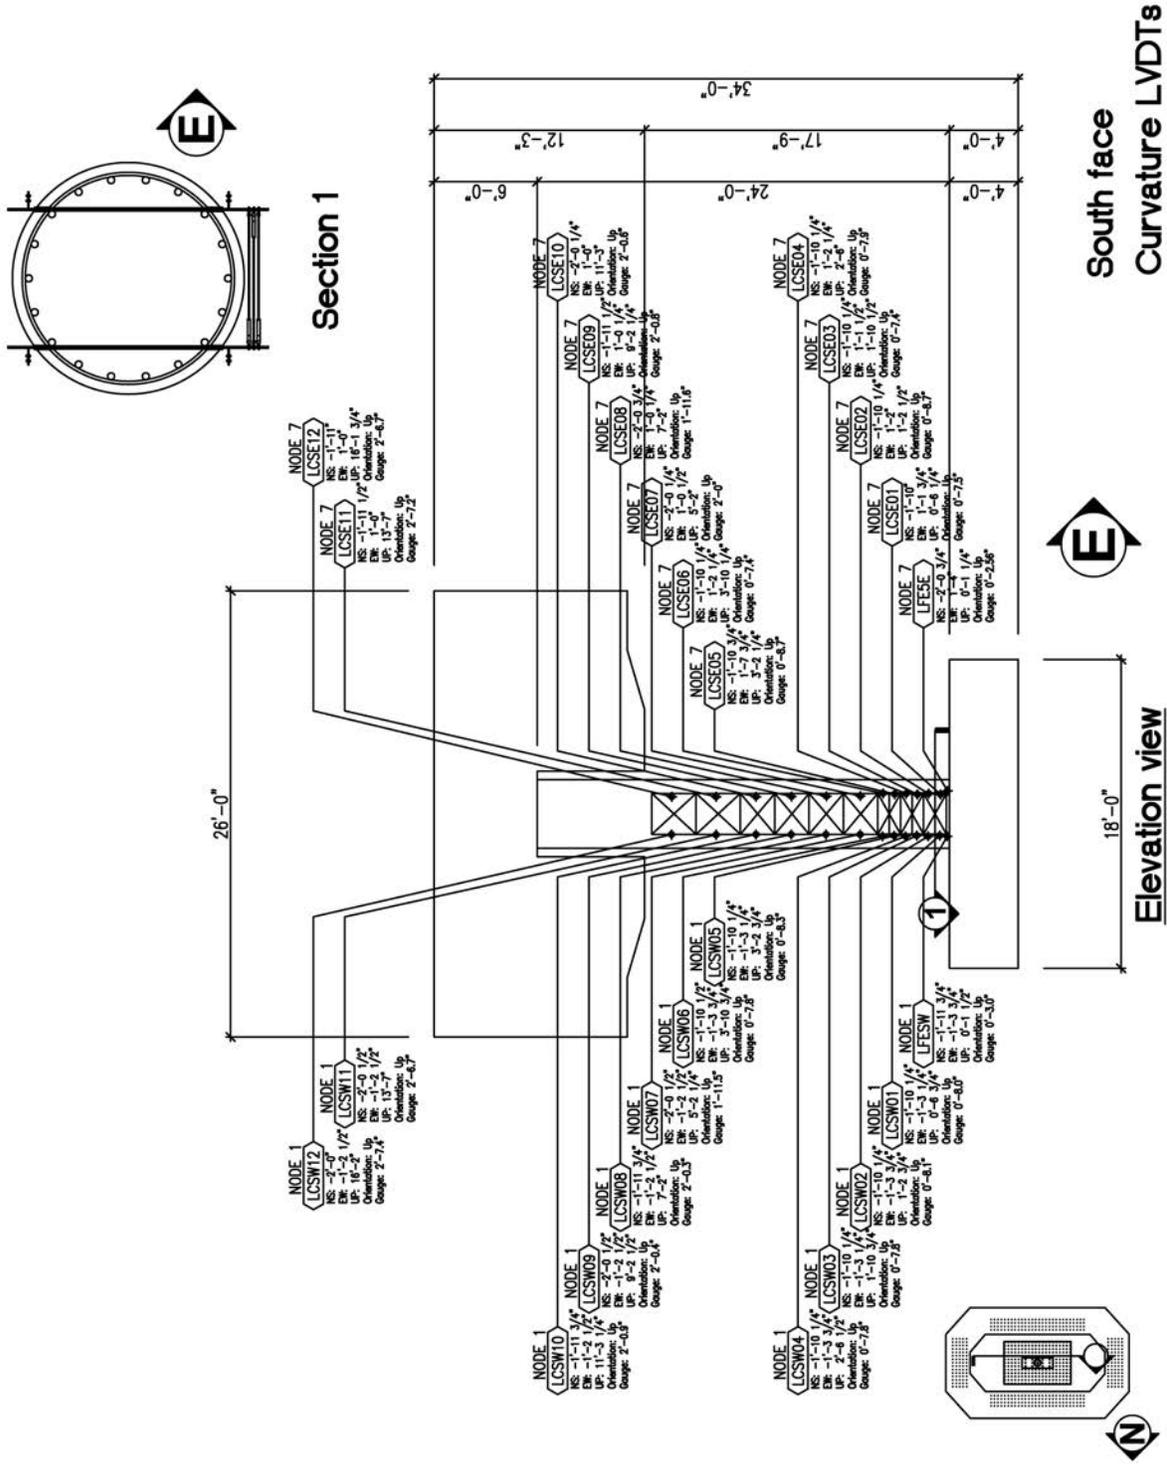
Figure A.5 Curvature and fixed-end rotation LVDT locations on the South face of the column.

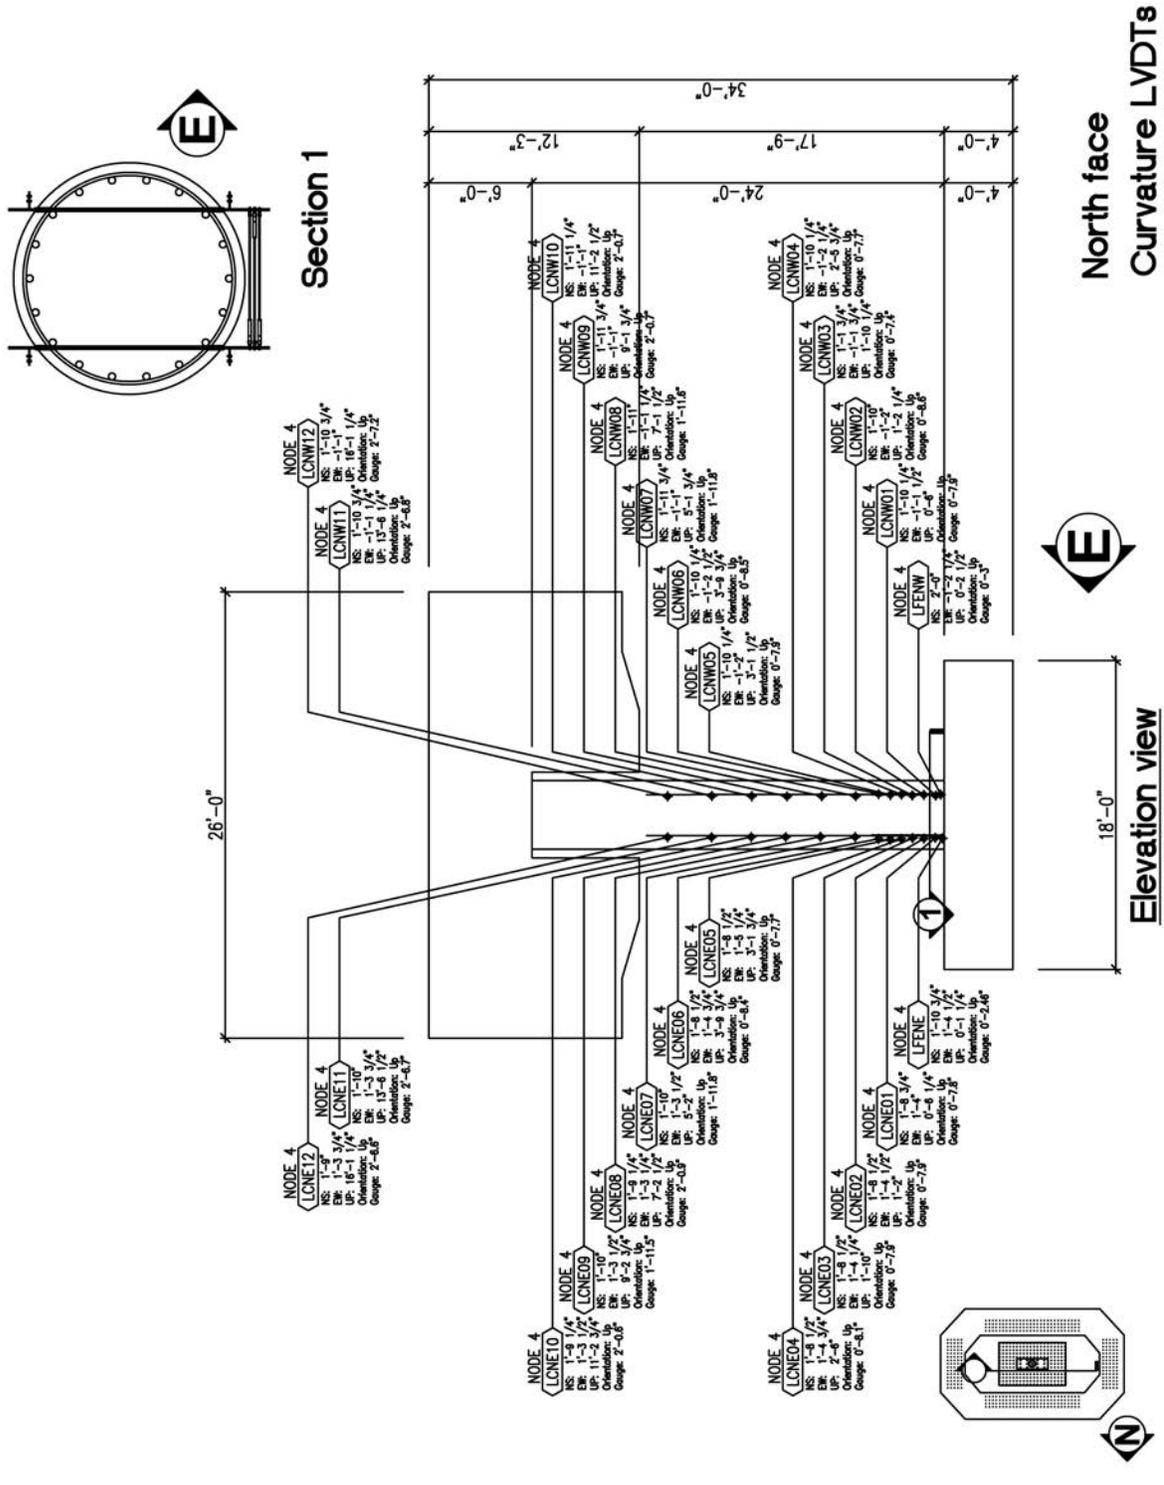
Figure A.6 Curvature and fixed-end rotation LVDT locations on the North face of the column.

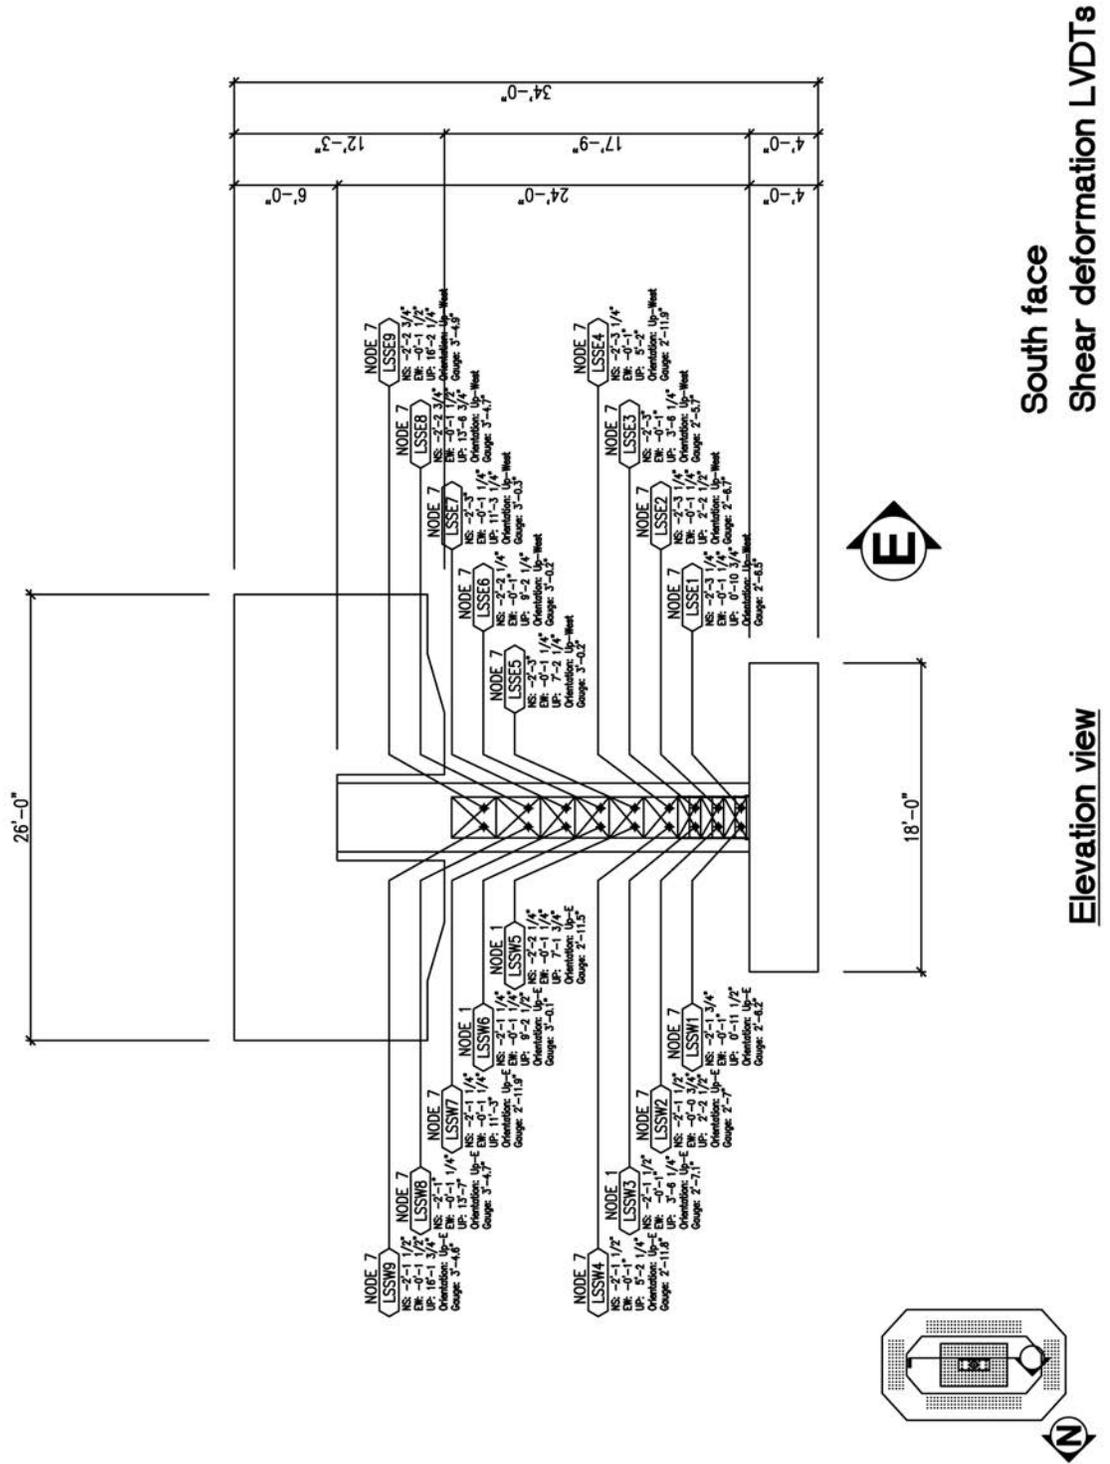
Figure A.7 Inclined shear LVDT locations on the South face of the column.

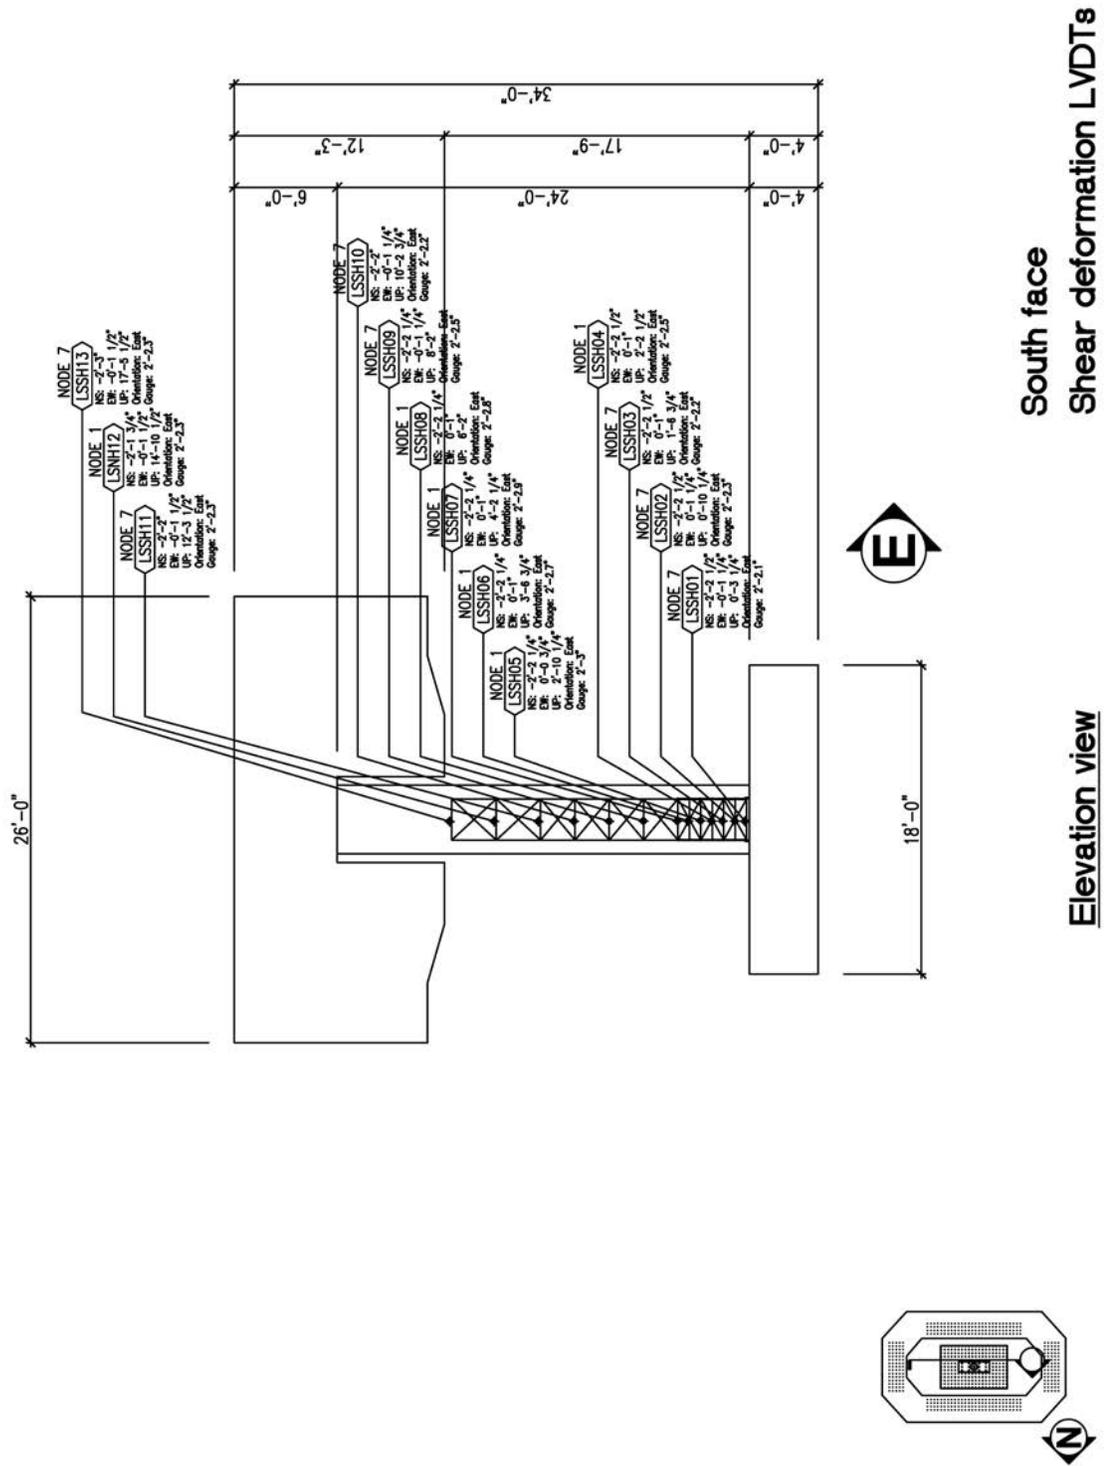
Figure A.8 Horizontal shear LVDT locations on the South face of the column.

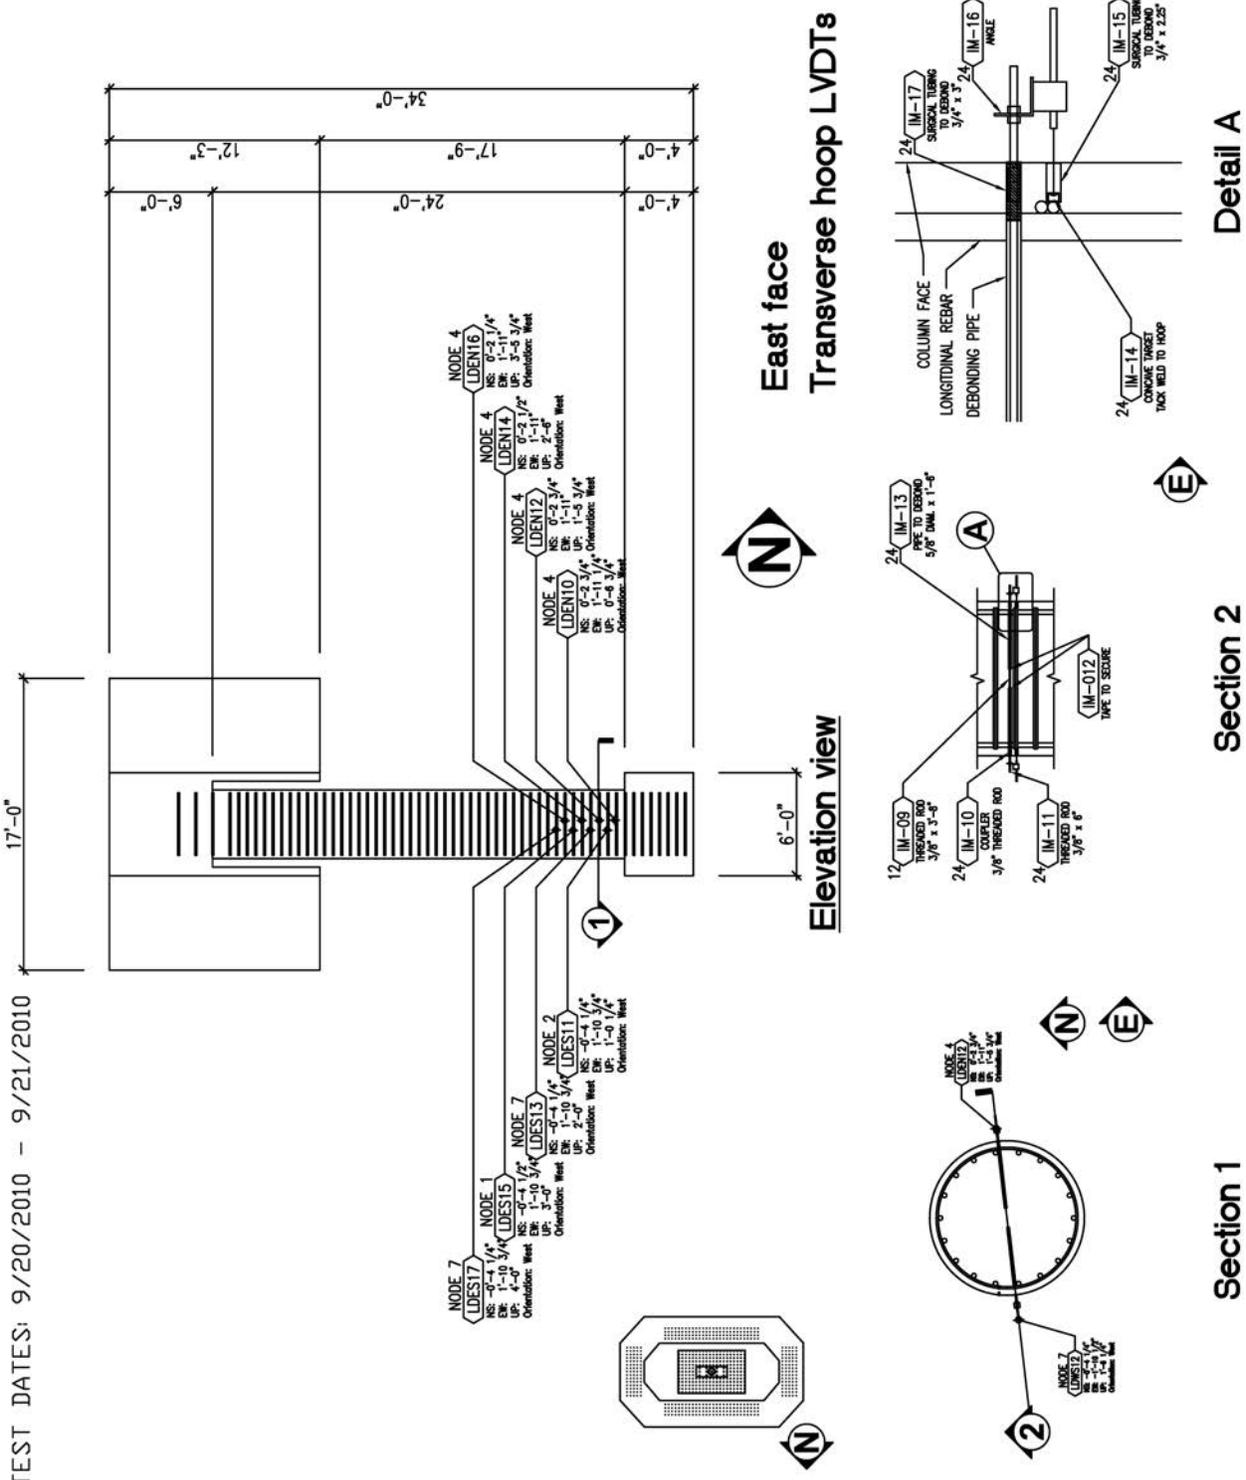
Figure A.9 Transverse hoop LVDT locations on the East face of the column.
