A Full-Scale, Single-Column Bridge Bent Tested by Shake-Table Excitation

Matthew J. Schoettler
José I. Restrepo
Gabriele Guerrini
David E. Duck
Francesco Carrea

Center for Civil Engineering Earthquake Research
Department of Civil Engineering/258
University of Nevada
Reno, NV 89557

August 2012

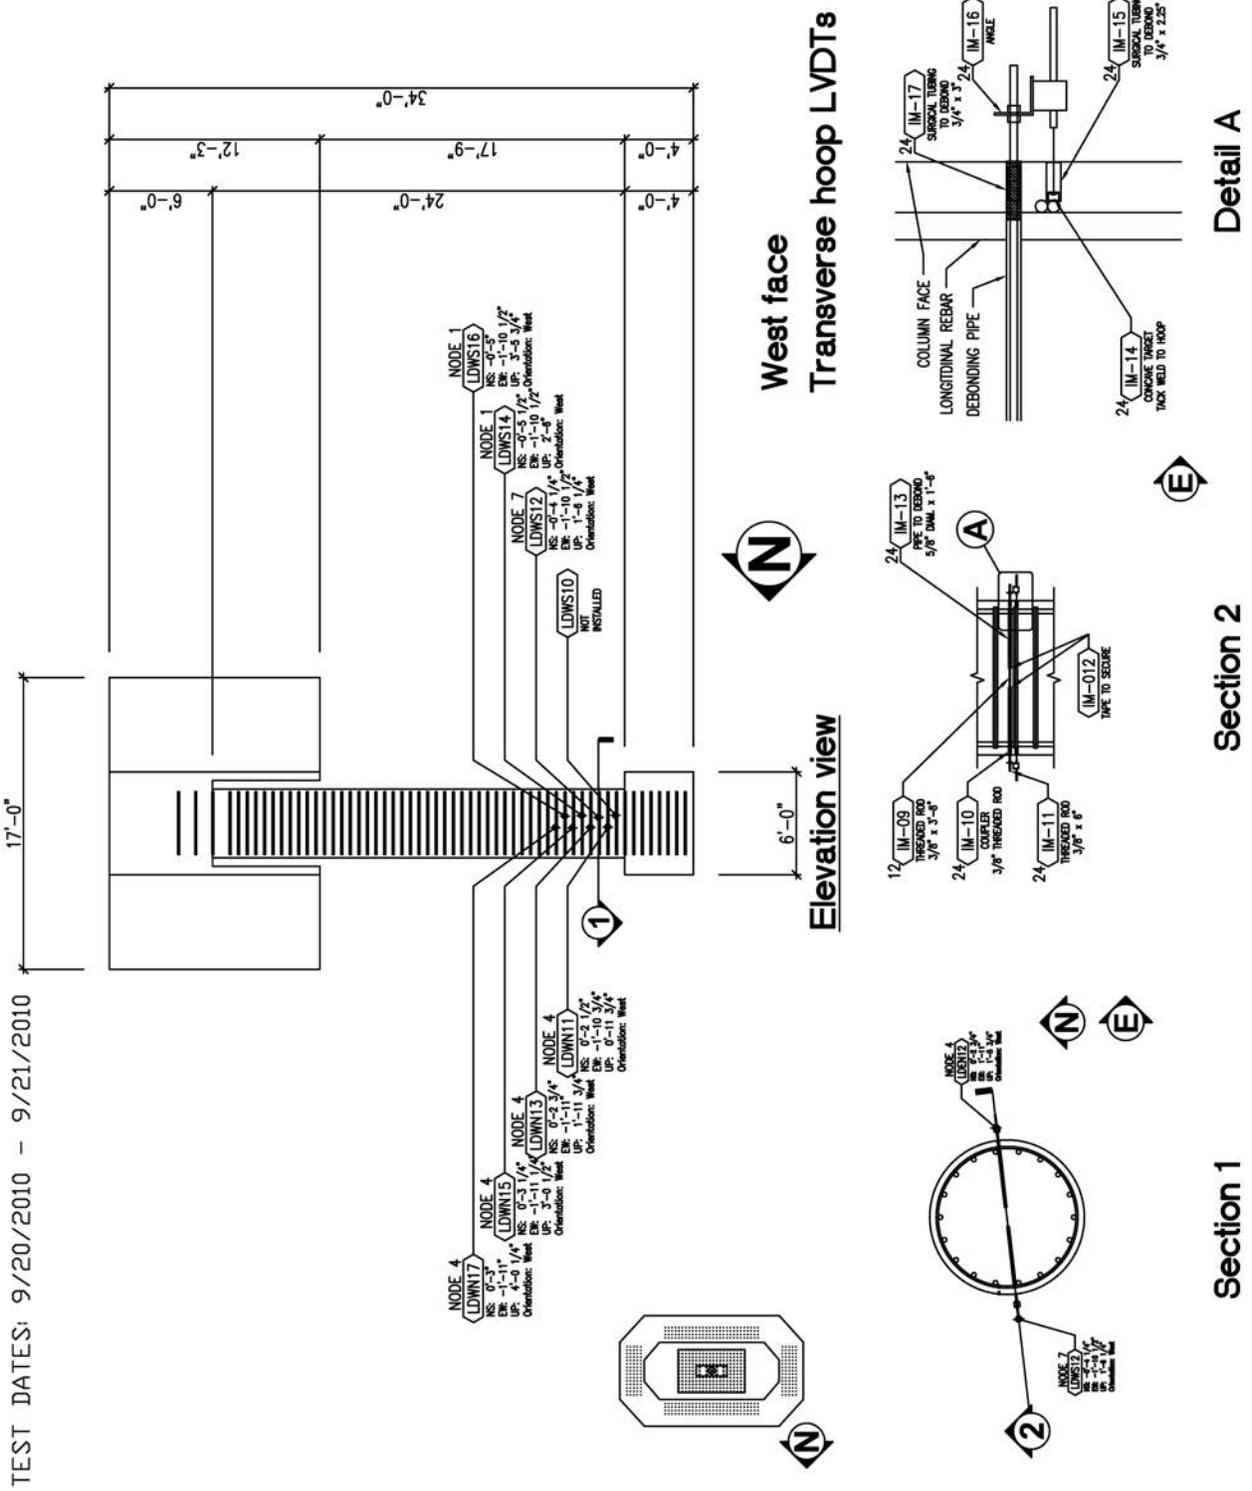
Figure A.10 Transverse hoop LVDT locations on the West face of the column.

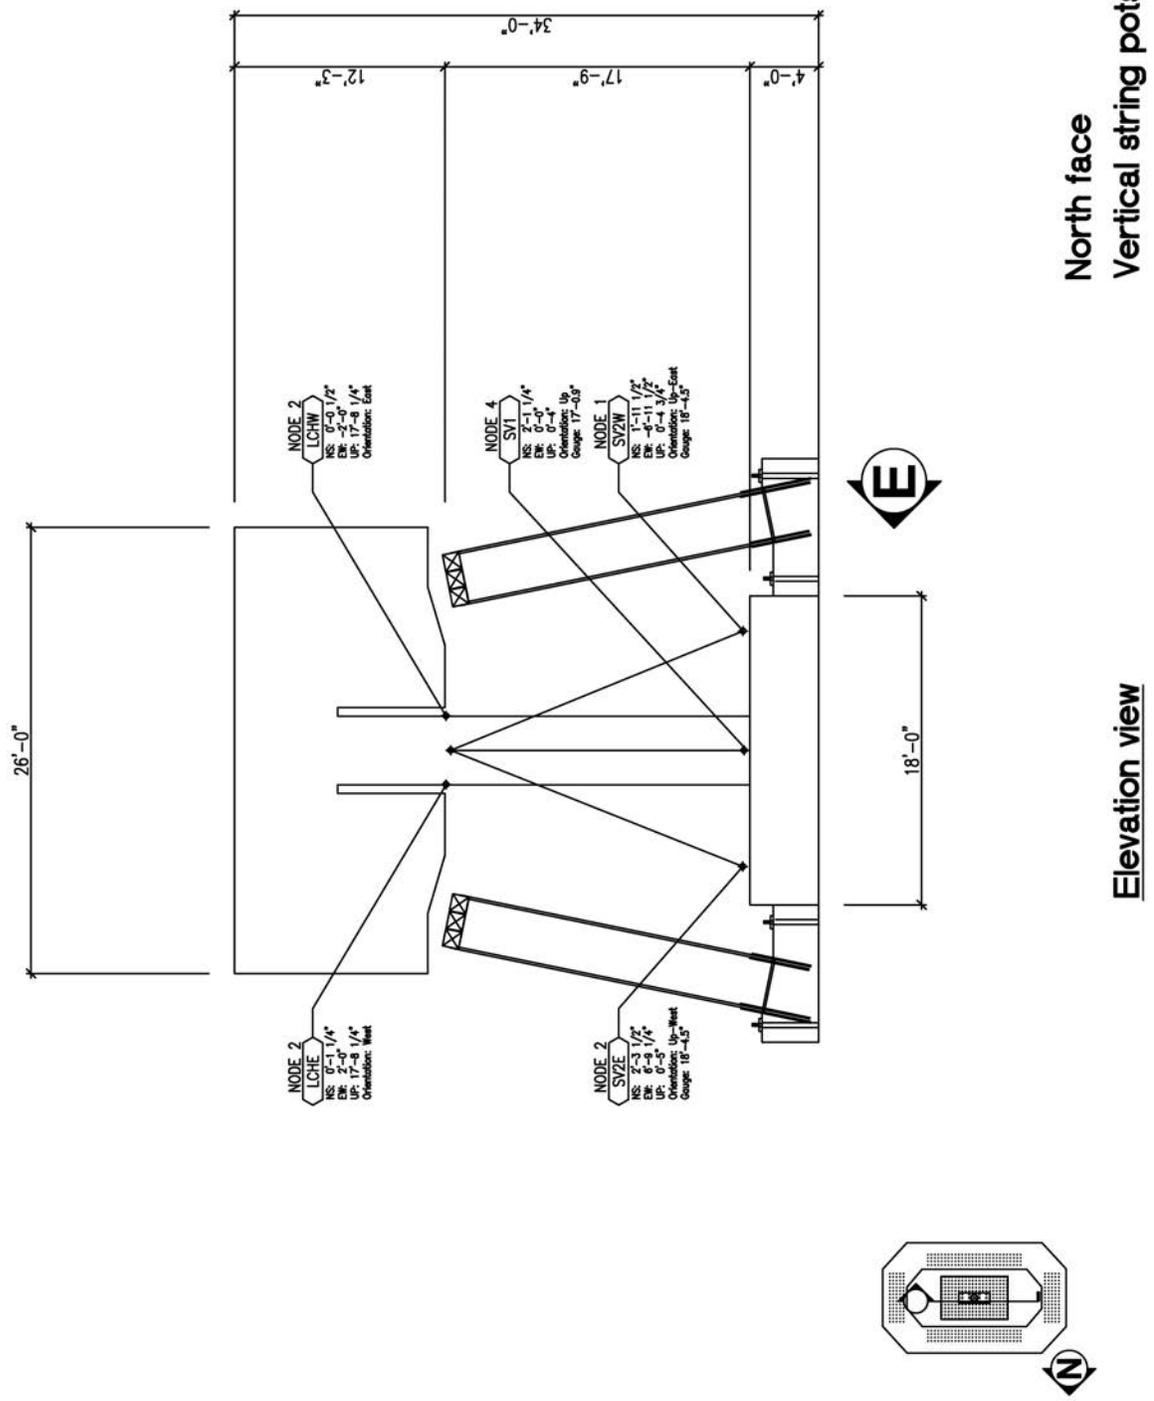
Figure A.12 Inclined spring potentiometer and column-to-top mass LVDT locations.

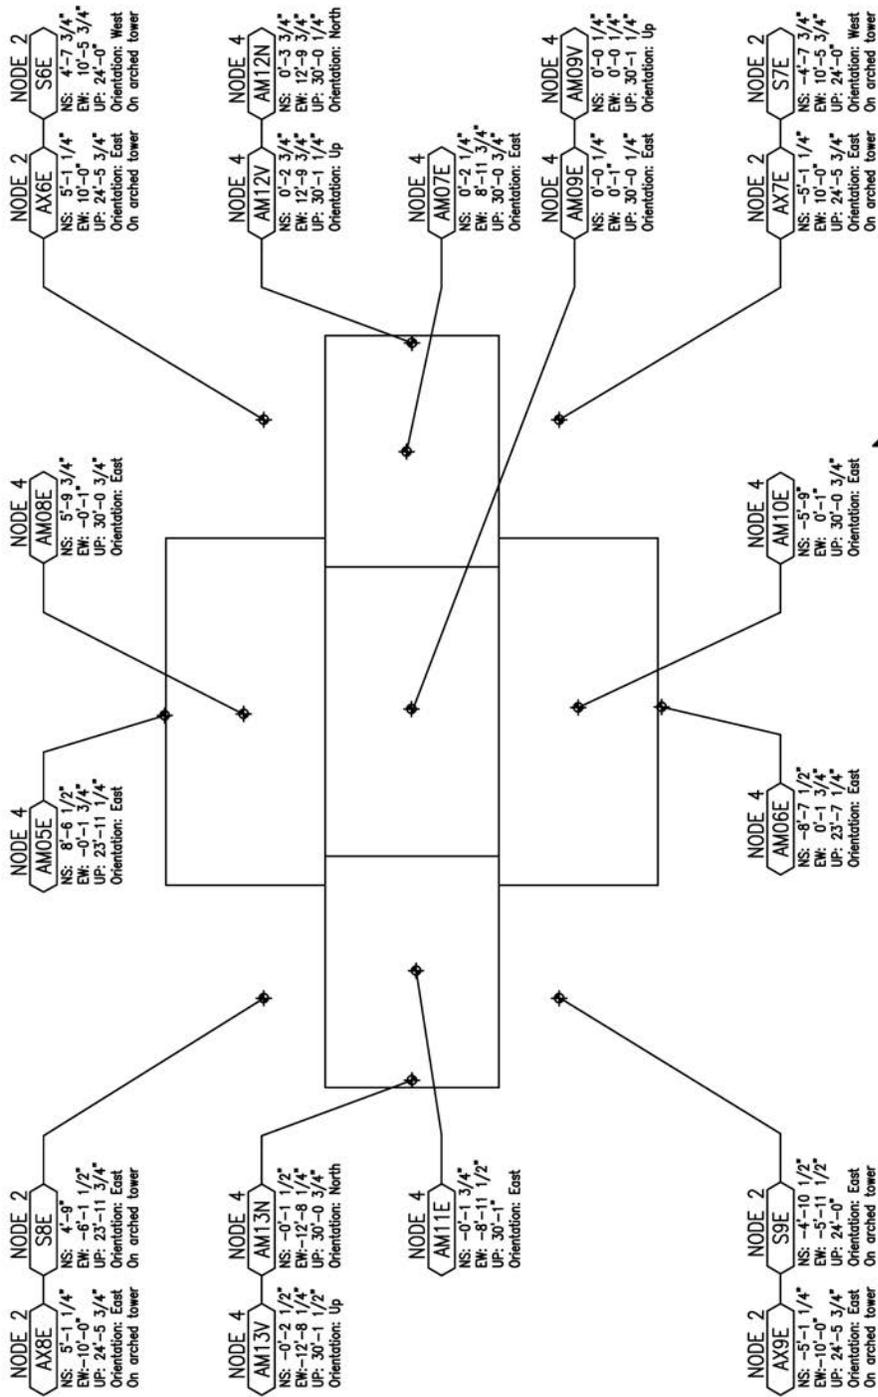
Superstructure mass
Accelerometer layout

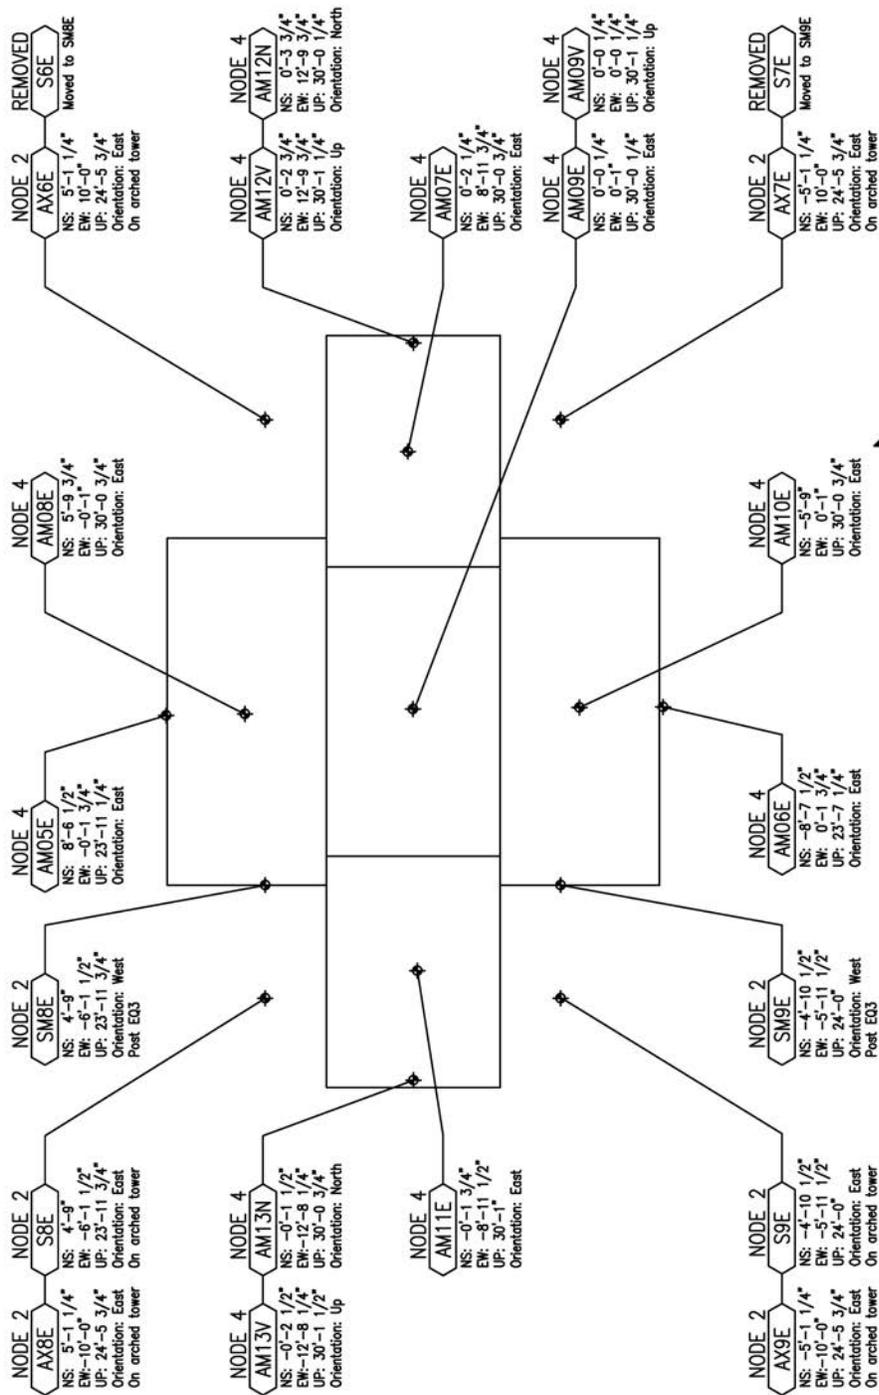
Superstructure mass
Accelerometer layout

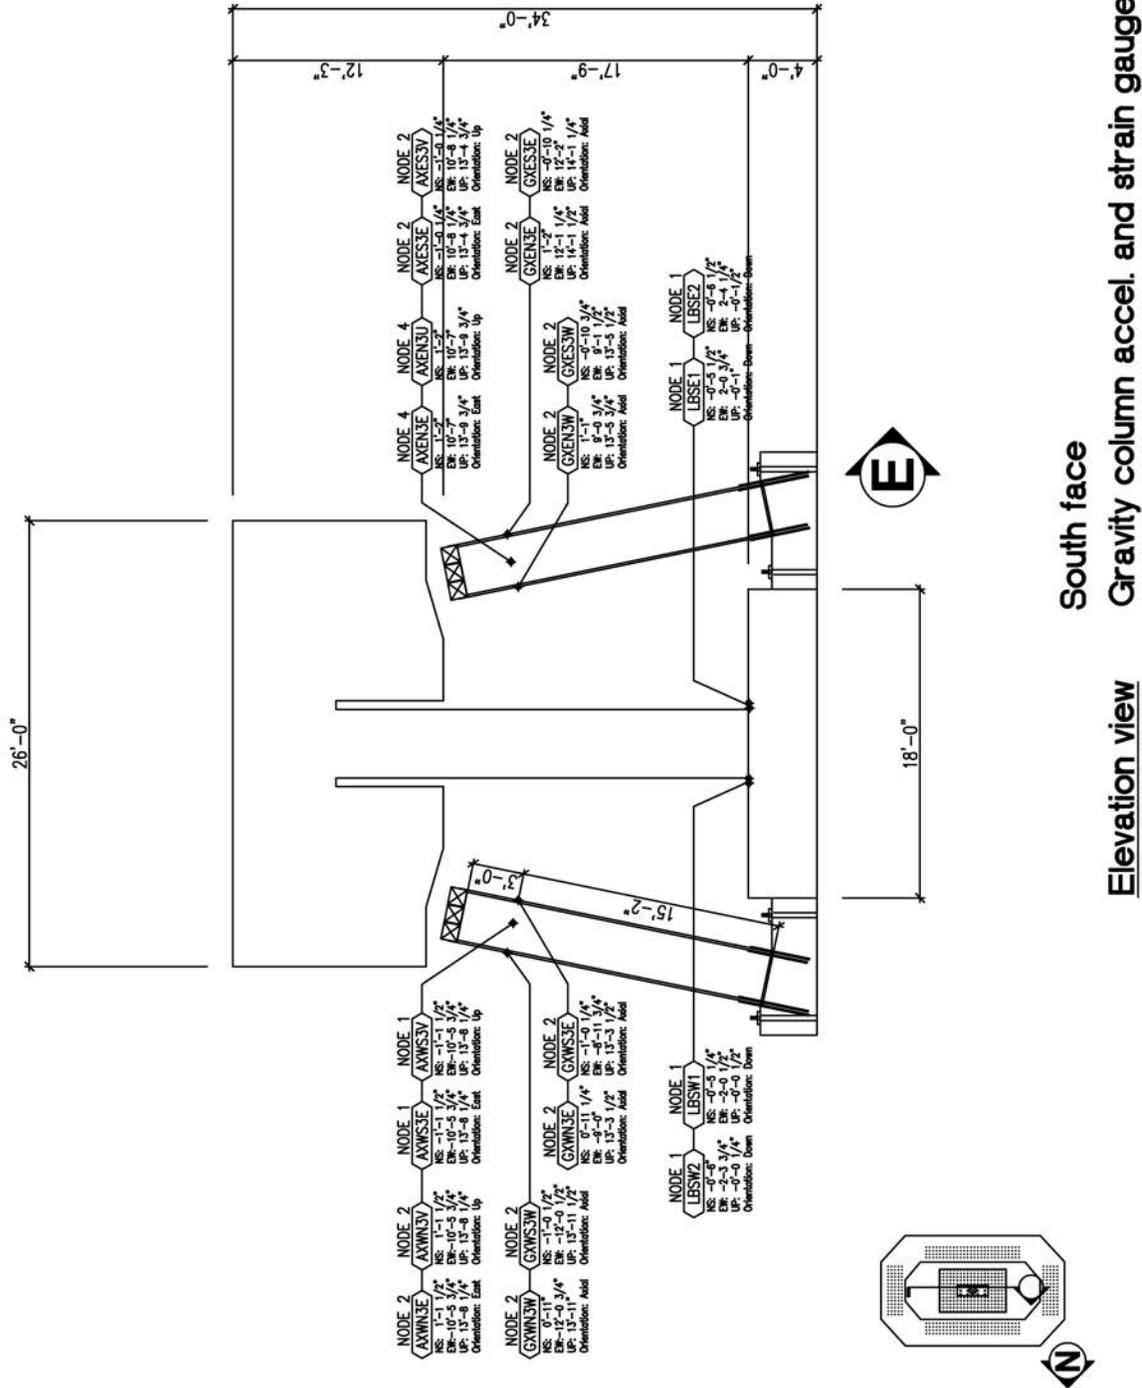
Figure A.17 Bond-slip LVDT locations and instrumentation locations on the inclined safety restraints.
