PAVEMENT SUBGRADE PERFORMANCE STUDY

National Pooled Fund Study SPR-208

Test Section 709

Subgrade AASHTO soil type A-6 at optimum moisture content

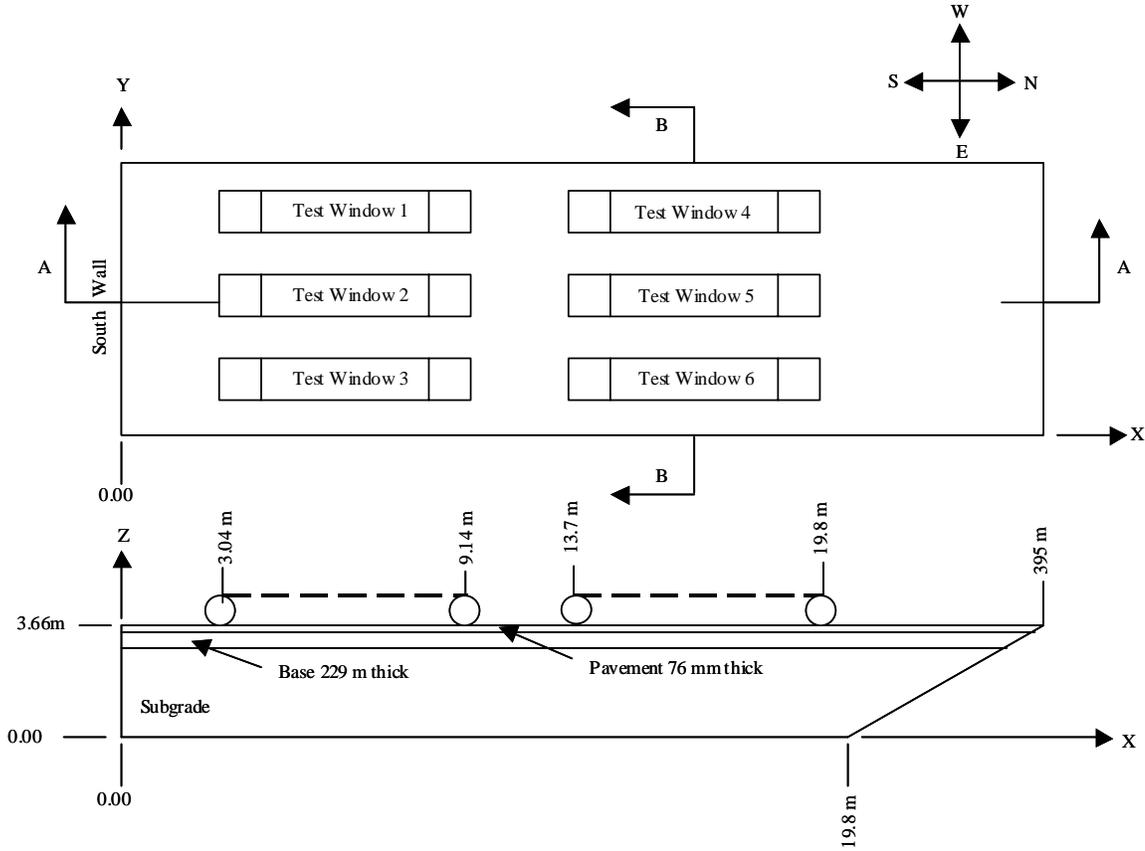
Figure 1a. Plan view and longitudinal cross section of test section.

The test section consists of a 76-mm (3-in) hot mixed asphalt (HMA) layer, a 229-mm (9-in) crushed gravel base course, and 3 m (10 ft) of subgrade soil over a concrete floor that simulated bedrock. The subgrade soil was classified as AASHTO soil type A-6. This soil was conditioned to 16 percent gravimetric moisture content. This is the optimum moisture content for this soil according to modified Proctor test results. The laboratory CBR test results indicate that, at this moisture content, the subgrade soil had a CBR of 15 percent.

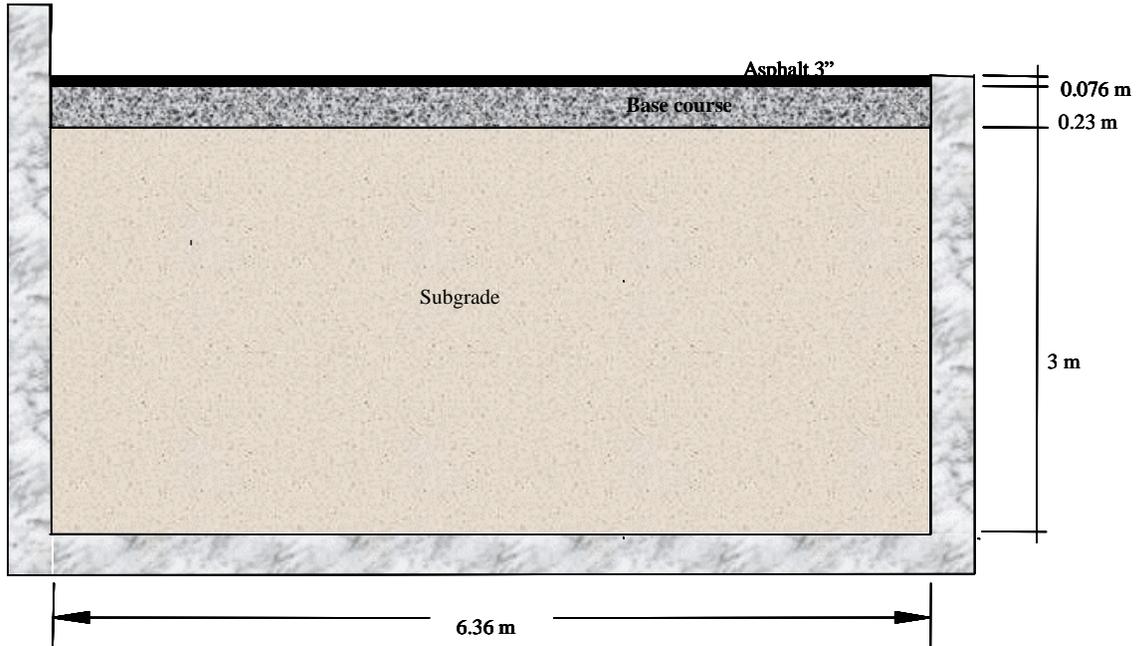
Figure 1b. Transversal cross section.

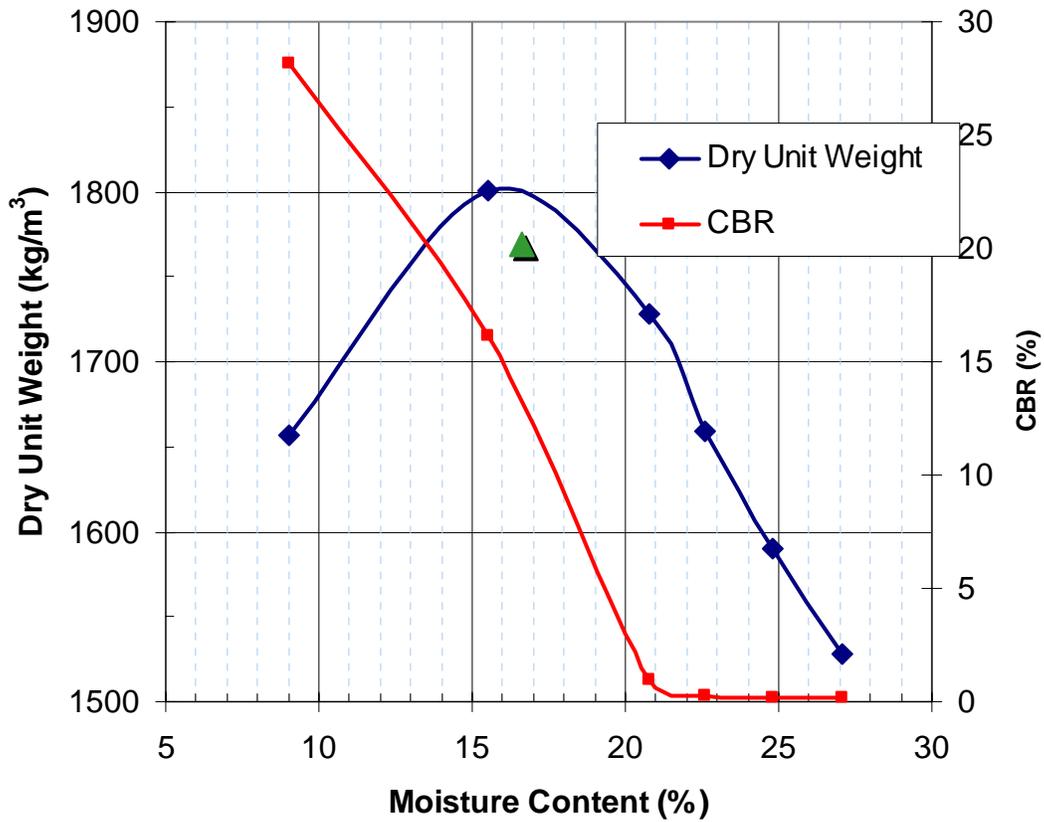
Figure 2. Modified Proctor and laboratory CBR test results for the subgrade soil.

Modified Proctor tests results show in Figure 3 indicated that the maximum density and optimum gravimetric moisture content for the subgrade soil were 1800 kg/m³ (112.5 pcf) and 16 % respectively. The design moisture content for this test section was the optimum moisture content, but the average as-built subgrade moisture content was 16.6 %. The laboratory CBR for this moisture content was approximately 13 percent.

Figure 18 also indicates when traffic was applied for each test window. Figure 3 shows that for the AASHTO A-6 subgrade soil at optimum moisture content of 16 the laboratory CBR value is 15 percent. Figure 19 shows that this is equivalent to a resilient modulus of 97 MPa (14 ksi). If the moisture content increases to 17.5 percent, the laboratory CBR is reduced to 10 percent, or 76 MPa (11 ksi). The CBR and resilient modulus decreases rapidly with an increase of moisture content on this subgrade soil type. The effect of moisture increase on the visco-plastic behavior of fine grain soils such as this AASHTO A-6 soil may be more pronounced than the effect on its elastic behavior.

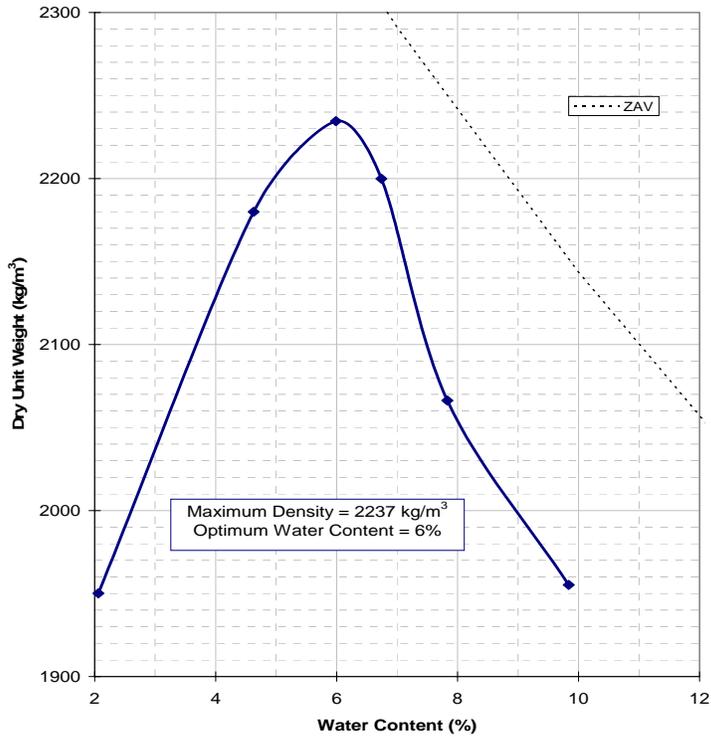
Figure 4. Base course modified Proctor test results.

The modified Proctor test results shown in Figure 4 indicate that the optimum gravimetric moisture content of the base course material was 6 percent and the maximum density was 2237 kg/m³ (139.5 pcf). Obtaining this moisture content with high hydraulic conductivity materials is difficult in practice. The average moisture content of the base course material during construction was 4.9 percent. The average moisture content of the base course material during the forensic evaluation was 3.2 percent. Apparently, the moisture content in the base course diminished gradually during the period of traffic testing. It appears that most of the moisture lost from the base course migrated down into the subgrade soil.

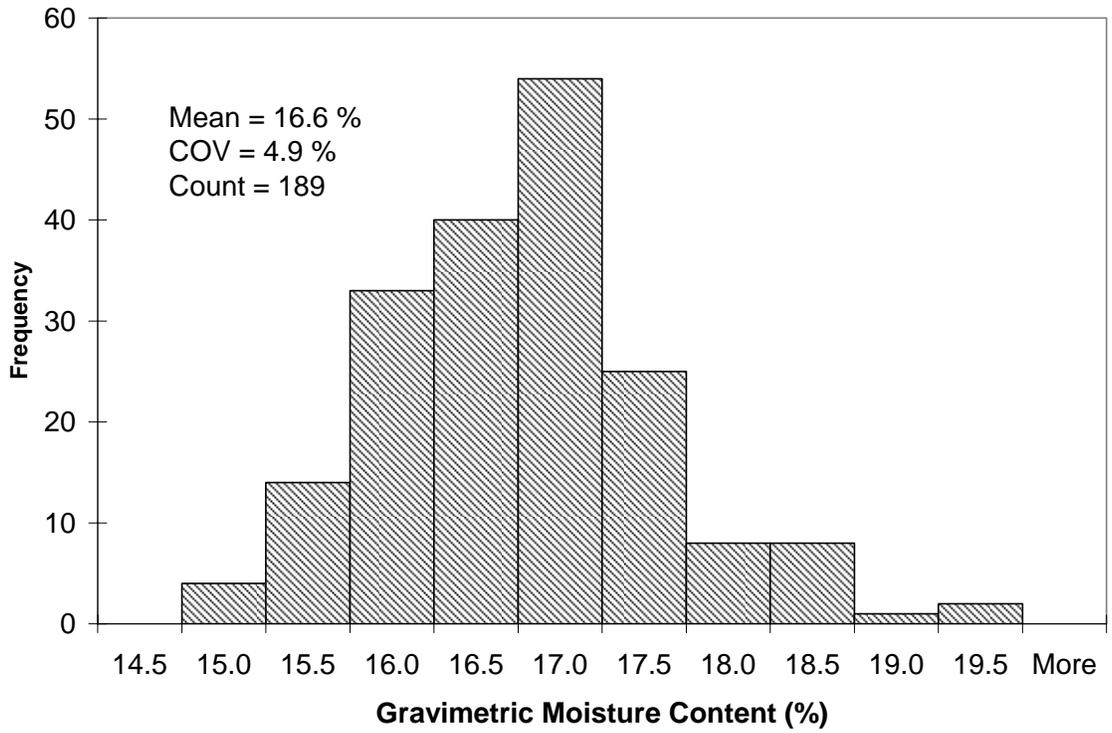
Figure 5. Subgrade moisture content.

The mean moisture content of the test subgrade was 16.6 percent. The average moisture content of the base was 4.9 percent. The mean dry density of the subgrade was 1769 kg/m^3 (109.9 pcf). The mean dry density of the base course was 2356 kg/m^3 (147.1 pcf). The mean density of the AC was 2304 kg/m^3 (143.8 pcf).

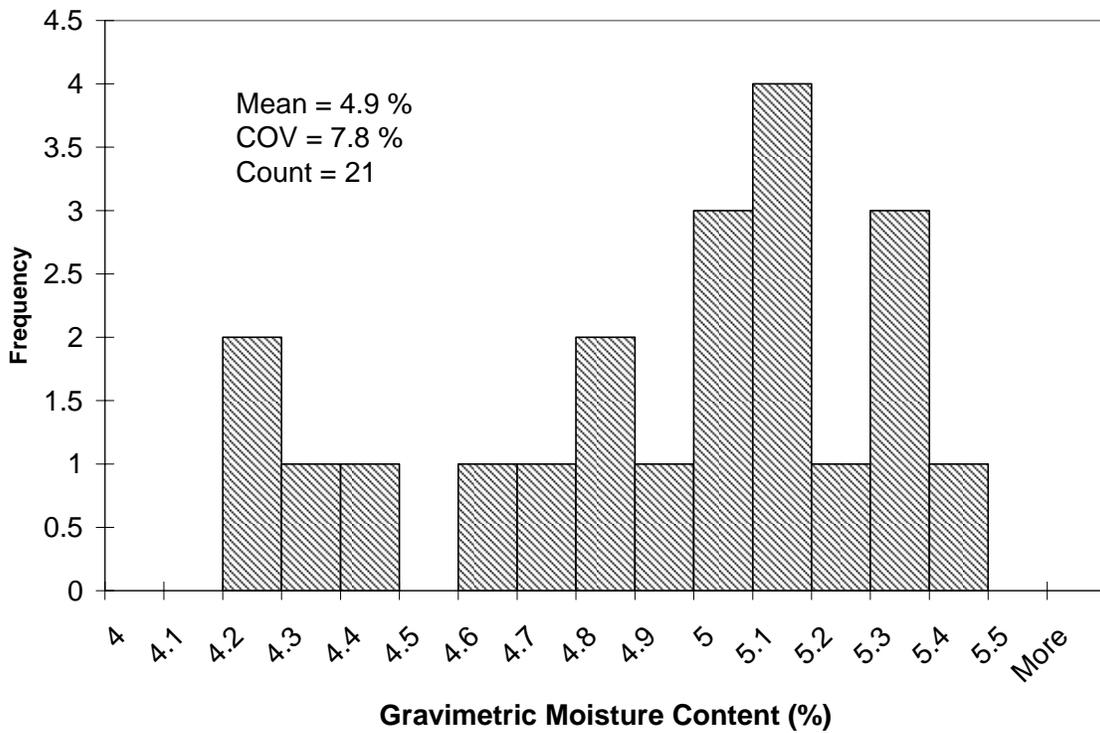
Figure 6. Base course moisture content.

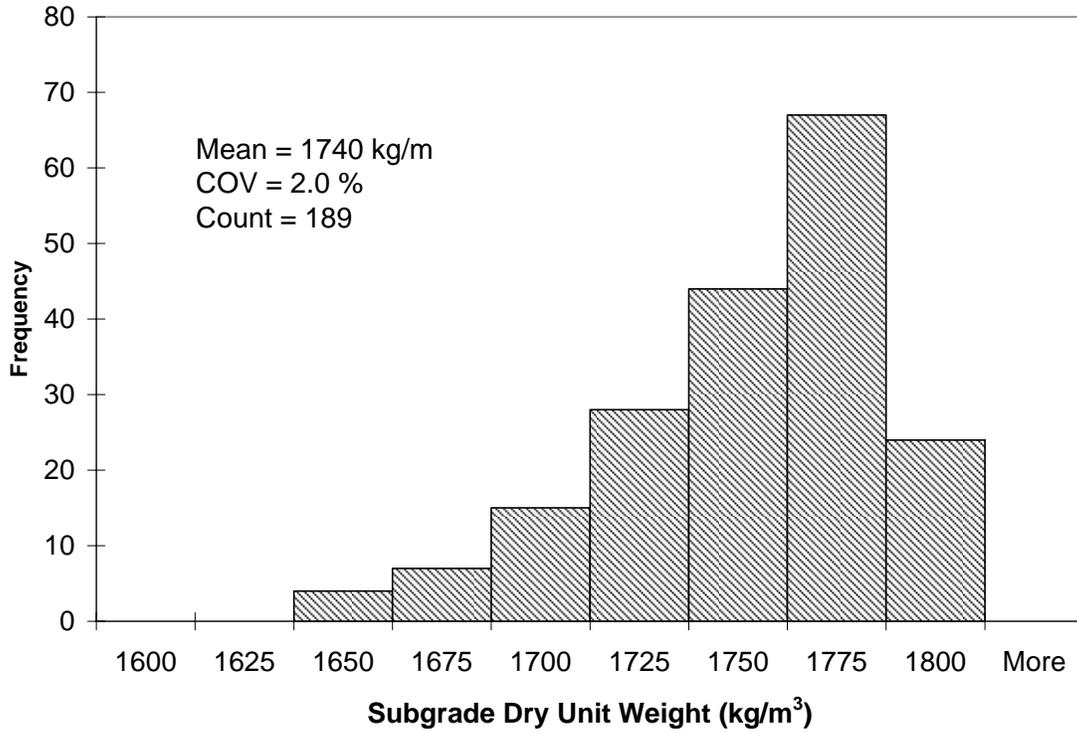
Figure 7. Subgrade dry unit weight.

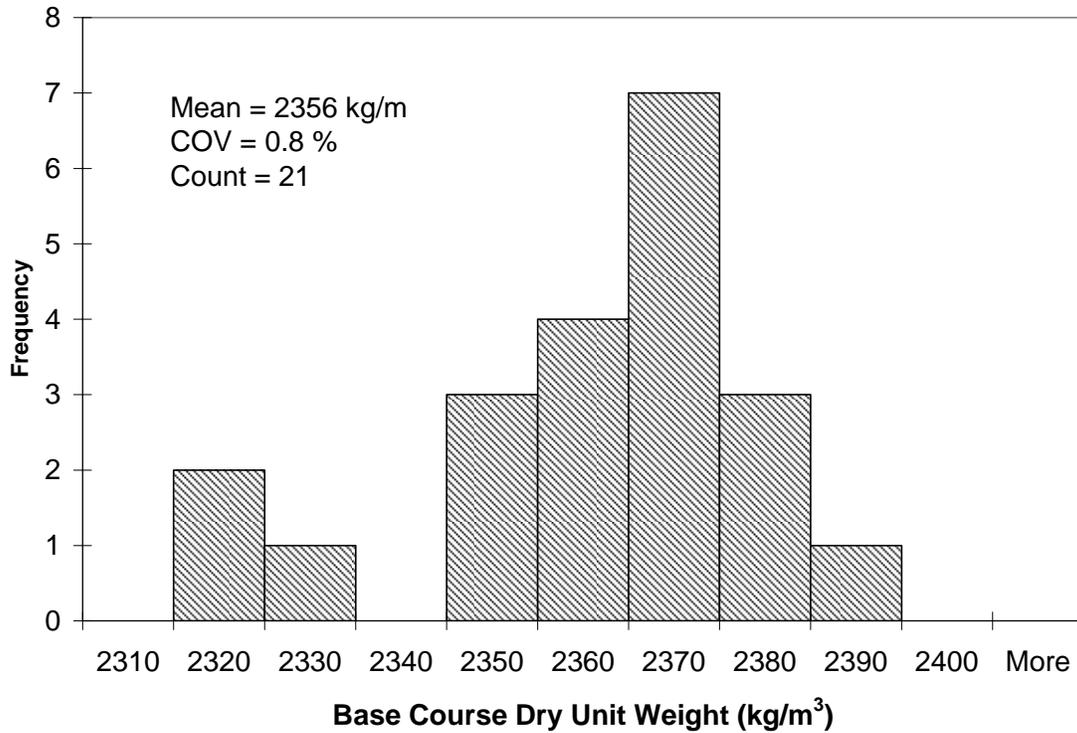
Figure 8. Base course dry unit weight.

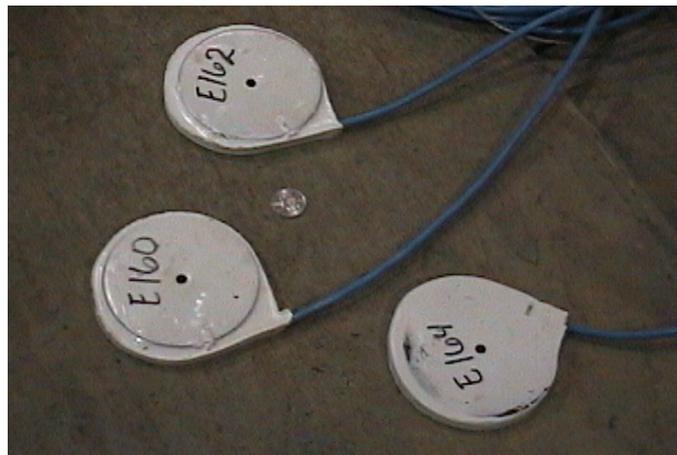
Figure 9. Emu coils in a co-planar arrangement to measure longitudinal and transverse deformations. A US 25-cent coin is included for scale reference.

Layer deformation measurements were made in the base and subgrade by means of ϵ mu coils. Strain can be deduced from deformation measurements between coil pairs in either coaxial or co-planar arrangements. The sensors were placed 150 mm center to center. Deformations were measured in the longitudinal (x), transverse (y), and vertical (z) direction of loading. Deformations in the vertical direction were measured to a depth of 1.52 m.

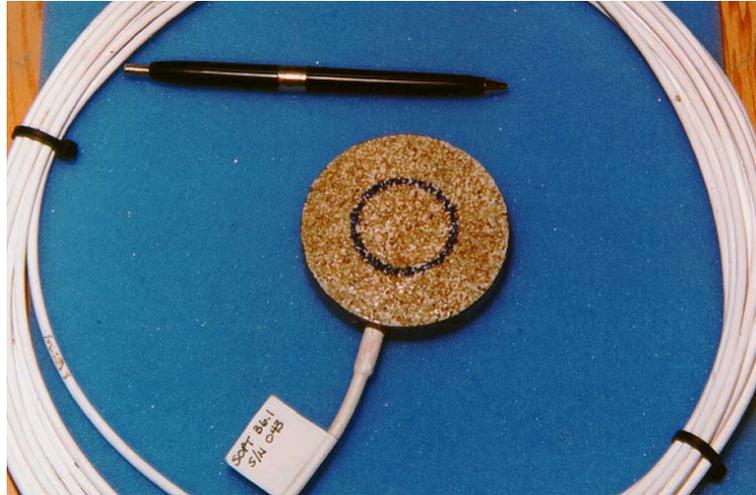
Figure 10. Dynatest® stress cell used in the subgrade.

A triaxial Dynatest® stress cell set was installed at a depth of 76 mm (3 in.) below the top of the subgrade in all test windows. In Test Window 2 an additional triaxial stress cell set was installed at a depth of 381 mm (15 in.) below the top of the subgrade. The diameter of the Dynatest® stress cells was 76 mm (3 in.).

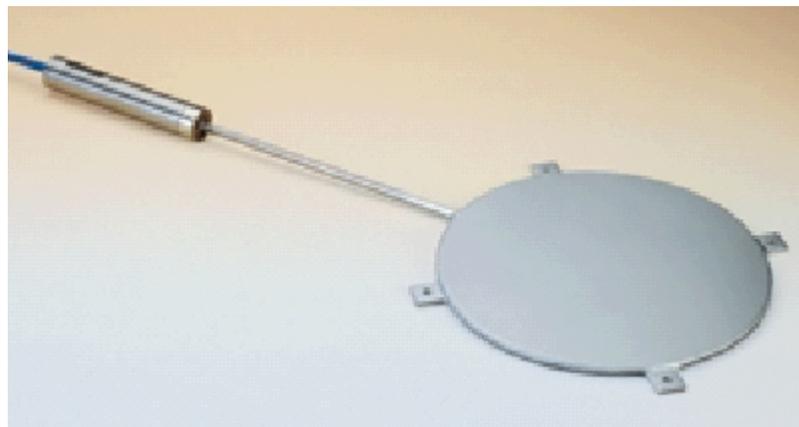
Figure 11. Geokon® stress cell used in the base course and subgrade.

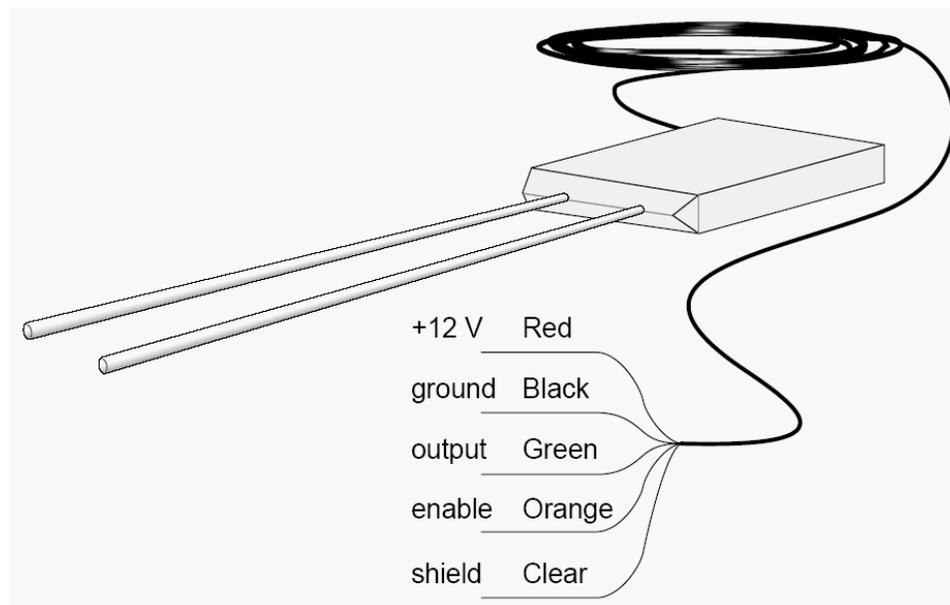
Figure 12. Campbell Scientific[®] reflectometer soil moisture probe model CS615.

Campbell Scientific® reflectometer soil moisture probes model CS615 were used to measure the moisture content in the base and subgrade during the traffic tests. These sensors measure the oscillation frequency between two rods embedded in the moist soil. The oscillation frequency is related to the dielectric constant that changes with moisture content, and to a lesser degree with temperature. The sensor readings are also affected by salinity, mineralogy and presence of organic materials. Volumetric moisture content is converted to gravimetric moisture content through weight-volume relationships and soil specific gravity. These sensors alone are not accurate enough for the purpose of this study, but this deficiency was corrected by oven dry measurements during construction and during the forensic evaluation.

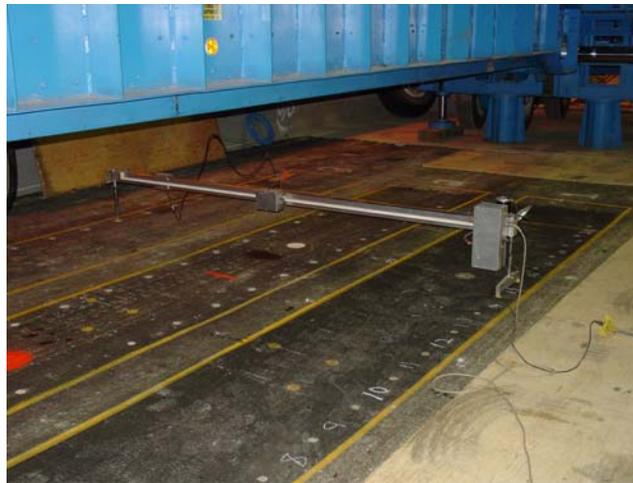
Figure 13. Laser profilometer.

passes and the corresponding depth measured at zero passes. A typical surface rut measurement and the definition of maximum rut depth are shown in Figure 15. Traffic testing was terminated when the average maximum surface rut depth of 12.5 mm was reached or exceeded.

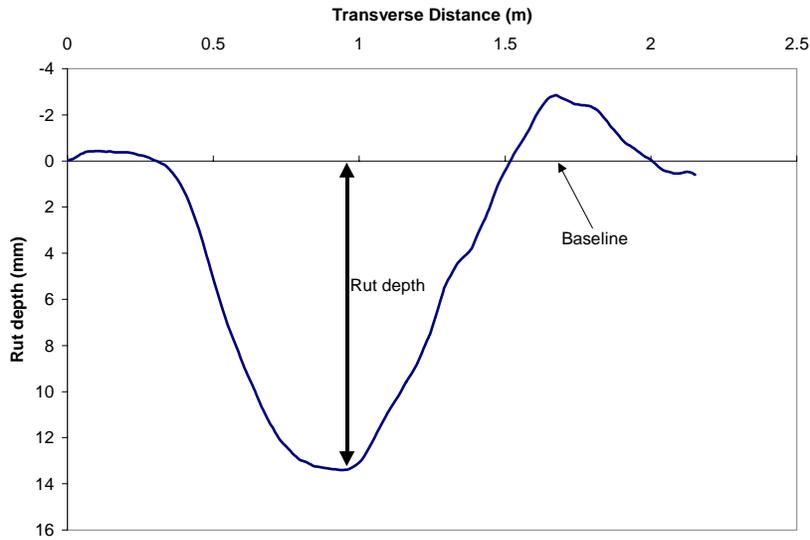
Figure 15. Definition of rut depth.

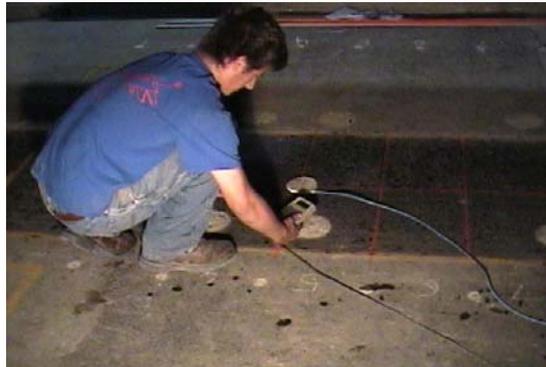
Figure 16. Measuring vertical deformation between the AC surface and the top of the base course.

4. Subsurface stress and displacement measurements conducted in the vertical, longitudinal, and transverse directions relative to the direction of traffic. The measurements were conducted at various pass levels to define their progression throughout the traffic tests. The displacement measurements were conducted dynamically upon the passing of tire traffic, and also statically when no traffic was occurring. The dynamic deformations measured the resilient deformation during traffic load events. The static measurements were intended to measure permanent deformation.
5. In addition to the ϵ mu coils embedded in the pavement, a mobile coil was placed on top of the asphalt over the vertical stack of embedded ϵ mu coils as shown in Figure 16. This provided a means to measure the vertical permanent deformation in the asphalt layer.

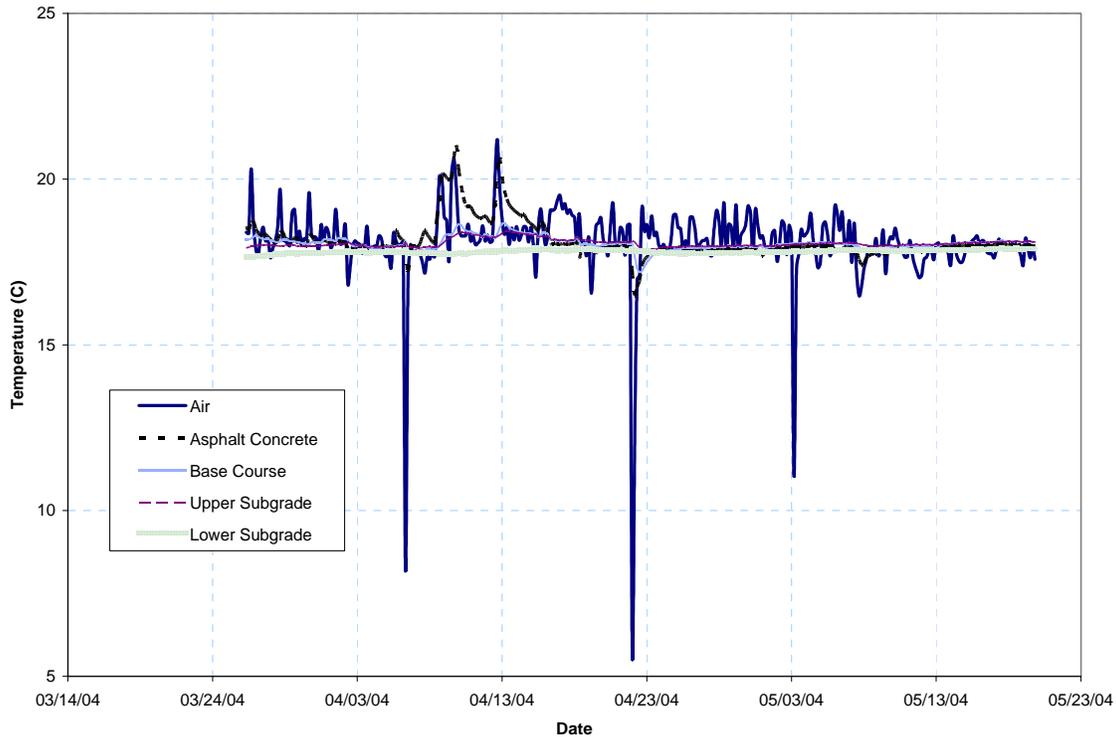
Figure 17. Air and pavement temperatures during the traffic test period.

The temperature oscillations in the asphalt concrete were not large enough to cause any significant stiffness variation. Thermocouples are accurate to ± 0.5 °C.

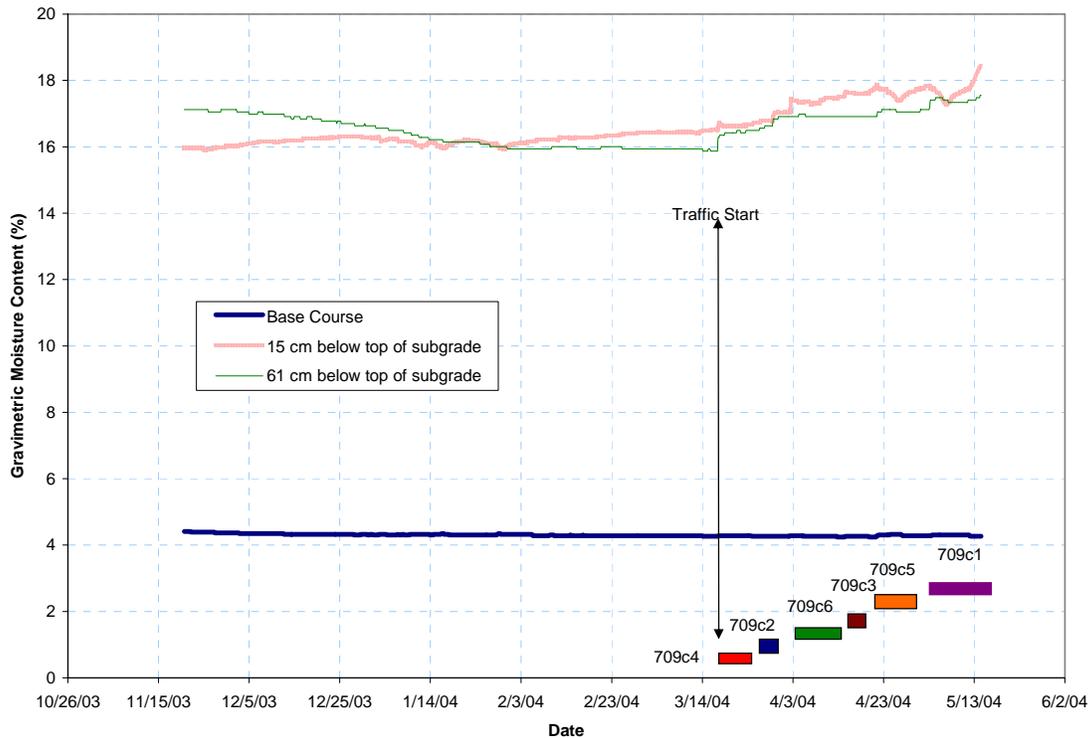
Figure 18. Moisture measurements in the base and subgrade in the period from construction to the forensic evaluation.

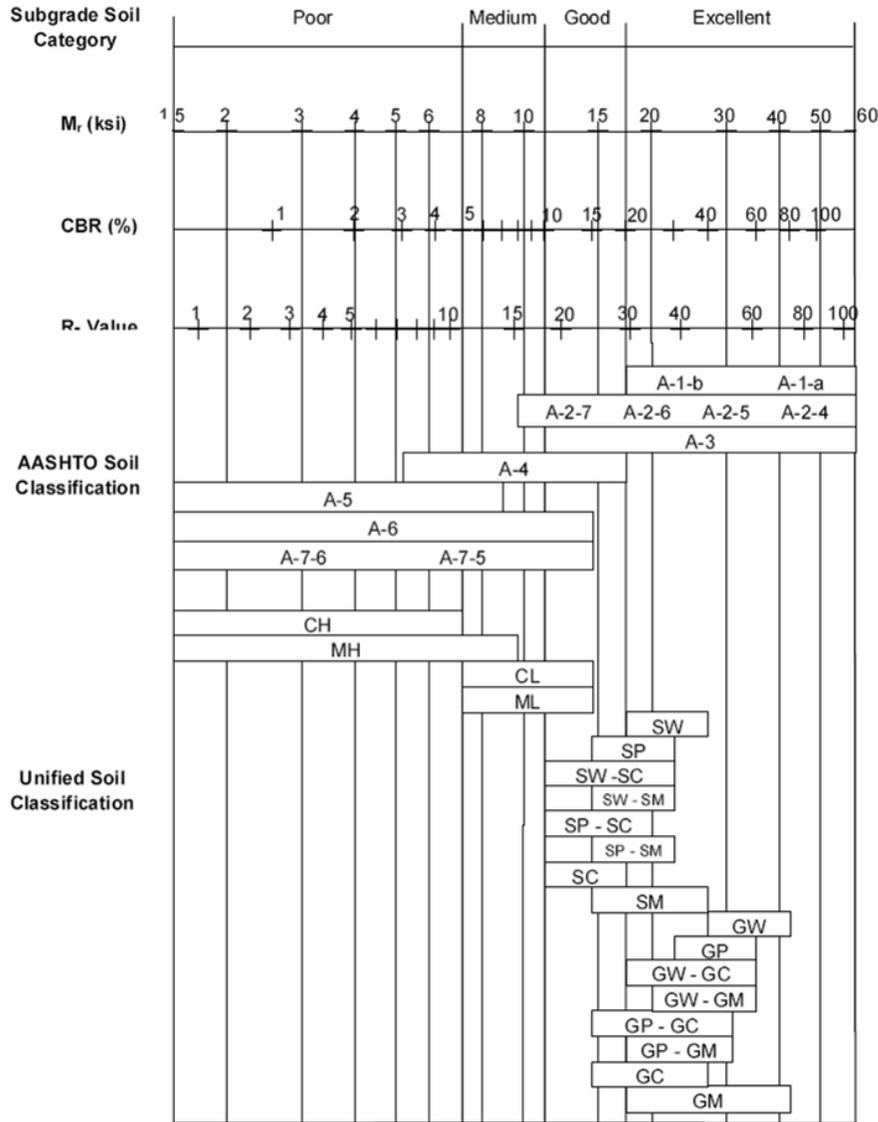
Figure 19. Relationships between CBR and resilient modulus for various soil types. (AASHTO M-E Guide, 2004).

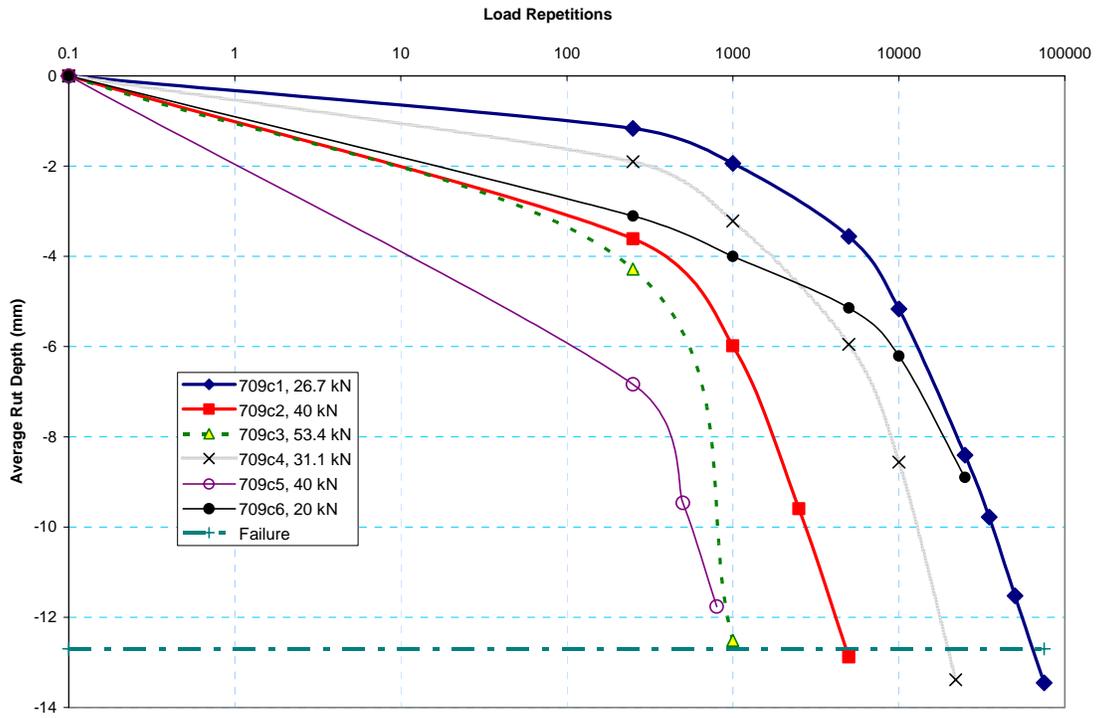
Figure 20. Average rut depth as function of semi-axial load intensity and repetitions.

The progressions of rut depths as a function of load repetitions in the various windows are presented in Figure 20. The average rut depth as a function of applied load was used to determine the number of load repetitions to reach the failure rut depth of 12.7 mm. In general, as the applied load increased so did the rate of rutting depth. However, the results from Test Windows 709c5 and 709c6 were anomalous because the asphalt concrete developed cracks and delamination prematurely. Test Window 709c4 was tested first. When the average rut depth was about the 12 mm, the asphalt surface course delaminated from the lower asphalt layer at a strip nearly including the northeastern portion of the test window. Cracking and shoving related to the asphalt delamination was observed as shown in Figure 23. The traffic was then stopped to avoid damage to the HVS, and the test was ended. The asphalt damage created cracks that later grew into Test Window 709c5. Test Windows 709c1 and 709c3 were then tested. The only distress observed in three test windows in the south region of the test section was surface rutting. No visible crack or other asphalt distress was observed in these test windows. Contrastingly, the three test windows in the north region of the test section had premature asphalt cracking, delamination, and shoving. Test Window 709c6 was tested next. The damage caused by traffic on Test Window 709c6 included cracks that grew quickly onto Test Window 709c5 when traffic was applied to this test window as shown in Figure 25. Therefore, the results from Test Windows 709c5 and 709c6 should be excluded from the analysis of Test Section 709. Notice the striations on the lower asphalt layer that are aligned with the direction of traffic. The exposed lower surface displayed a light colored, thin film of rock powder produced by grinding of aggregates during delamination and shoving. The premature asphalt failure was probably due to excessive cooling of the asphalt during placement and compaction. Paving occurred in a cold day at the end of the paving season. More detailed examination of the asphalt failure was conducted during the forensic evaluation, and the existence of delamination and poor bond between the upper and lower asphalt layers were confirmed. Interlayer bond in the south region of the test section that includes test windows 709c1, 709c2 and 709c3 was adequate.

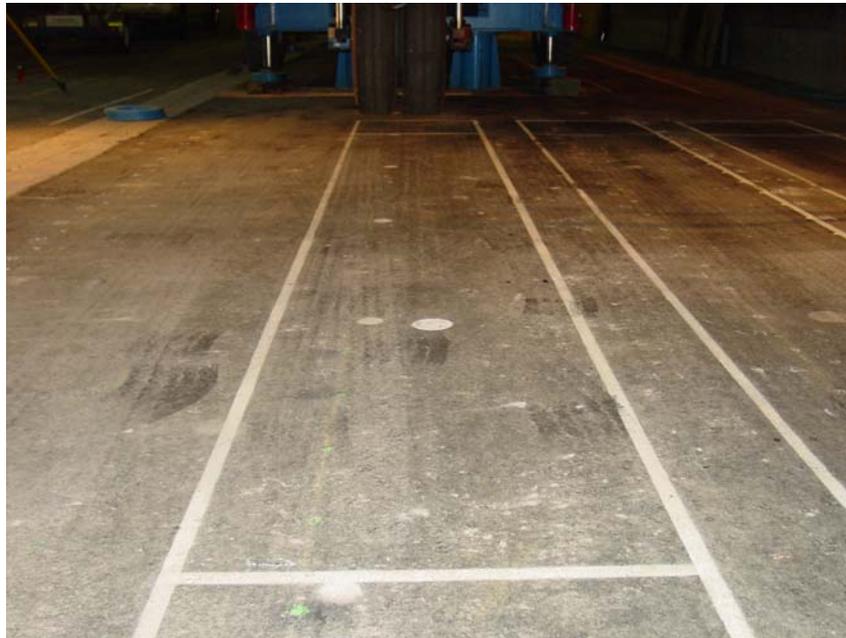
Figure 21. Test Window 709c1 before HVS traffic.

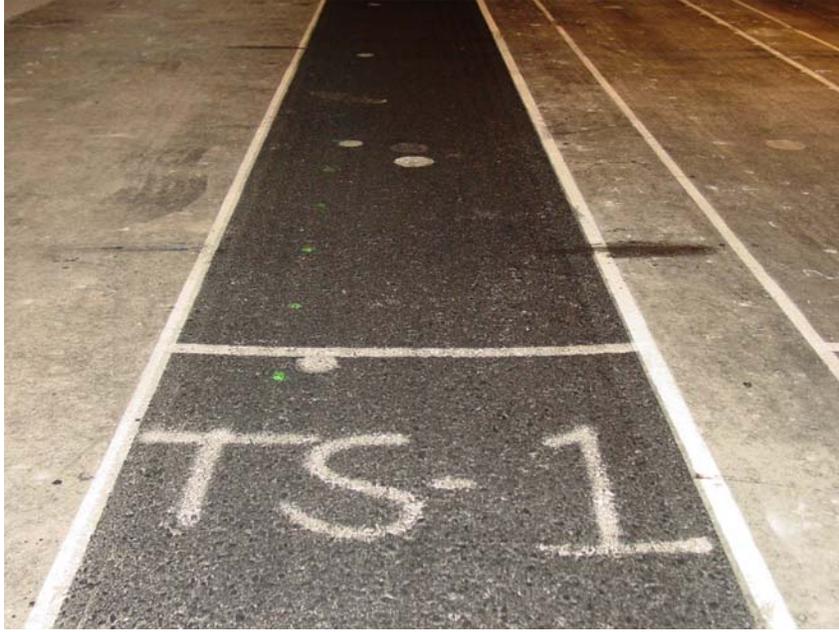
Figure 22. Test Window 709c1 at the end of HVS traffic.

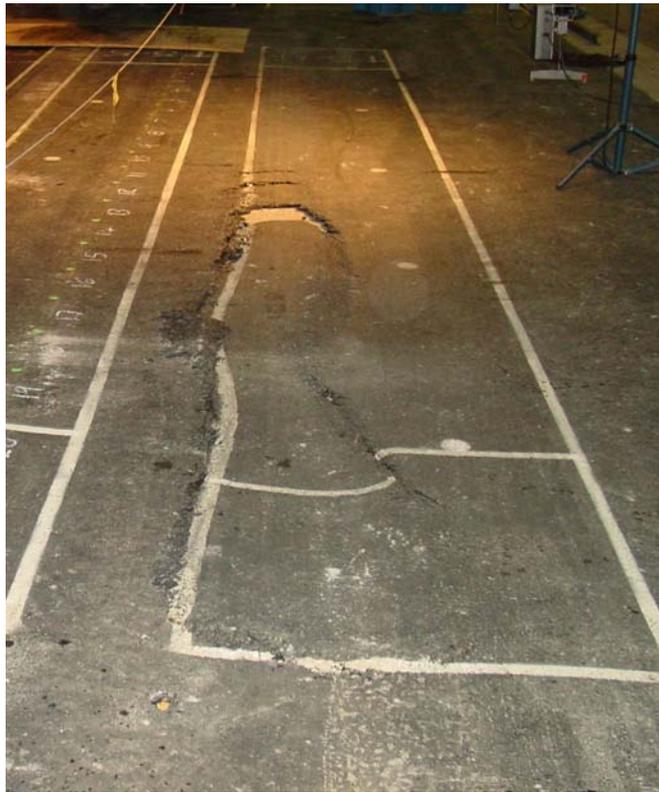
Figure 23. Test Window 709c4 at the end of HVS traffic.

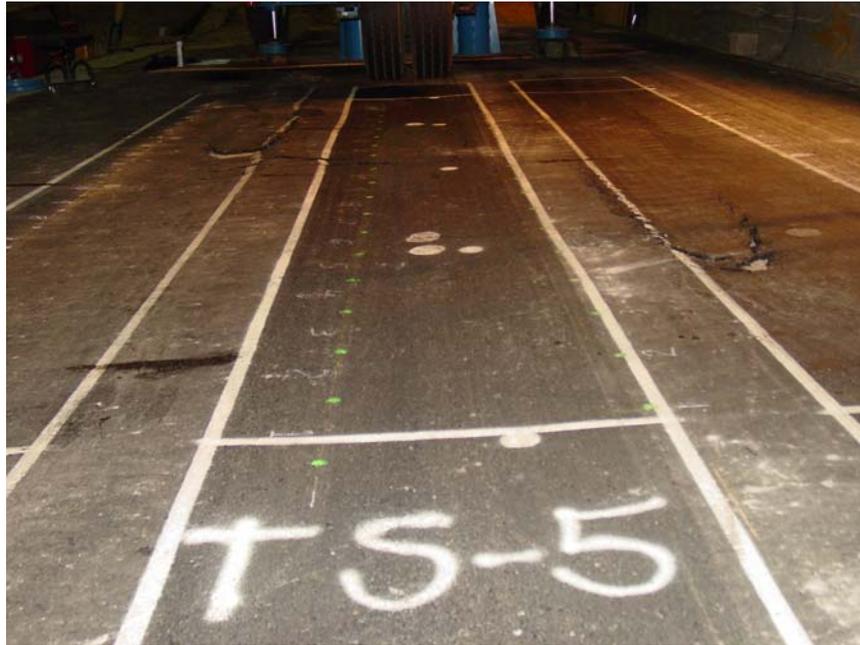
Figure 24. Damage to Test Windows 709c5 caused by neighboring test windows.

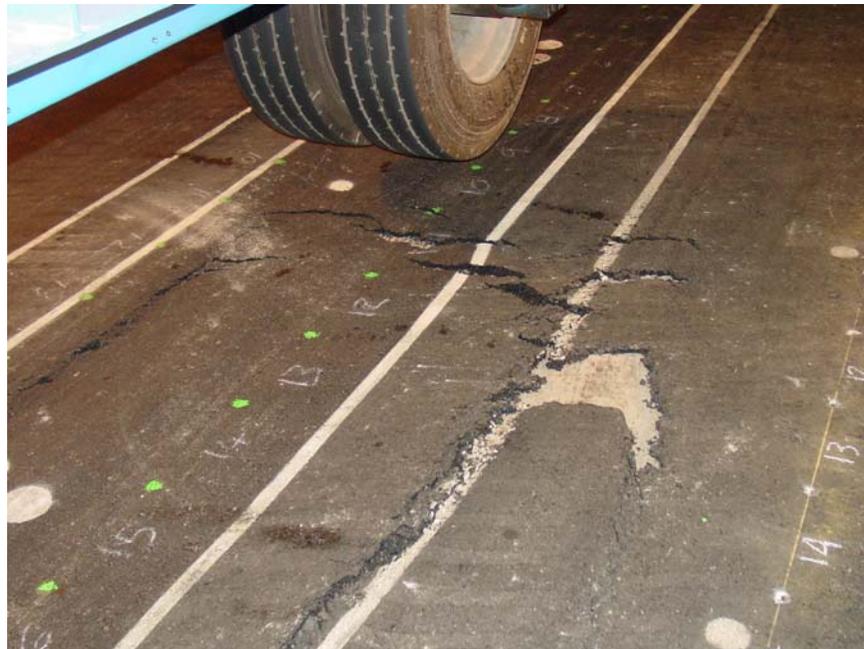
Figure 25. Test Window 709c5 at the end of HVS traffic.

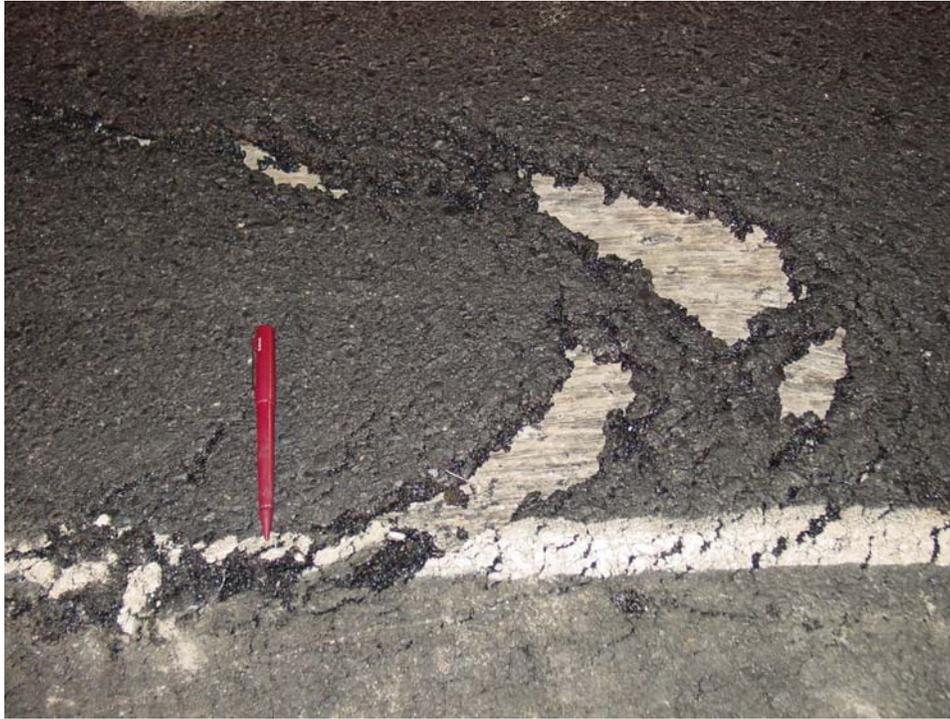
Figure 26. Close up of delaminated area showing striations on the lower asphalt layer.

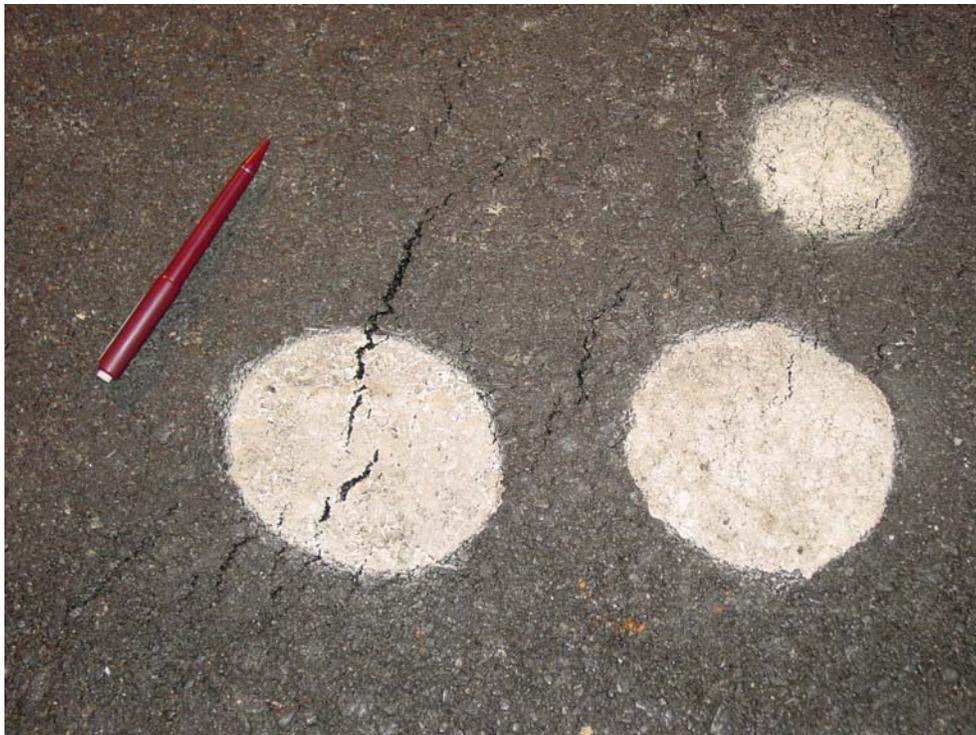
Figure 27. Close up of asphalt cracking over the emu sensors.
