PAVEMENT SUBGRADE PERFORMANCE STUDY

National Pooled Fund Study SPR-208

Test Section 709

Subgrade AASHTO soil type A-6 at optimum moisture content

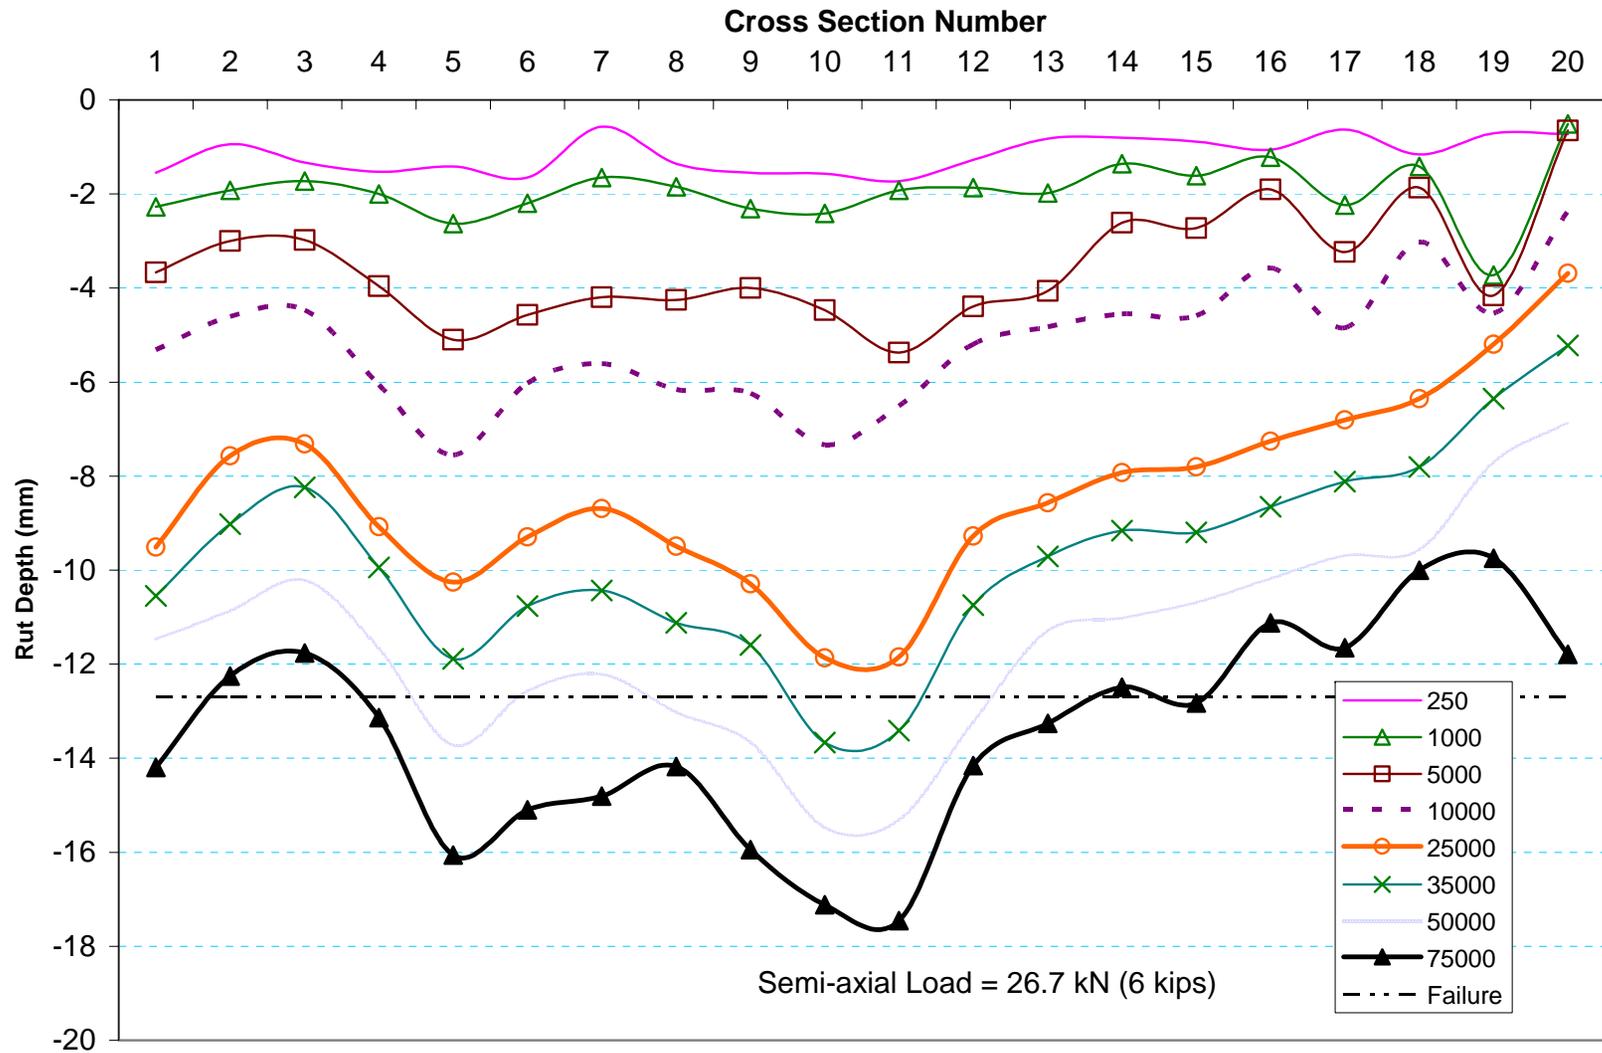
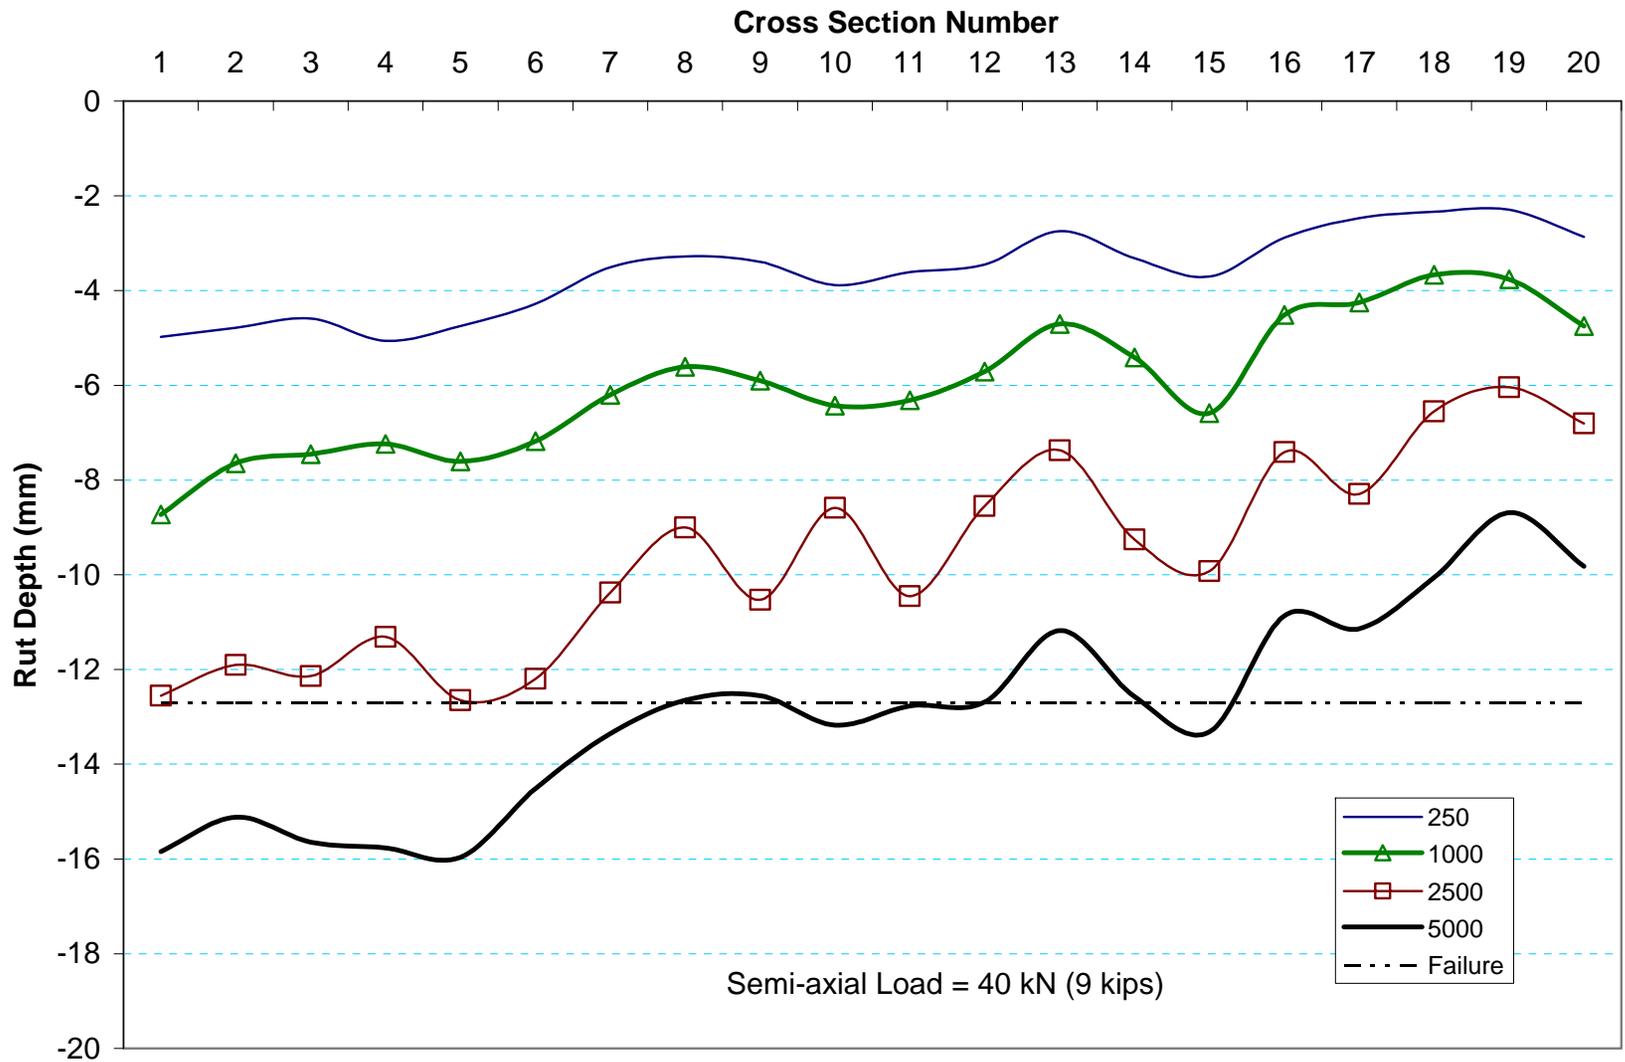
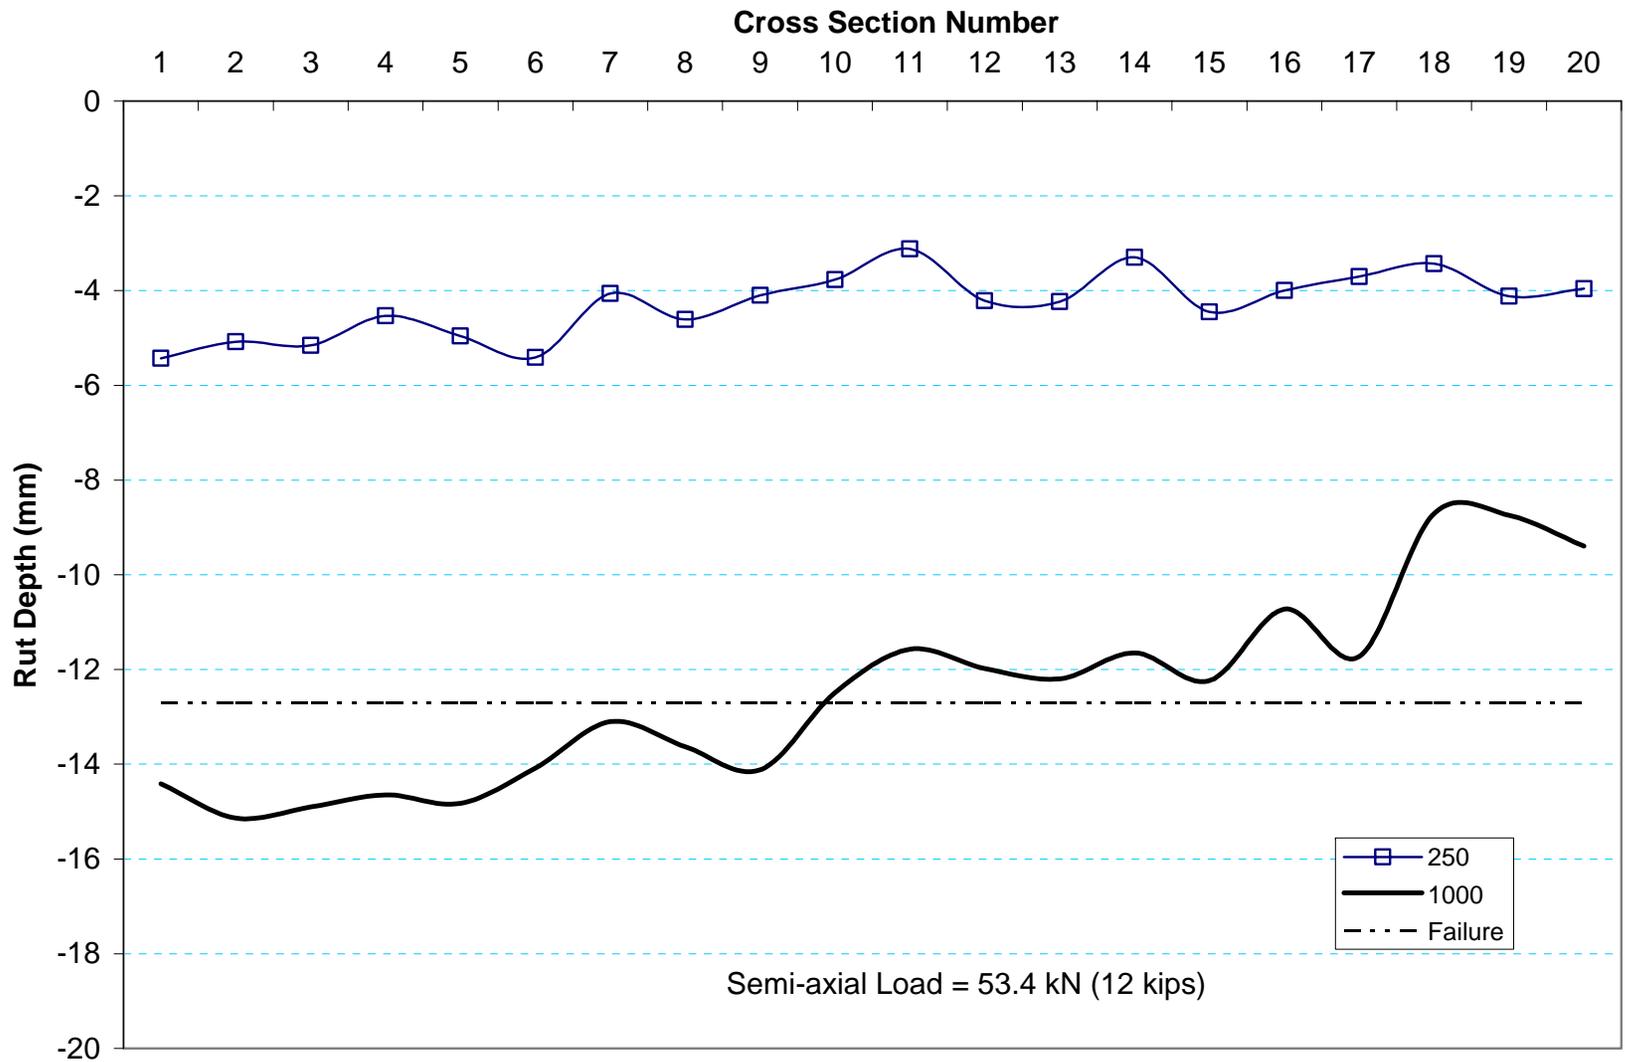
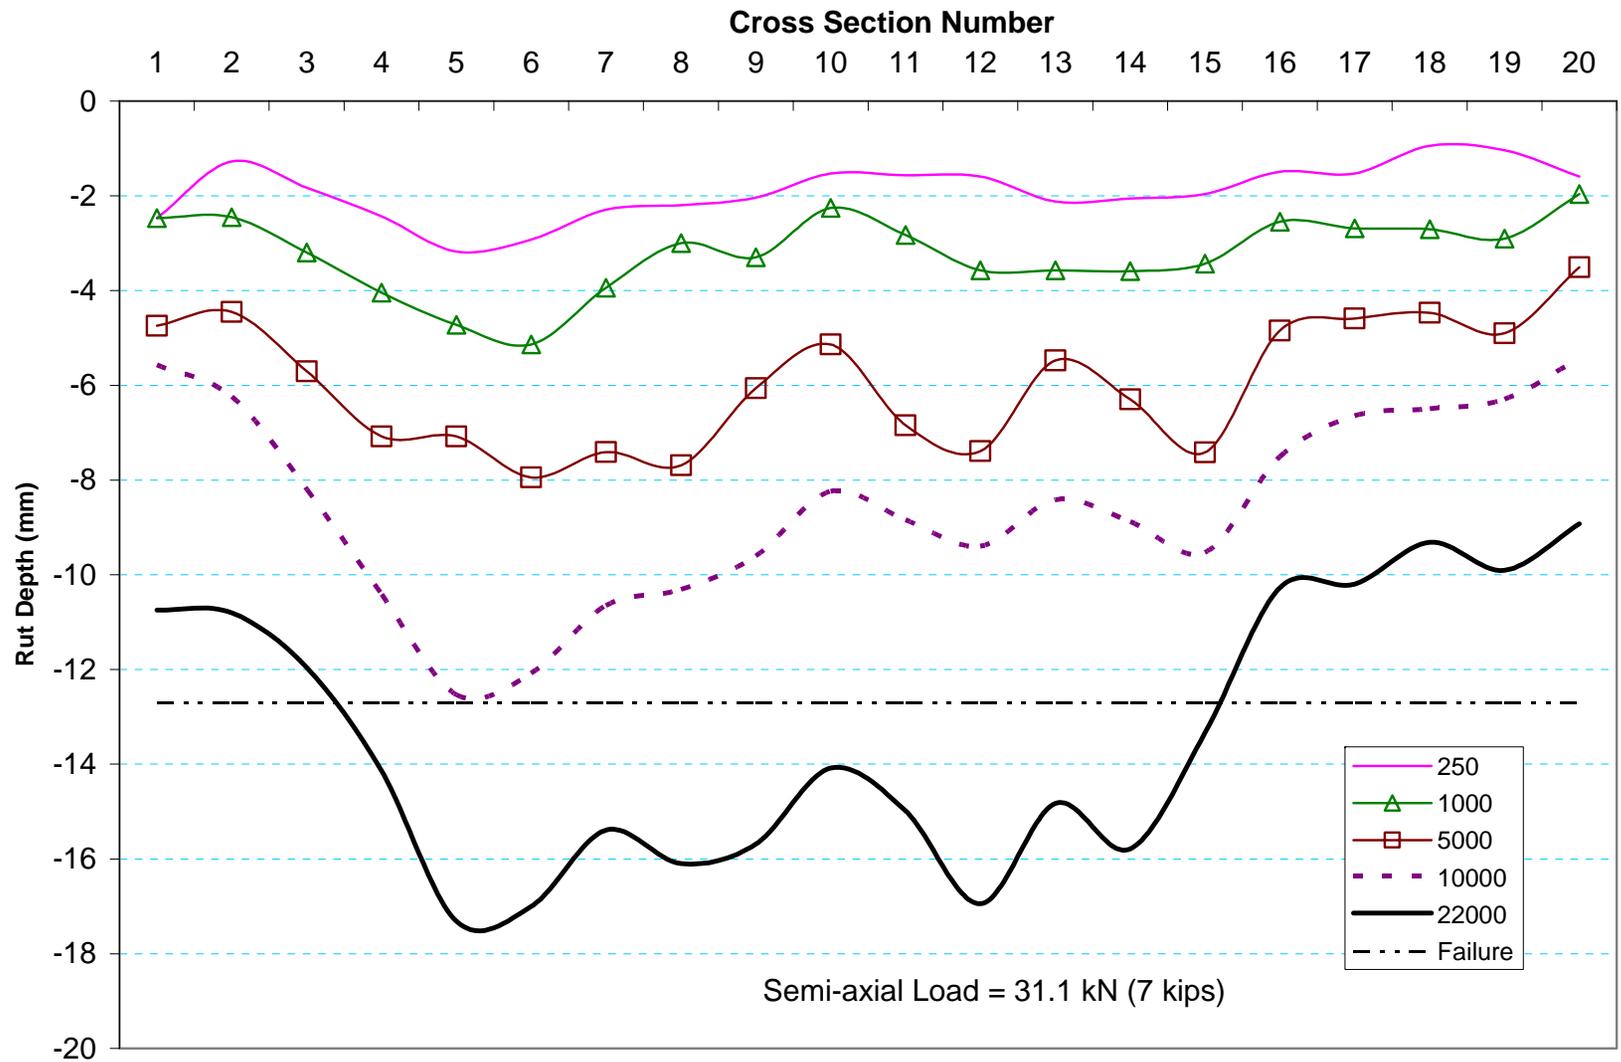
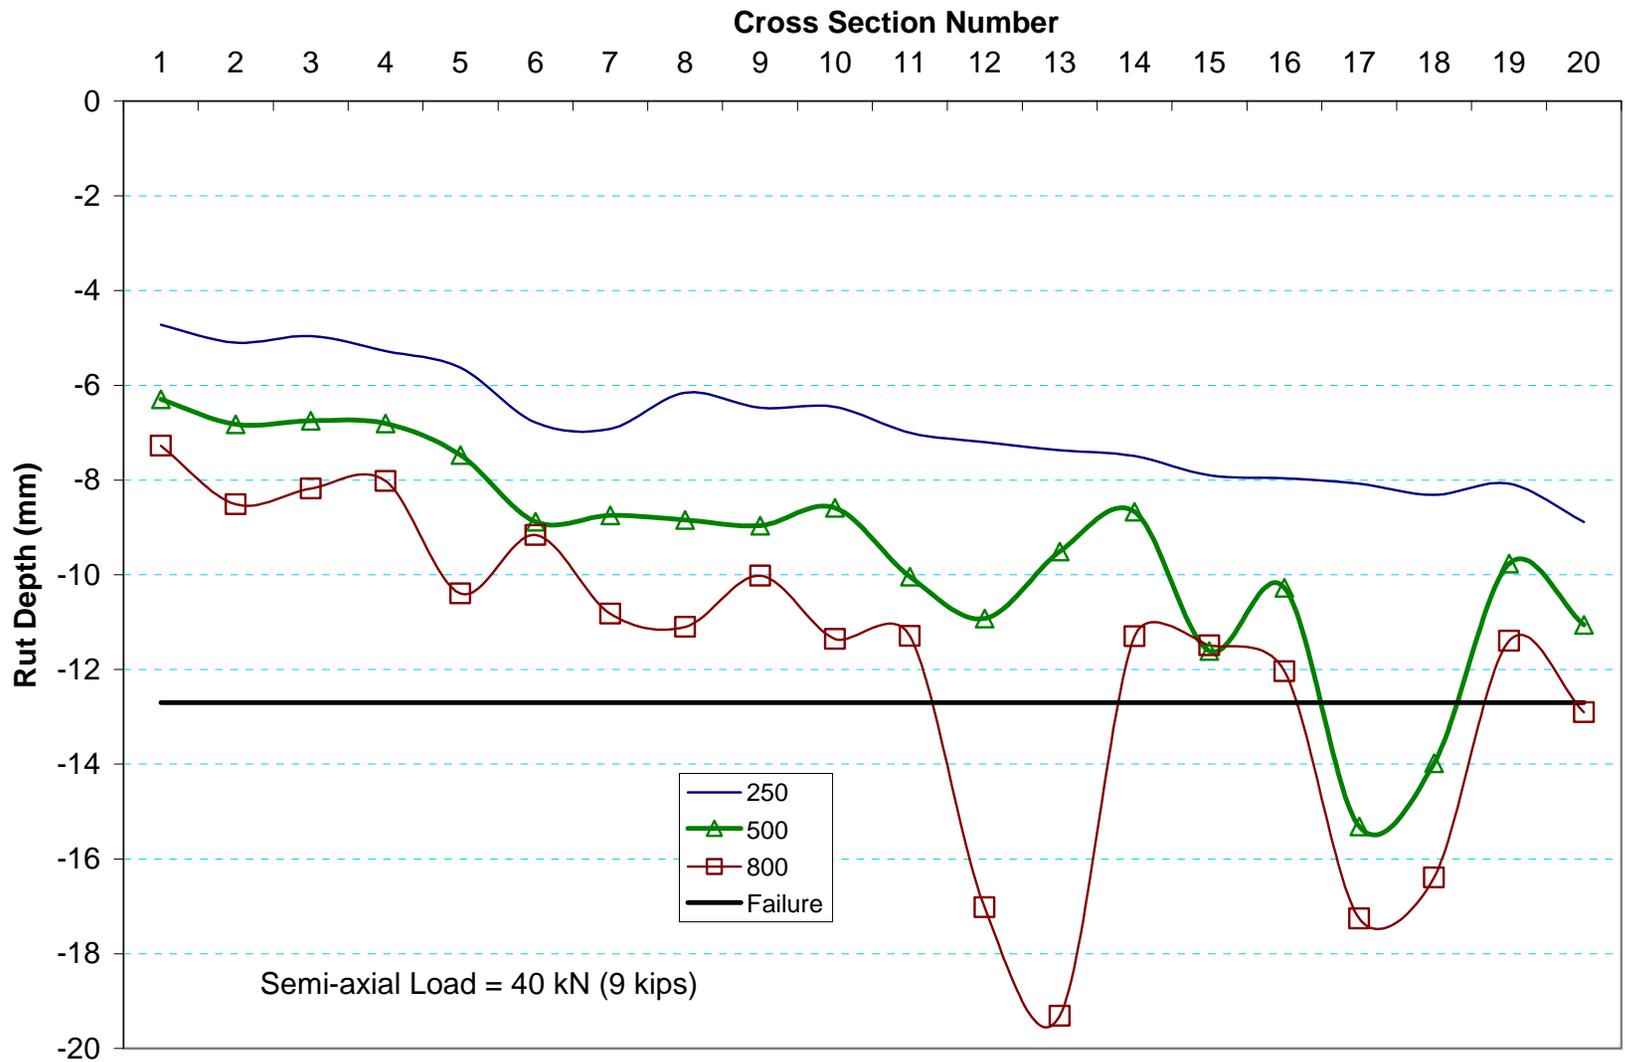
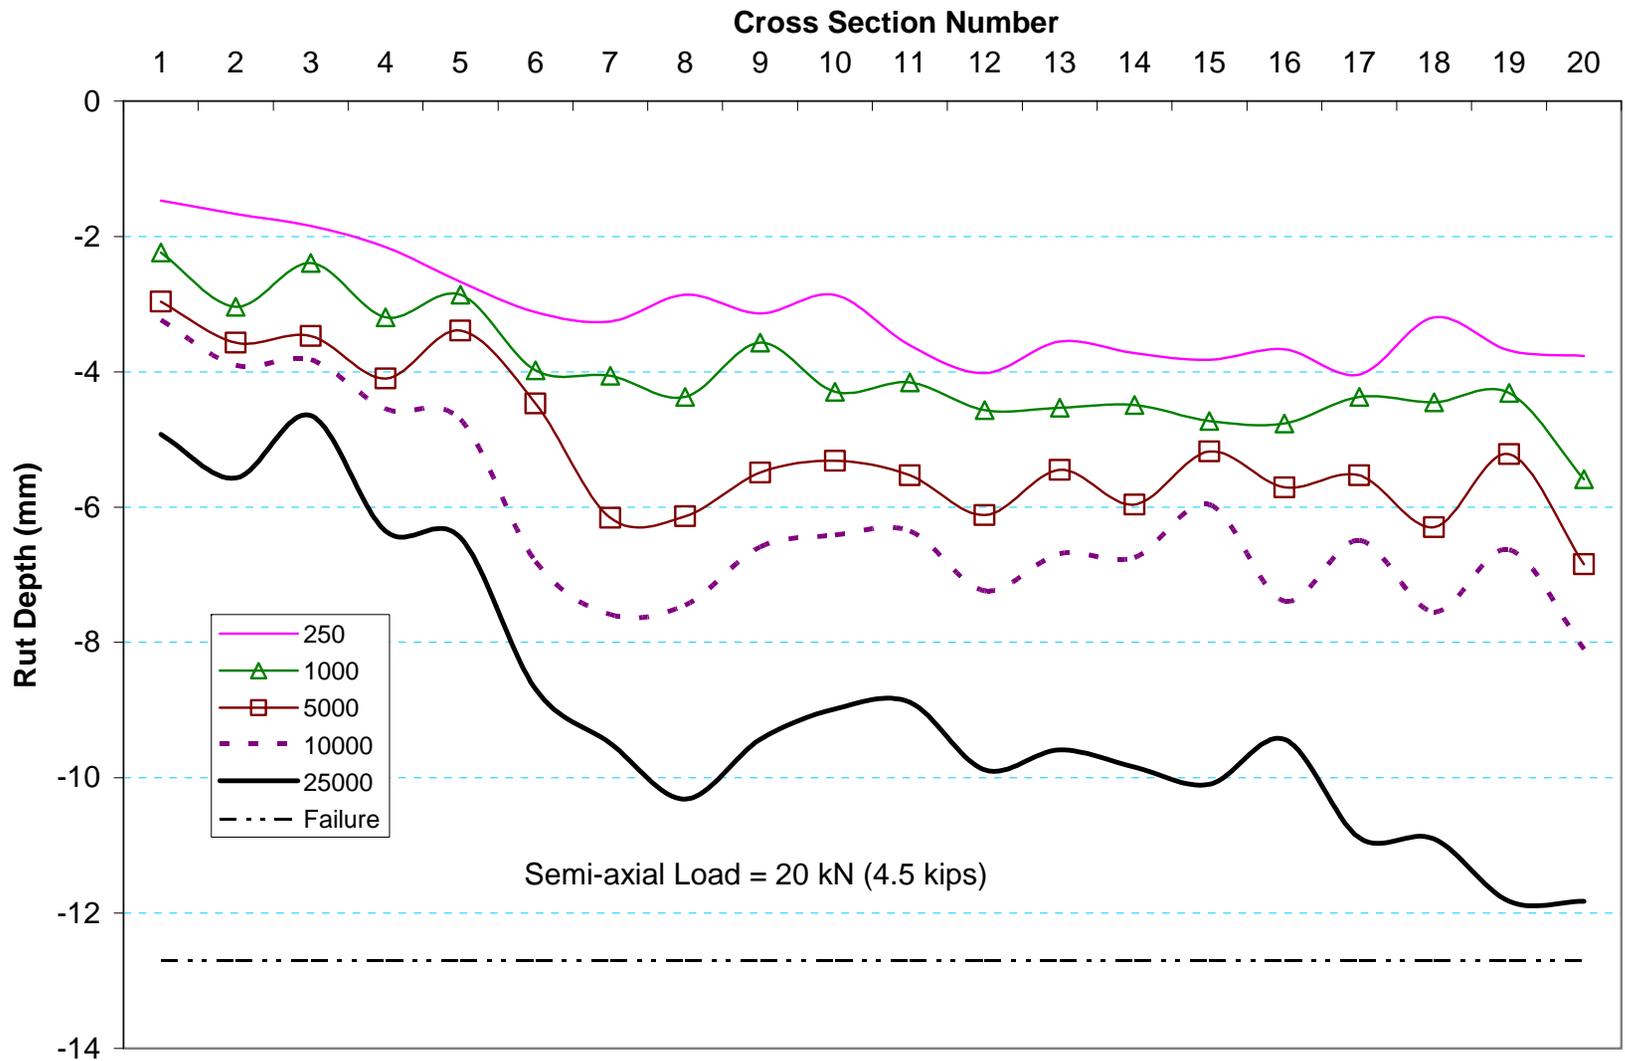
Figure 28. Progression of surface rutting along the center of the tire path in Test Window C1.

Figure 29. Progression of surface rutting along the center of the tire path in Test Window C2.

Figure 30. Progression of surface rutting along the center of the tire path in Test Window C3.

Figure 31. Progression of surface rutting along the center of the tire path in Test Window C4.

Figure 32. Progression of surface rutting along the center of the tire path in Test Window C5.

Figure 33. Progression of surface rutting along the center of the tire path in Test Window C6.

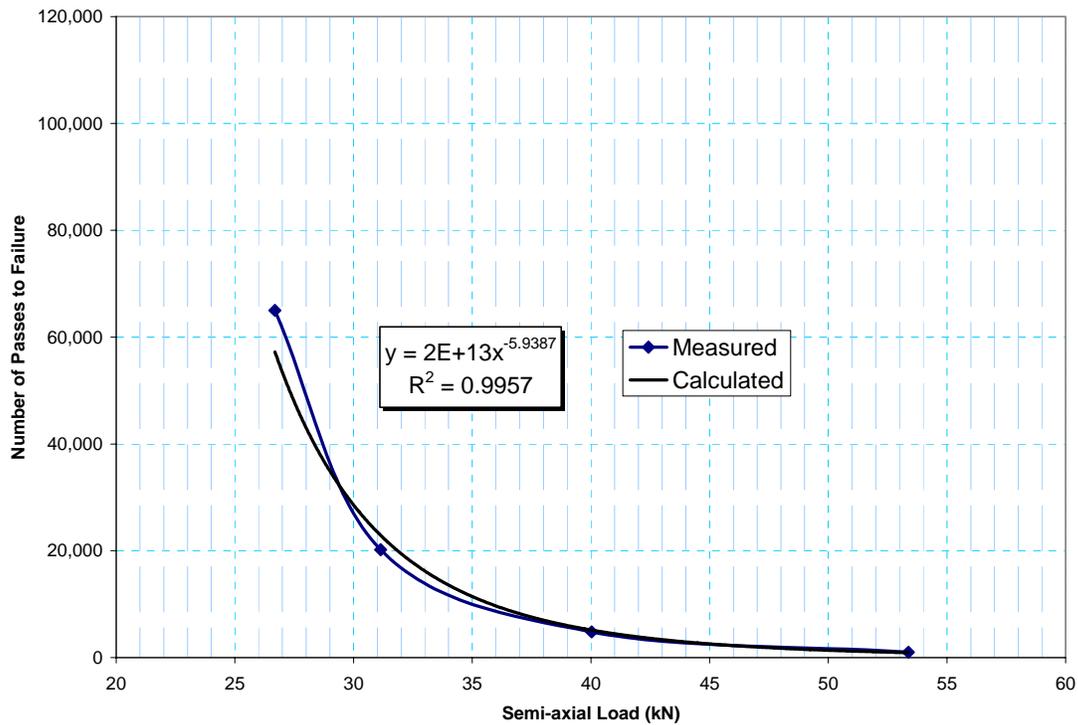
Figure 34 Load repetitions as a function of rut depth.

Table 8 shows the number of traffic passes that were required to cause a rut depth of 12.7 mm (0.5 in). The results from Test Windows 709c5 and 709c6 were excluded due to the premature asphalt concrete failures described above. Figure 34 graphically shows the relationship between load intensity and number of traffic passes to failure, and also a power function that fits the experimental data with an R^2 value of 0.996.

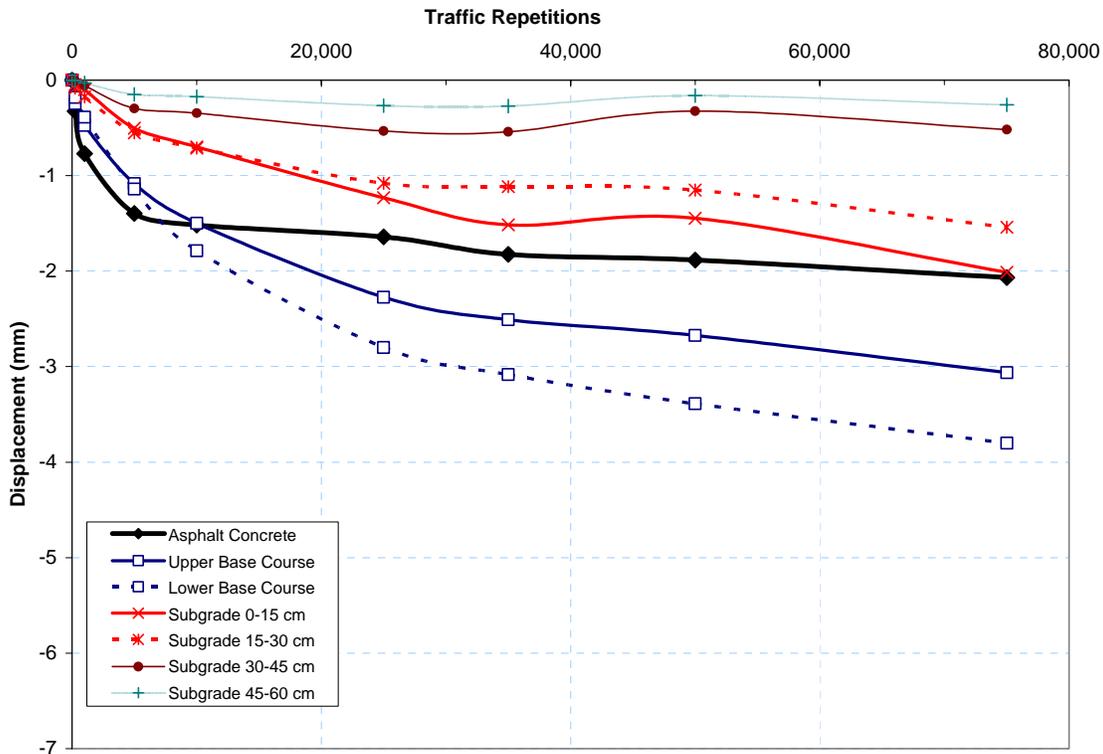
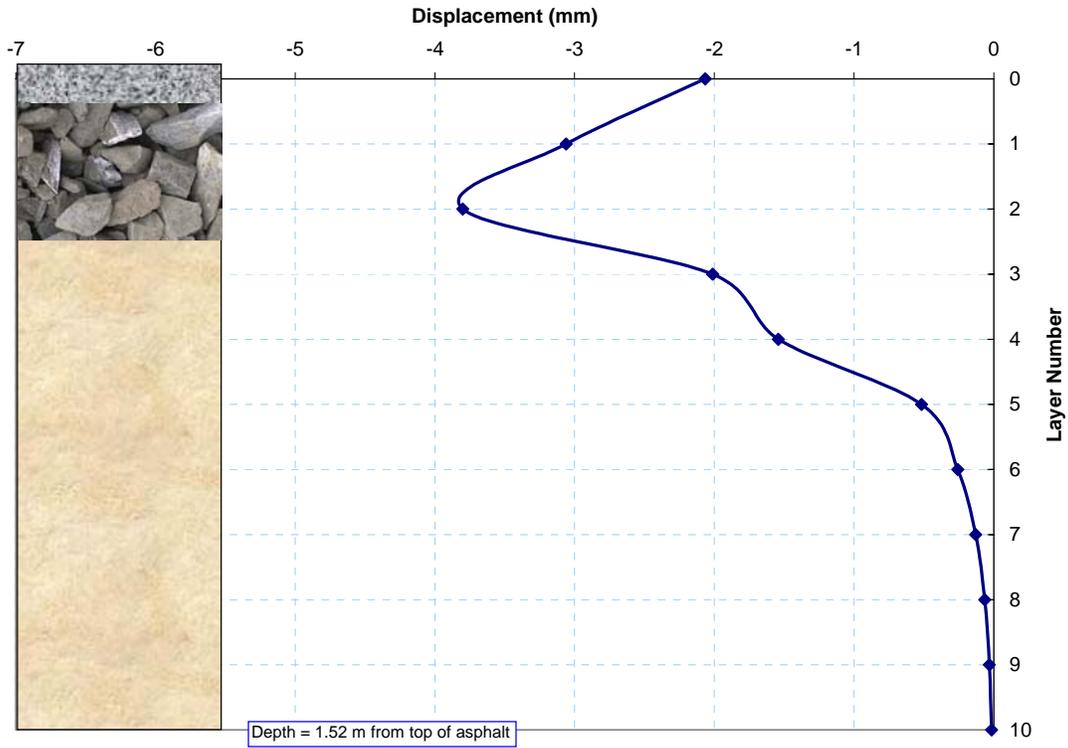
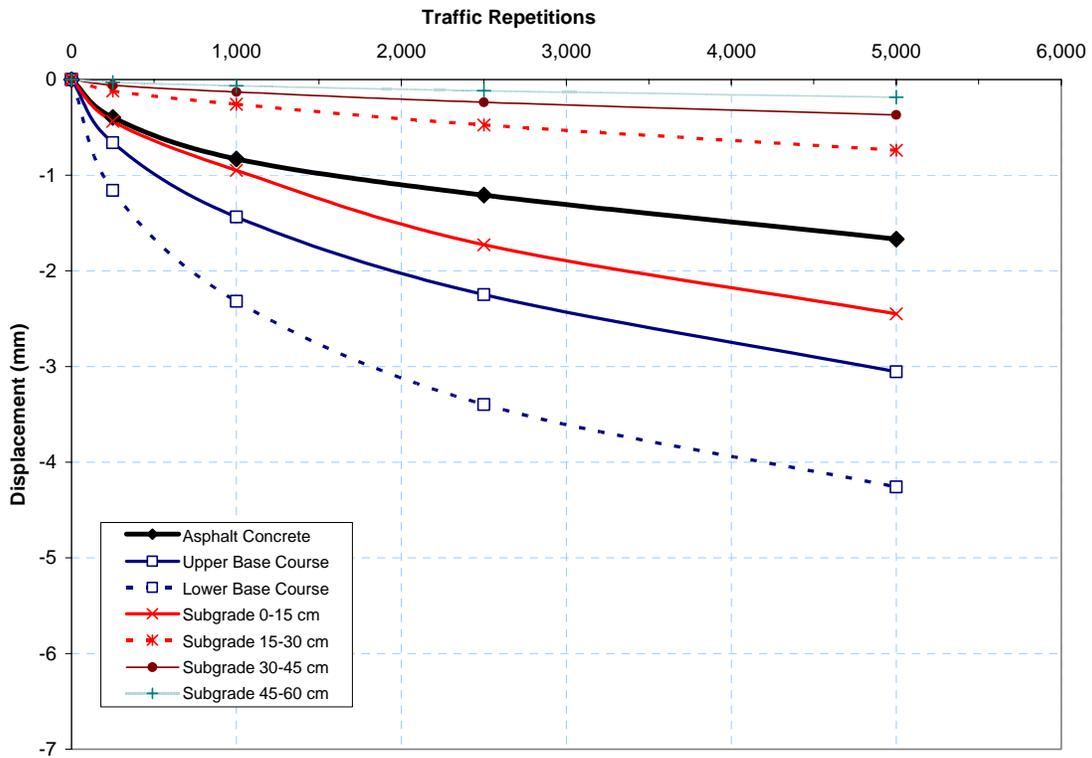
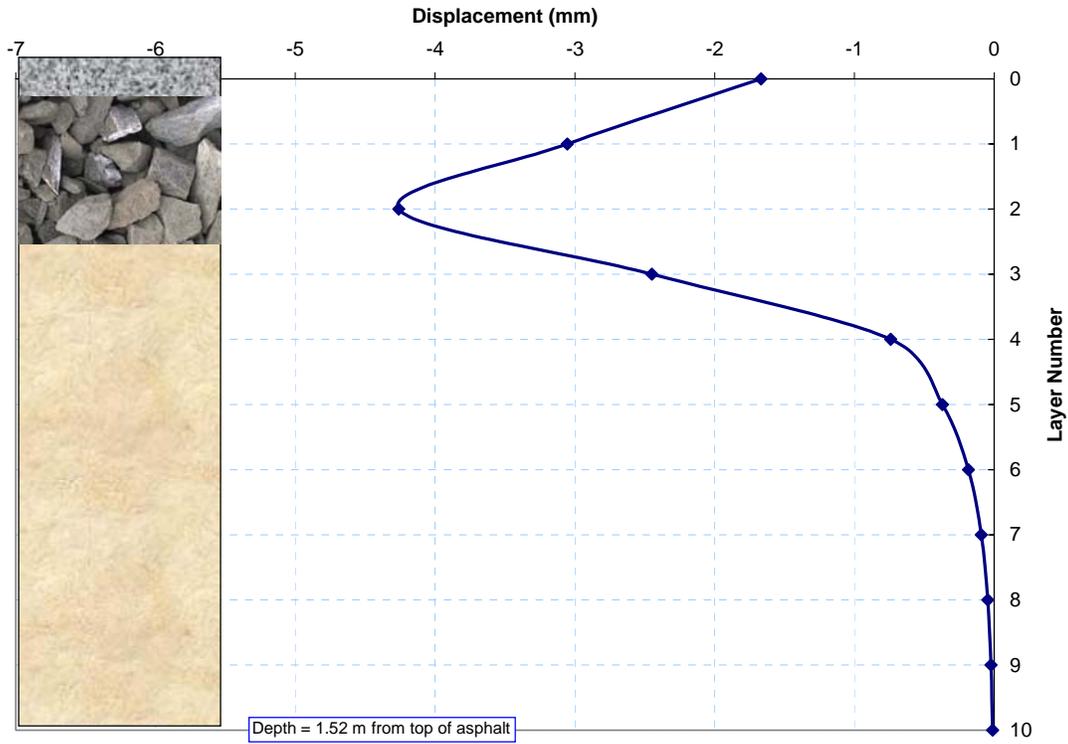
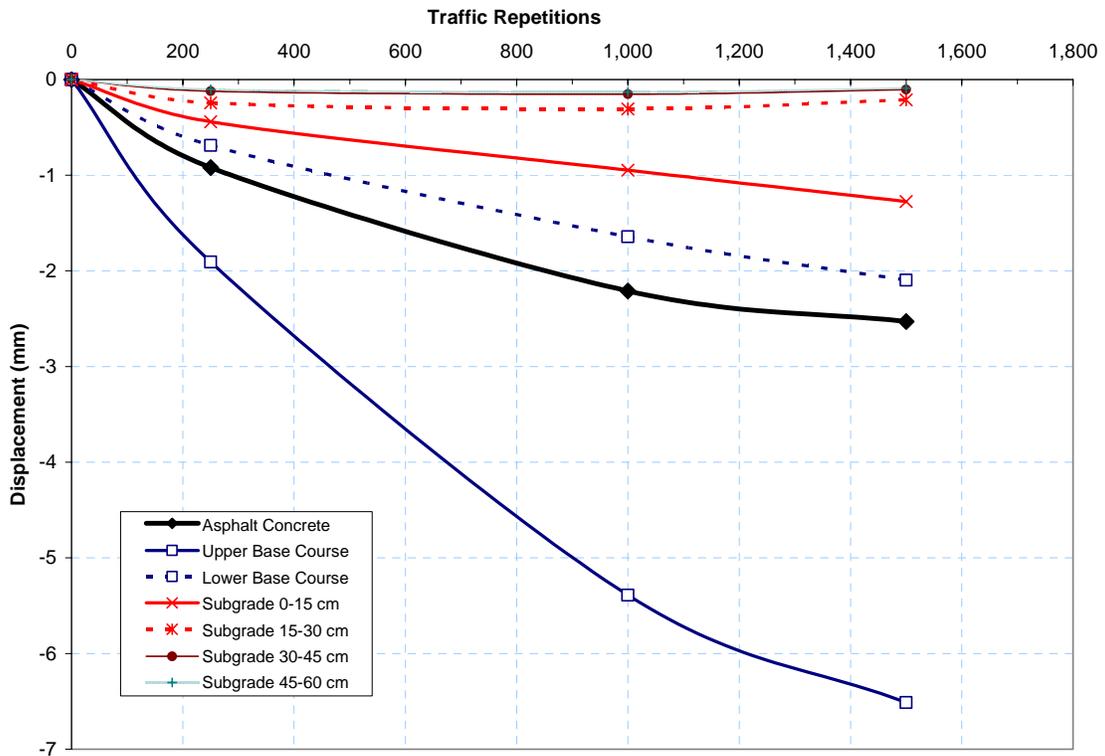
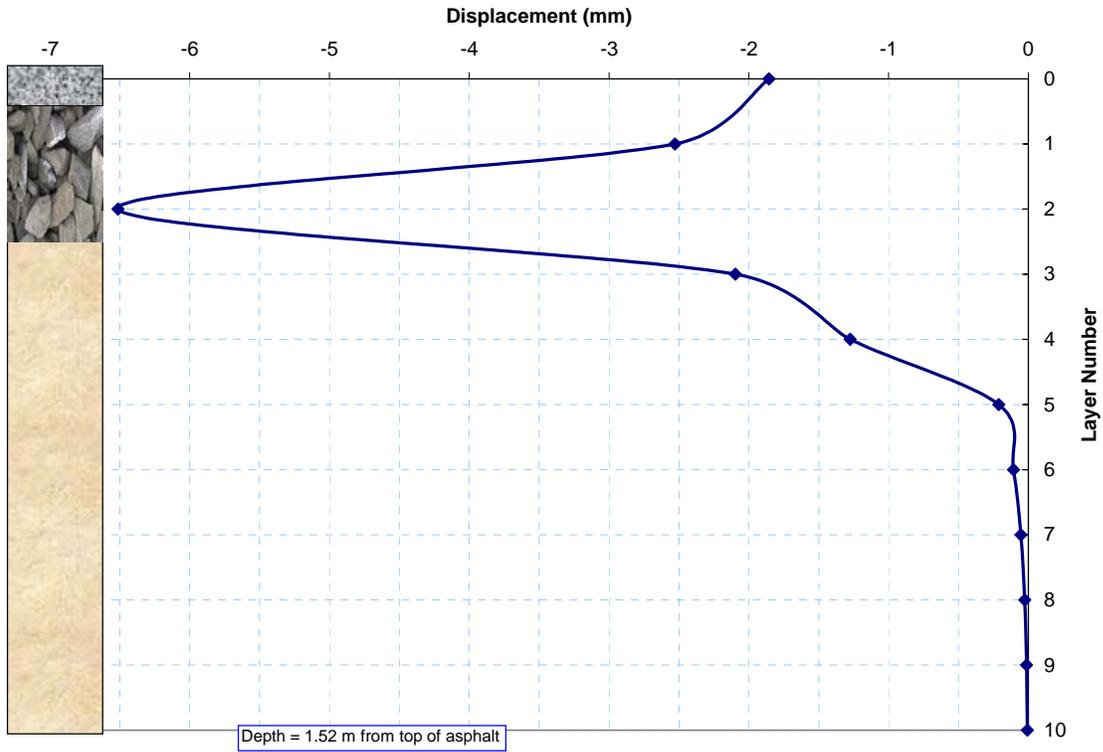
Figure 35a. Layer by layer vertical permanent deformation in Test Window 709c1 with 26.7 kN semi-axial load.

Figure 35b. Layer by layer vertical permanent deformation at failure in Test Window 709c1 with 26.7 kN semi-axial load.

Figure 36a. Layer by layer vertical permanent deformation in Test Window 709c2 with 40 kN semi-axial load.

Figure 36b. Layer by layer vertical permanent deformation at failure in Test Window 709c2 with 40 kN semi-axial load.

Figure 37a. Layer by layer vertical permanent deformation in Test Window 709c3 with 53.4 kN semi-axial load.

Figure 37b. Layer by layer vertical permanent deformation at failure in Test Window 709c3 with 53.4 kN semi-axial load.

Permanent deformation measurements were collected from εmu coils embedded in the base and the subgrade. Measurements were conducted before traffic began and at various stages throughout the traffic tests. An additional mobile εmu coil was placed at the asphalt surface and paired with a coil embedded just below the bottom of the asphalt concrete (AC) to measure the vertical deformation that occurred in the asphalt layer. Three stacks of εmu coils were embedded to form triaxial arrangements in the base and subgrade. Vertical pairs of εmu coils were embedded down to a depth of 1.52 m (5 ft) from the asphalt surface. Previous experiments have shown that, at this depth, the strains are normally small compared to electronic noise.

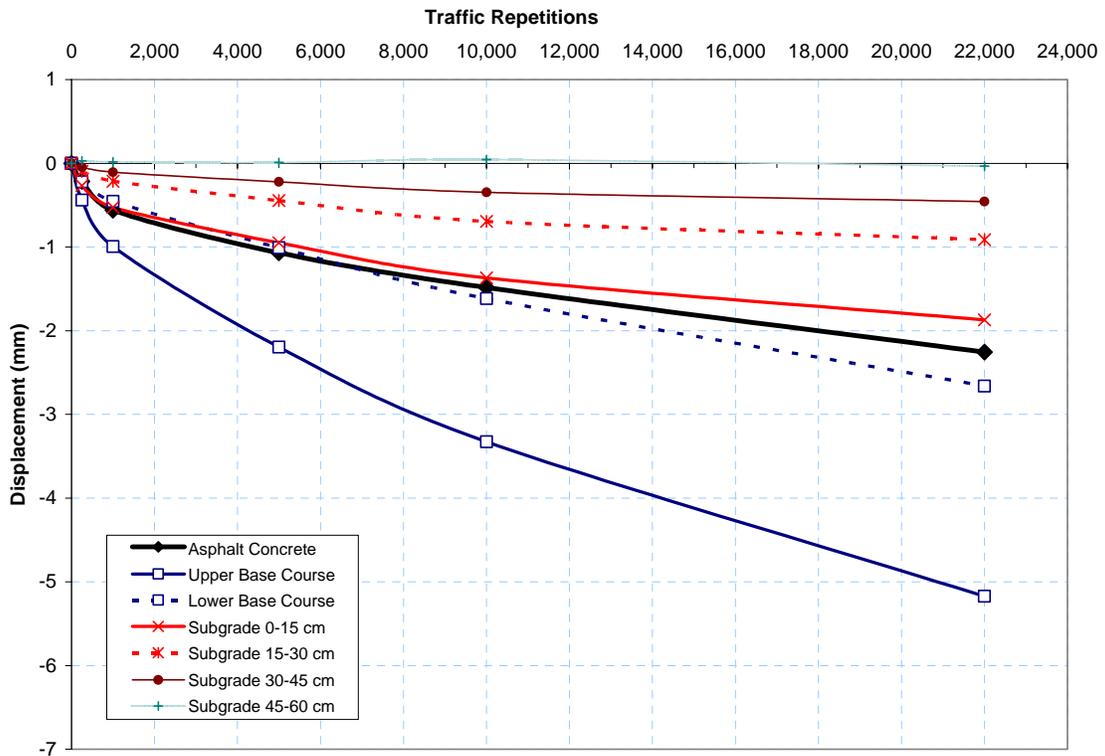
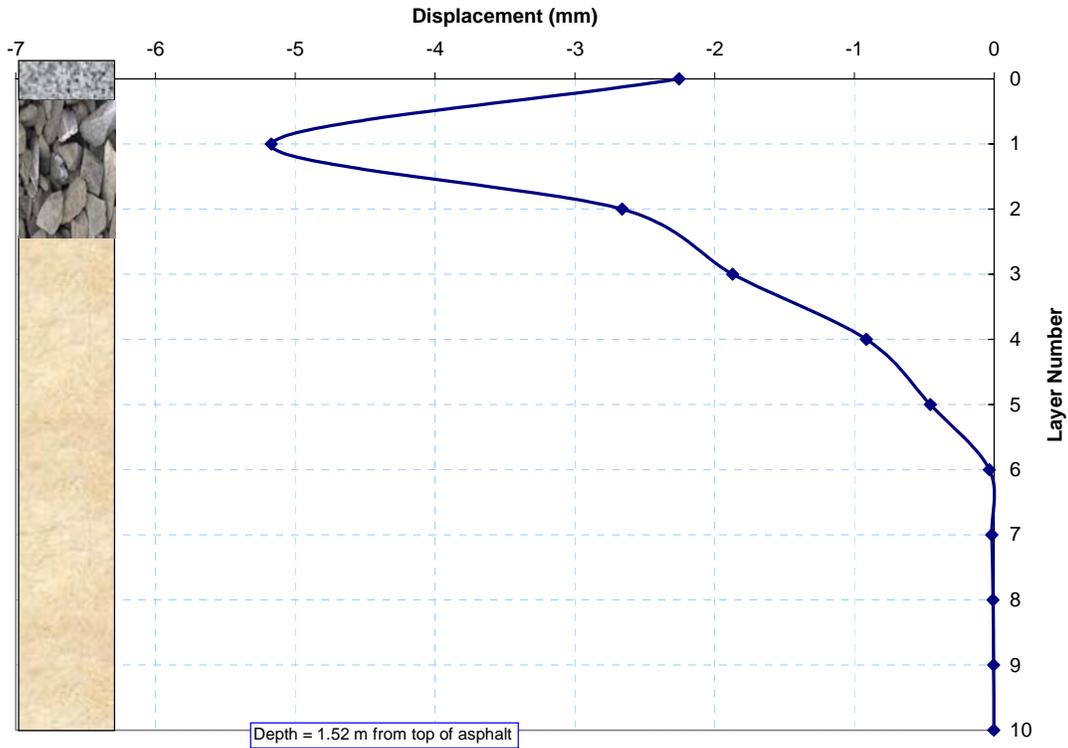
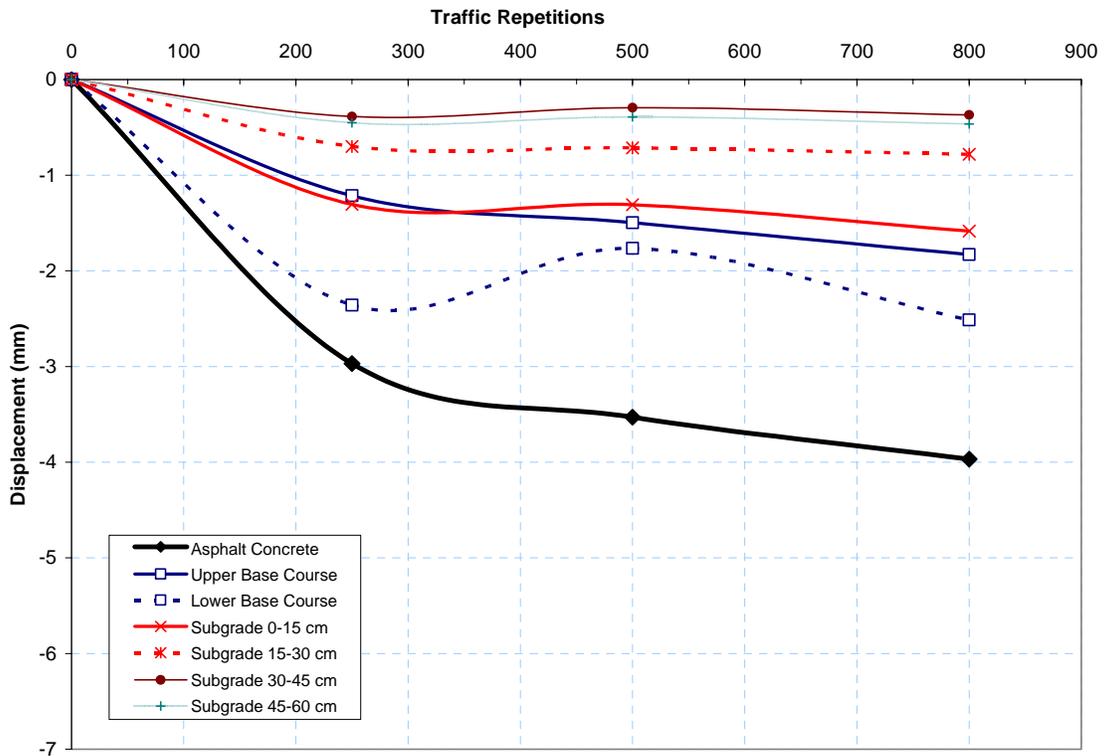
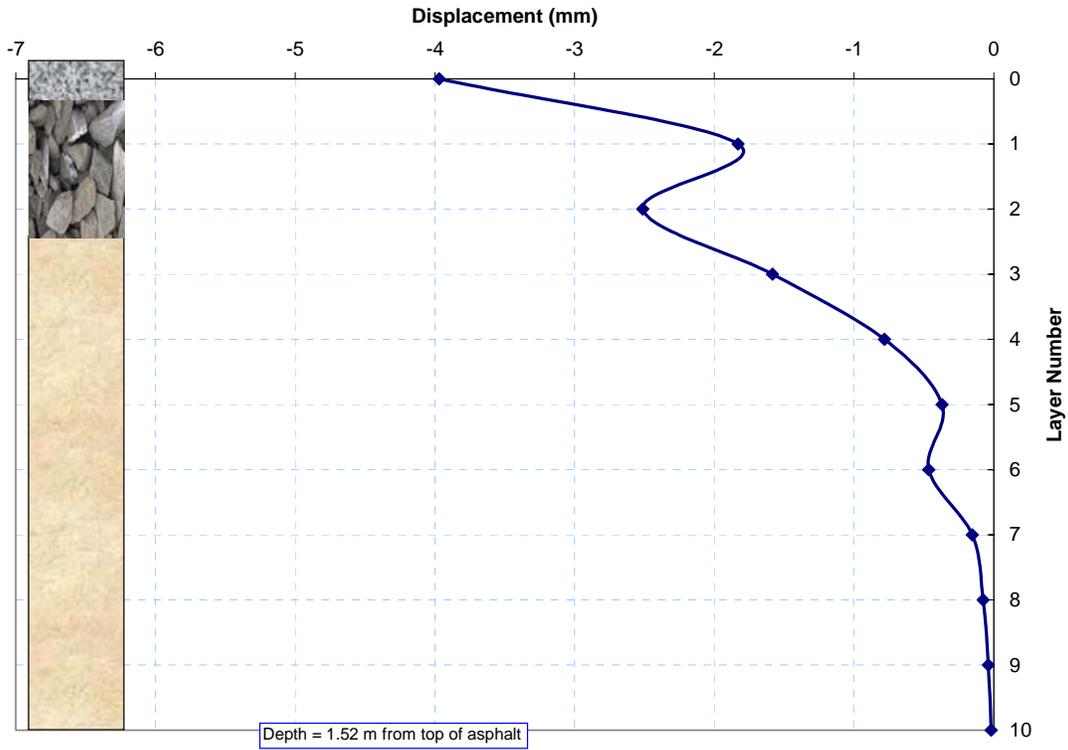
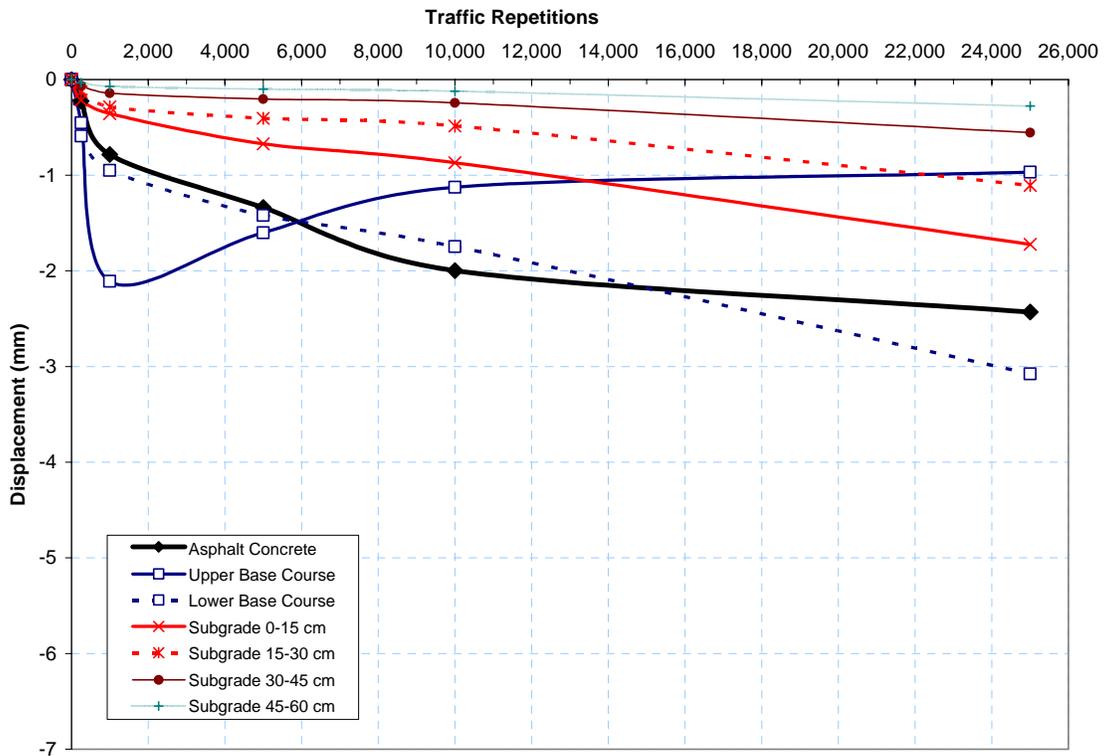
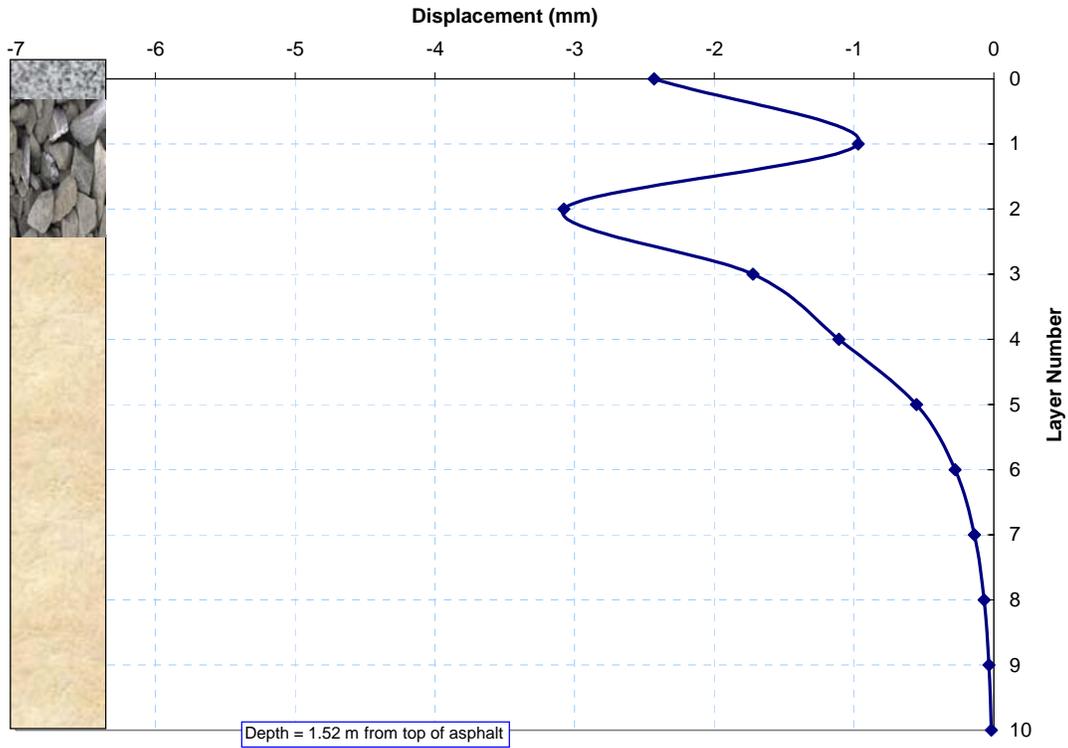
Figure 38a. Layer by layer vertical permanent deformation in Test Window 709c4 with 31.1 kN semi-axial load.

Figure 38b. Layer by layer vertical permanent deformation at failure in Test Window 709c4 with 31.1 kN semi-axial load.

Figure 39a. Layer by layer vertical permanent deformation in Test Window 709c5 with 40 kN semi-axial load.

Figure 39b. Layer by layer vertical permanent deformation at failure in Test Window 709c5 with 40 kN semi-axial load.

Figure 40a. Layer by layer vertical permanent deformation in Test Window 709c6 with 20 kN semi-axial load.

Figure 40b. Layer by layer vertical permanent deformation at failure in Test Window 709c6 with 20 kN semi-axial load.

The permanent deformations in Test Windows 709c5 and 709c6 were heavily influenced by premature asphalt failure in the form of delamination, cracking and shoving. These results should not be used in the general analysis of Test Window 709 because they could obscure valid trends observed in the remaining test windows.

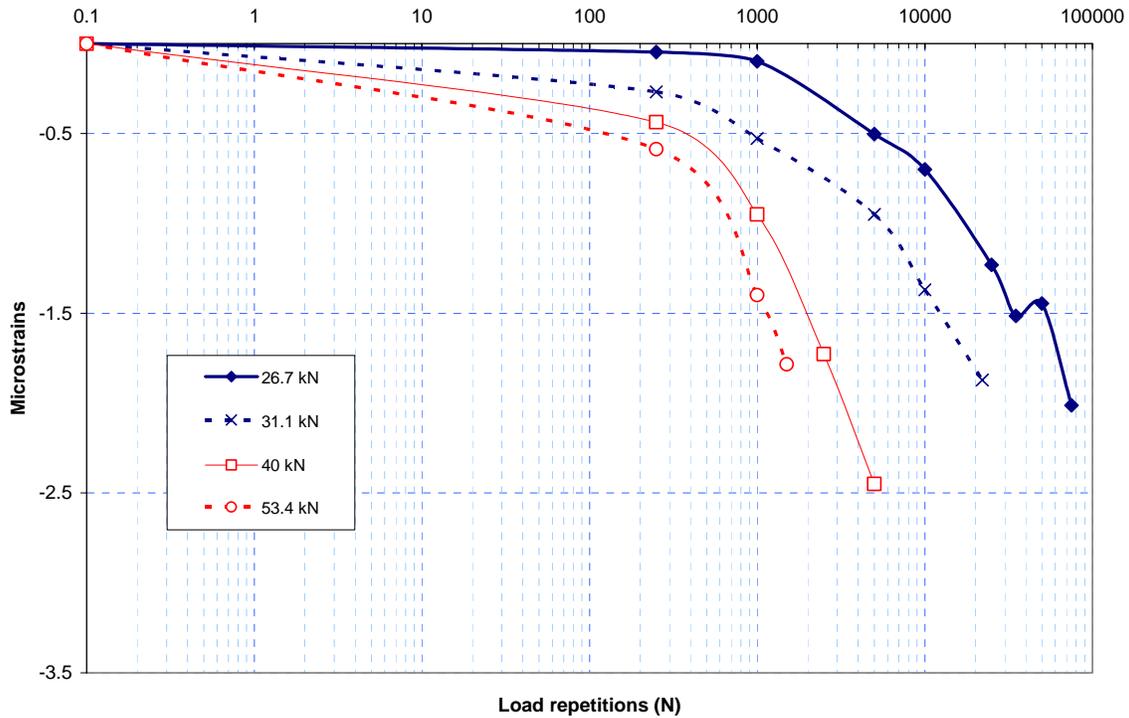
Figure 41. Permanent vertical deformation in the top 15 cm of the subgrade.

The vertical permanent strains on the top of the subgrade as a function of load repetitions are shown in Figure 41. The strains were compressive. There appears to be good correlation between applied load and permanent deformation and strain.
