PAVEMENT SUBGRADE PERFORMANCE STUDY

National Pooled Fund Study SPR-208

Test Section 709

Subgrade AASHTO soil type A-6 at optimum moisture content

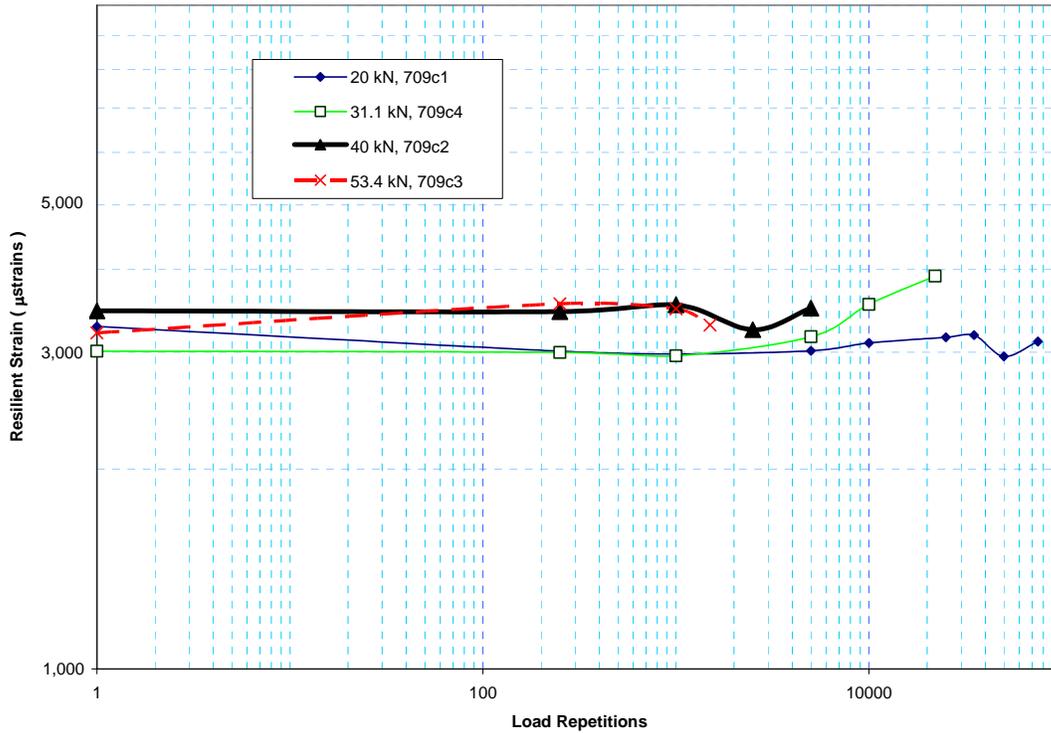
Figure 42. Resilient vertical strains 76 mm (3 in) below the top of subgrade as function of load repetitions

below the top of the subgrade are presented in Figure 42. It can be seen that, in this test section, the resilient strains remained nearly constant throughout the traffic tests.

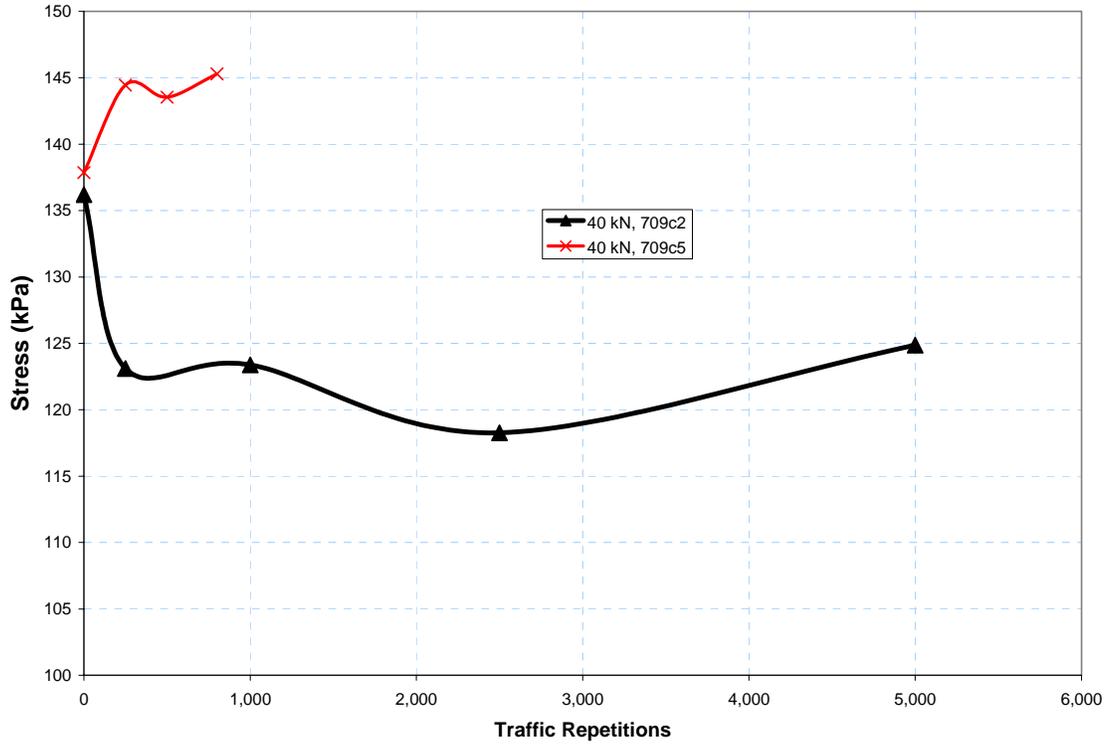
Figure 43. Stress measurements in the middle of the base course in Test Windows 709c2 and 709c5, both with 40 kN semi-axial load.

Stress measurements were conducted by means of two types of gauges: Geokon and Dynatest. Figure 43 shows the stress measurements conducted in Test Windows 709c2 and 709c5, both loaded with 40 kN (9 kips) semiaxial load. The stress measurements in Test Window 709c5 was largely affected by a wide crack and delamination that occurred in the asphalt concrete. The stress measurements in Test Window 709c2 are good measurements of stress at points in the center of the thickness of the base course located directly under the tire path.

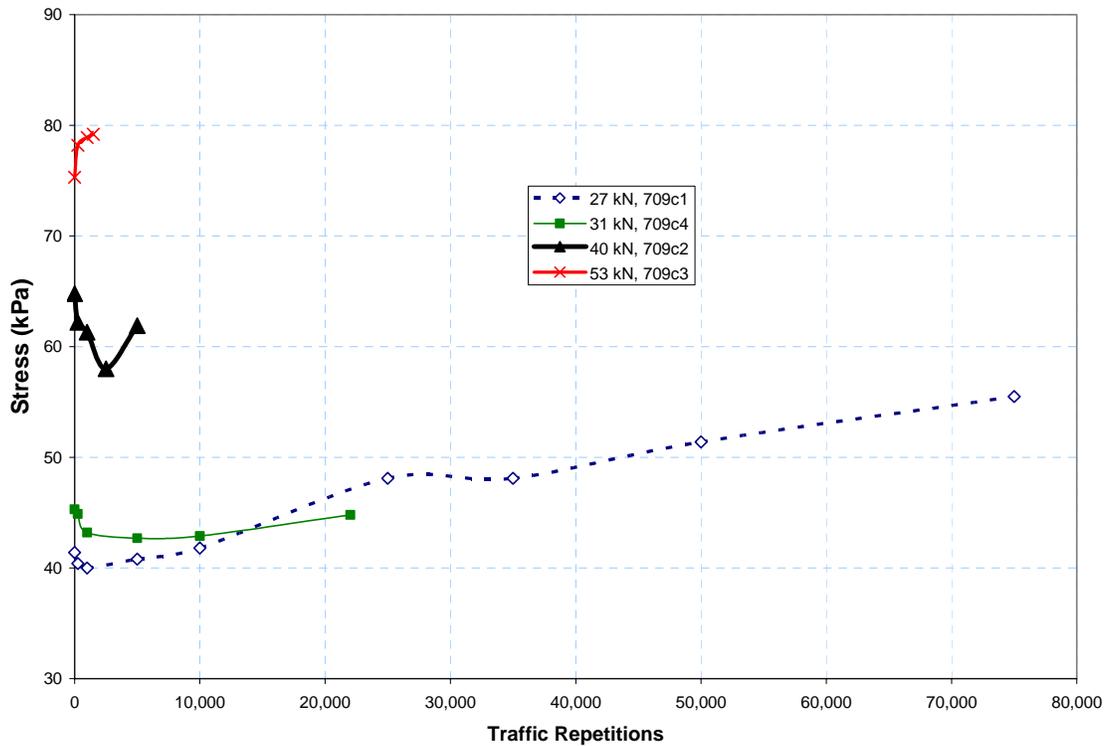
Figure 44. Stress measurements at a depth of 76 mm below the top of the subgrade for various semi-axial loads.

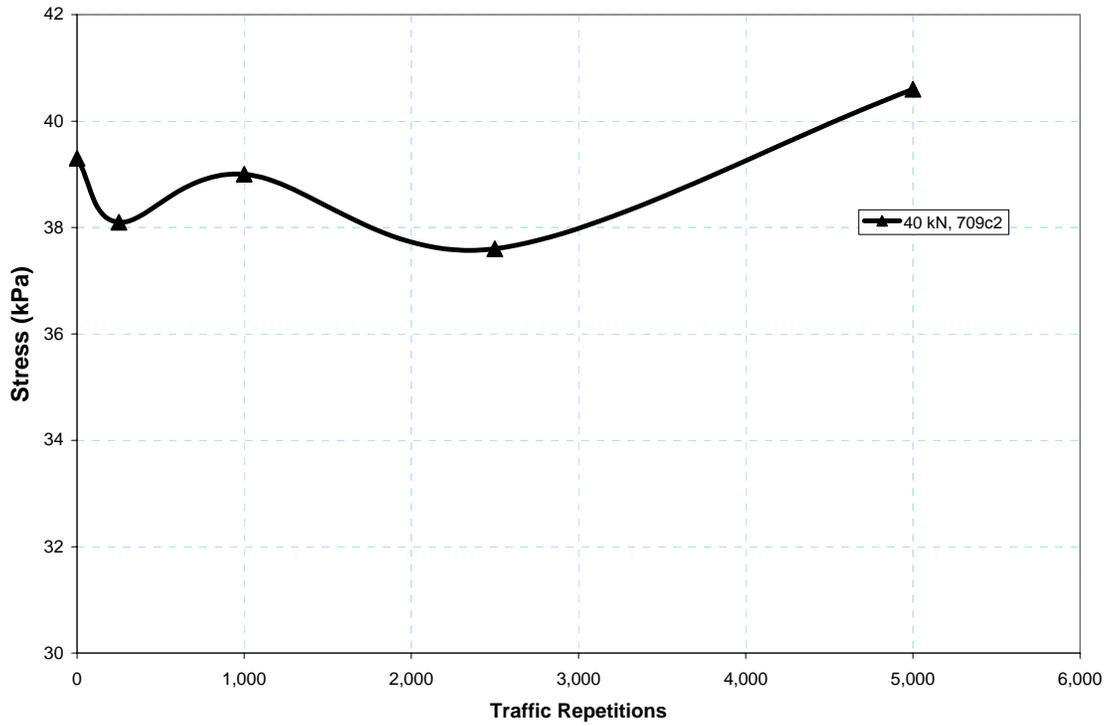
Figure 45. Stress measurements at a depth of 304 mm (1ft.) below the top of the subgrade for a semi-axial load of 40 kN (9kips).

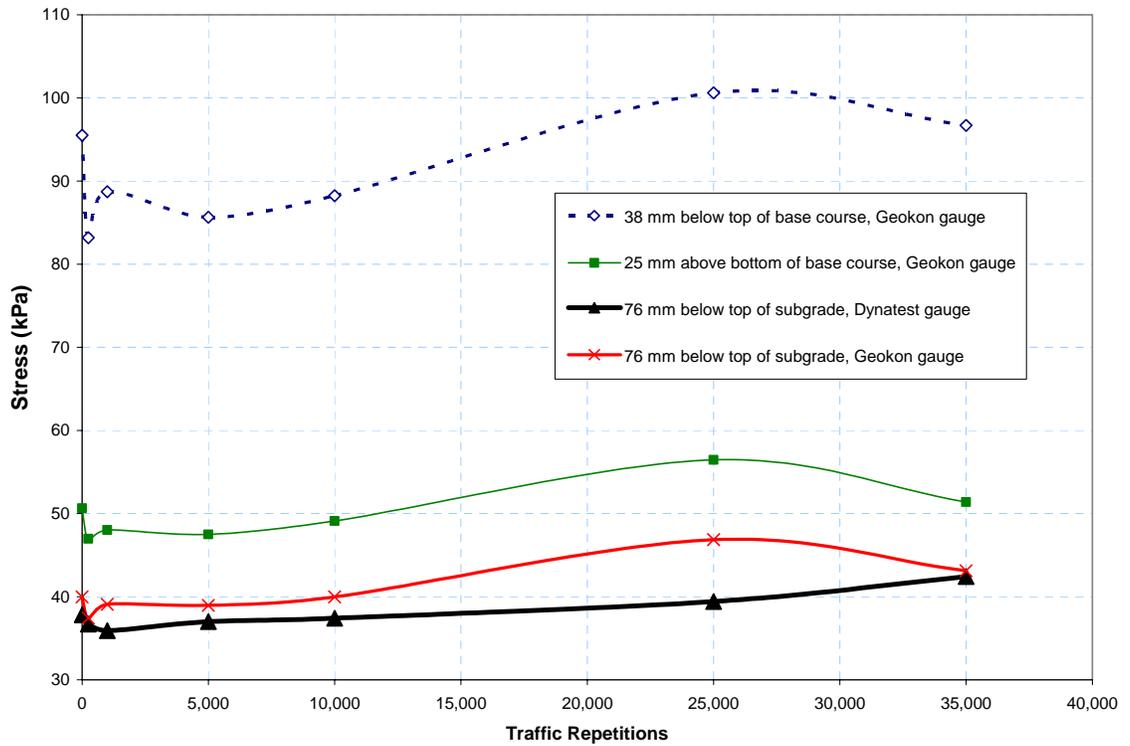
Figure 46. Stress measurements at various depths in Test Window 709c6 with a semi-axial load of 20 kN (4.5 kips).

In most cases, stress increased slightly with traffic repetitions. This is probably due to packing of soil particles under the action of traffic. Figure 46 apparently suggests that, under similar conditions, the Dynatest gauges registered only slightly lower stress than the Geokon sensors.

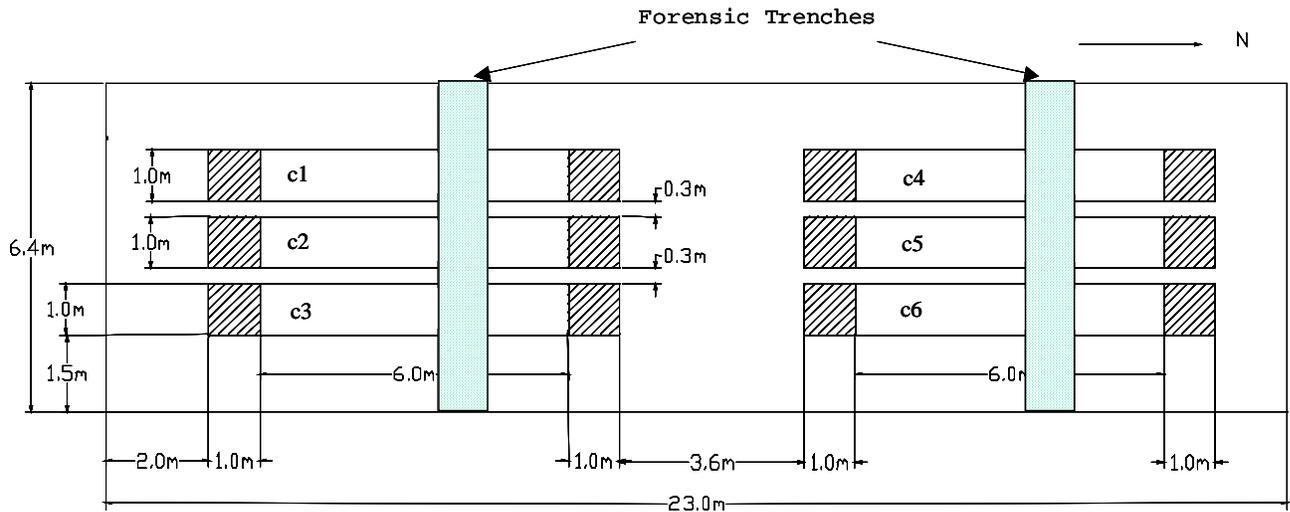
Figure 47. Location of the forensic trenches in Test Section 709

A forensic evaluation was conducted to establish the condition of the pavement structure at the end of the traffic tests. Two trenches were cut across the test windows. One trench was excavated across test windows 1, 2, and 3 on the south region of the test section. This trench will be referred to as the “South Trench”. Another trench was excavated in the north region of the test section. This trench cut across test windows 4, 5, and 6. The boundaries of the trenches were carefully located and marked to avoid damaging the embedded sensors and wires. Dry saw cutting was used to avoid disturbing the base and subgrade moisture contents. Base course and subgrade soil samples were taken immediately after exposure to determine their moisture contents by the oven-dry method. The side surfaces were carefully scrapped and dusted off to be able to measure asphalt and base layer thickness.

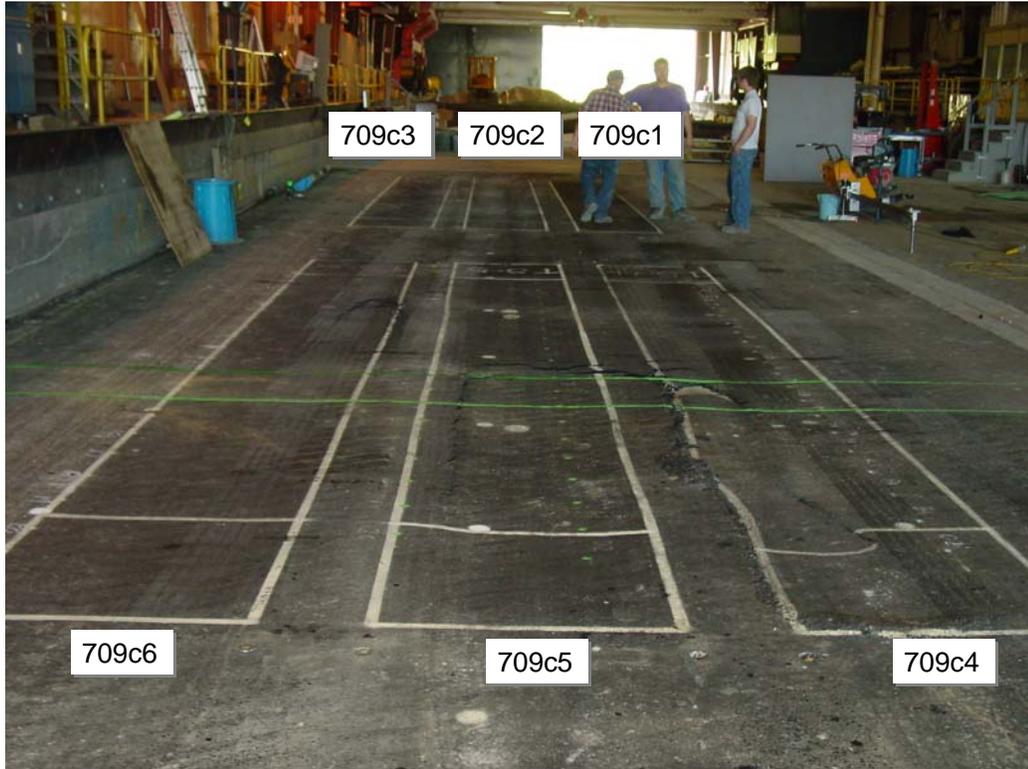
Figure 48. Forensic trenches.

Figure 48 shows a view of the test section at the end of traffic. The distress mode in test windows 709c1, 709c2, and 709c3 were limited to smooth rutting. Contrastingly, the distress modes in test windows 709c4, 709c5, and 709c6 included delamination of the asphalt surface course, cracking and shoving. Test window 709c4 was traffic tested first. Only smooth rutting was observed throughout most the test. Delamination, cracking and shoving appeared suddenly near the end of the traffic tests. Therefore, the test results of Test Windows 709c4 should be valid. The test results obtained in test windows 709c5 and 709c6 should not be used to draw conclusions of general behavior because of their

premature asphalt failures and damage caused by traffic applied to neighboring test windows.

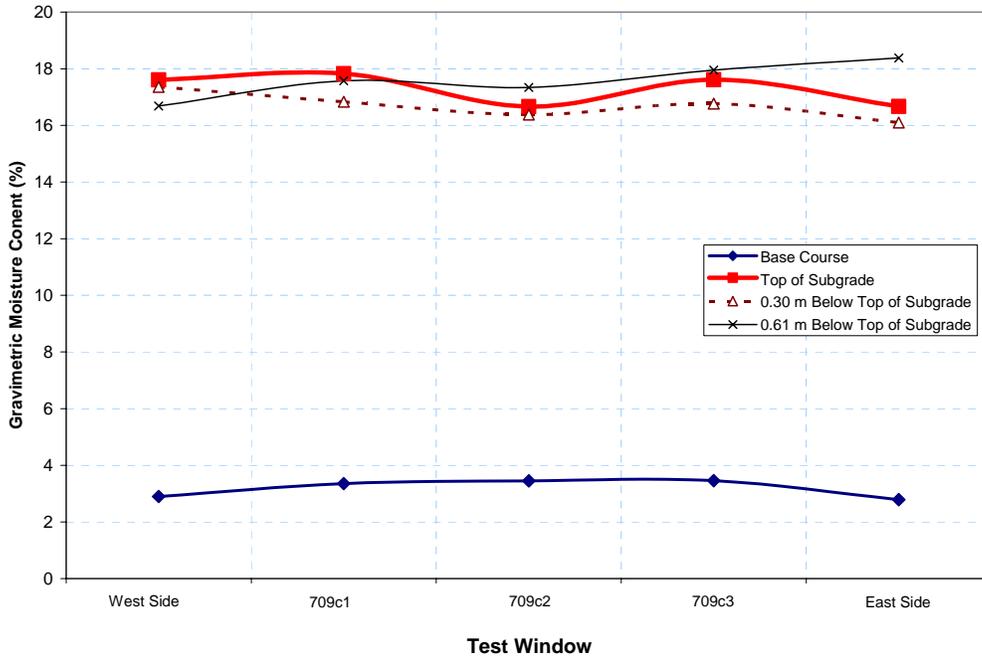
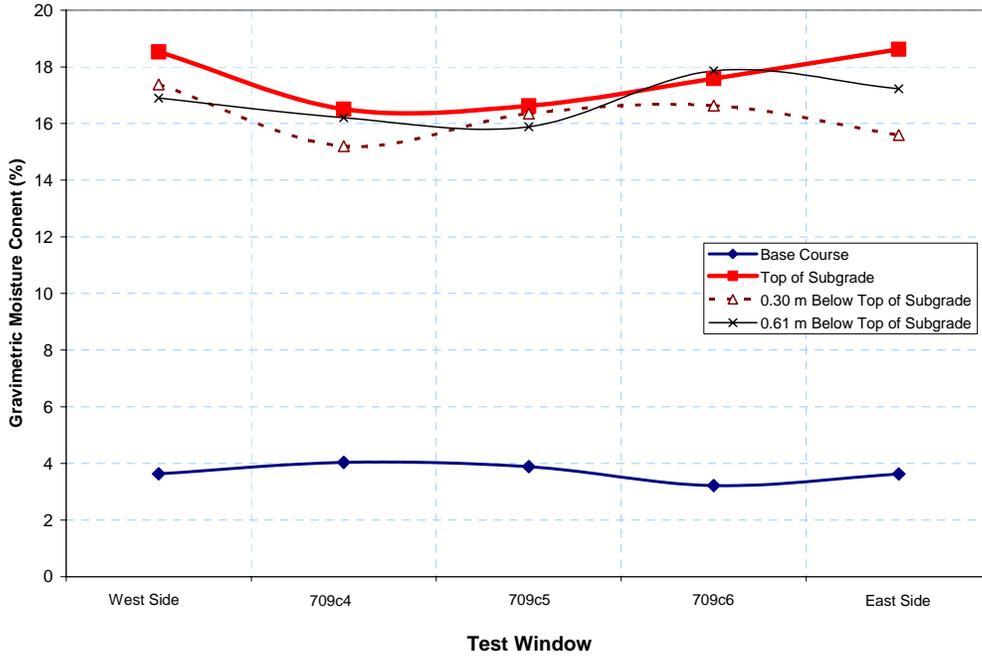
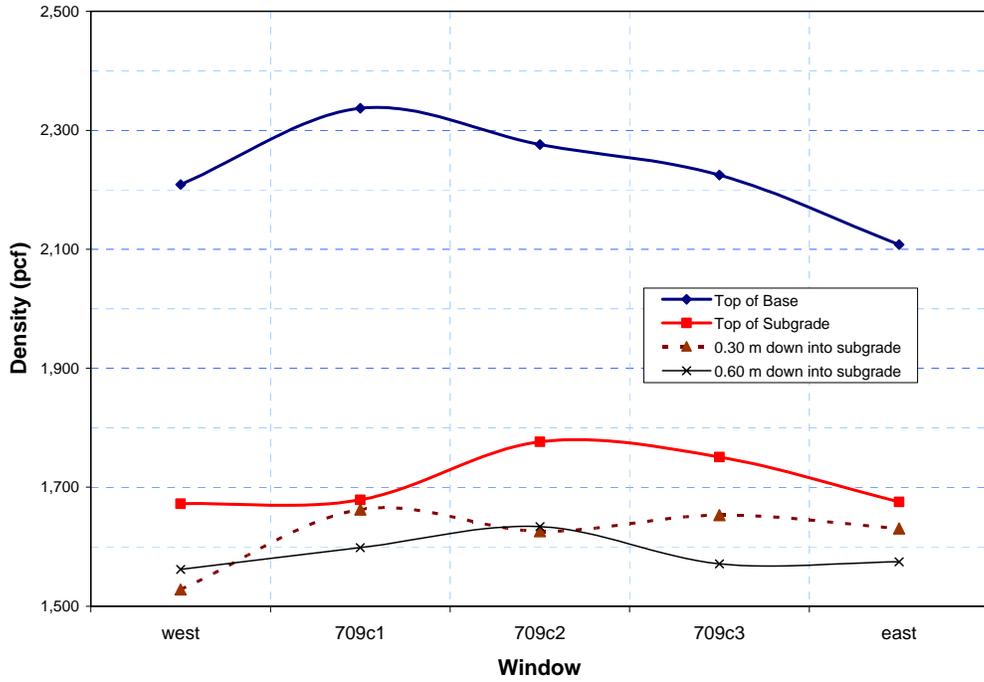
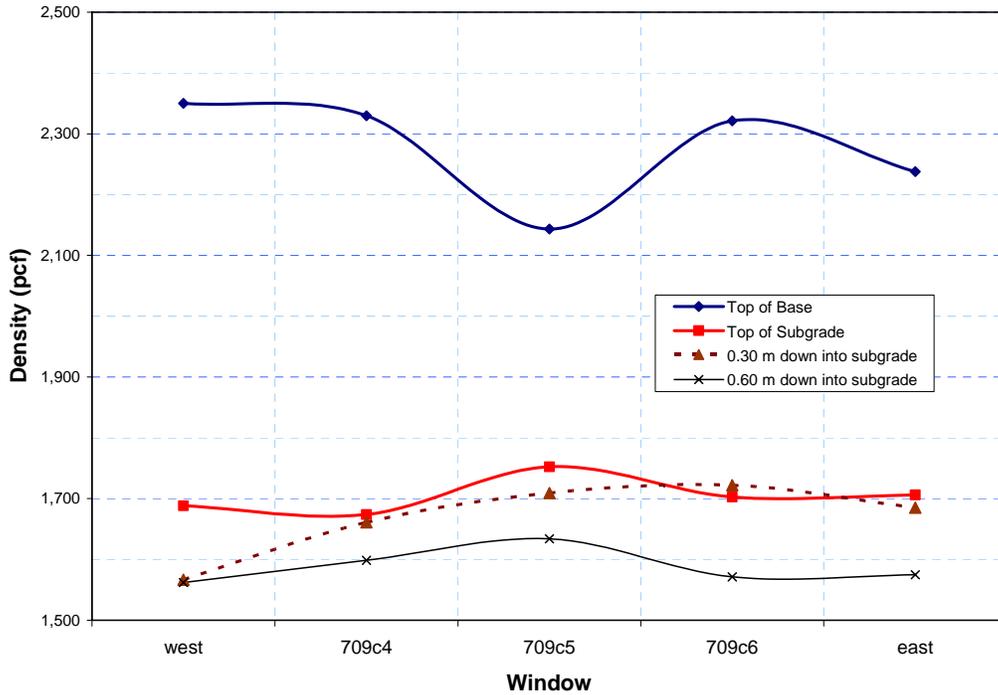
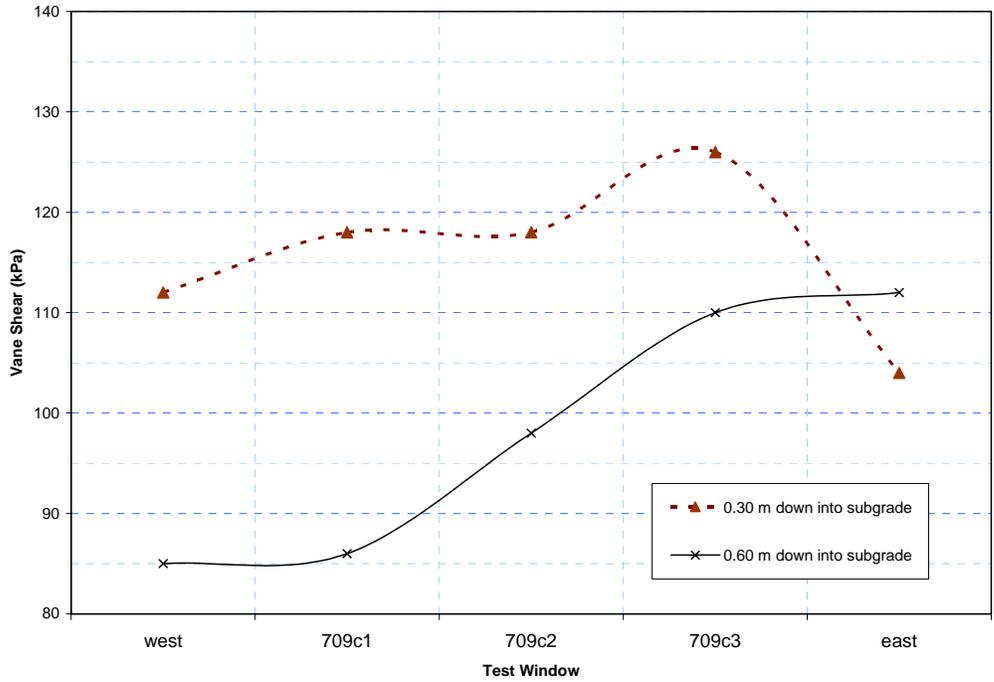
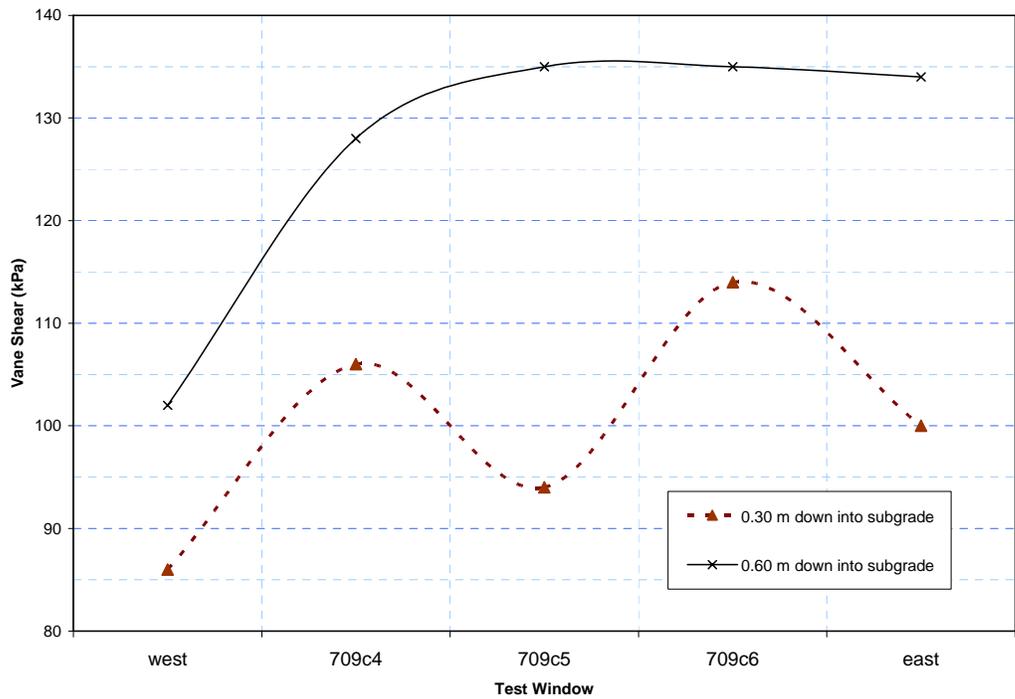
Figure 49. Moisture content in the base and upper subgrade in the south trench.

Figure 50. Moisture content in the base and upper subgrade in the north trench.

Figure 51. Density measurements in the base and upper subgrade in the south trench.

Figure 52. Density measurements in the base and upper subgrade in the north trench.

Figure 53. Vane shear measurements in the upper subgrade in the south trench.

Figure 54. Vane shear measurements in the upper subgrade in the north trench.

Moisture and density measurements were conducted inside the trenches in the base course and in the upper subgrade down to a depth of 0.91 m (3 ft.) below the top of the asphalt concrete. Figure 49 and 50 show the gravimetric moisture contents in the south and north trenches respectively. The measured values are consistent with those obtained during the construction. Figures 51 and 52 show density measurements for the south and north trenches at each test window and also at locations outside the traffic areas at the east and west sides of the test windows. Most measured values are above 90 percent of modified Proctor density. Vane shear measurements were conducted at the top of the subgrade, at 0.30 m (1 ft.) and 0.61 m (2 ft) below the top of the subgrade. Figure 53 and Figure 54 show Vane shear measurements in the trenches at each test window and at side locations. Notice that the values for the top of the subgrade were omitted because the shear strengths exceeded the capacity of 140 kPa of the measuring device.

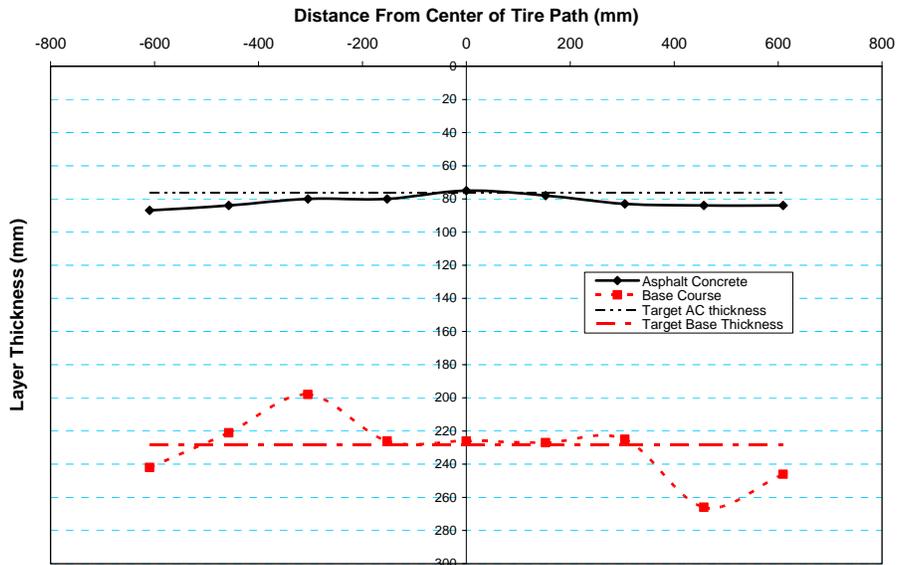
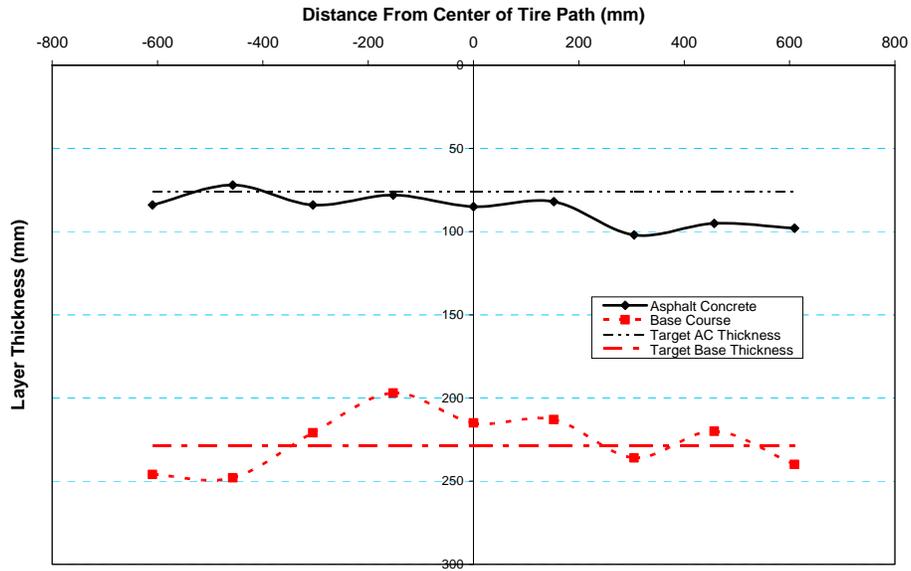
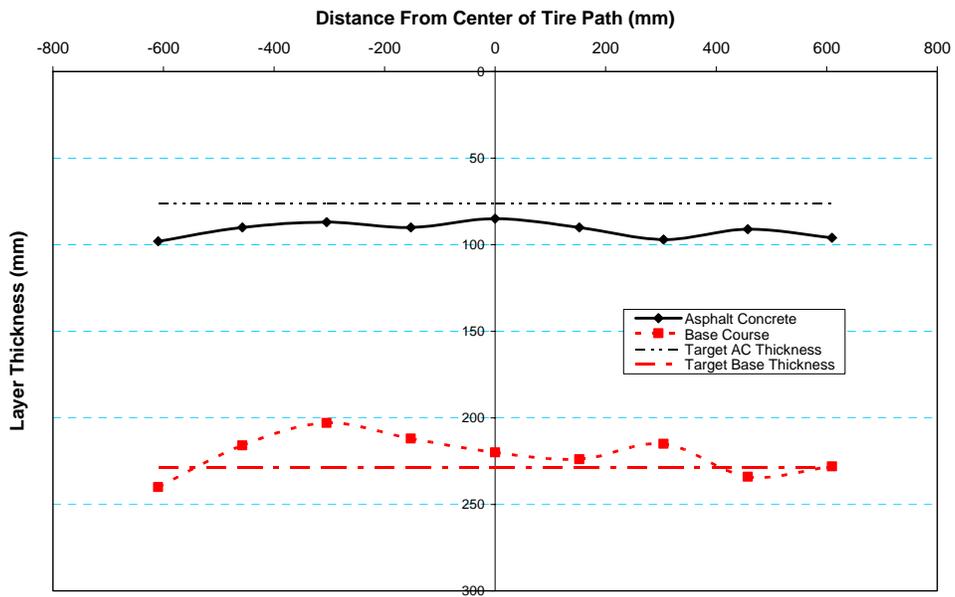
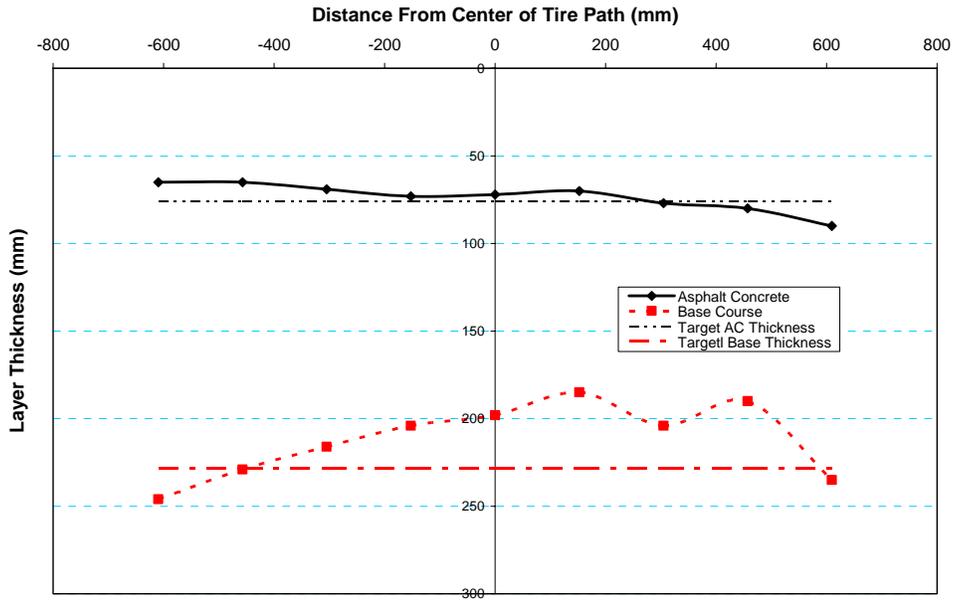
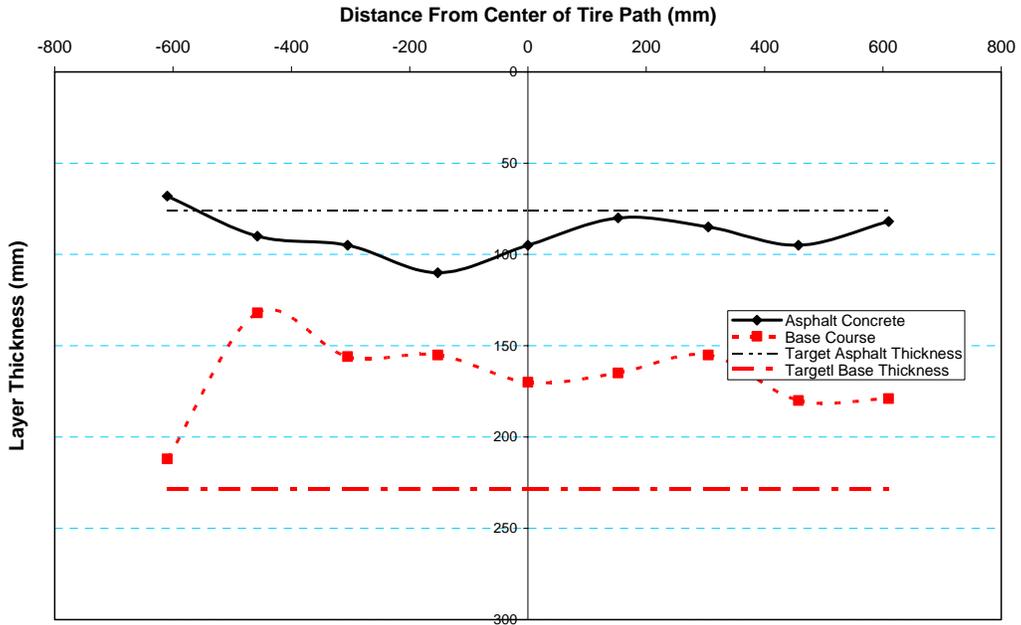
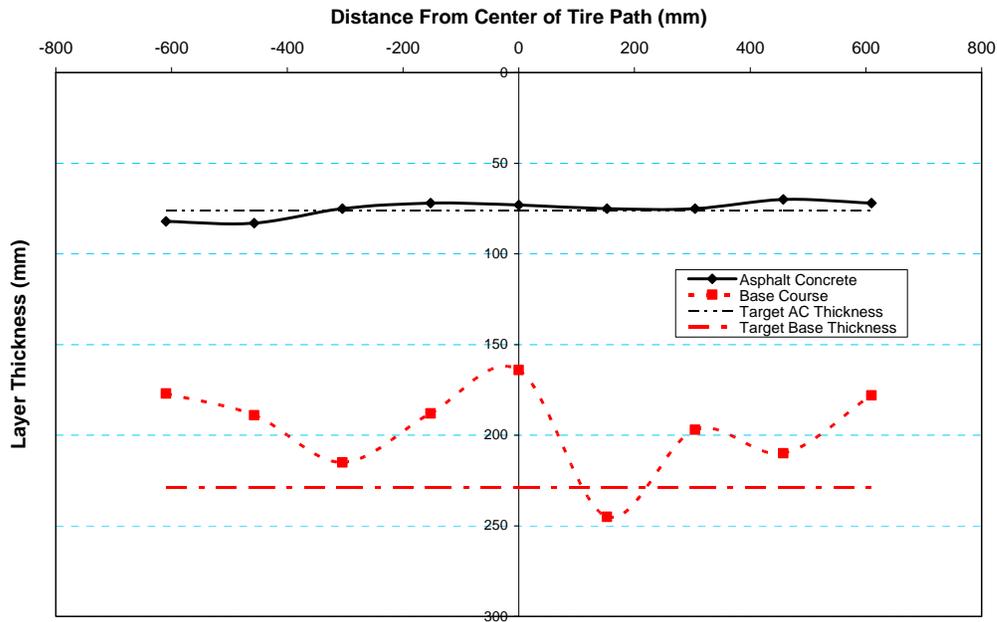
Figure 55. Layer thickness measurements across Test Window C1.

Figure 56. Layer thickness measurements across Test Window C2.

Figure 57. Layer thickness measurements across Test Window C3.

Figure 58. Layer thickness measurements across Test Window C4.

Figure 59. Layer thickness measurements across Test Window C5.

Figure 60. Layer thickness measurements across Test Window C6.

In Test Window 709c5 the average asphalt thickness was 10 mm (3/8 in.) larger than its design value. The average base course thickness was 51 mm (2 in) less than its intended value. This is a very significant deviation that must be considered in the analysis. Undoubtedly this was an important contributing factor to the poor performance observed in this test window.

In Test Window 709c6 the average asphalt thickness was as intended, but the base course was 25 mm (1 in.) thinner than intended. This may have contributed to the poor performance of this test window.

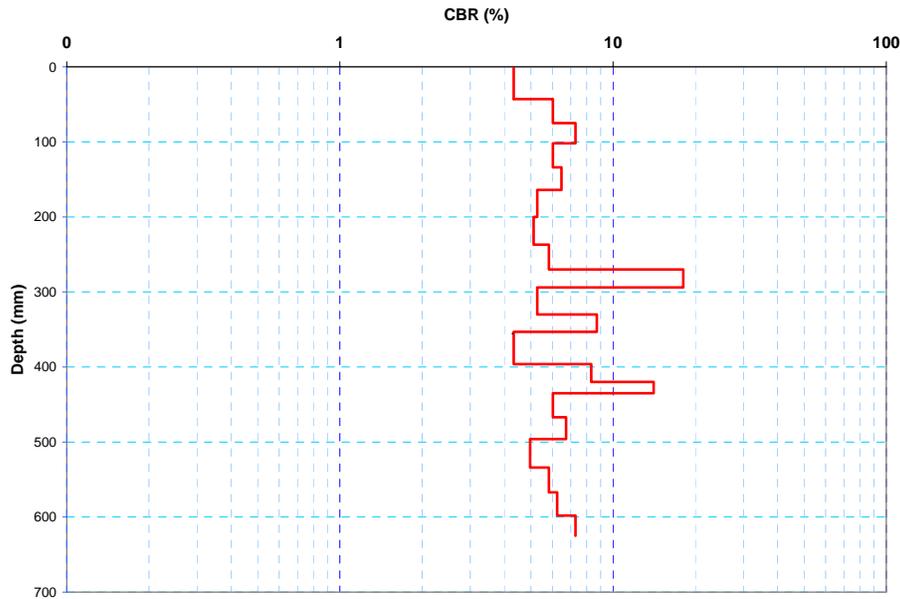
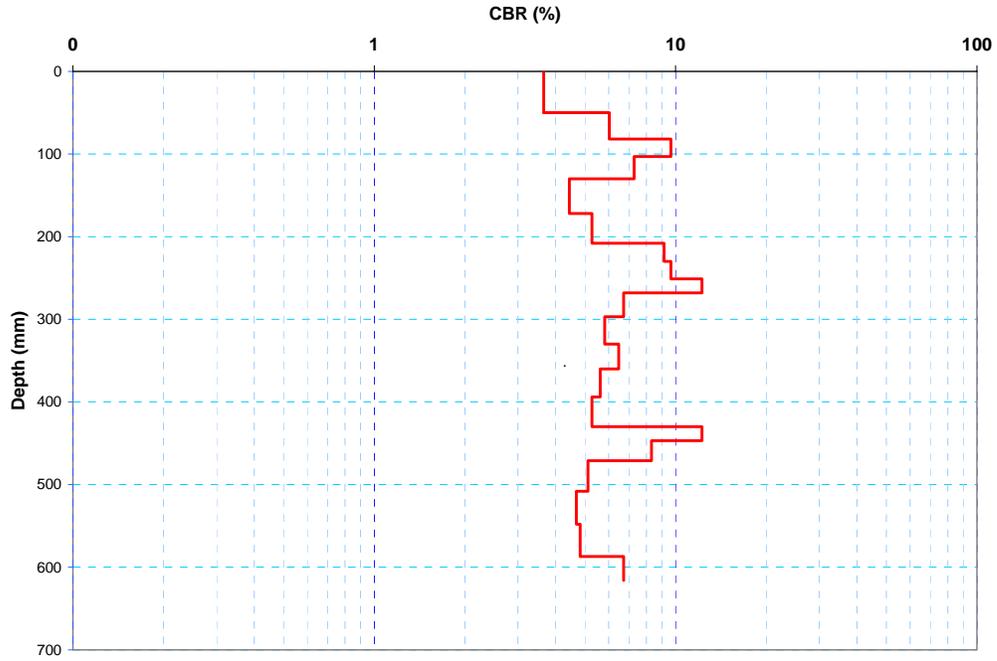
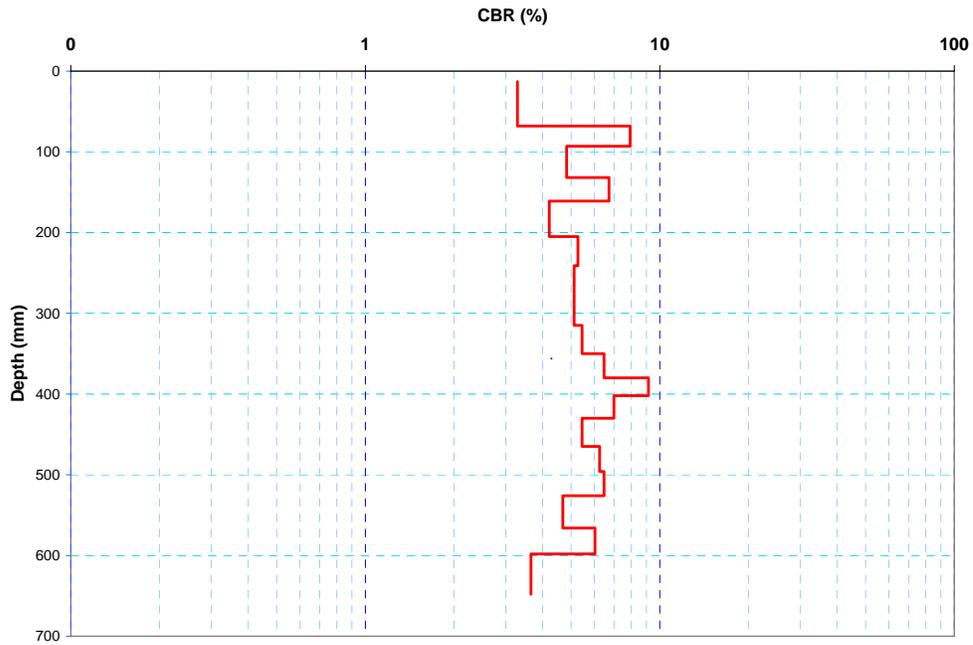
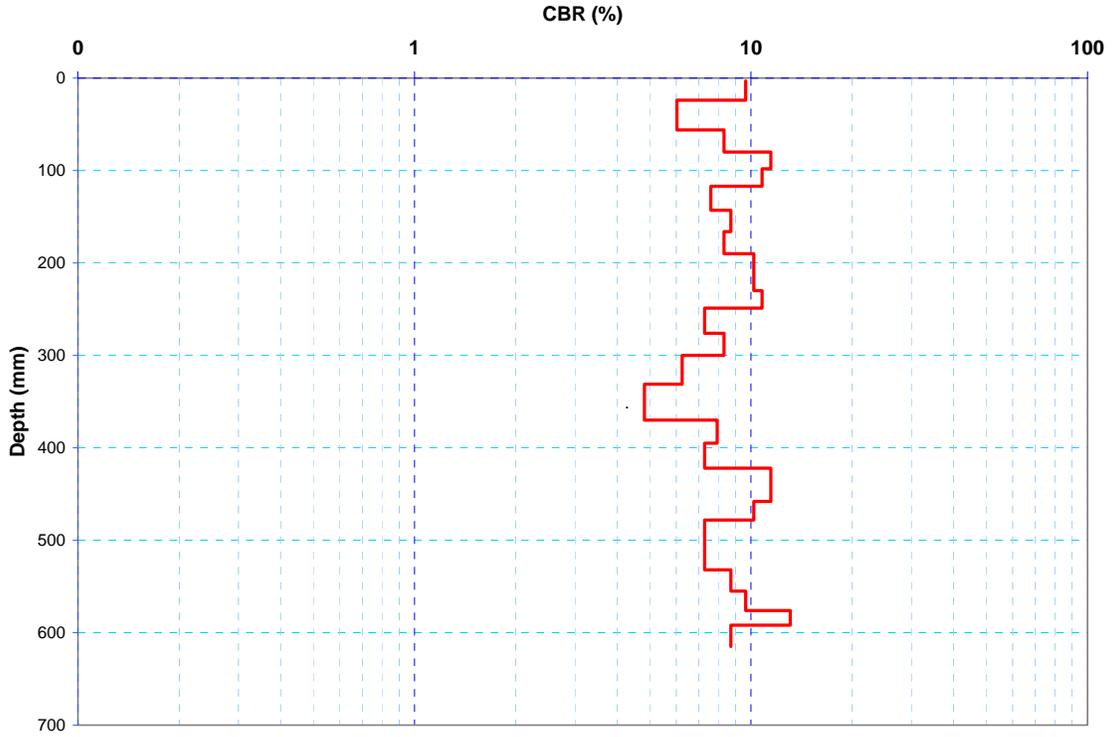
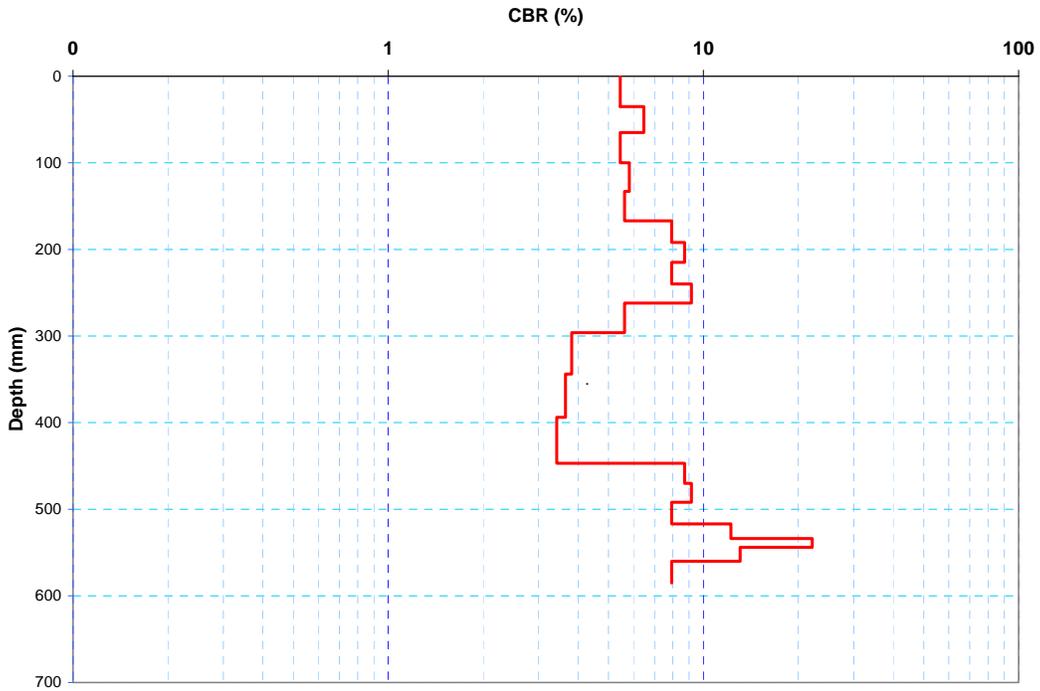
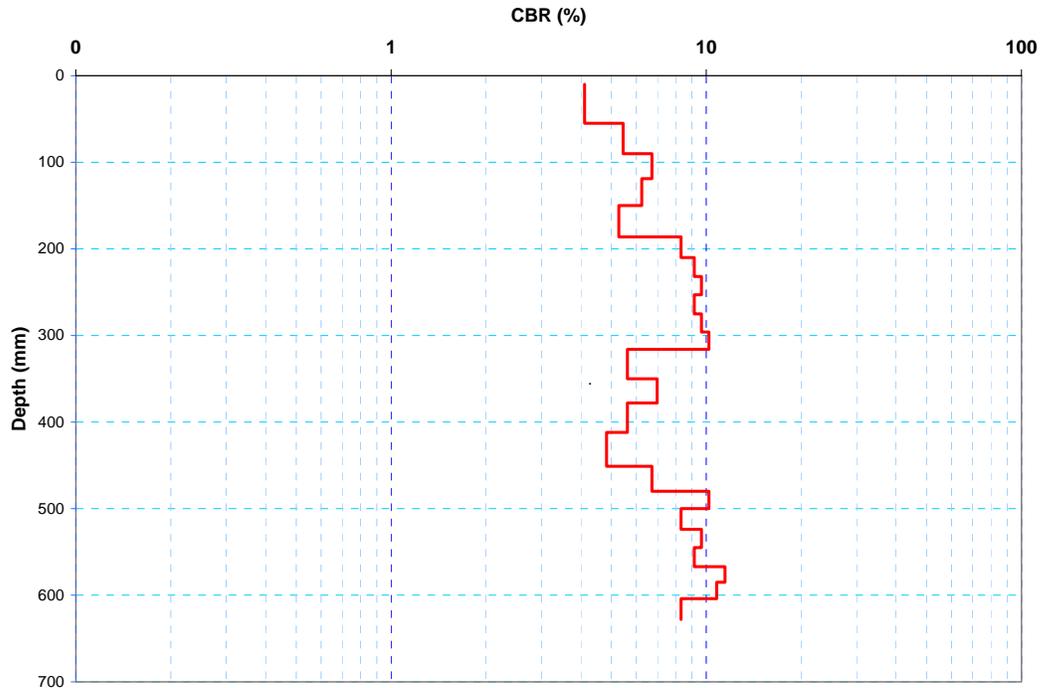
Figure 61. Subgrade CBR in Test Window C1.

Figure 62. Subgrade CBR in Test Window C2.

Figure 63. Subgrade CBR in Test Window C3.

Figure 64. Subgrade CBR in Test Window C4.

Figure 65. Subgrade CBR in Test Window C5.

Figure 66. Subgrade CBR in Test Window C6.

Dynamic cone penetrometer (DCP) measurements were conducted from the top of the subgrade down to a depth of at least 0.61 m (2 ft.). Figures 61 through 66 show profiles of CBR values obtained through DCP-CBR correlations. The average subgrade CBR value was 7 percent. According to Figure 19, this corresponds to a resilient modulus of 62 MPa (9,000 psi).

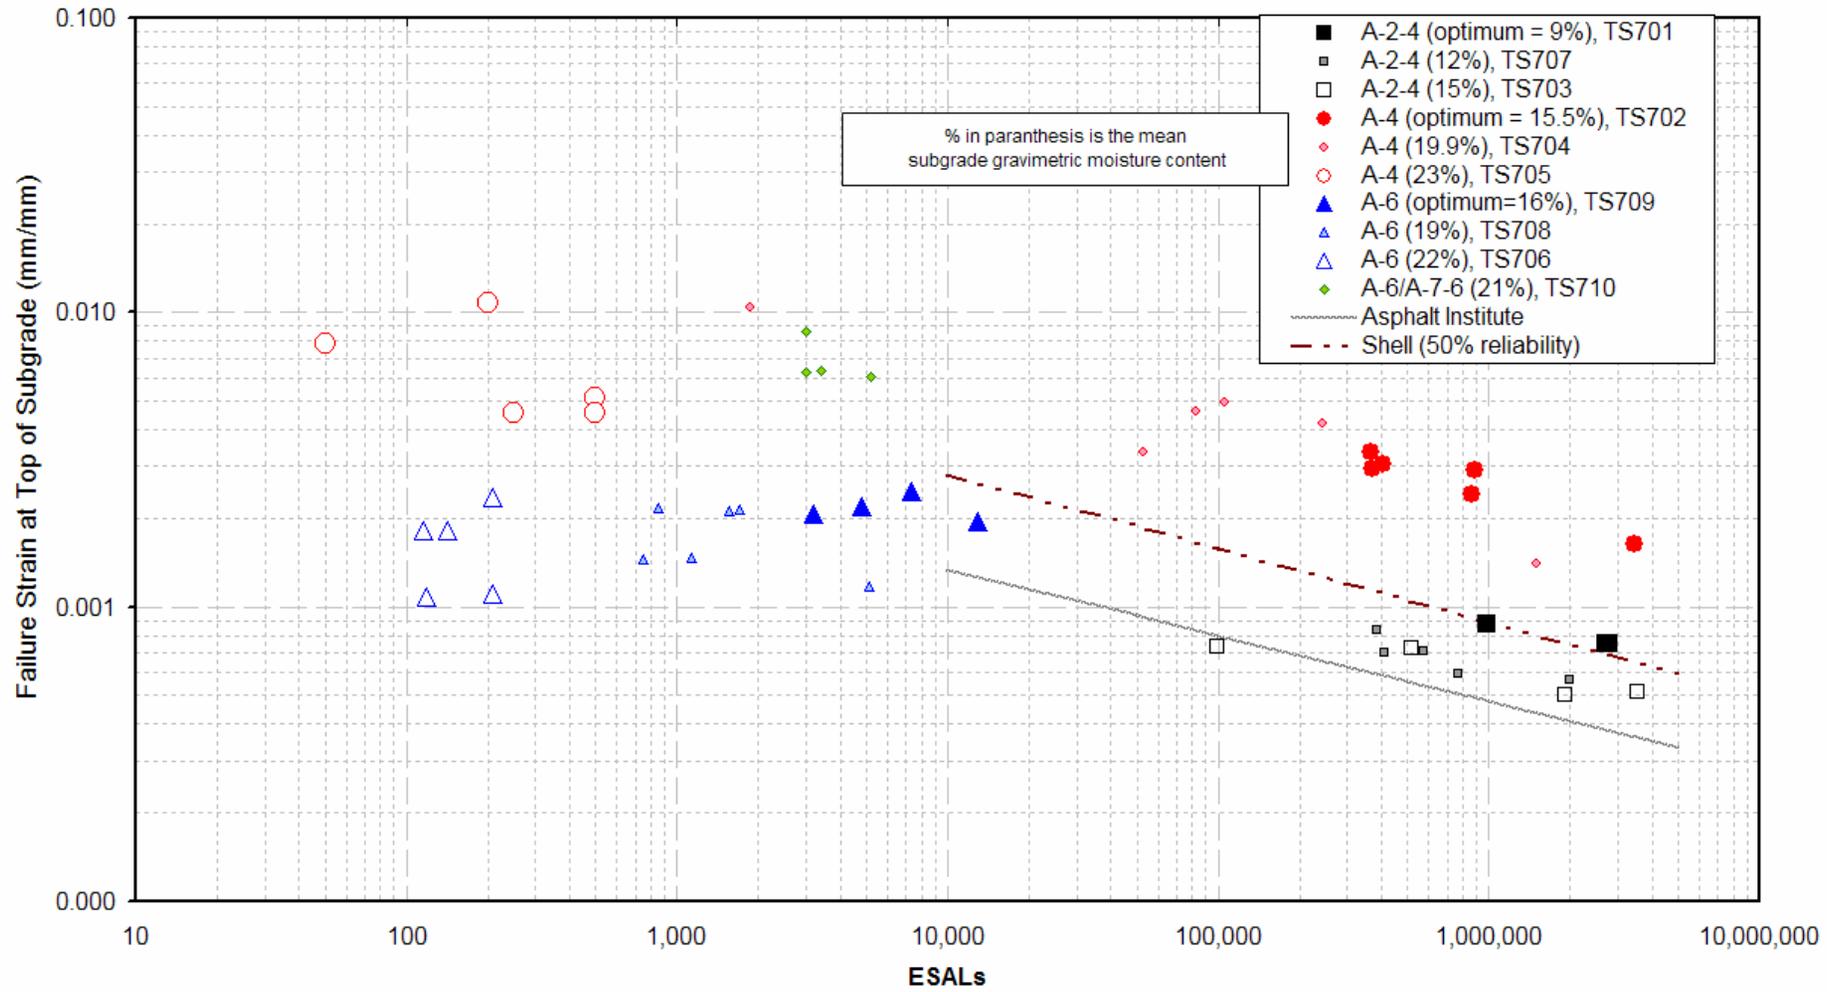
Figure 67. Effect of soil type and moisture content on subgrade failure criteria.

The dynamic strains at failure at the top of the subgrade are compared with the current Asphalt Institute and Shell subgrade failure criteria in Figure 67. As explained

Figure 67 shows that the AASHTO type A-2-4 soil is significantly less susceptible to moisture content than the other soil types. Subgrade soil AASHTO type A-4 is most susceptible to moisture variations. This is a silty soil, and therefore, it is also most susceptible to frost heaving and spring thaw weakening. Unfortunately, this is also the most abundant subgrade soil type found in the United States and in the world (Rollings, R., 2004).
