## **Cataloged Observed Patterns of Failure**

## **US 90 Henderson Point—No Vertical Restraint (if bond breaker used on dowels)**

## I-10 Twin Spans—Broken Connections

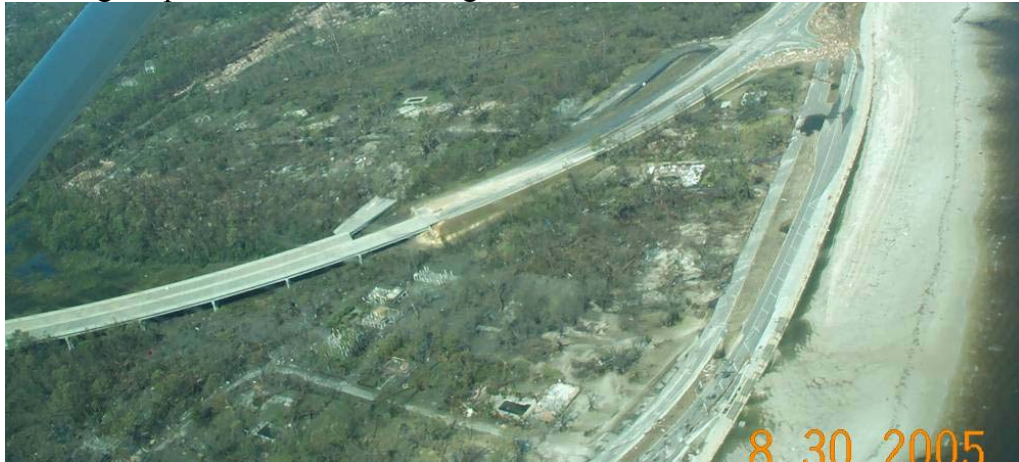
- Side by side chorded multi-span prestressed bulb-T girder bridges
- Bridge Drawings dated 1996
- Elastomeric bearing pads at free end
- Full depth doweled diaphragms at fixed ends
- One span of bridge dislodged completely, others shifted
- Dislodged span was where bridge met grade (lowest elevation/most submersion)
- Dislodged span was about 123' long and 48' wide

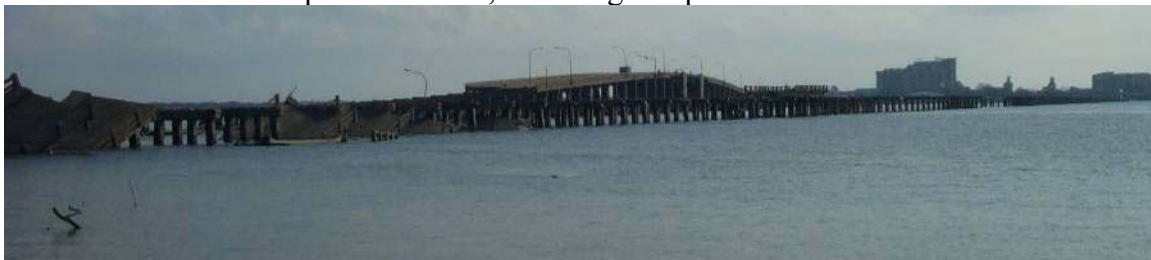
- Bridge contained concrete girder spans, steel girder spans, and a bascule span
- Bridge plans dated 1959
- Concrete girder spans
  - Prestressed girders
  - 52' typical span length
  - 33' 5" typical span width
  - Used on lower elevation spans
  - Majority of bridge was concrete spans
- Steel girder spans
  - Wide flange sections
  - 76' typical span length
  - Used on higher elevation spans adjacent to bascule
- Low elevation spans were lost, while higher spans were left intact

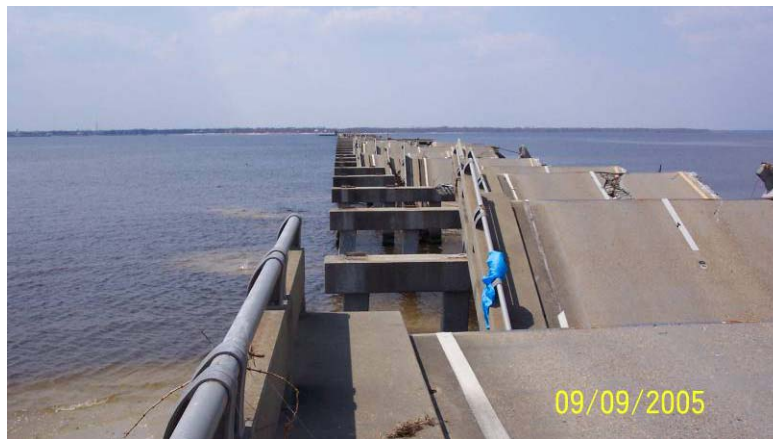
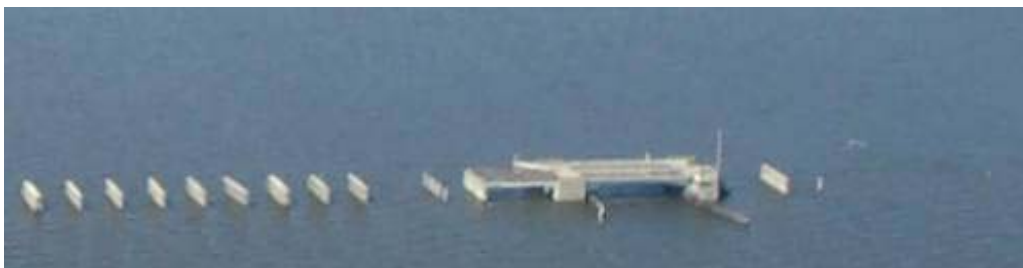
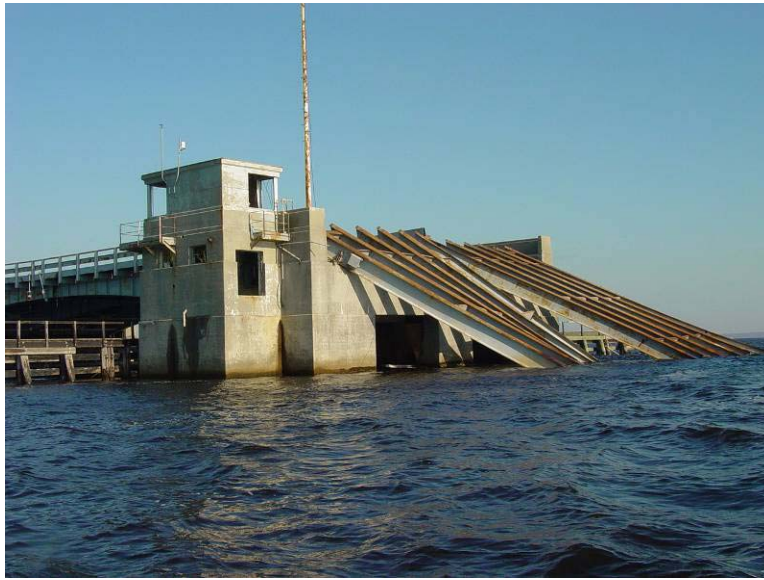
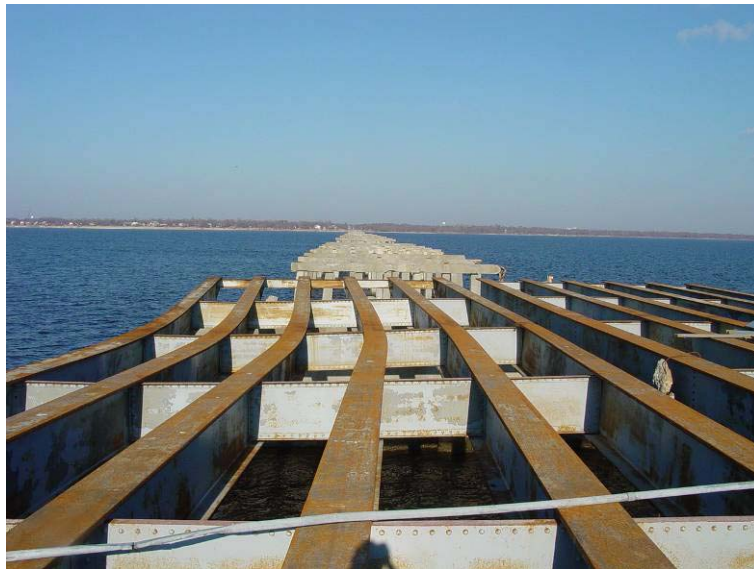
- Bearings provide no positive connection that would resist uplift
- Bearing details shown below are from sheet 12 of the bridge plans
- Pintles should project  $\frac{3}{4}$ " from the rocker or sole plate
- The picture below from Robertson et al shows Pintles that appear to be undamaged

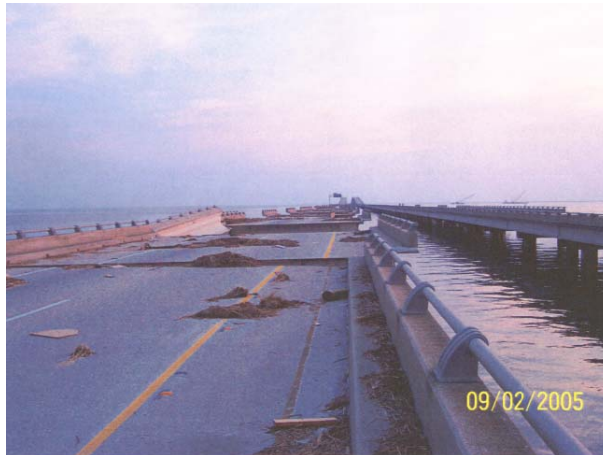
- Bridge consisted of concrete spans and steel spans
- Concrete spans
  - Precast prestressed concrete girders
  - Typical span length 65 ft
  - Used steel and bronze bearings
- Steel Spans
  - Used at higher elevation, not impacted by surge
- Low lying spans impacted by surge while higher elevation spans largely undamaged
- Some spans completely dislodged while others shifted laterally
