Technical Memorandum

Re. Forensic Desktop Study Report: Pennsylvania LTPP Test Section 42_1597

The Long-Term Pavement Performance (LTPP) General Pavement Studies-1 (GPS-1) Asphalt Concrete (AC) Pavement on Granular Base test section 42_1597¹ was nominated for a desktop study under TPF-5(332) "LTPP Forensic Evaluations." This test section was originally constructed in 1980 and was incorporated into the LTPP program in 1988 as 6.5 inches of asphalt concrete (split between two layers) and 16.8 inches of unbound granular base over a fine-grained subgrade soil. During the first 20 years of the pavement's history, the test section received five treatments—crack sealing in June 1990, June 1996, and May 1999, patching in August 1997, and a shoulder restoration and mill and overlay in July 2000, which moved the test section to GPS-6S AC Overlay of Milled AC Pavement Using Conventional or Modified Asphalt. Following the mill and overlay in 2000, the pavement section received crack sealing in June 2011, a slurry seal in June 2015, and crack sealing again in June 2019. The overlay event in 2000, which occurred approximately 20 years after the construction of the pavement section, provides an

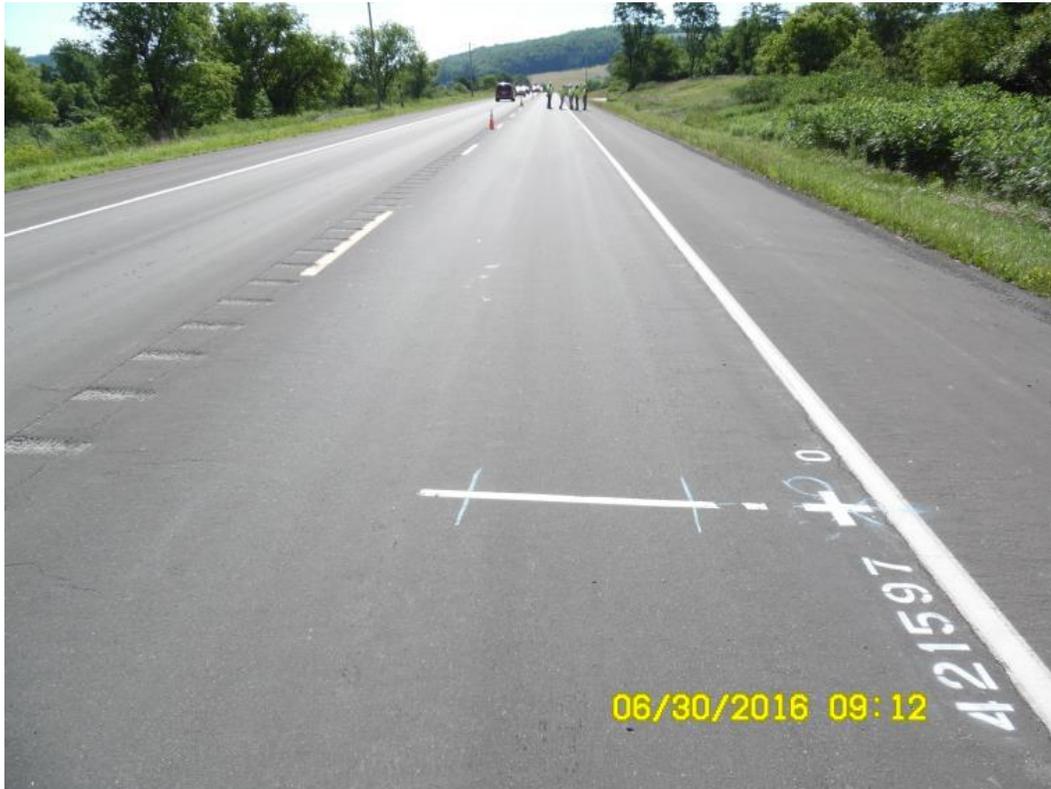
Photograph 1. LTPP Section 42_1597 at Station 0+00 looking eastbound in 2016.

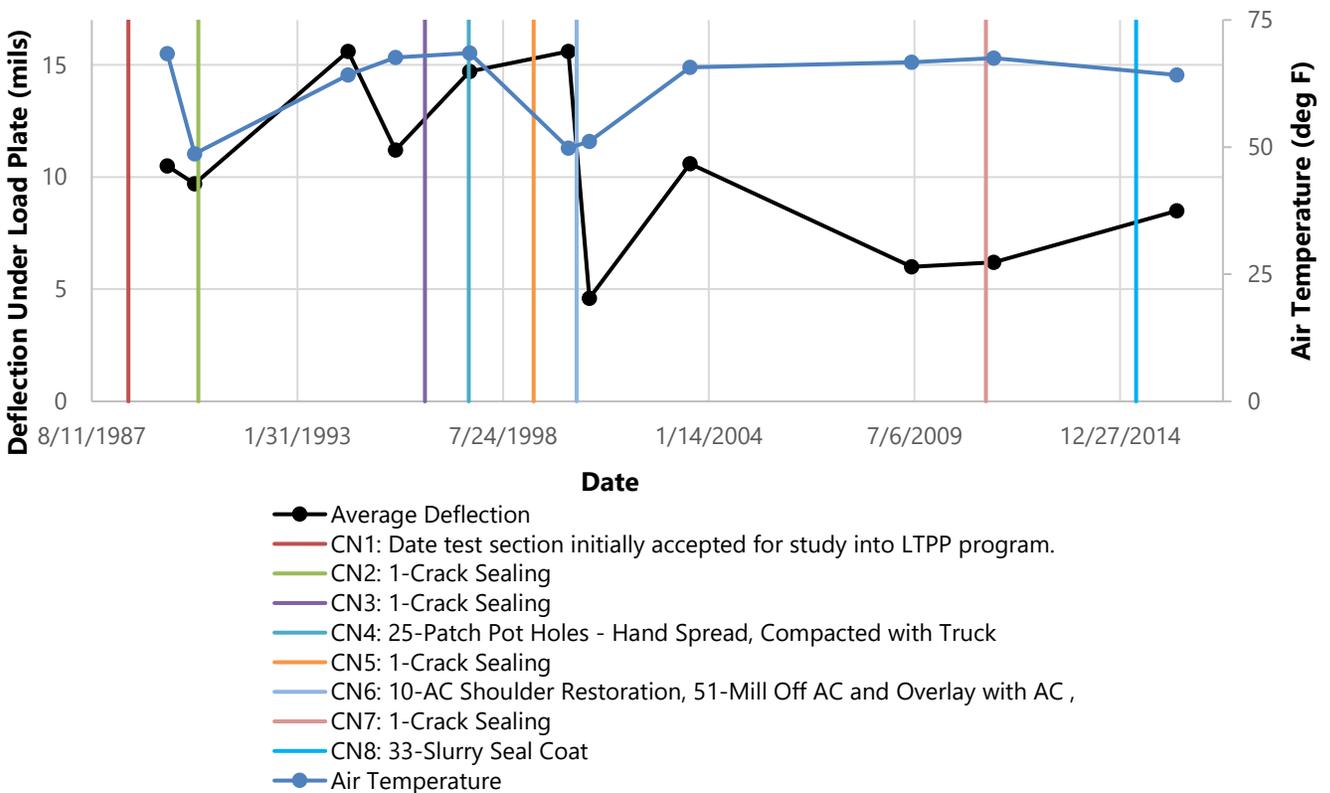
Error! Reference source not found. shows the average FWD deflections under the nominal 9,000-pound load plate. The deflection of the sensor located in the center of the load plate is a general indication of the total “strength” or response of all layers in the pavement structure to a vertically applied load. As shown in **Error! Reference source not found.**, the deflections reported ranged from 9.7 mils (May 1990) to 15.6 mils (June 1994 and April 2000) prior to the mill and overlay and from 4.6 mils (November 2000) to 10.6 mils (July 2003) following the mill and overlay; the reported deflections were higher prior to the mill and overlay event in 2000. Following this construction event, when the overall AC thickness increased, the deflections subsequently decreased. As shown in the figure, the fluctuations in the deflections reported prior to and following the mill and overlay event appear to be affected by the air temperature at the time of testing. Generally, as the air temperature at the time of testing increased, the deflections reported increased. Notable exceptions to this trend included the deflections reported in September 1995, April 2000, and June 2009.

Figure 1. FWD deflections under the load plate over time with air temperature and the 7-day precipitation at test section.

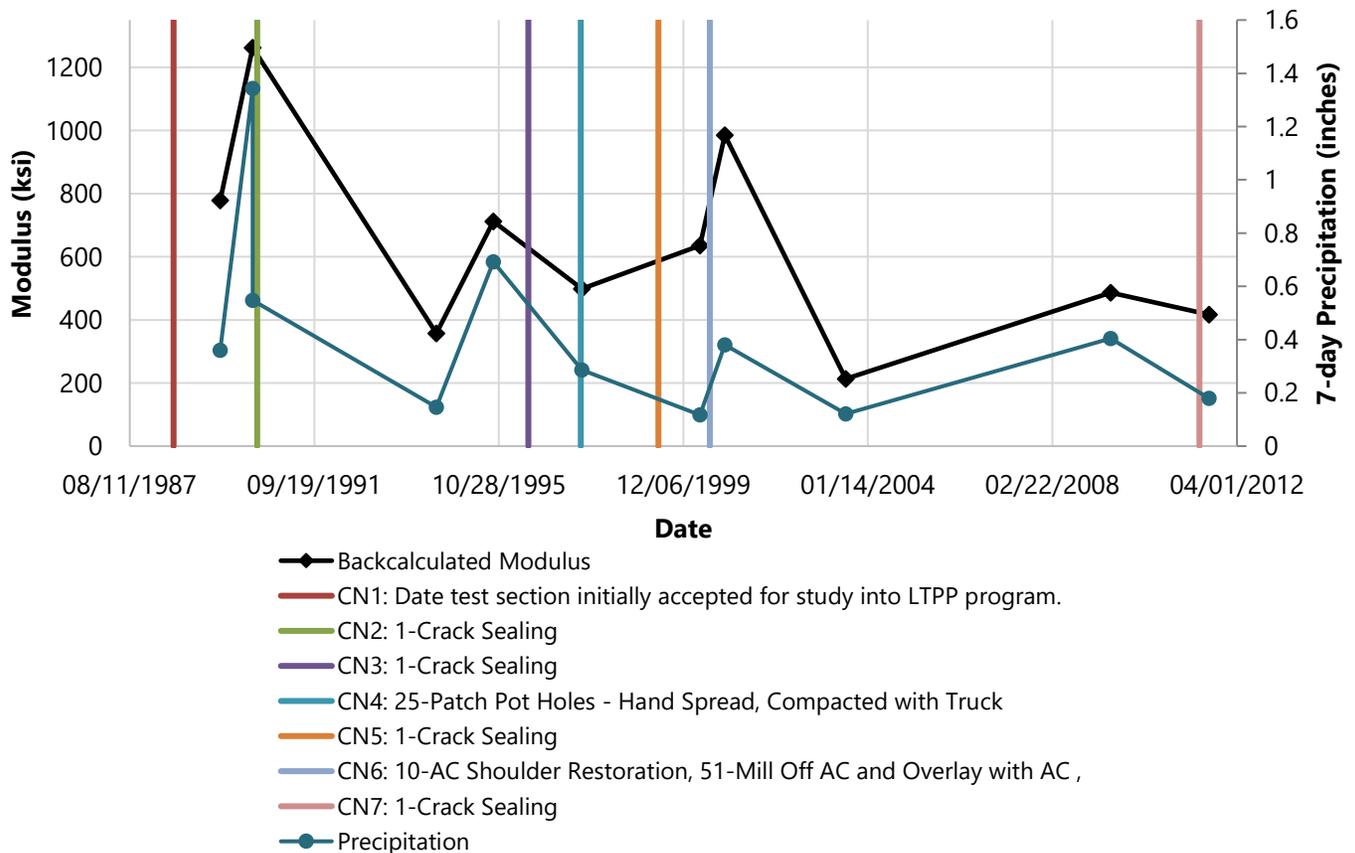
As shown in the figures below, in addition to temperature affecting the structural properties of the section at the time of testing, moisture (measured as the cumulative precipitation reported the 7 days leading up to the FWD collection dates) also played a role in the reported moduli over time. For each of the four layers, increases in the 7-day precipitation typically led to increases in the reported moduli. For the AC layer (Layer 1), prior to the mill and overlay event in 2000, the moduli reported ranged from 357 ksi to 1,263 ksi. Following the mill and overlay event, the moduli reported for Layer 1 ranged from 213 ksi to 985 ksi. The range of values reported for Layers 2, 3, and 4 prior to the 2000 mill and overlay event was 15-20 ksi, 12-30 ksi, and 54-70 ksi, respectively. Following the mill and overlay, the range of values reported for Layers 2, 3, and 4 was 25-38 ksi, 17 to 30 ksi, and 72-90 ksi. For all four layers, the moduli values reported directly after the mill and overlay increased despite an increase in the overall pavement thickness. This may be the result of stress hardening; a thicker pavement structure may have led to an increase in stress and therefore, a higher modulus.

Figure 2. Average backcalculated modulus for AC (Layer 1) and the 7-day precipitation at test section.

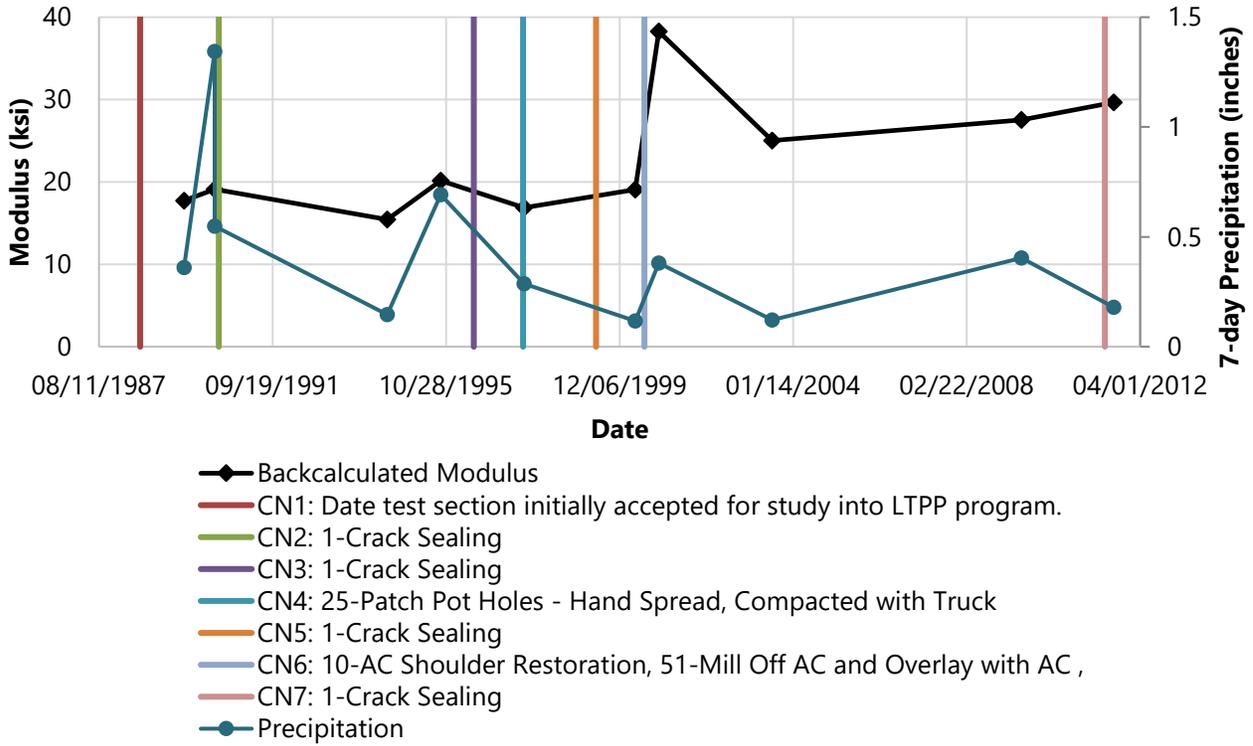
Figure 3. Average backcalculated modulus for base layer (Layer 2) and the 7-day precipitation at test section.

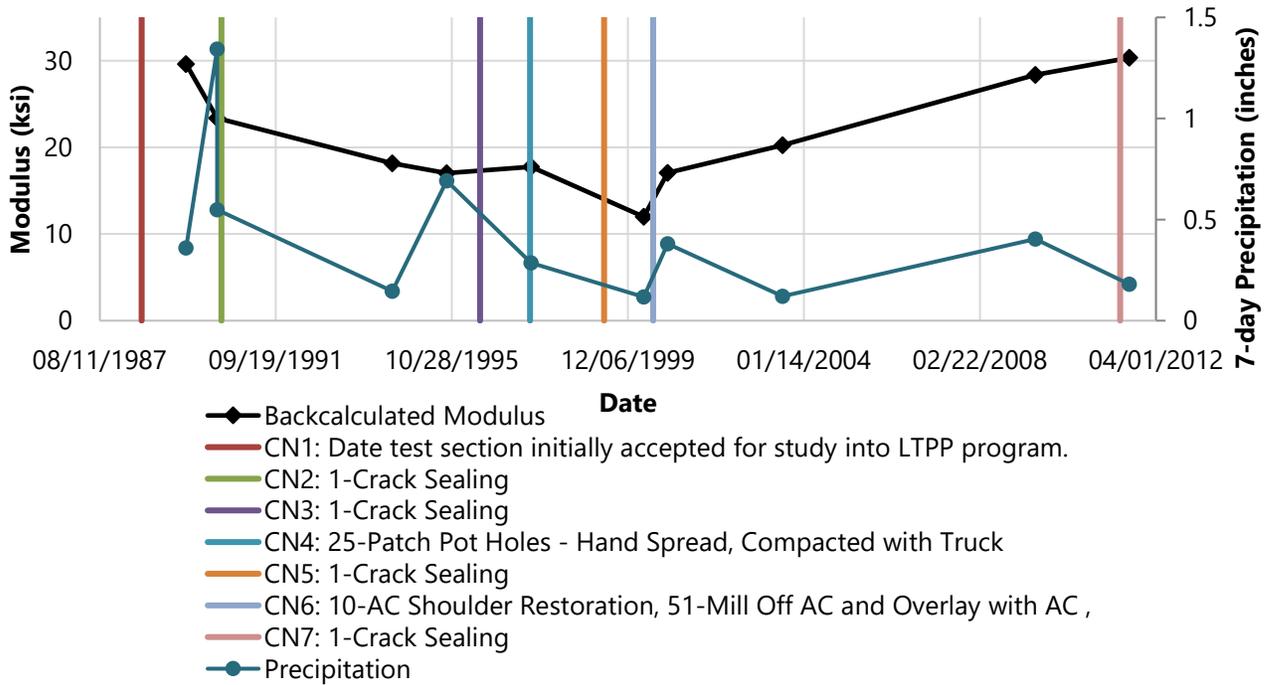
Figure 4. Average backcalculated modulus for the first 24-inches of subgrade (Layer 3) and the 7-day precipitation at test section.

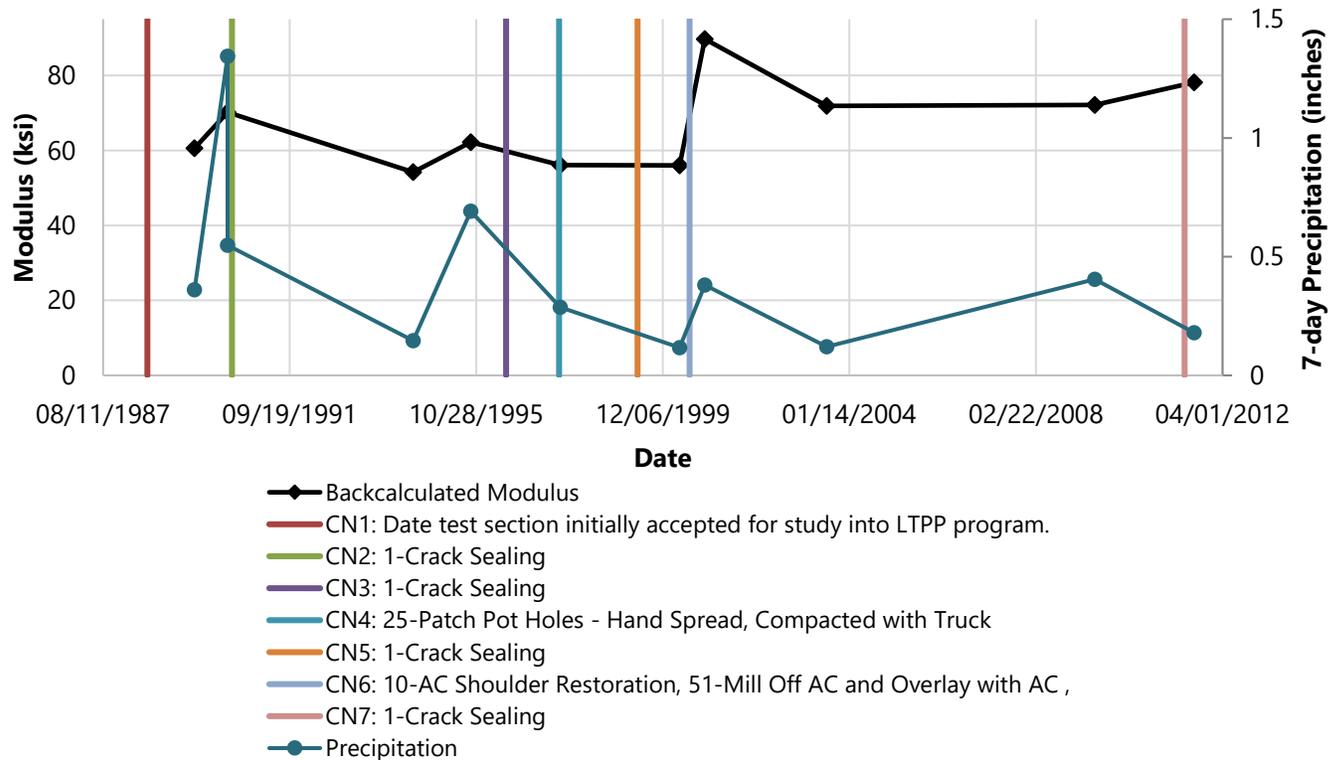
Figure 5. Average backcalculated modulus for remaining subgrade (Layer 4) and the 7-day precipitation at test section.

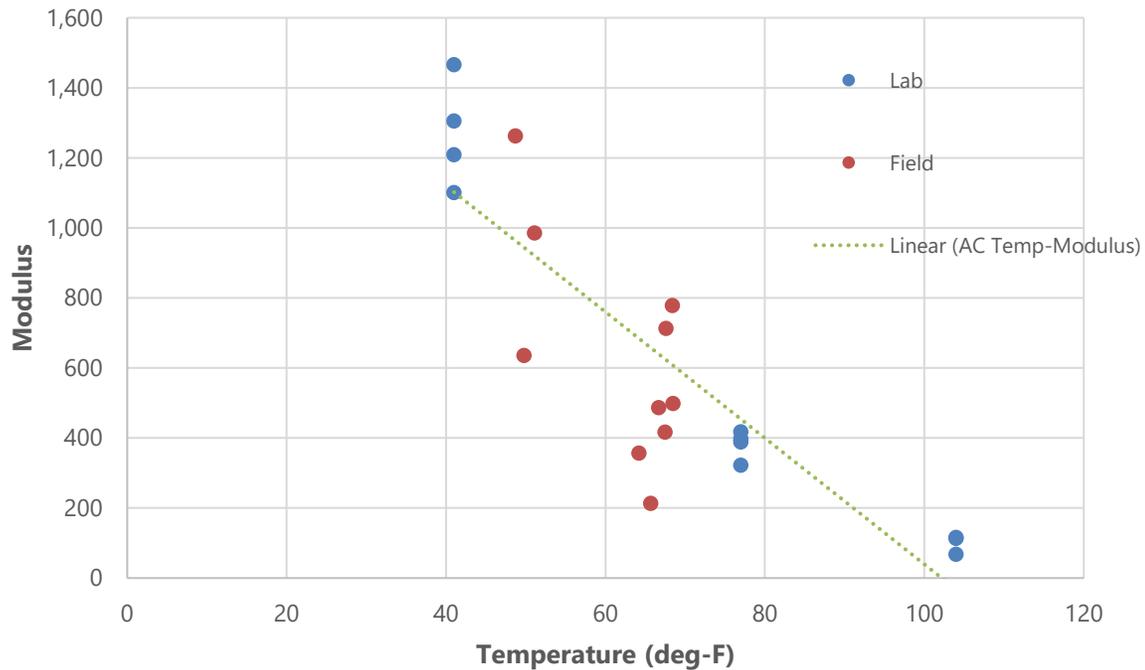
The reasonableness of the backcalculated layer moduli was compared to moduli derived from laboratory resilient modulus testing. Table 4 summarizes the laboratory test results for two AC layers (Layer 5 and Layer 6 in the LTPP database) and the subgrade layer. For the AC layers, moduli values are shown for three test temperatures – 41, 77, and 104°F, respectively. As shown in Figure 6, the AC modulus versus temperature relationship for the field- (FWD-derived backcalculated moduli) and lab-measured resilient moduli appears to be reasonable; there appears to be a clear trend between temperature and the pavement modulus. For the subgrade layer, various statistical analyses were conducted for the range of stress states (confining and deviatoric stresses) to which the laboratory samples were subjected. The laboratory values for the subgrade were slightly lower than the backcalculated moduli reported for the top 24 inches of subgrade.

Figure 6. Field- and lab-derived AC resilient modulus values.

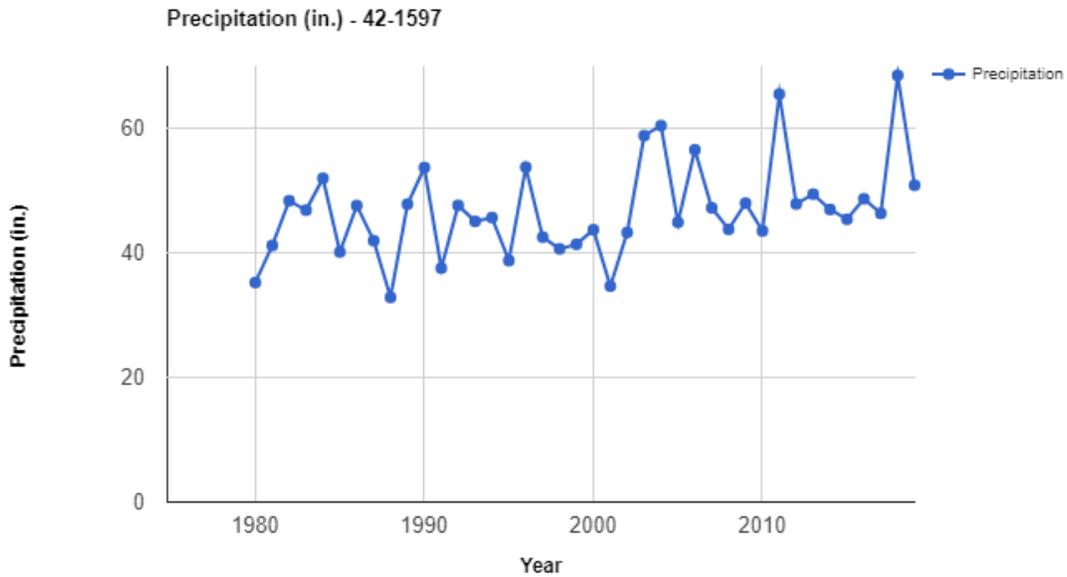
The time history for average annual precipitation (from MERRA) since 1980 is shown in Figure 7. While the average annual precipitation observed over the analysis period fluctuated on a year-to-year basis, the average yearly precipitation observed increased over time. As shown in the figure, between 1988, when the test section was incorporated into the LTPP program, and 2019, the average annual precipitation at the test section increased from 33 inches to 51 inches. Additionally, notable spikes in precipitation were observed in 2003, 2004, 2011, and 2018, when 59, 61, 66, and 69 inches of precipitation were reported, respectively. These notable spikes are likely related to extreme weather events reported in central Pennsylvania including Tropical Storm Henri, Hurricane Isabel, and the President's Day Storm II in 2003, Hurricane Ivan in 2004, and Hurricane Irene, Hurricane Agnes, and Tropical Storm Lee in 2011 as well as abnormally wet spring and summer seasons in 2018.

Figure 7. Average yearly precipitation over time.

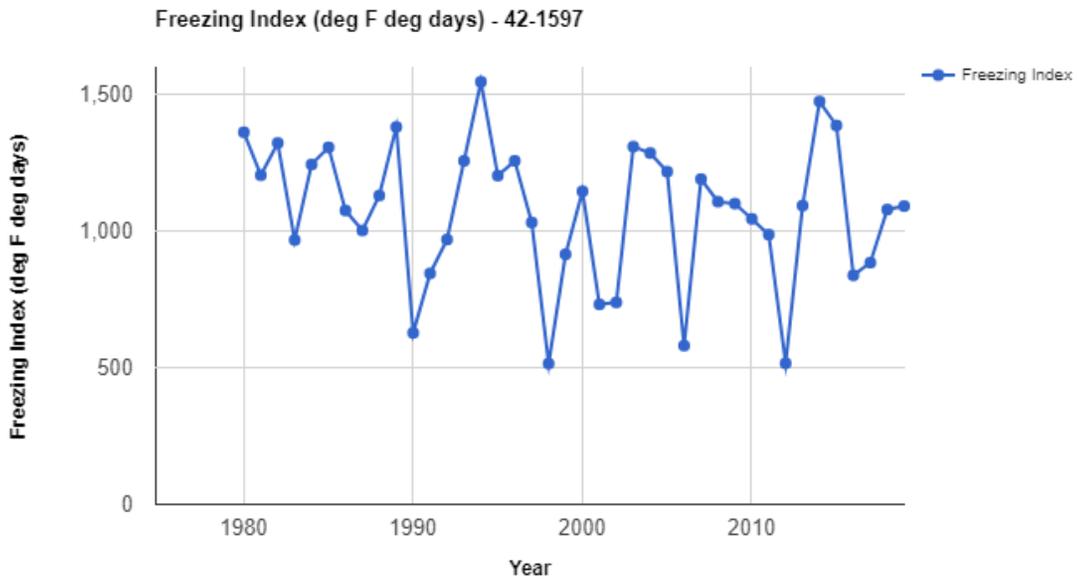
Figure 8 shows the time history of the average annual freezing index (from MERRA) for the test site. The freezing index is the summation of the difference between freezing temperature and the average air temperature when it is less than freezing over a year's time. This index is an indicator of the harshness of the winter season relative to issues such as ground frost and low temperature cracking in pavements. As depicted in Figure 8, the freezing index values ranged from 516 deg F deg days (1998) to 1,548 deg F deg days (1994) during the analysis period. As shown in the figure, the overall trend of the freezing index is decreasing overtime, indicating the climate is getting warmer. This trend could have implications on the overall performance of the pavement overtime.

Figure 8. Average annual freezing index over time.

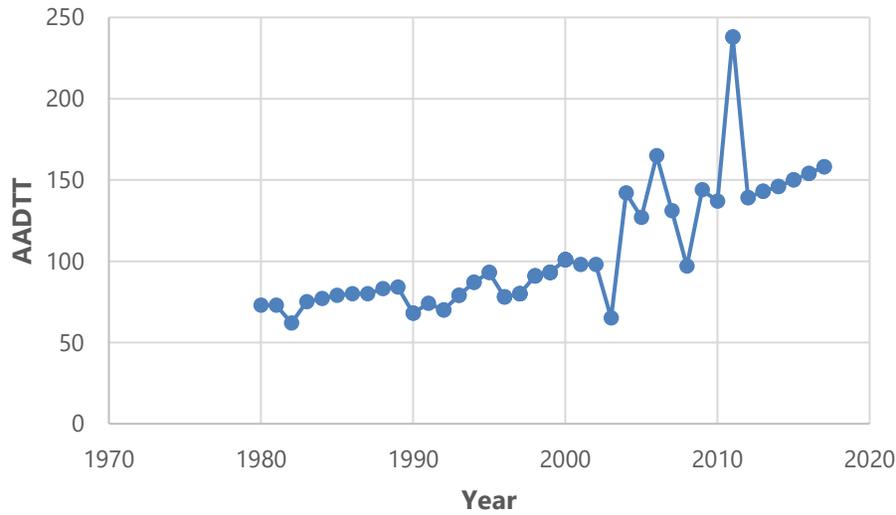
Figure 9 shows the annual average daily truck traffic (AADTT) data in the LTPP test lane by year. The annual truck traffic counts increase from 73 in 1980 to 158 in 2017. The average number of ESALS reported on the section also increased over time as depicted in Figure 10. The number of ESALS increased from 5,280 in 1980 to 29,364 in 2017. The fluctuations in both the AADTT and ESALS reported for the test section are likely a result of the source of the data used over time. A combination of historical AADTT values (1980-1989), state provided AADTT values (1990, 1992, and 1996), monitored values (1991, 1993-1995, 1997, and 2000-2003), monitored values calculated from class data (1998-1999 and 2004-2011), and values

Figure 9. Average annual daily truck traffic (AADTT) history.

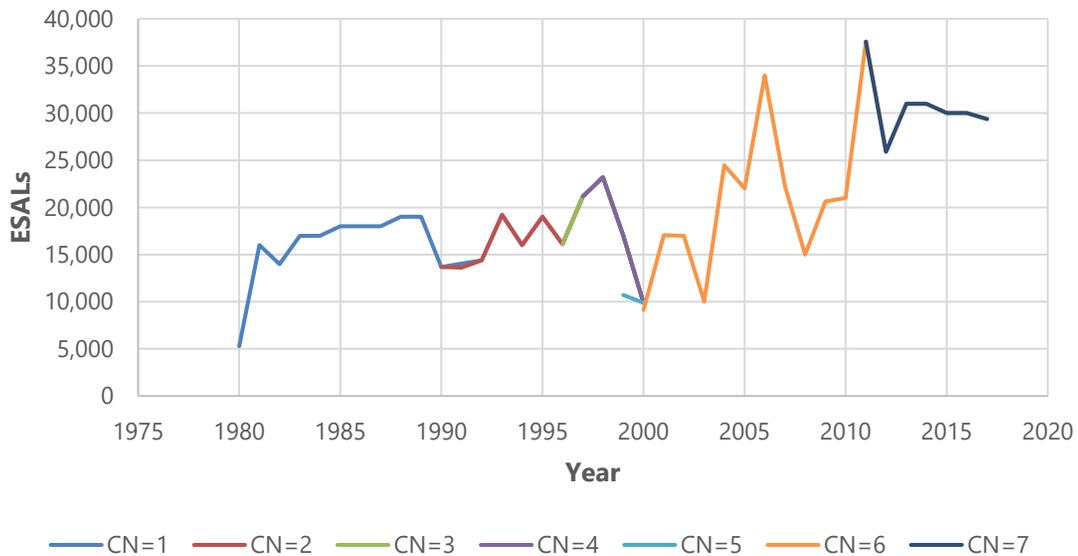
Figure 10. Estimated annual ESALs for vehicle classes 4-13 over time.

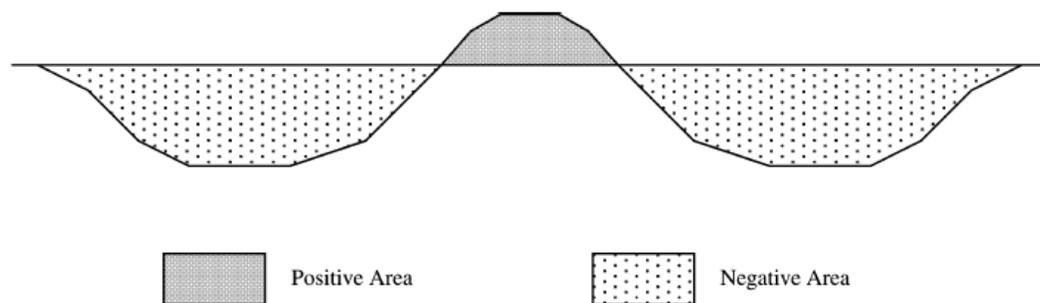
measured from the pavement surface to the wire reference line as depicted in Figure 19. Similarly, the positive area (A_P) and negative area (A_N) are the sum of the areas above and below the transverse profile reference line, respectively. Using these parameters, the ratio of positive area to negative area (R), total area (A_T), and the theoretical total areas for the HMA, base, and subgrade failure (C_1, C_2 , and C_3 , respectively) are calculated and used to assess the failed layer. The assessment of the parameters used to determine the lowest layer contributing to the pavement's surface deformation is described in Figure 20.

Figure 19. Transverse profile maximum rut depth and positive and negative areas (White et al., 2002)
