**FATIGUE TESTS OF CRACKED AND
REPAIRED ALUMINUM CONNECTIONS
OF OVERHEAD SIGN STRUCTURES –
FINAL REPORT**

**New York State Department of Transportation
Utah Department of Transportation**

August 2003

**Civil & Environmental Engineering
College of Engineering
University of Utah
Salt Lake City, Utah**

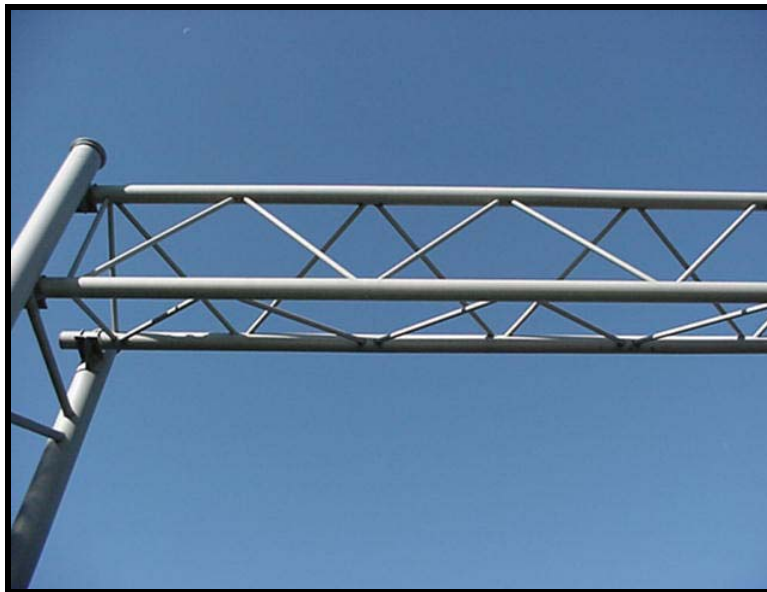
Overhead sign structures support signs that make travel safer by providing timely information to the driver. However, several aluminum sign structures after inspection exhibit structural damage, the most prevalent of which is cracking of the joint between internal trussing and the main chords. The cause of the cracks is due to several factors, the greatest contributor of which is the fact that when the original truss designs were done in the 1960's fatigue design was not a code requirement. Other factors include lack of shop inspection during fabrication, insufficient construction supervision, and thermal strains developed in the welding process, all of which may cause internal stresses into the overhead sign structure before the sign is attached. Cracks in the welds of aluminum overhead sign structures can propagate to complete failure of members, which can cause signs to fall and cause injuries. The truss considered here is a three-dimensional truss, or tri-truss system, as shown in Figure 1. Figure 2 shows a typical crack in a welded aluminum connection.

Figure 1. Tri-truss aluminum overhead sign support structure

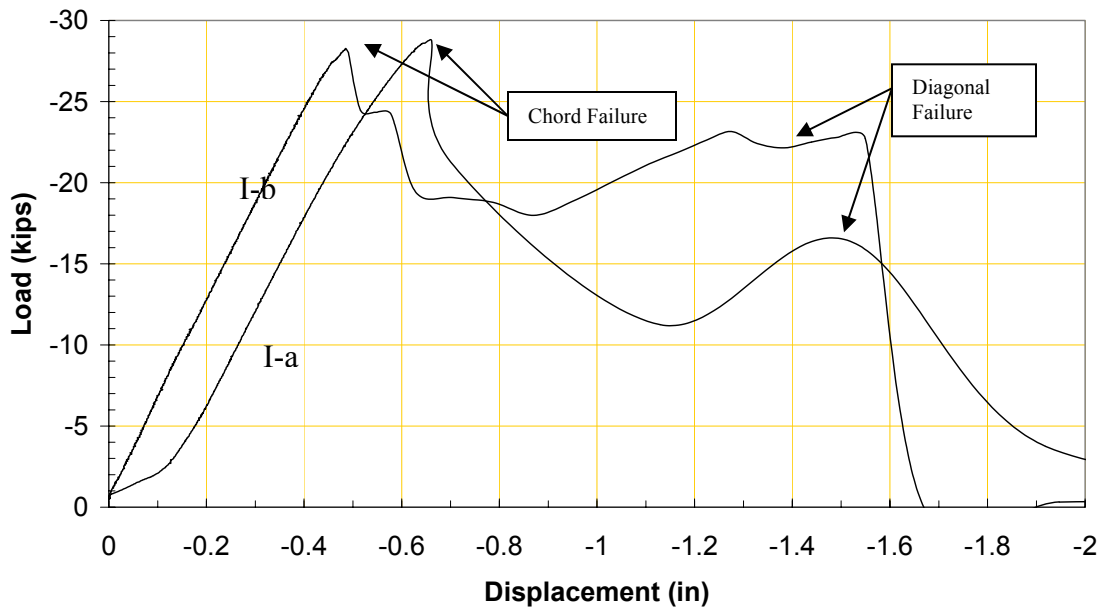
Static tests I-a and I-b had a similar failure mode and load/displacement curve. Failure occurred at the toe of the weld and continued almost entirely around the chord, as can be seen in Figure 7. Immediately following failure of the chord the diagonal was subjected to combined tensile and bending stress, due to the large deflection of the cracked chord, which subsequently caused the diagonal to fail as seen in Figure 8. This failure of the diagonal was secondary to the failure of the chord. This failure mode is different from the static test of the as-is connection in the previous study (Pantelides and Nadauld 2001). In this case, the weld performed well and the base material at the toe of the weld was seen to be the primary failure mode. In the previous study, the failure was through the throat of the weld.

Figure 8. Test I-a and I-b Load vs. Displacement curves

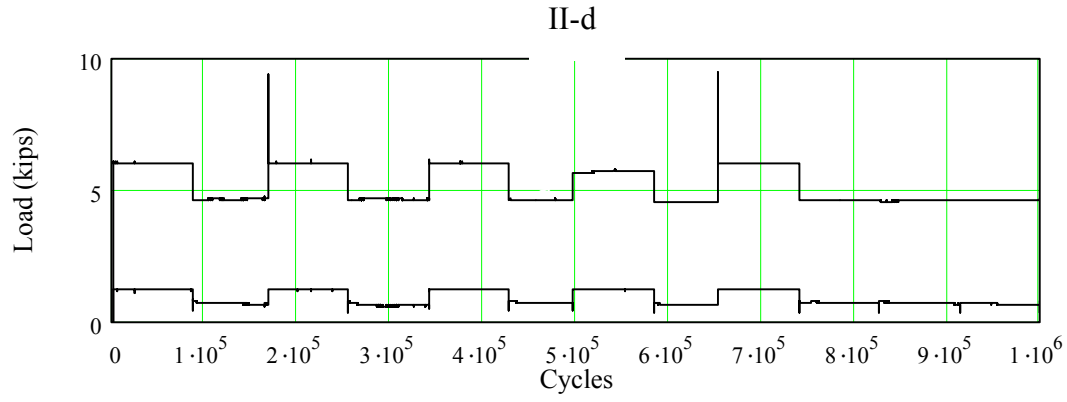
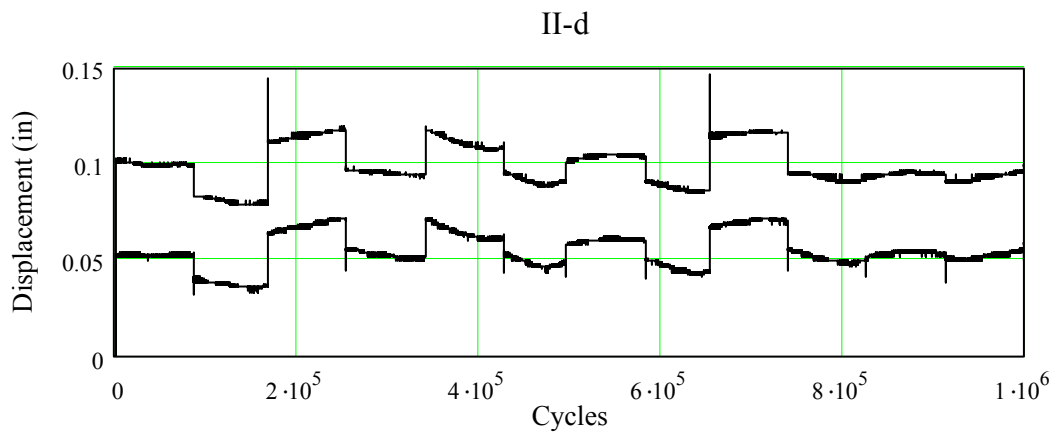
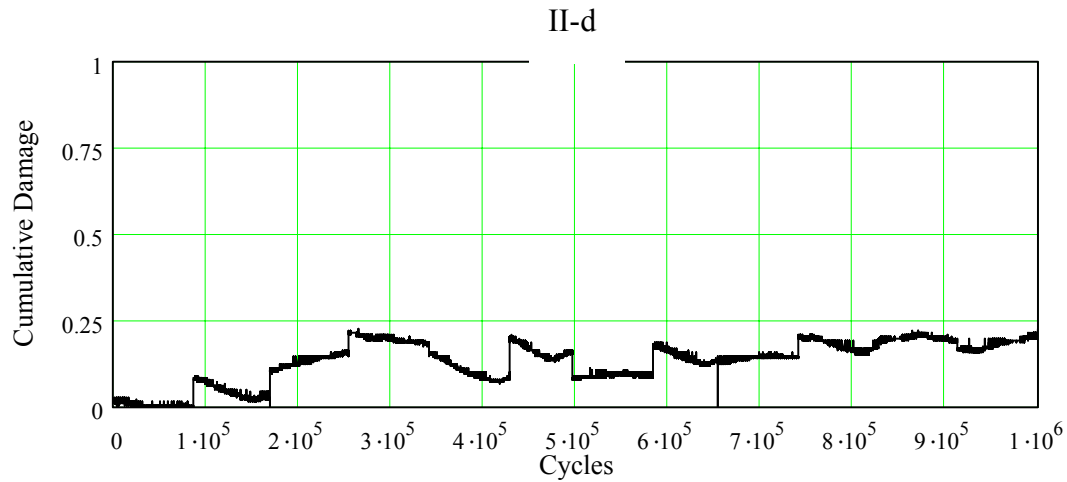
In test II-d the failure was a result of static loading after being fatigued to 1×10^6 cycles. Prior to the static test there was no visible crack in the weld. The load, displacement, and damage curves for this test are shown in Figures 10(a), (b), and (c), respectively. From Figure 10(a) it can be seen that the maximum load was not constant through the test. This loading sequence was not intended, but was a result of the testing system. This problem was only encountered for the tests that were conducted at a load less than 10 kips. Despite the varying loading, it can be seen that the Cumulative Damage remained relatively constant through the duration of the test. The maximum damage calculated was 0.22, which means the stiffness was reduced by 22% over the 1×10^6 cycles. The failed specimen after the static test is shown in Figures 11(a) and 11(b); the static load–displacement curve for test II-d after 1×10^6 is shown in Figure 11(c).

Figure 10. Test II-d: (a) Load – Cycles, (b) Displacement – Cycles, (c) Cumulative Damage – Cycles plots

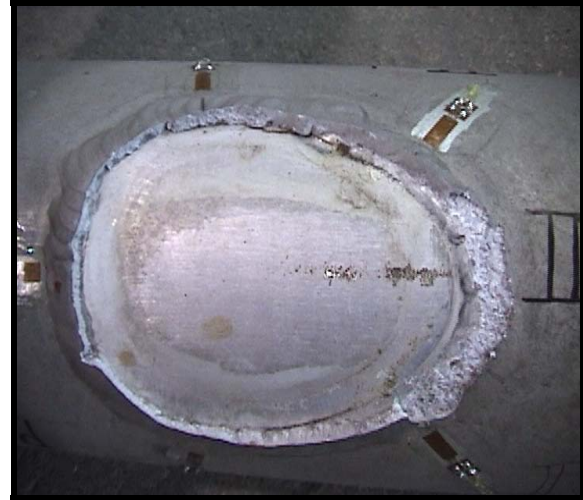
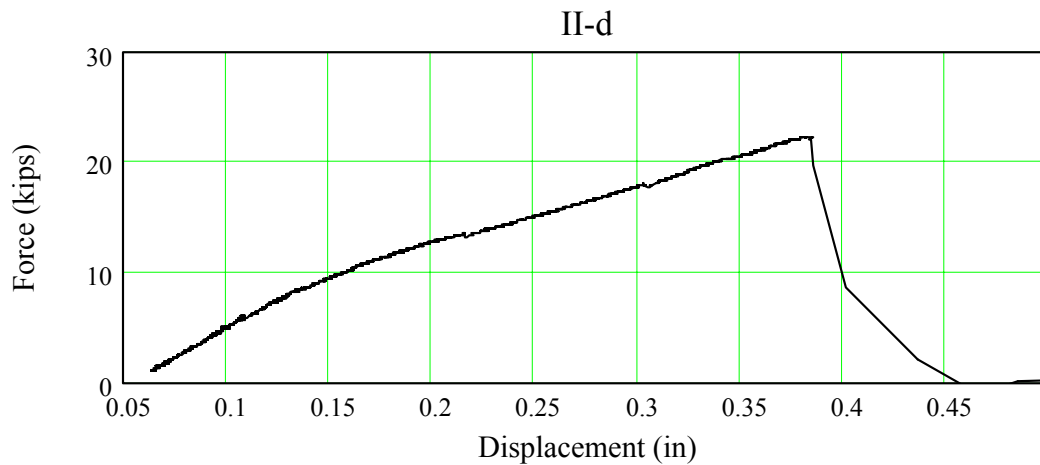
Figure 11. Static Load Test for Specimen of Test II-d after 1×10^6 cycles: (a) diagonal and chord, (b) failure plane on chord, (c) Force–Displacement curve

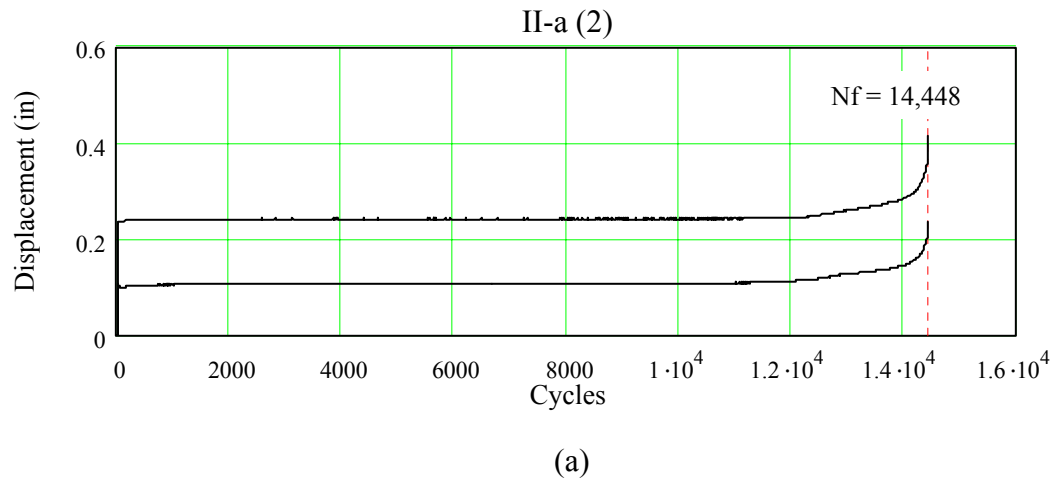
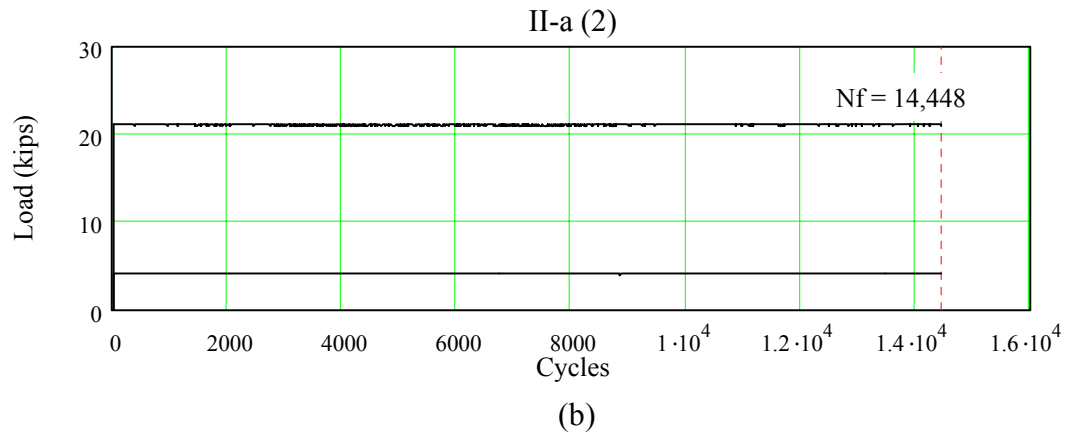
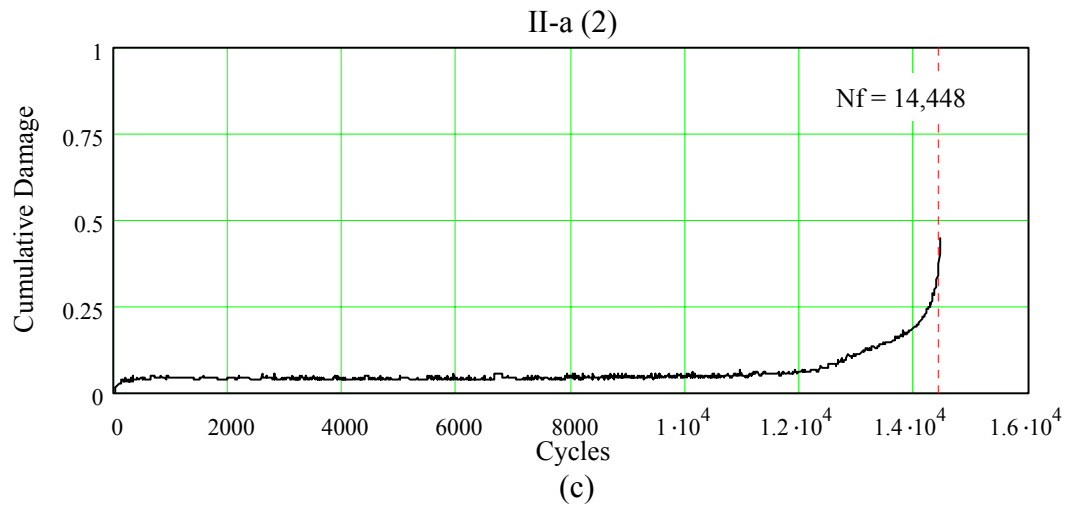
The second failure mode for the Series (II) testing was observed in tests II-a (2), II-b (1), II-b (2), and II-c. The failure consisted of a crack initiated at the toe of the weld, through the base metal. The crack then propagated away from the weld through the chord, and would have continued around the chord – similar to the failure of the series I tests, as shown in Figure 12(a). However, the steel pipe inside the chord forced the crack to propagate through the base material outside the weld, a distance of $\frac{1}{2}$ " to 1" following the weld contour, as shown in Figure 12(b). Figures 13, 14, 15, and 16 show the load, displacement, and cumulative damage curves for tests II-a (2), II-b (1), II-b (2), and II-c, respectively. In all of the fatigue plots failure is indicated by

N_f , which is the number of cycles to failure. All four tests follow the same pattern of damage, with the onset of cracking represented by the increase of slope in the cumulative damage curves. This was verified by test observations. For example, in test II-a (2) the first visible crack appeared at 12,000 cycles. As can be seen in Figure 13, at 12,000 cycles the cumulative damage begins to increase – showing the presence of a crack. The damage immediately before complete failure of the joint varied from 0.45 to 0.79. For all of the tests the damage was less than 0.25 for the majority of the test, demonstrating that most of the damage occurs in the last 20 to 30 percent of the total fatigue life of the joint.

Figure 13. Test II-a (2): (a) Load – Cycles, (b) Displacement – Cycles, (c) Cumulative Damage – Cycles plots

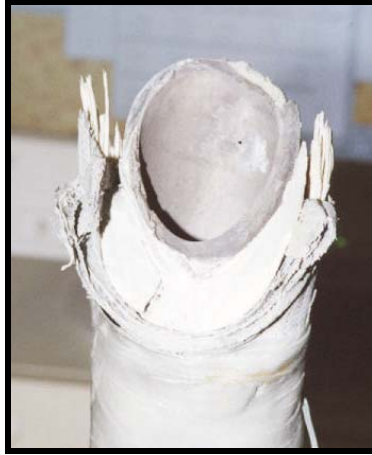
Test III-d lasted the pre-determined infinite-life-limit of 1×10^6 cycles, and was subsequently tested in static tension to failure, as shown in Figure 18. Of all the tests in the present research and the previous research (Pantelides and Nadauld 2001), test III-d obtained the largest static tensile load of 44.17 kips at a displacement of 0.75 in., as shown in Figure 21. This test also had the least damage after reaching 1×10^6 cycles; the maximum cumulative damage was 0.19, as shown in Figure 20(c). The cause of this large static strength and superior fatigue behavior is not clear.

Figure 18. Test III-d: (a), (b), and (c) Failure of weld and FRP composite

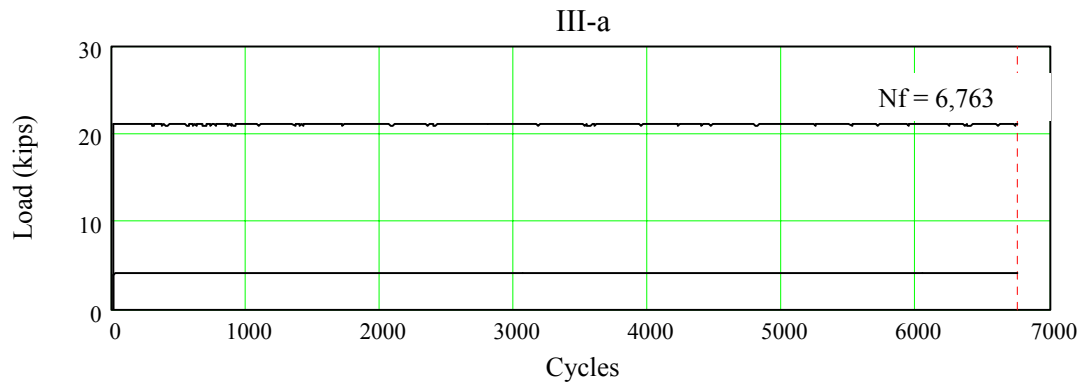
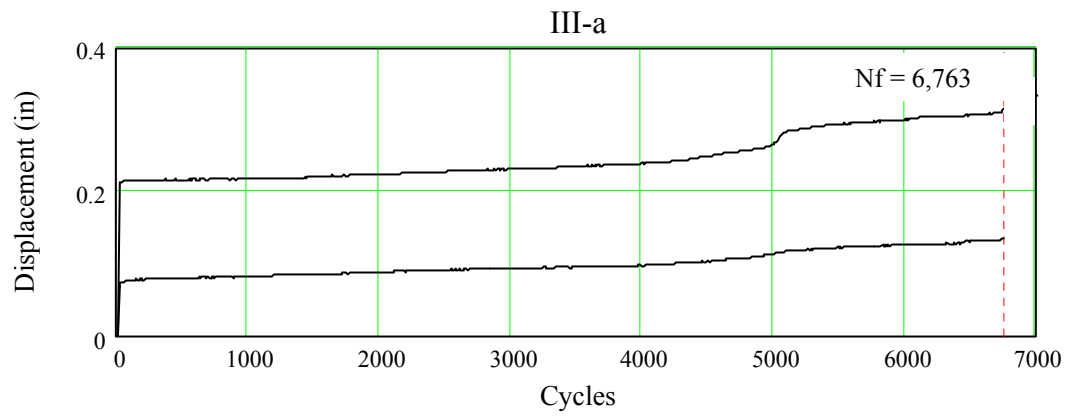
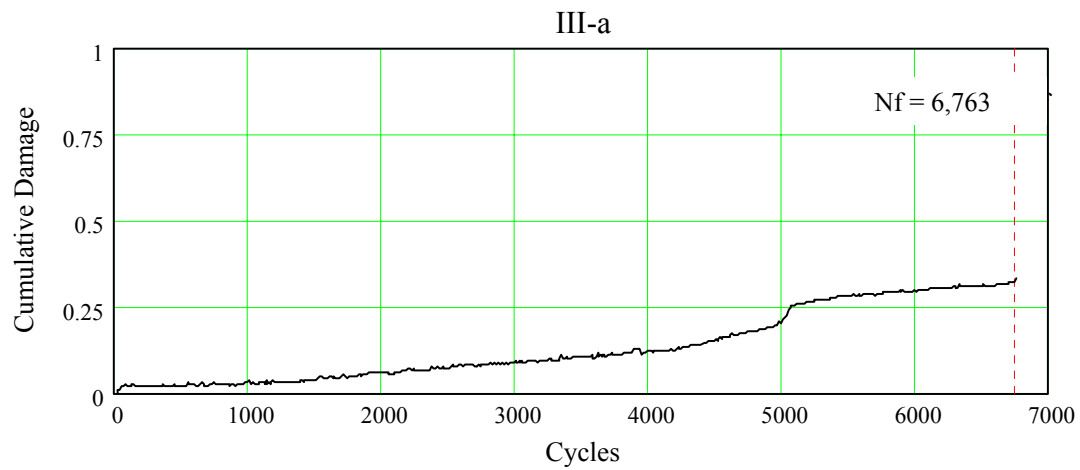
Series (III) tests had two basic failure modes: (1) cracking through the throat of the weld and FRP tensile failure, and (2) cracking through the toe of the weld, followed by cracking through the throat of the weld and FRP tensile failure. The first failure mode occurred in tests III-a and III-d and is shown in Figure 17 and Figure 18. This failure consisted of initial cracking of the FRP composite (note the horizontal lines in Figure 17) followed by cracking failure through the throat of the weld and finally by tensile failure of the FRP composite. The load, displacement, and cumulative damage curves are shown in Figure 19 for test III-a, and Figure 20 for test III-d. It can be seen in Figure 19(b) and (c) that the weld failed at about 5000 cycles, and the FRP failed much later at 6763 cycles. From Figure 19(c) it is also evident that the damage did not increase as rapidly near the failure point, as compared to the Series (II) tests. This indicates that for this particular failure mode, the failure is more brittle than that of the Series (II) tests. This is also shown by the lower cumulative damage of 0.33 at failure for test III-a, which is slightly less than the comparable test II-a (2).

Figure 19. Test III-a: (a) Load – Cycles, (b) Displacement – Cycles, (c) Cumulative Damage – Cycles plots

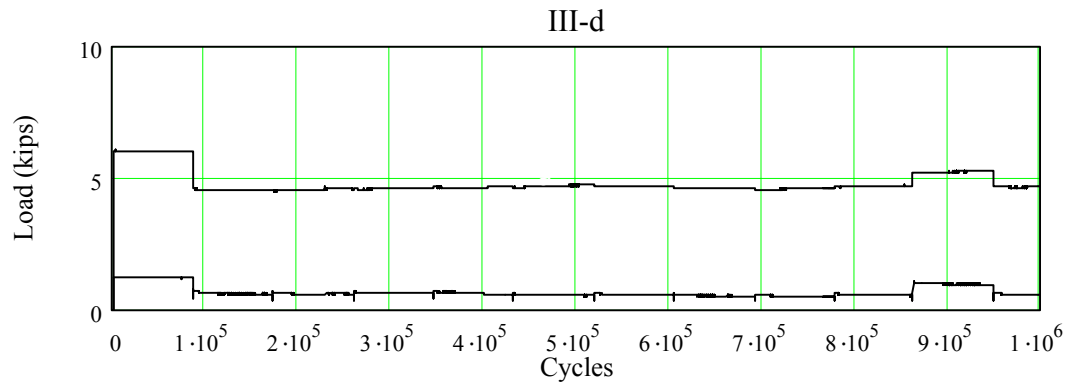
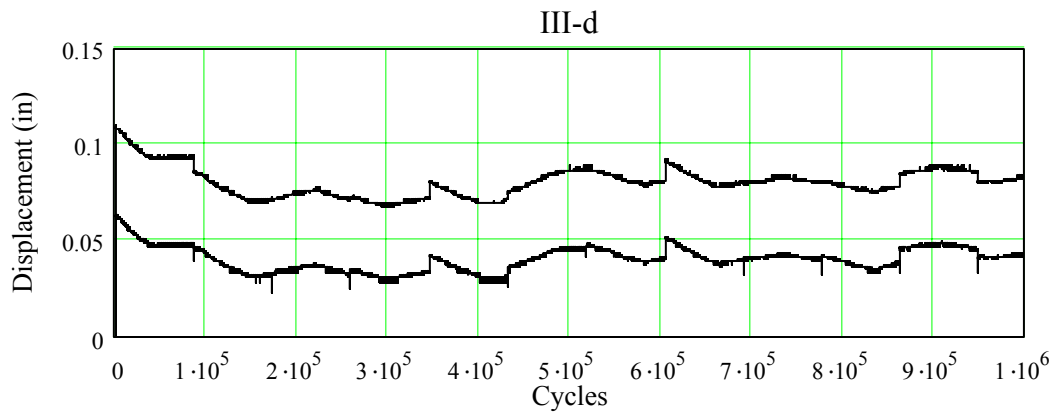
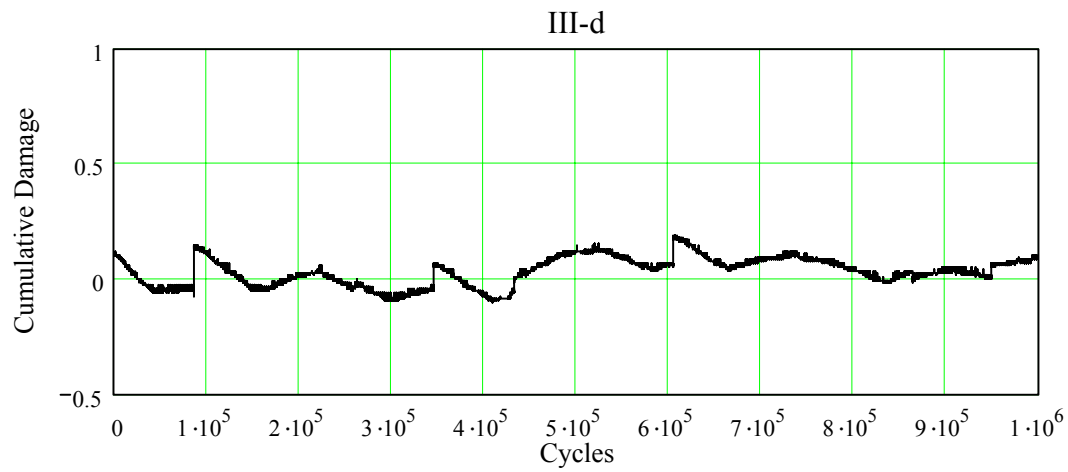
Figure 20. Test III-d: (a) Load – Cycles, (b) Displacement – Cycles, (c) Cumulative Damage – Cycles plots

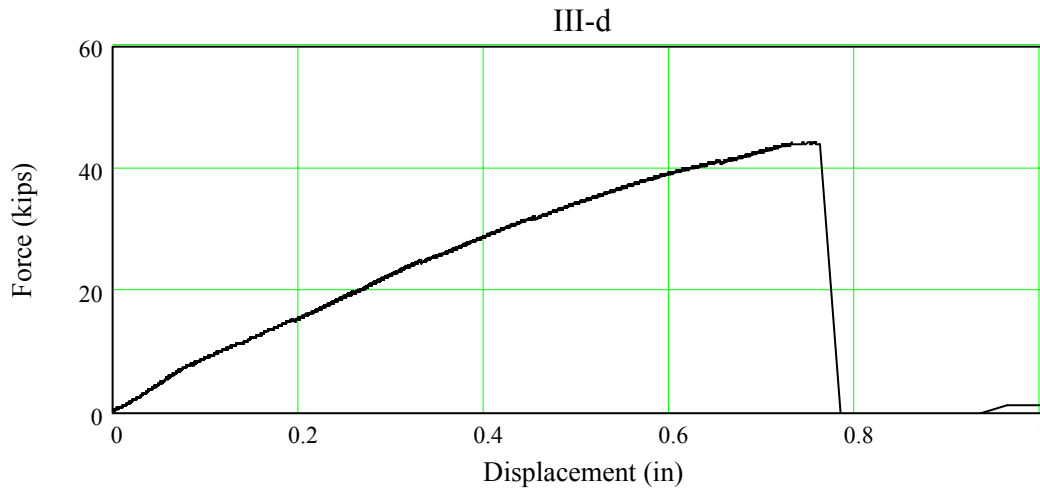
Figure 21. Test III-d: Static Load – Displacement curve after 1×10^6 cycles

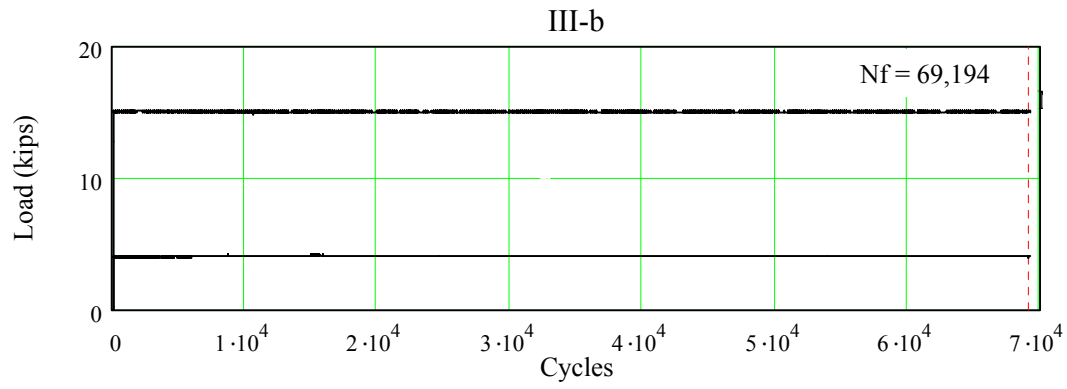
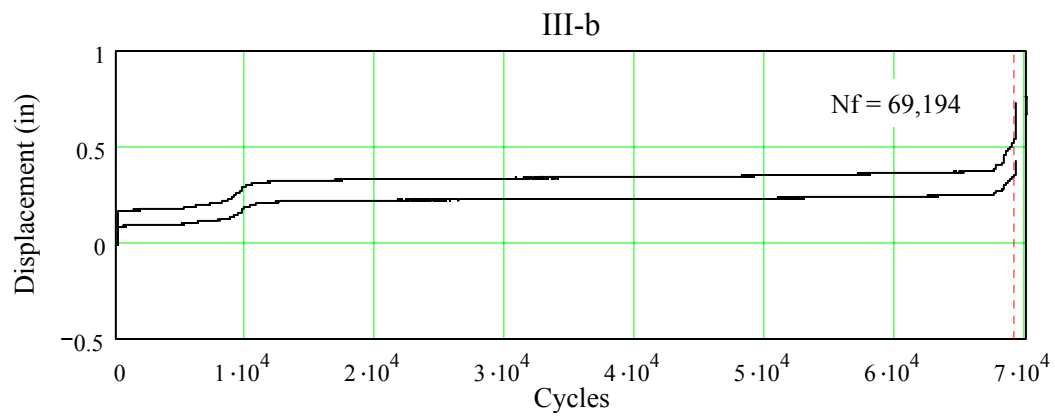
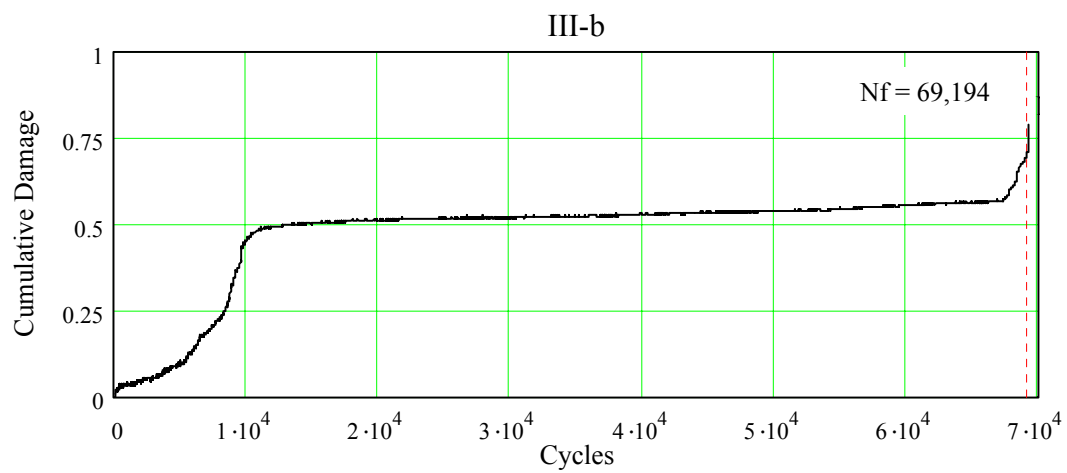
Figure 24. Test III-b: (a) Load – Cycles, (b) Displacement – Cycles, (c) Cumulative Damage – Cycles plots

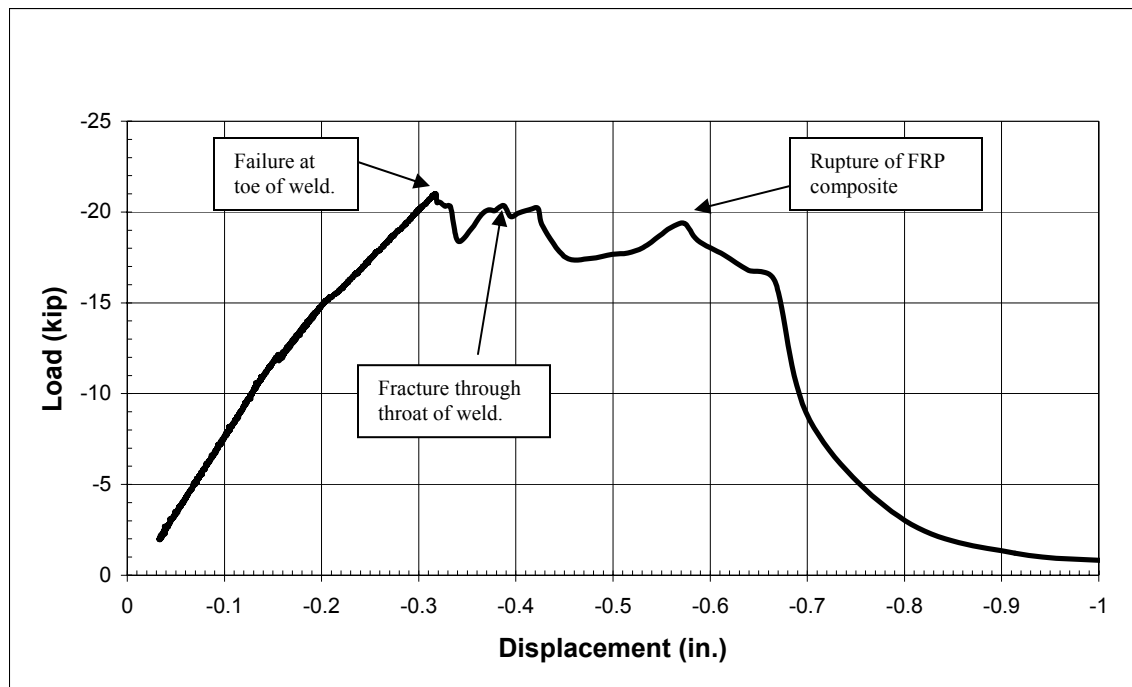
Figure 26. Static test of test III-c after 1×10^6 cycles

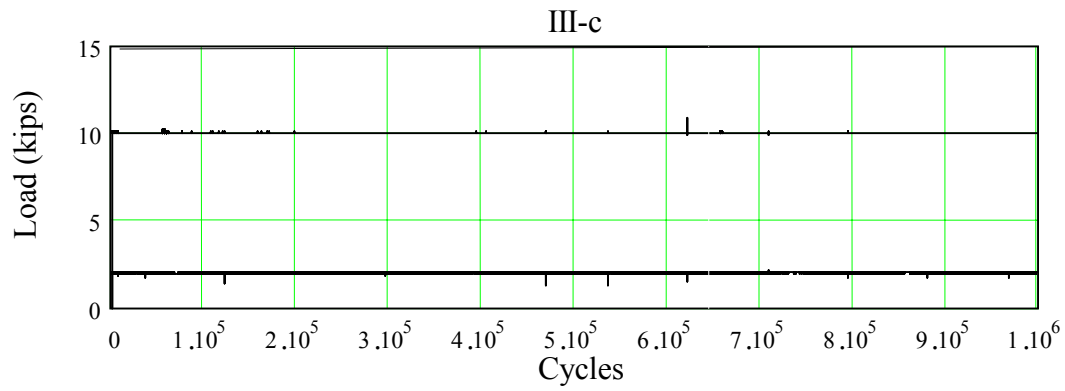
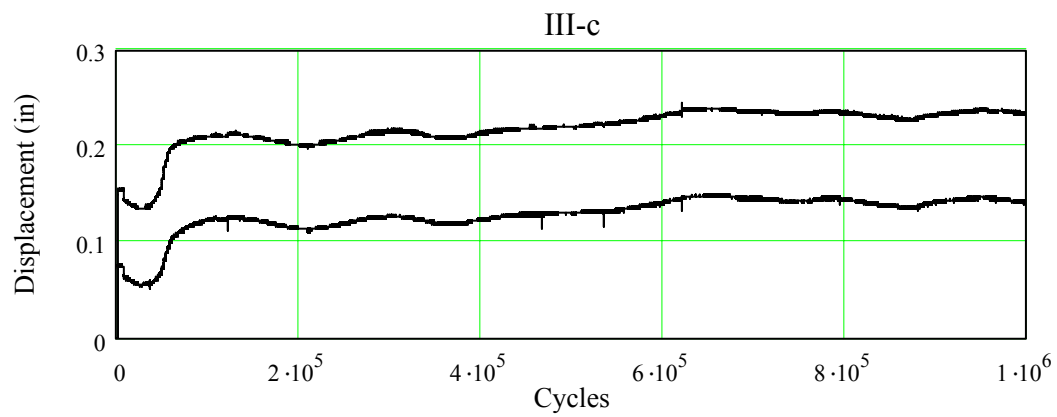
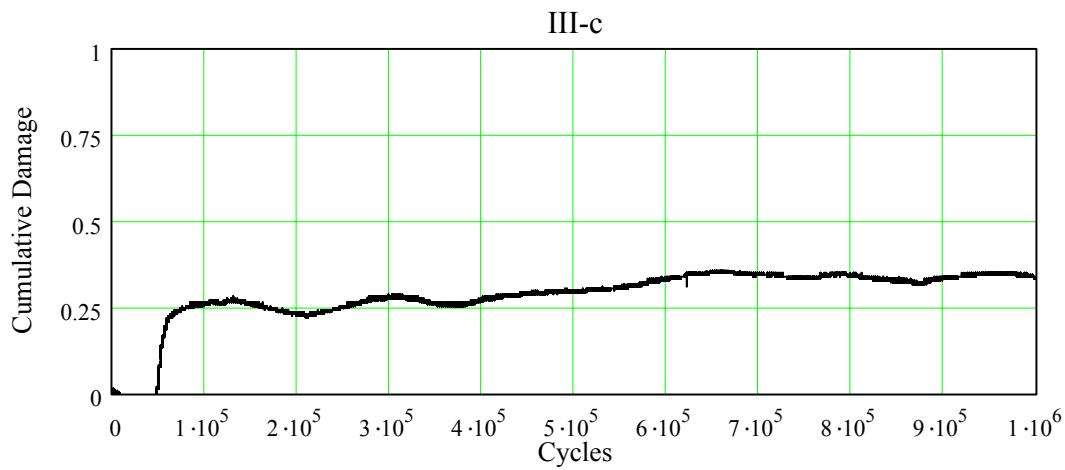
Figure 27. Test III-c: (a) Load – Cycles, (b) Displacement – Cycles, (c) Cumulative Damage – Cycles plots

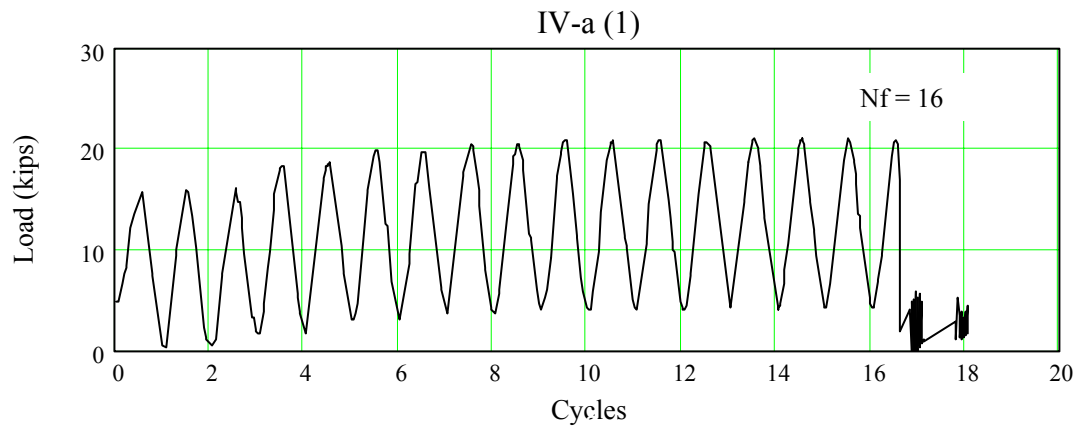
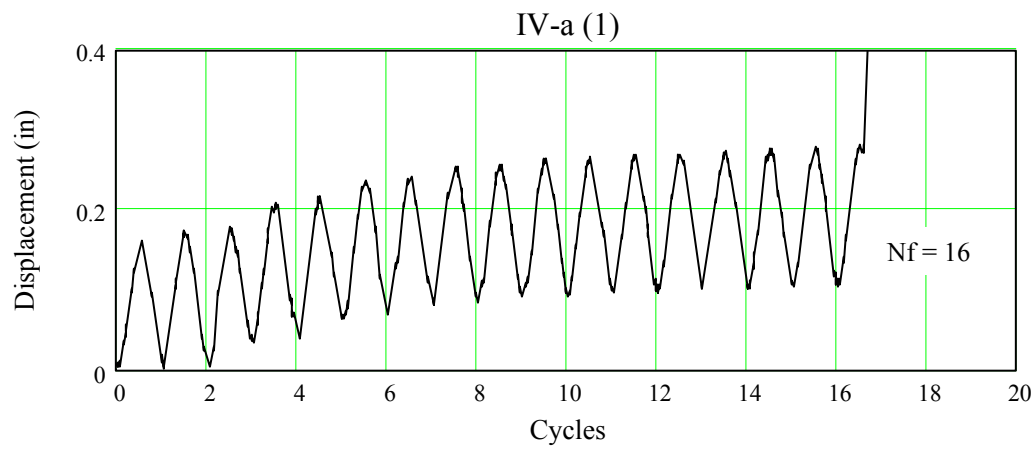
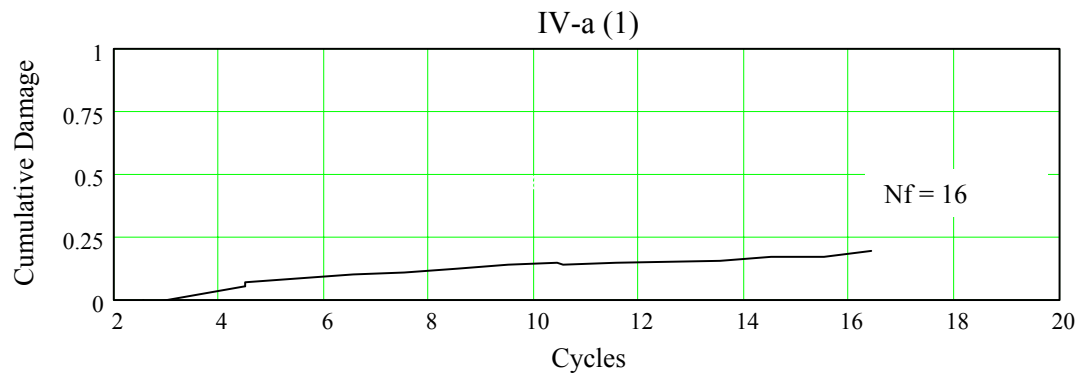
Figure 29. Test IV-a (1): (a) Load vs. Cycles, (b) Displacement vs. Cycles, (c) Cumulative Damage vs. Cycles

Failure mode 2 is the tensile failure of the FRP composite. Test IV-a was repeated to determine if the adhesive failure was due to quality control issues, during the application of the FRP. This second test, IV-a (2), had an FRP composite tensile failure even though the test unit and loading program were identical to test IV-a (1), as shown in Figure 31. The maximum strain in the GFRP composite for test IV-a (1) was 0.55%, whereas the maximum measured strain for test IV-a (2) was 1.55%. This indicates that there were likely some quality control issues in the preparation of test unit IV-a (1). However, the test results presented in this research are not sufficient to determine definitively the cause of such poor performance for test IV-a (1). For the present investigation it is sufficient to say that test IV-a (1) had lower bond strength than test IV-a (2), which was prepared using the same process and materials. However, both test IV-a (1) and IV-a (2) overall did not perform as well as expected. Figure 33 shows the load, displacement, and cumulative damage curves for test IV-a (2). The load and displacement curves are similar to test IV-a (1), however the cumulative damage curve shows that test IV-a (2) had a much higher cumulative damage, 0.42, just prior to failure. Even though most of the damage occurred in the last few cycles, this result is better than that obtained in test IV-a (1) as it gives more warning of impending failure.

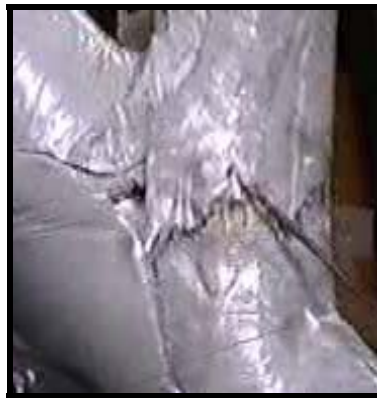
Figure 32. Sequence of failure for test IV-b: (a) 0.004 sec. prior to failure, (b) 0.467 sec. after failure, (c) 1.746 sec. after failure

Test IV-b also had an FRP composite failure, as shown in Figure 32. This test also did not perform as well as expected, considering it failed after just 913 cycles. This poor performance is also indicated in Figure 34. It can be seen that the failure occurred suddenly, with very little sign of damage (which was 0.33 just prior to failure), or increased displacement as was seen in the Series (II) and Series (III) tests.

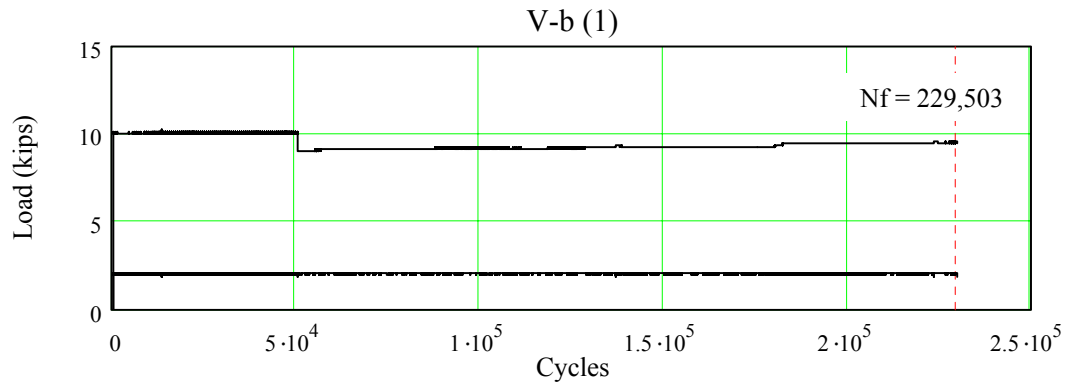
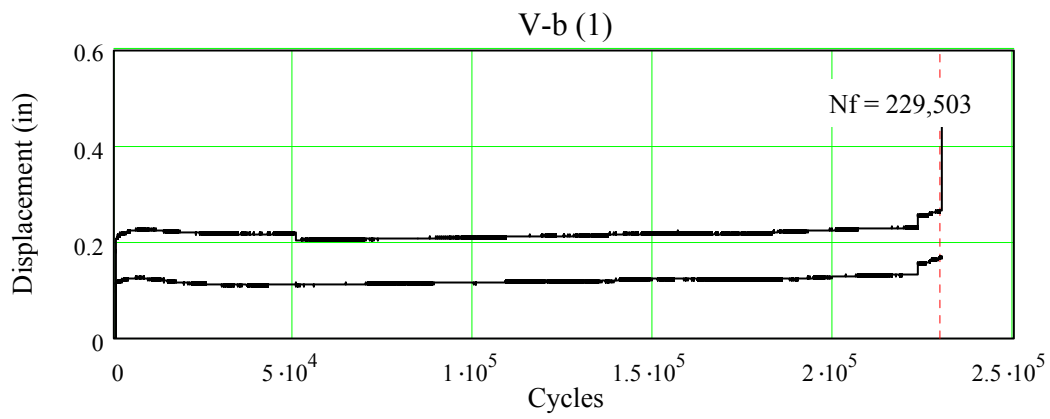
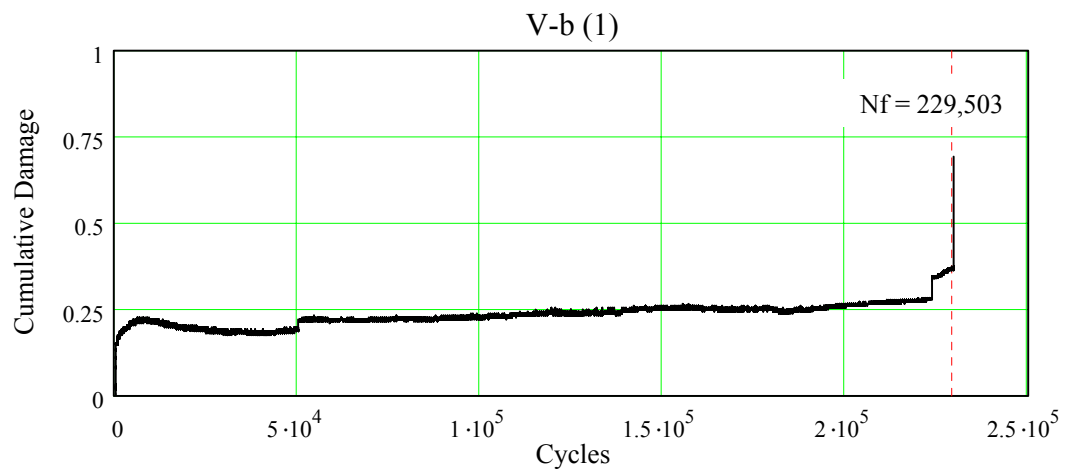
Figure 36. Test V-b (1): (a) Load vs. Cycles, (b) Displacement vs. Cycles, (c) Cumulative Damage vs. Cycles

This failure mode was only observed in test V-b (1), as shown in Figure 35(a). This type of failure was caused by the decreased bond length of test unit V-b (1) that was about 2 inches shorter than all the other retrofitted test units in this study. However, in this particular test the FRP was also observed to tear open as the aluminum tube was pulled out of the FRP jacket, as shown in Figure 35(a) and (b). This tearing was caused by the weld that remained at the end of the diagonal member, which caused the diameter of the diagonal at the weld to be larger than the pipe diameter. This is certainly an advantage, due to the mechanical interlocking of the diagonal and the FRP, even though this failure mode is the least desirable due to its lower strength and sudden failure. It can be seen in Figure 36 that the cumulative damage of test unit V-b (1) increased very rapidly at the beginning of the test, likely due to the failure of the remaining 10% of the weld. The damage then slowly increased until it reached 0.28 at 224,101 cycles, at which point the damage jumped to 0.35. This sudden increase in damage is likely the onset of the adhesive failure, which was interrupted by the weld interlocking with the FRP as discussed earlier. The damage then continued to increase at a much more rapid rate until it reached 0.69, when the weld at the end of the diagonal ripped through the FRP composite jacket as shown in Figure 35.

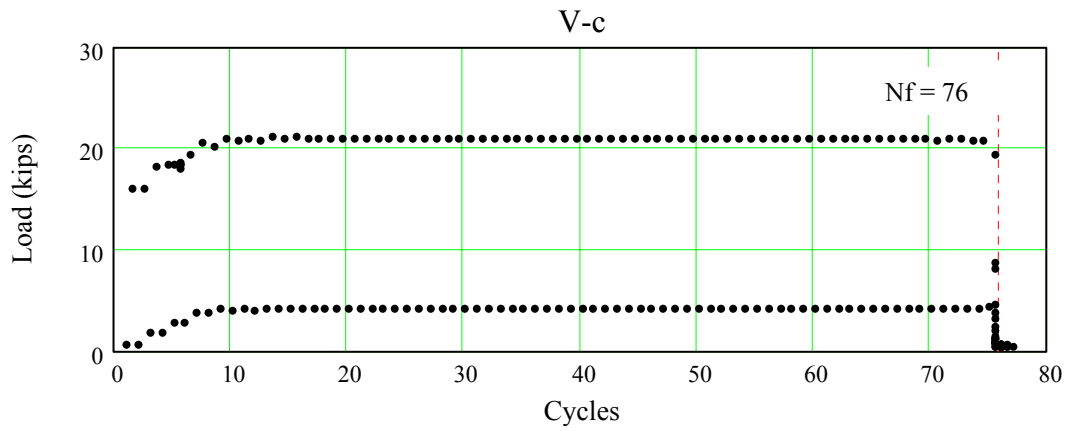
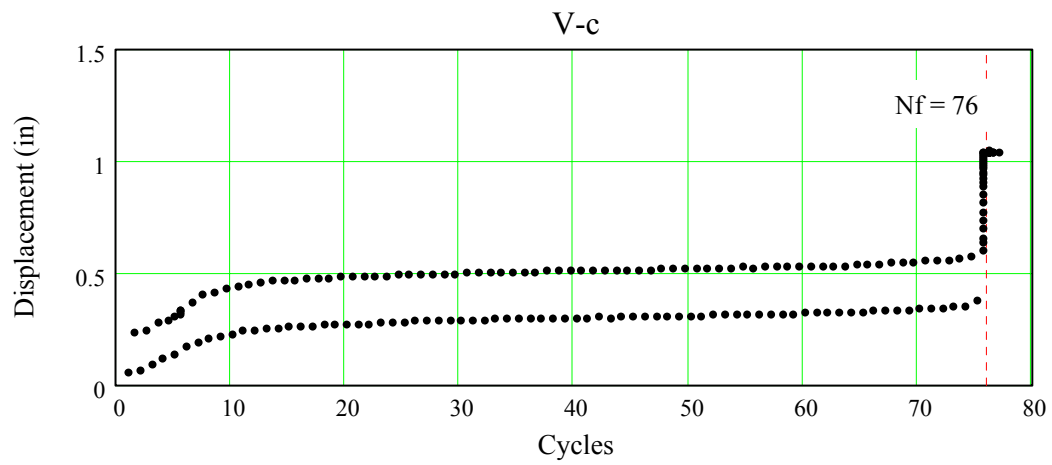
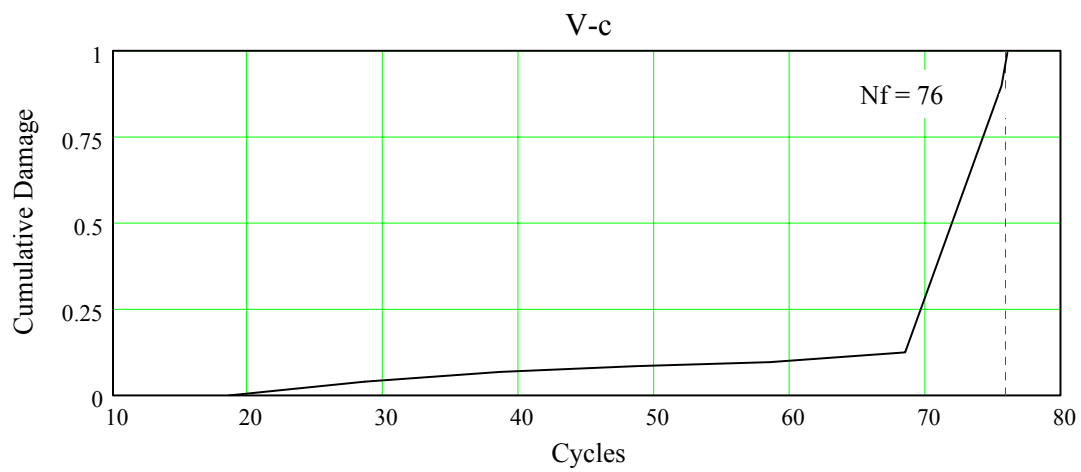
Figure 38. Test V-c: (a) Load vs. Cycles, (b) Displacement vs. Cycles, (c) Cumulative Damage vs. Cycles

Tests V-c and V-a each failed as a result of FRP composite tensile failure as described in Series (IV) Results, as shown in Figure 37. Test V-c performed much better than the Series (IV) tests at the same load, with 2.5 times more cycles than test IV-a (1) and over 4 times as many cycles as test IV-a (2). However, test V-c still did not perform as well as tests II-a and III-a. Figure 38 shows the load, displacement, and cumulative damage curves for test V-c. Again, from these plots it can be seen that the failure was rather abrupt, compared to the Series (II) and (III) tests. With a cumulative damage of only 0.12 just prior to failure, it is clear that this failure was abrupt with little or no warning of impending failure, such as large displacements and visually observed cracking.

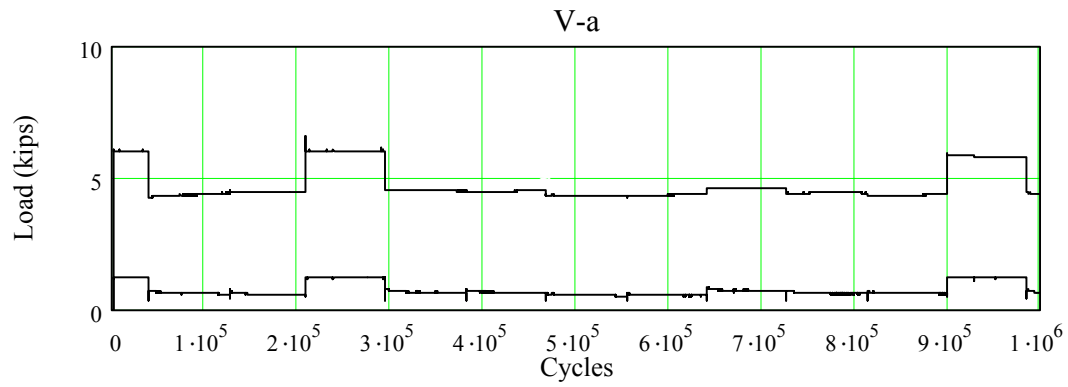
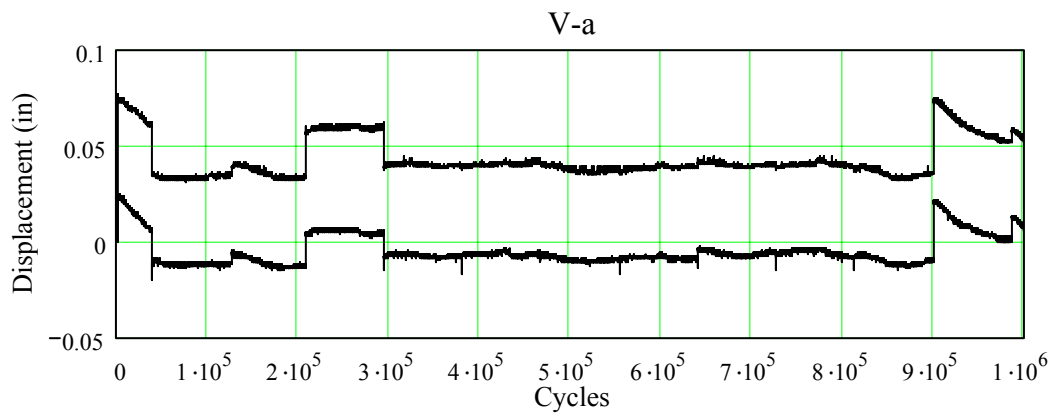
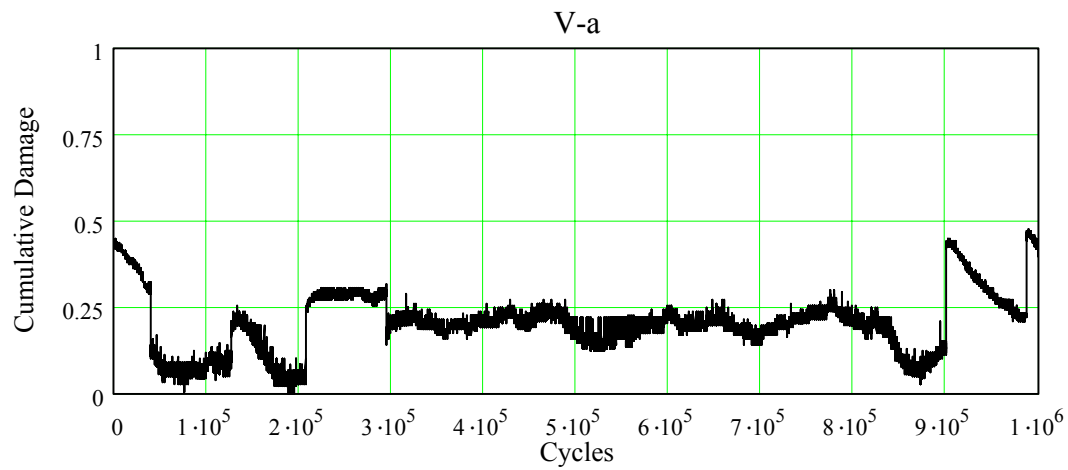
Figure 39. Test V-a: (a) Load vs. Cycles, (b) Displacement vs. Cycles, (c) Cumulative Damage vs. Cycles

Test V-a reached the 1×10^6 -cycle infinite life benchmark, and was subsequently tested to failure in static tension. It can be seen in Figure 39, that the damage curve is non-uniform with several sudden jumps in damage and displacement. Although these jumps occur at sudden changes in the loading, as shown in Figure 39(a), they are still larger than what might be expected with a small change in the loading. These large jumps in displacement and damage are likely caused by slipping of the gripping mechanism that was used, as described in the previous report (Pantelides and Nadauld 2001). Loading the test unit to 10 kips, and then releasing the load to a minimum tensile load of 1 kip set the gripping mechanism. Unfortunately in this test the load repeatedly dropped below the programmed minimum of 1.2 kips, which may have allowed the gripping mechanism to slip slightly. When the loading was then increased, the gripping mechanism was set again, however at a higher displacement.

Despite these difficulties, it can still be determined from Figure 39 that the cumulative damage, setting aside errors caused by the gripping mechanism, remained fairly constant through the test. The same observations were made in tests II-d, III-c, and III-c, which all reached the 1,000,000 cycle infinite life limit.

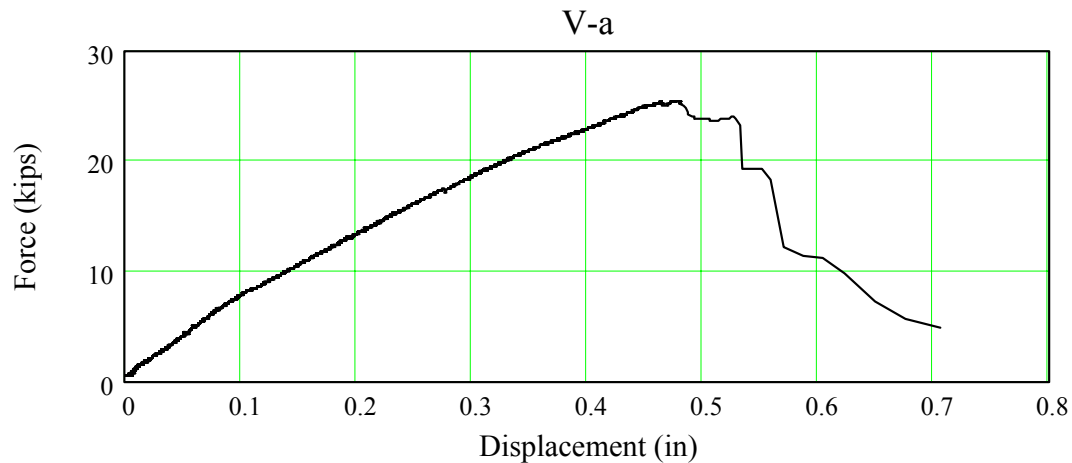
Figure 40. Static Test V-a Load vs. Displacement Curve

The static load vs. displacement curve for test V-a is shown in Figure 40. It can be seen that failure occurred at a load of 25.4 kips. This is near the static tensile capacity of the test unit without undergoing any fatigue cycles, indicating that the composite lost very little of its strength and, therefore, very little damage occurred.
