**FATIGUE TESTS OF CRACKED AND
REPAIRED ALUMINUM CONNECTIONS
OF OVERHEAD SIGN STRUCTURES –
FINAL REPORT**

**New York State Department of Transportation
Utah Department of Transportation**

August 2003

**Civil & Environmental Engineering
College of Engineering
University of Utah
Salt Lake City, Utah**

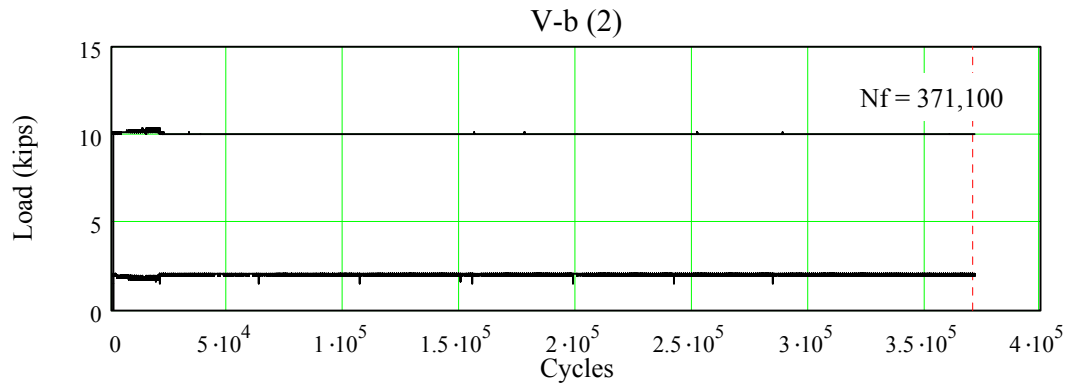
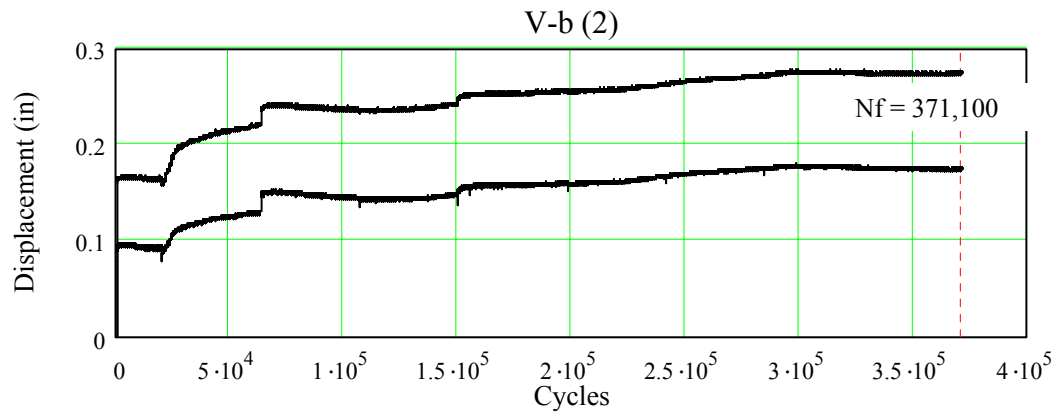
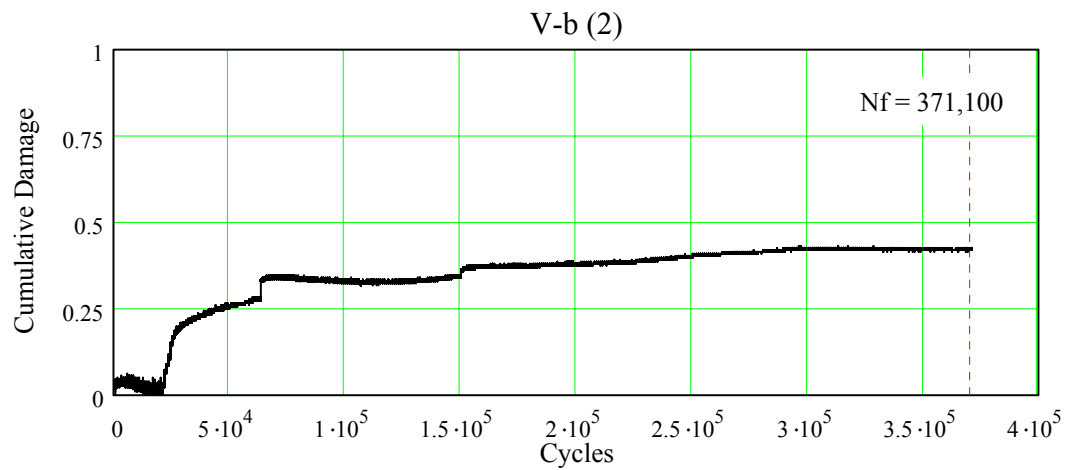
Figure 42. Test V-b (2): (a) Load vs. Cycles, (b) Displacement vs. Cycles, (c) Cumulative Damage vs. Cycles

From Figure 42, it can be seen that the cumulative damage increased rapidly at the beginning of the test until at 66,294 cycles, when the damage was 0.35. At this point in the test, two cracks had developed on the FRP, one 2 in. long at the toe of the weld, and another approximately 1.5 in. above the first which was 1 in. long, as shown in Figure 43(a). The cumulative damage then slowly increased until it reached a value of 0.42 at failure. Due to the large amount of damage that had already taken place, it is likely that the test unit was close to failure in tension due to the fatigue loading prior to equipment failure.

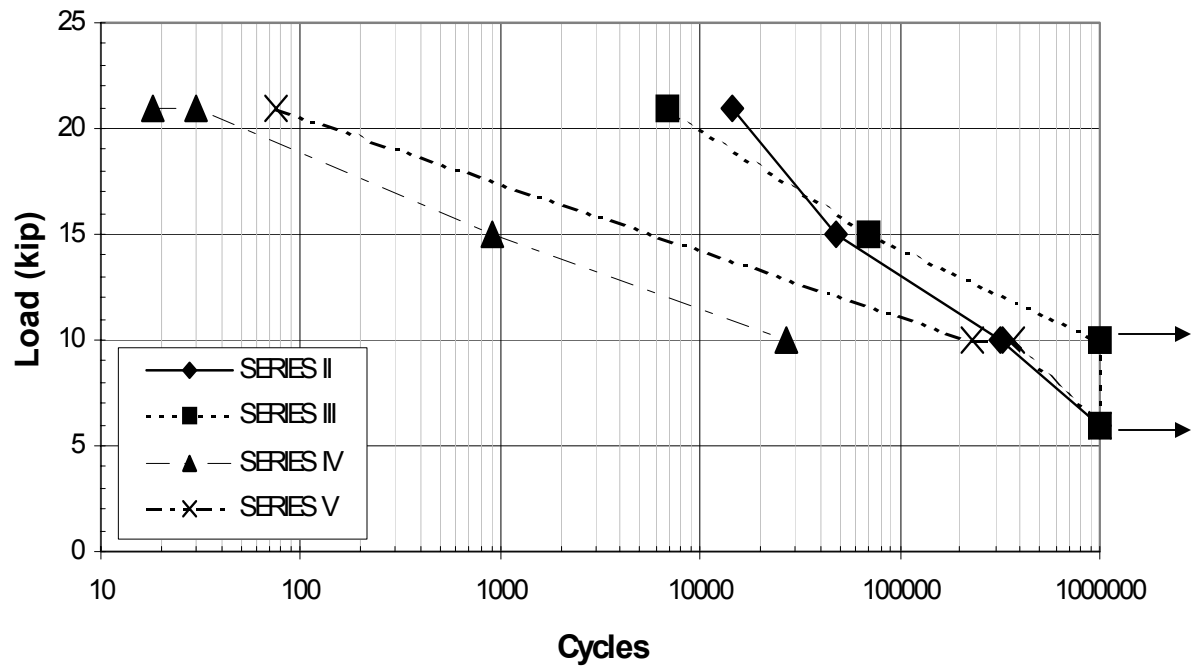
Figure 44. S-N Curves

Figure 44 shows the S-N curves for all the fatigue tests. It can be observed that the as-is welded test units (Series II) and the retrofitted joints from the field with GFRP composites (Series III) show similar behavior. The retrofitted units from the field with GFRP composite showed better fatigue behavior for the lower stress range. On the other hand, the tack-welded joints with new aluminum pipes and GFRP composites (Series IV) did not perform as well as Series (II) and (III). This poor performance was due to decreased bond strength caused by the use of new aluminum test units. Finally, the reclaimed aluminum units with the weld 90% destroyed and retrofitted with GFRP (Series V) test units performed better than Series (IV) but not as well as Series (II) and (III) in the high stress range; however, Series (V) did perform as well as Series (II) in the lower stress range as evidenced by Figure 44.
