Testing of State Roadside Safety Systems Volume I: Technical Report

PUBLICATION NO. FHWA-RD-98-036

APRIL 1999

6. Performing Organization Code	
7. Author(s) King K. Mak, Roger P. Bligh, and Wanda L. Menges				8. Performing Organization Report No. Research Foundation 471470-Vol. I

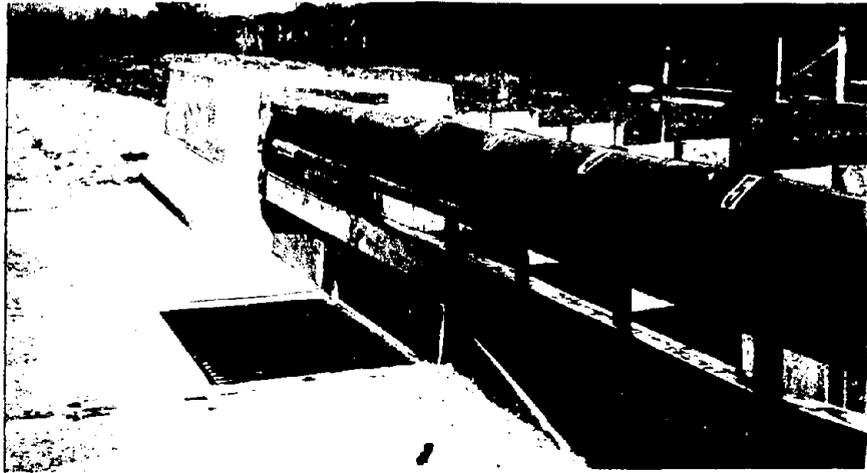
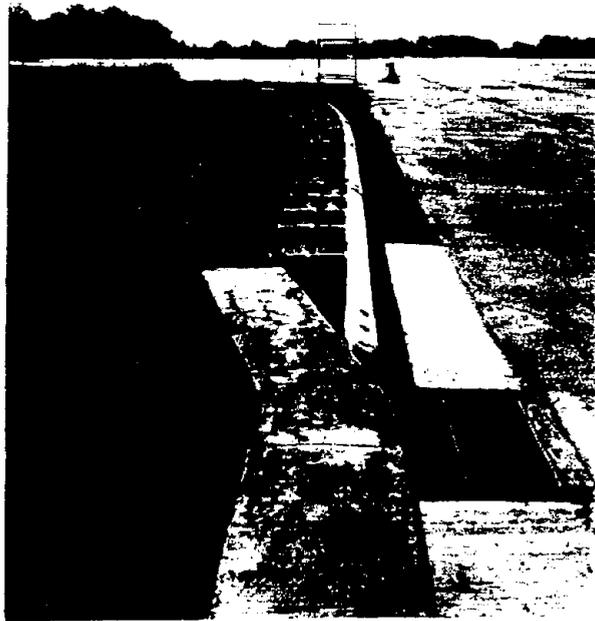
Figure 17. Photographs of test installation 471470-3.

The total length of contact of the vehicle with the transition system was 5.3 m (17.5 ft). The maximum permanent deformation of the W-beam rail element was 191 mm (7.5 in), located at the end of the wingwall. The lower corrugation of the W-beam had been flattened against the wingwall. The tilting movement of the concrete safety shape caused the concrete foundation to move and subsequently to settle 13 mm (0.5 in) above ground level and was pushed backwards a distance of 13 mm (0.5 in). The drainage inlet was also pushed back a distance of 16 mm (5/8 in).

Another suggestion is to replace the bent plate rubrail with a structural C6x8.2 channel rubrail, which is lower in cost and more readily available from suppliers. The structural strength of the rubrail does not appear to be of concern from the standpoint of impact performance.

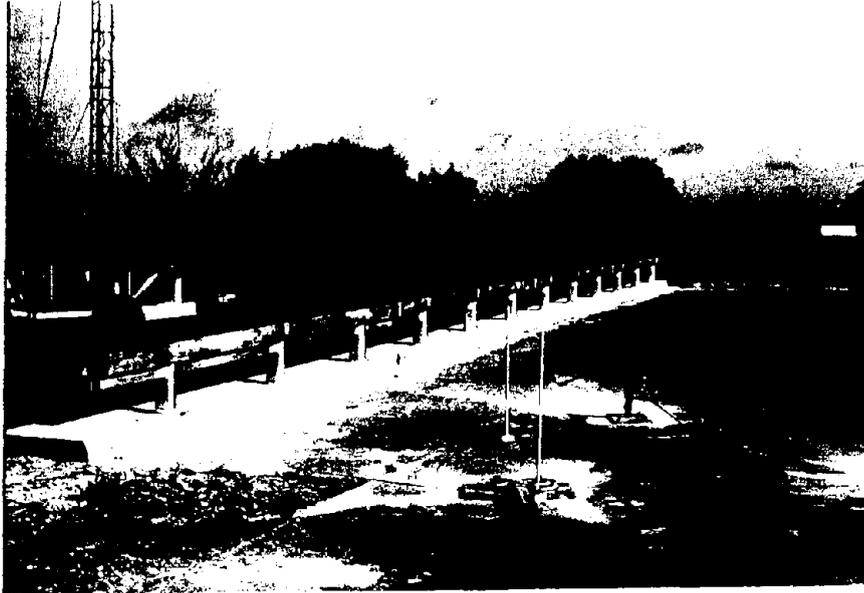
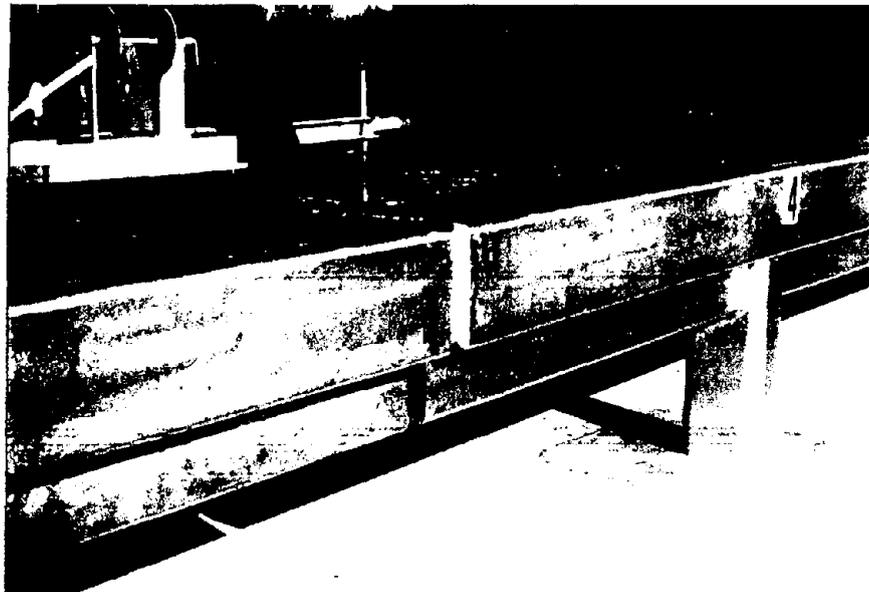
Figure 22. Photographs of test installation 471470-6.

In the first test (test no. 471470-6) with the original bridge rail design, the vehicle was redirected and did not penetrate or go over the bridge railing. The bridge railing received only minimal damage and there were no detached elements or debris to show potential for penetration of the occupant compartment or to present undue hazard to other traffic. The vehicle remained upright and stable during the impact with the bridge railing and after exiting the test installation. However, the vehicle sustained extensive damage and there was considerable deformation and intrusion into the passenger compartment. The exit trajectory of the vehicle was judged not to pose any potential hazard to adjacent traffic. The occupant impact velocities and ridedown accelerations were within the acceptable limits.

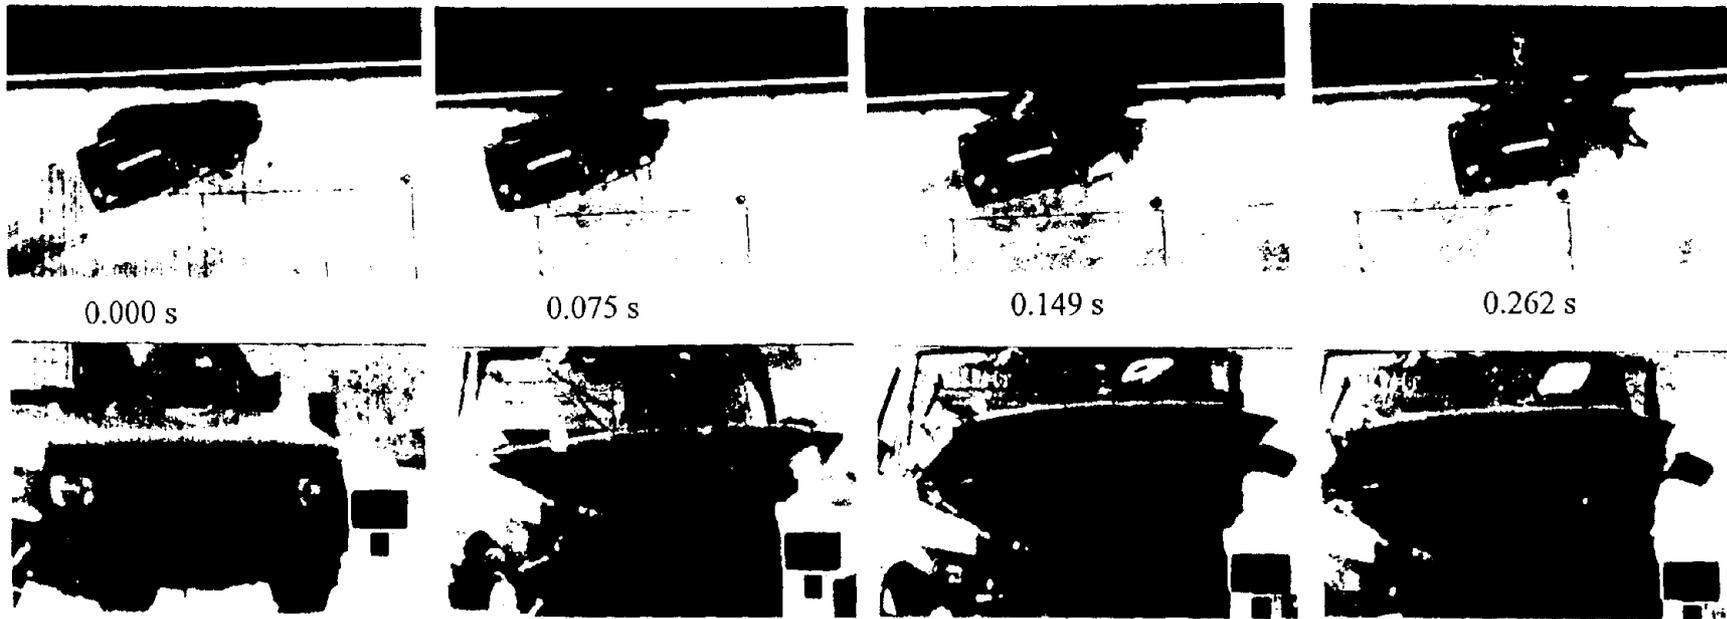
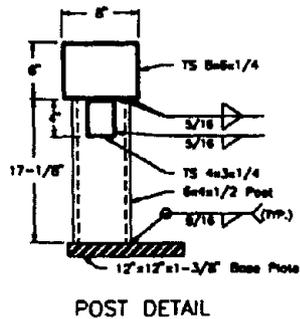
Figure 24. Summary of results for test 471470-6.

The vehicle impacted the bridge railing midspan between posts 3 and 4, or approximately 5.72 m (18 ft, 9 in) downstream from the upstream end of the bridge railing. As the vehicle bumper contacted the bridge rail, the left front tire contacted the curb at the same time and appeared to partially air out. The vehicle bumper hit post 4 and the vehicle began to redirect. The left front tire of the vehicle mounted the curb and contacted post 4 when the roof of the vehicle began to buckle. Tire marks indicated that the left front tire

folded and went underneath the box beam and overlapped post 4 by a distance of 254 mm (10 in). The tires began to pull to the left and the front bumper began to come apart, extending behind the rail. There was sudden left steer input again, and the front bumper of the vehicle contacted post 5. The vehicle was traveling parallel to the bridge rail system at a speed of 62.9 km/h (39.1 mi/h). The left front tire impacted post 5, again pulling the front tires to the left. The vehicle exited the bridge rail traveling at a speed of 55.5 km/h (34.5 mi/h) with an exit angle of 1.5 degrees. After the vehicle exited from the bridge rail, the bumper struck post 6, cleared the rail and the left front tire dropped off the curb. Due to the damage sustained by the left front tire and the orientation of the front tires, the vehicle turned back toward the bridge rail after exiting from the initial impact and impacted it again near post 8. The vehicle then rode along and off the end of the bridge rail. The brakes were applied after the vehicle cleared the test installation and the vehicle came to rest 32.0 m (105 ft) downstream from and 7.6 m (25 ft) behind the point of initial impact. A summary of pertinent data from the electronic instrumentation, high-speed film, and field measurements is given in figure 24.

There was no permanent deformation of the bridge railing. The total length of contact for the initial impact was 4.0 m (13.0 ft). Tire marks extended 254 mm (10.0 in) under the rail element at post 4. The vehicle's sway bar, left strut, and inner C.V. joint were damaged. The windshield was broken, and the roof, floor pan, and instrument panel were bent. There was damage to the front bumper, hood, grill, radiator, left front quarter panel, left rear door and glass, left rear quarter panel, and the rear bumper. The firewall and floor pan were pushed into the steering column and clutch pedal for a maximum intrusion into the occupant compartment of 356 mm (14.0 in). The wheelbase on the right side was shortened from 2.1 m (84.0 in) to 1.7 m (66.5 in). The left front tire and rim were damaged from contact with the posts and the rear tire and rim were damaged in later contact with the curb. Maximum crush to the vehicle was 254 mm (10.0 in) at the left front corner at bumper height.

Review of the results of the first test suggested that the unsatisfactory performance of the original bridge rail design was caused by the bumper underriding the beam element of the bridge rail, resulting in the bumper impacting the posts head-on and the left front tire of the vehicle snagging severely on the posts. It was therefore recommended that the bottom TS 102-mm × 76.2-mm × 6.4-mm (4-in × 3-in × 1/4-in) box-beam sections be replaced with wider TS 152-mm × 50.8-mm × 6.4-mm (6-in × 2-in × 1/4-in) box-beam sections and the box-beam sections be moved forward to be flush with the face of the posts on the traffic side. This would reduce the potential for the bumper and the front wheel of the vehicle to underride the beam element of the bridge rail and impact the posts directly.

As mentioned previously, the original design of the Washington, DC, bridge rail did not perform satisfactorily in the first crash test (test no. 471470-6) with an 820-kg passenger car. The bridge rail design was then modified by replacing the bottom TS 102-mm × 76.2-mm × 6.4-mm (4-in × 3-in × 1/4-in) box-beam sections with wider TS 152-mm × 50.8-mm × 6.4-mm (6-in × 2-in × 1/4-in) box-beam sections and moving the box-beam sections forward to be flush with the face of the posts on the traffic side. These box-beam sections were welded to the bottom of the top box-beam rail element and to the sides of the posts. The modified bridge rail design was then crash tested in the next two crash tests (test nos. 471470-8 and 471470-9). Photographs of the modified test installation are shown in figure 23.

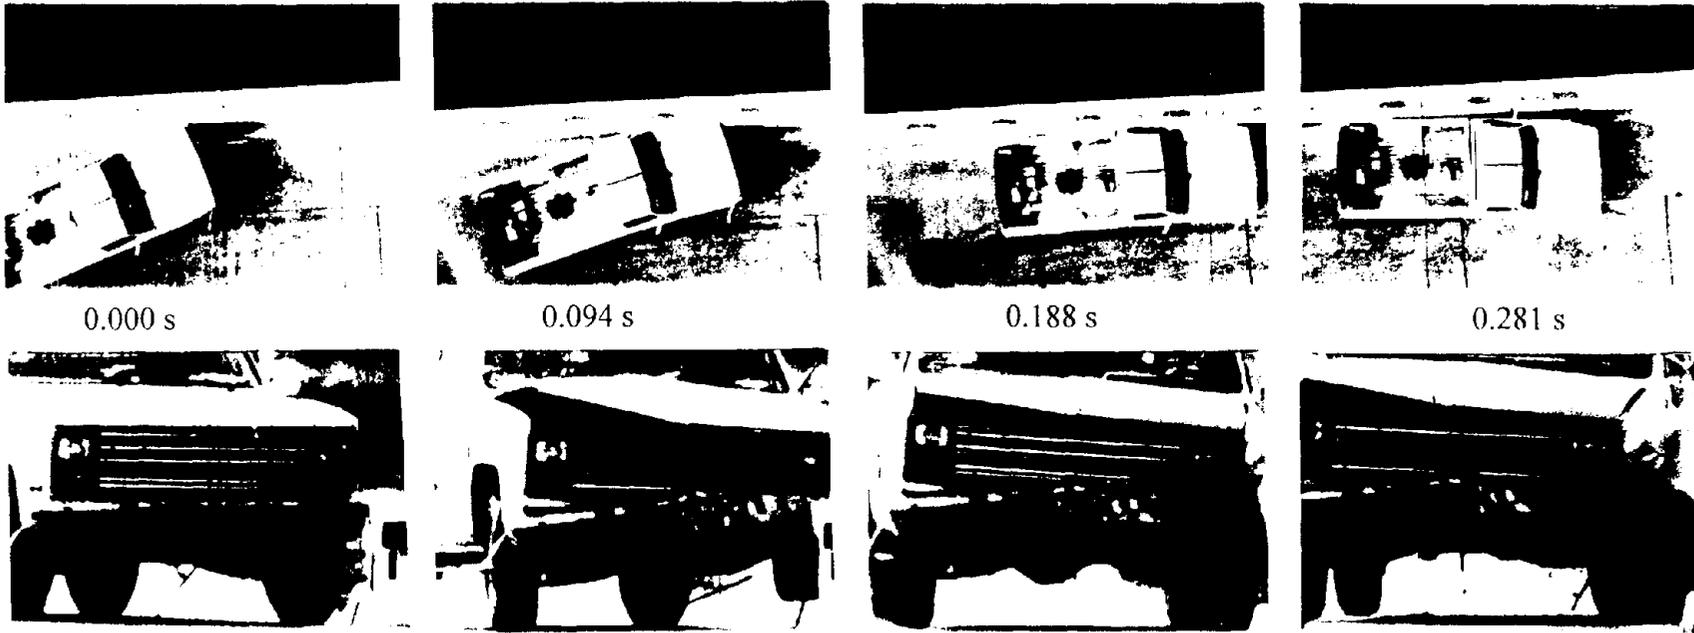
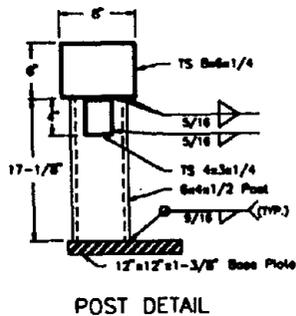
Figure 26. Summary of results for test 471470-9.

There was no permanent deformation of the bridge railing. The total length of contact with the rail was 3.9 m (12.9 ft). Tire marks indicated that the tire did not go under the rail element. The vehicle's driver-side window was broken and there was damage to the front bumper, hood, grill, left front quarter panel, left door, left rear quarter panel, and the rear bumper. The left front and rear rims were damaged from contact with the curb and rail element. Maximum crush to the vehicle was 254 mm (10.0 in) at the left front corner at bumper height.

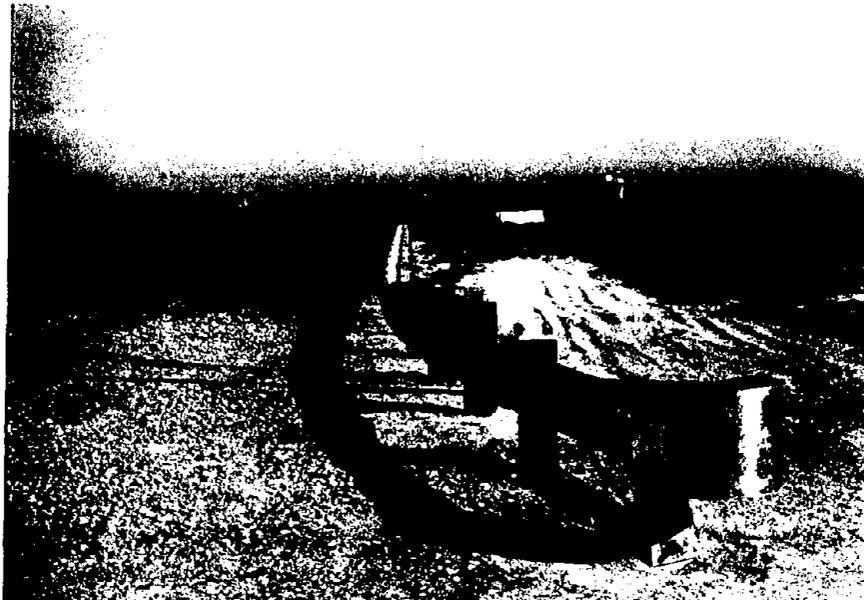
Figure 30. Photographs of test installation 471470-10.

It was noted and marked that there were four kinks in the lower edge of the W-beam rail element as a result of pulling the rail element back 102 mm (4 in) at post 2. These kinks, measured from the centerline of post 1, were at 813 mm (32.0 in), 1435 mm (56.5 in), 2337 mm (92.0 in), and 3226 mm (127.0 in). Photographs of the completed installation used in the second test (test no. 471470-10) are shown in figure 30.

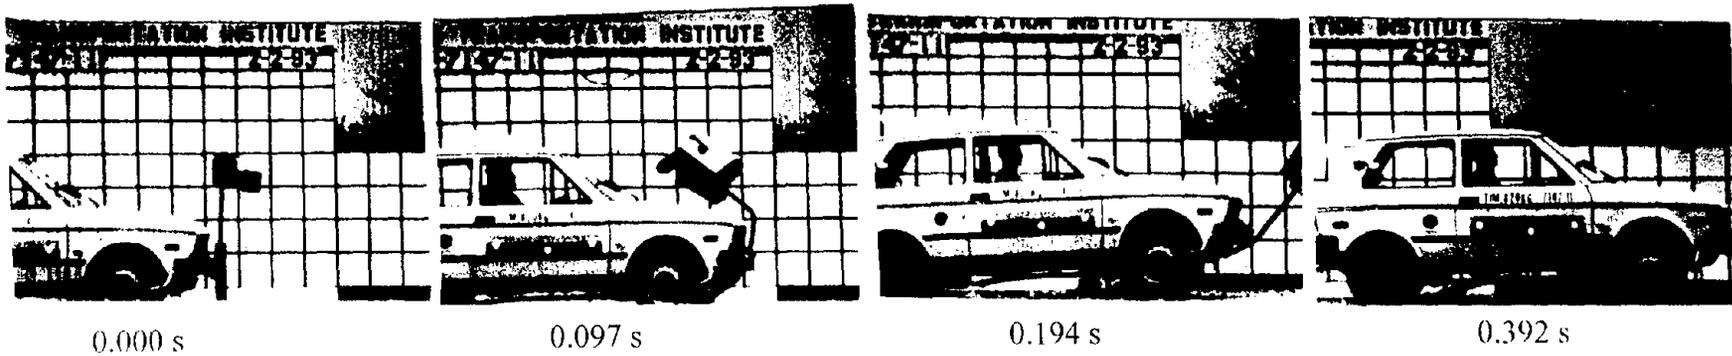
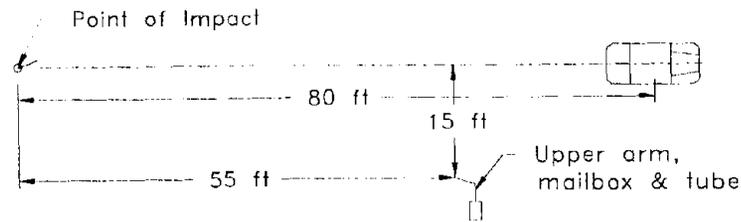
Figure 37. Summary of results for test 471470-12.

The mailbox installation separated into several pieces. The plastic newspaper tube landed 15 m (48 ft) downstream and 8 m (25 ft) to the left of the point of impact. The deformed mailbox landed 18 m (60 ft) downstream and 5 m (18 ft) to the left of point of impact. The cantilever arm and wood board were found 22 m (72 ft) downstream and 12 m (38 ft) to the left of the point of impact. The vertical support arm was only scraped and the U-channel base post was bent and pushed back 150 mm (6 in) at ground level.

There was 120 mm (4.7 in) permanent deformation to the vehicle bumper where contact with the vertical support and the U-channel base post occurred. The A-pillar on the driver's side was deformed from impact by the mailbox and the windshield was cracked around the point of impact. The door post on the driver side was bent and the glass broken out. There was also damage to the hood and grill and the right rear tire and rim. There was a dent in the gas tank, and scrape marks and a dent along the floor pan on the right side of the undercarriage caused by contact with the vertical support.

Impact Speed	104.9 km/h (65.2 mi/h)
Impact Angle	0 deg-381 mm (15 in) Offset
Exit Speed	98.0 km/h (60.9 mi/h)
Change in Velocity	6.9 km/h (4.3 mi/h)
Change in Momentum	1573 N-s (354 lb-s)
Vehicle Accelerations (Max. 0.050-s avg)	
Longitudinal	-1.9 g's
Lateral	1.0 g's
Occupant Impact Velocity	
Longitudinal	1.3 m/s (4.3 ft/s)
Lateral	1.4 m/s (4.5 ft/s)
Occupant Ridedown Accelerations	
Longitudinal	-2.7 g's
Lateral	4.6 g's

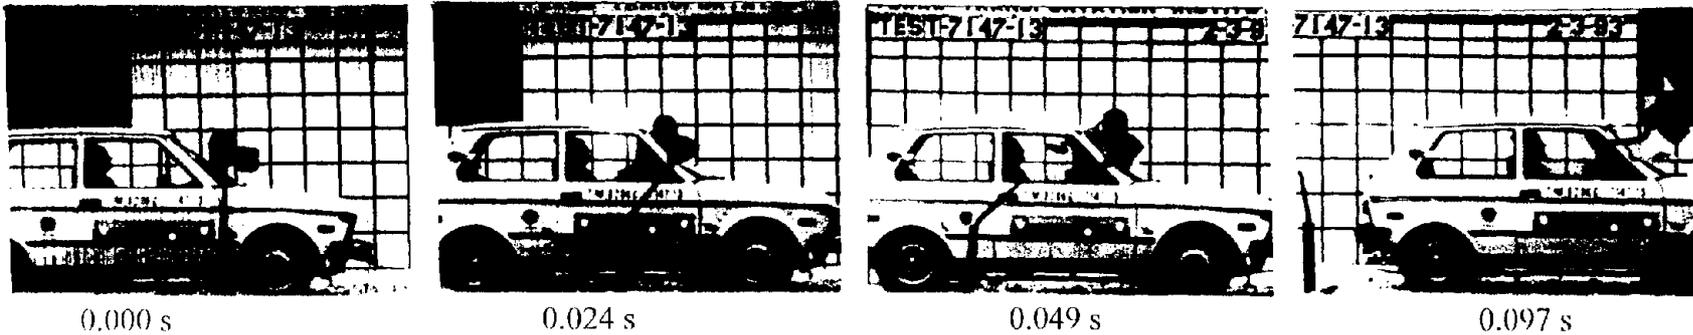
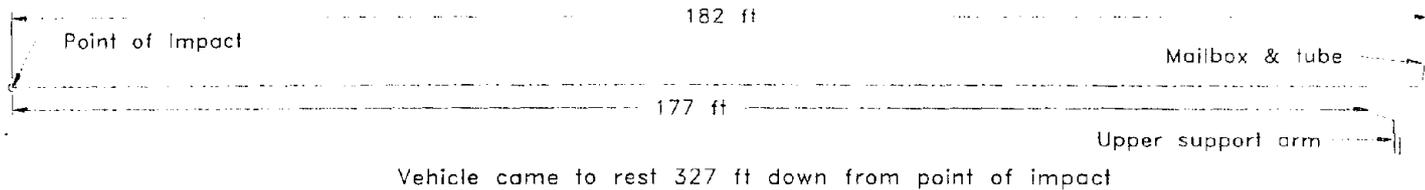
Figure 38. Summary of results for test 471470-13.

Test No.	7147-13	Impact Speed	103.0 km/h (64.0 mi/h)
Date	02/03/93	Impact Angle	0 deg-offset to Impact Box
Test Installation	Minnesota	Exit Speed	99.6 km/h (61.9 mi/h)
	Swing-Away Mailbox	Change in Velocity	3.4 km/h (2.1 mi/h)
Mounting Height	1016 mm (40 in)	Change in Momentum	768 N-s (172 lb-s)
Installation Depth	1575 mm (62 in) Driven	Vehicle Accelerations	
Soil Type	Strong Soil (S-1)	(Max. 0.050-s avg)	
Test Vehicle	1986 Yugo GV	Longitudinal	-1.0 g's
Vehicle Weight		Lateral	0.5 g's
Test Inertia	820 kg (1806 lb)	Occupant Impact Velocity	
Gross Static	895 kg (1971 lb)	Longitudinal	No Contact
Vehicle Damage Classification		Lateral	1.2 m/s (3.9 ft/s)
TAD	None Applicable	Occupant Ridedown Accelerations	
CDC	12FRGN6	Longitudinal	N/A
Maximum Vehicle Crush	Penetrated Windshield	Lateral	1.0 g's

The mailbox installation separated into several pieces. The cantilever arm and part of the wood board landed 54 m (177 ft) downstream and 1.4 m (4.5 ft) to the right of the point of impact. The severely deformed mailbox, part of the wood board, and plastic newspaper tube came to rest 55 m (182 ft) downstream and 0.3 m (1 ft) to the left of the point of impact. The vertical support was only scraped and the U-channel base post was not damaged or pushed back.

There was 30-mm (1.2-in) permanent deformation to the A-pillar on the passenger's side of the vehicle, and the door post on the passenger's side was deformed at the location where the cantilever arm made contact. The windshield was broken out and lying on the floorboard of the vehicle. However, it should be noted that the windshield actually went outward and upward after separation from the vehicle and was partially on the roof of the vehicle before falling back into the occupant compartment. There was also a scratch located on the left rear section of the roof from contact by the detached cantilever arm as it went over the vehicle.

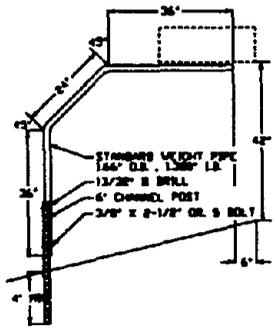
Figure 39. Summary of results for test 471470-14.

The vehicle sustained damage around the windshield area and in the occupant compartment. The mailbox assemblies intruded into the occupant compartment through the windshield and remained partially in the compartment throughout the test period. The roof of the vehicle was deformed upward from inside the vehicle approximately 50 mm (2 in). The passenger's side door was pushed out 40 mm (1.6 in) and the glass was shattered. The A-pillar and door post on the passenger's side were also deformed. The windshield was inside the vehicle.

Test No.	7147-14	Impact Speed	101.0 km/h (62.8 mi/h)
Date	02/03/93	Impact Angle	0 deg-Offset to Impact Box
Test Installation	Minnesota	Exit Speed	Remained in and on Vehicle
Mounting Height	Swing-Away Mailbox	Change in Velocity	N/A
Installation Depth	1016 mm (40 in)	Change in Momentum	N/A
Soil Type	1575 mm (62 in) Driven	Vehicle Accelerations	
Test Vehicle	Strong Soil (S-1)	(Max. 0.050-s avg)	
Vehicle Weight	1989 Yugo GV	Longitudinal	-1.3 g's
Test Inertia	820 kg (1806 lb)	Lateral	-0.3 g's
Gross Static	895 kg (1971 lb)	Occupant Impact Velocity	
Vehicle Damage Classification		Longitudinal	0.9 m/s (2.8 ft/s)
TAD	None Applicable	Lateral	No Contact
CDC	12FRGN7	Occupant Ridedown Accelerations	
Maximum Vehicle Crush	Penetrated Windshield	Longitudinal	-0.3 g's
		Lateral	N/A

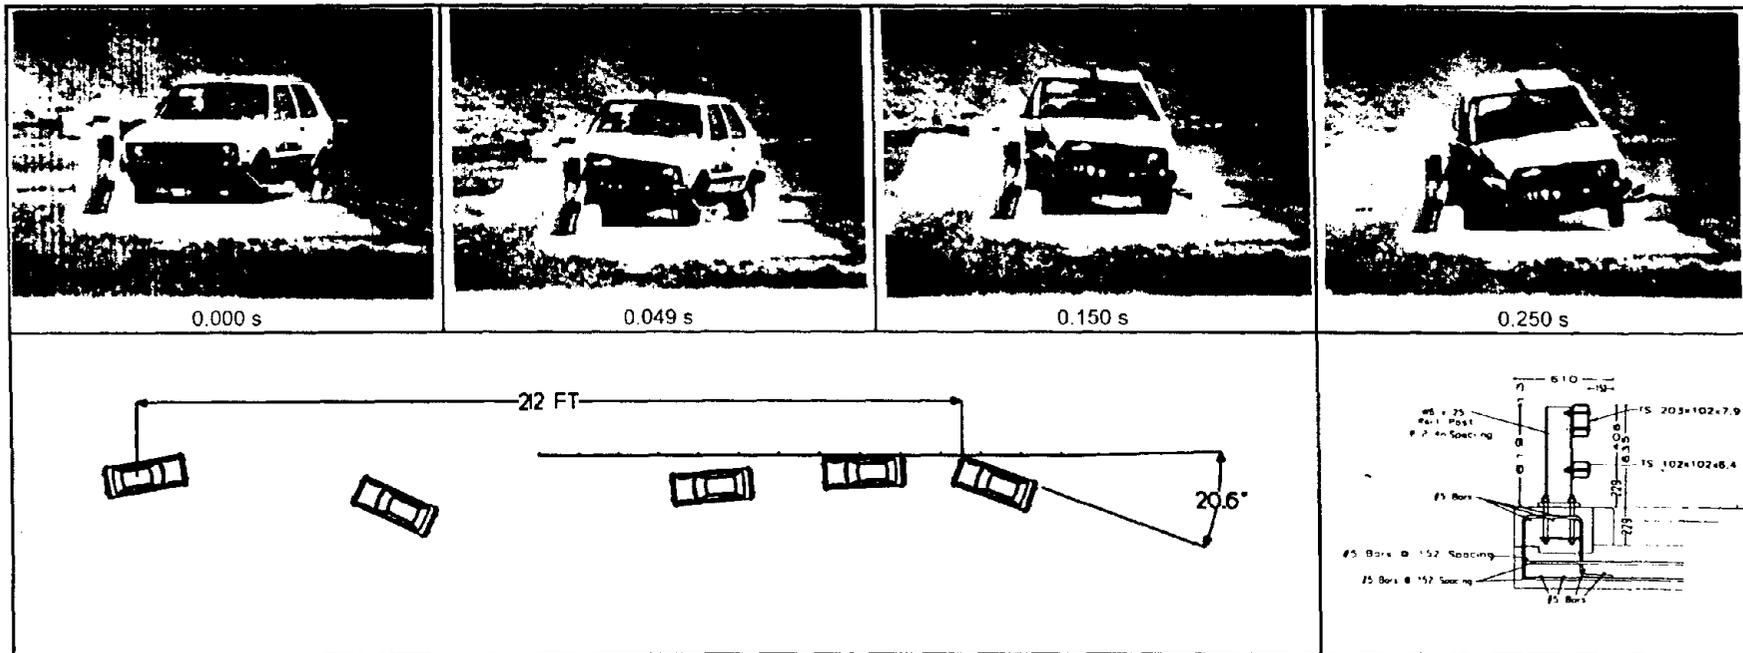
General Information		Impact Conditions		Test Article Deflections (mm)	
Test Agency	Texas Transportation Institute	Speed (km/h)	100.9(62.7 mi/h)	Dynamic	Not Available
Test No.	7147-18	Angle (deg)	20.6	Permanent	6 (0.25 in)
Date	07/20/93	Exit Conditions		Vehicle Damage	
Test Article		Speed (km/h)	88.7 (55.1 mi/h)	Exterior	
Type	Bridge Rail	Angle (deg)	2.2	VDS	01RFQ-3
Installation Length (m)	NETC Bridge Rail	Occupant Risk Values		CDC	01FREK2
Size and/or Dimension	30.5 (100 ft)	Impact Velocity (m/s)			03RDES1
and Material of Key Elements	Tubular Steel Rail Elements on	x-direction	5.2 (16.9 ft/s)	Interior	
	W6 X 25 Steel Posts @ 2.4 m	y-direction	8.4 (27.5 ft/s)	OCDI	RS0100000
Soil Type and Condition	on 241-mm Curb	THIV (optional)		Maximum Exterior	
Test Vehicle	Concrete Bridge Deck, Dry	Ridedown Accelerations (g's)		Vehicle Crush (mm)	124 (4.9 in)
Type	Production Model	x-direction	-1.6	Max. Occ. Compart.

Designation	820 C	y-direction	-6.8	Deformation (mm)	32 (1.3 in)
Model	1986 Yugo GV	PHD (optional)		Post-Impact Behavior	
Mass (kg) Curb	809 (1782 lb)	ASI (optional)		Max. Roll Angle (deg)	15
Test Inertial	817 (1800 lb)	Max. 0.050-s Averages (g's)		Max. Pitch Angle (deg)	-7
Dummy	77 (170 lb)	x-direction	-6.1	Max. Yaw Angle (deg)	-32
Gross Static	894 (1970 lb)	y-direction	-15.2		
		z-direction	-2.6

The bridge railing received only cosmetic damage. However, the curb section and bridge deck sustained structural damage at the two posts immediately upstream and downstream of the point of impact (posts 3 and 4). It appears from the damage patterns that the curb section and bridge deck failed under the combination of bending and shear forces (principally shear), as evidenced by the 45-degree cracks starting at the anchor bolts. This suggested that there might not be sufficient concrete cover and steel reinforcement around the anchorage bolts to resist the forces acting on the post and anchorage assembly during impact. The vehicle was in contact with the bridge railing for a total length of 6.1 m (19.9 ft).

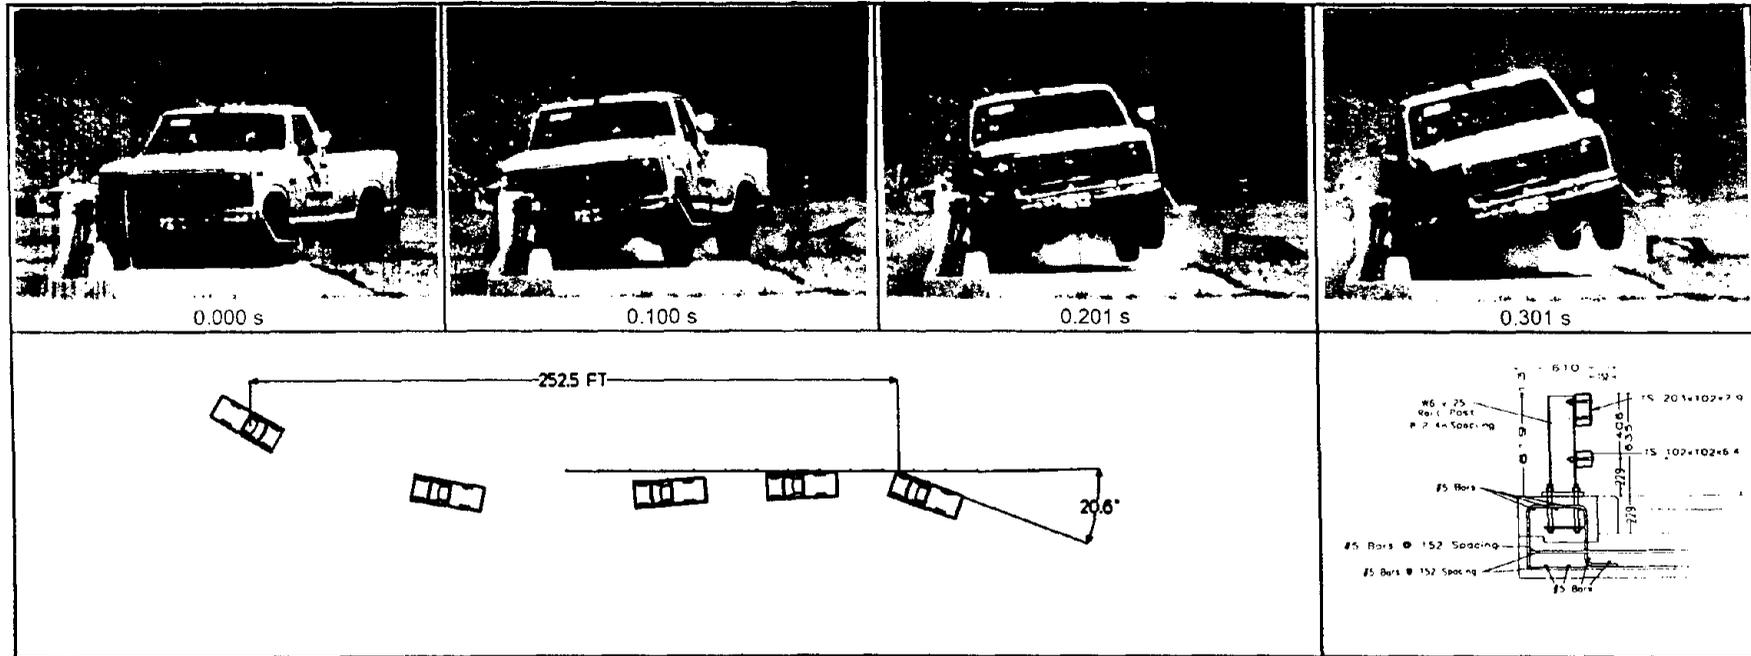
The vehicle sustained damage to the right side. Maximum crush at the right front corner at bumper height was 254 mm (10.0 in) and there was 25 mm (1.0 in) of crush at the right A pillar. The wheelbase on the right side was shortened by 32 mm (1.75 in). The tie rod and right radius arm were damaged. Also, damage was done to the front bumper, hood, grill, right front fender, right front rim, right door, right rear bumper, and right rear tire and rim.

General Information		Impact Conditions		Test Article Deflections (mm)	
Test Agency	Texas Transportation Institute	Speed (km/h)	92.2 (57.3 mi/h)	Dynamic	Not Available
Test No.	7147-19	Angle (deg)	20.6	Permanent	6 (0.25 in)
Date	07/22/93	Exit Conditions		Vehicle Damage	
Test Article	Bridge Rail	Speed (km/h)	78.2 (48.6 mi/h)	Exterior	
Type	NETC Bridge Rail	Angle (deg)	2.2	VDS	01RFQ-3
Installation Length (m)	30.5 (100 ft)	Occupant Risk Values		CDC	01FREK2
Size and/or Dimension and Material of Key Elements	Tubular Steel Rail Elements on W6 X 25 Steel Posts @ 2.4 m on 241-mm Curb	Impact Velocity (m/s)			03RDES1
Soil Type and Condition	Concrete Bridge Deck, Dry	x-direction	3.7 (12.2 ft/s)	Interior	
Test Vehicle		y-direction	6.6 (21.5 ft/s)	OCDI	RS0000000
Type	Production Model	THIV (optional)		Maximum Exterior Vehicle Crush (mm)	254 (10.0 in)
Designation	2000 P	Ridedown Accelerations (g's)		Max. Occ. Compart. Deformation (mm)	25 (1.0 in)

Model	1984 Ford F250 Pickup	x-direction	-2.5	Post-Impact Behavior	
Mass (kg) Curb	1980 (4361 lb)	y-direction	-12.2	Max. Roll Angle (deg)	26
Test Inertial Dummy	2452 (5400 lb)	PHD (optional)		Max. Pitch Angle (deg)	-5
Dummy	76 (168 lb)	ASI (optional)		Max. Yaw Angle (deg)	-25
Gross Static	2528 (5568 lb)	Max. 0.050-s Averages (g's)			
		x-direction	-3.4		
		y-direction	-10.3		
		z-direction	-2.4

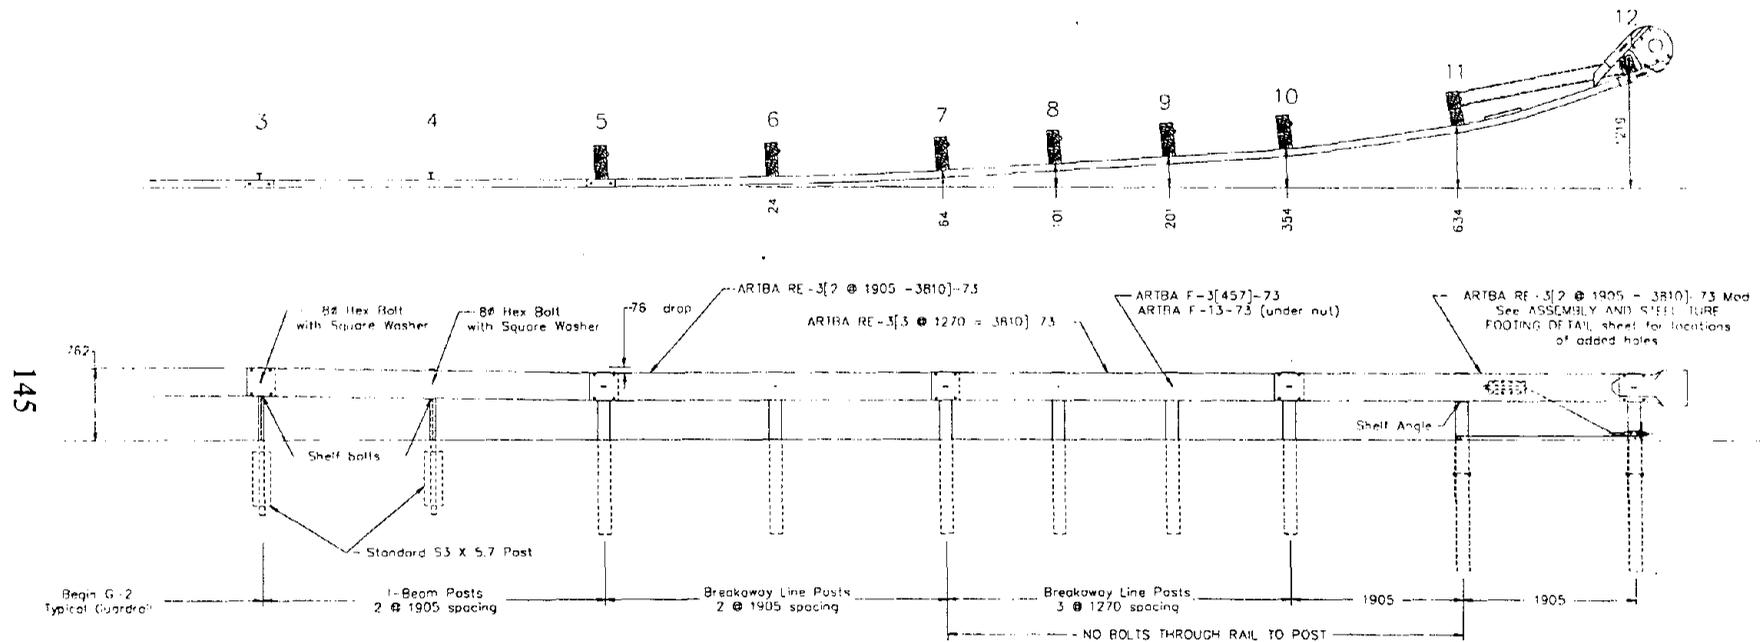
Figure 58. Schematic of the modified Mini-MELT used for test 471470-23.

The Mini-MELT design was revised because of the unsatisfactory performance in the first crash test. Figure 58 shows a schematic of the modified Mini-MELT as constructed and tested in the second crash test (test no. 471470-23). Photographs of the terminal are shown in figure 59. The modified Mini-MELT had a total length of 15.2 m (50 ft), consisting of two 1.9-m (6-ft, 3-in) spans at the end of the terminal, followed by three 1.3-m (4-ft, 2-in) spans, two 1.9-m (6-ft, 3-in) spans with wood posts, and a transition section of two 1.9-m (6-ft, 3-in) spans with steel posts. The height to the top of the W-beam rail element in the terminal section was 0.69 m (27 in), compared with 0.76 m (30 in) for the standard G2 guardrail system. The reduction in height was effected with a drop of 76.2 mm (3.0 in) over the 3.8-m (12-ft, 6-in) transition section just before the last wood post of the terminal.

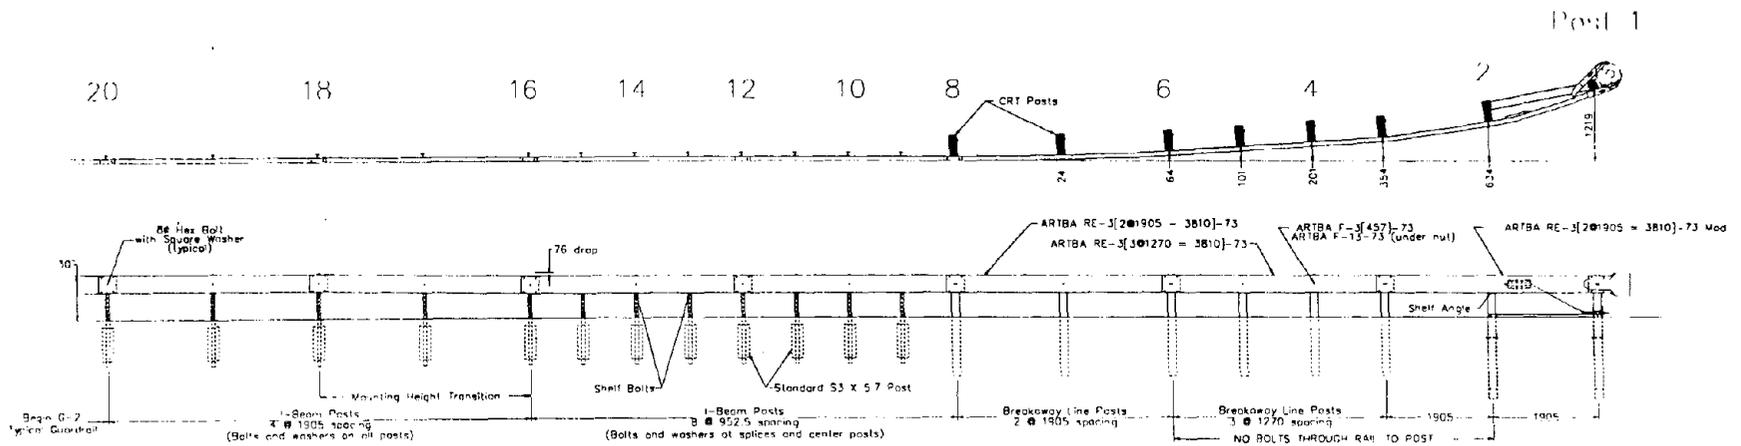
Figure 62. Details of the modified mini-MELT for the weak-post G2 guardrail system used for tests 471470-24 and 471470-25.

The Mini-MELT design was further modified because of the unsatisfactory performance in the second crash test. Figure 62 shows a schematic of the modified Mini-MELT as constructed and tested. Photographs of the terminal are shown in figure 63. The modified mini-MELT had a total length of 26.6 m (87 ft, 6 in), consisting of two 1.9-m (6-ft, 3-in) spans at the end of the terminal, followed by three 1.3-m (4-ft, 2-in) spans, two 1.9-m (6-ft, 3-in) spans, and a 15.2-m (50-ft) transition section. The transition section consisted of eight 0.95-m (3-ft, 1-1/2-in) spans and then four 1.9-m (6-ft, 3-in) spans. The height to the top of the W-beam rail element in the terminal section was 0.69 m (27 in), compared with 0.76 m (30 in) for the standard G2 guardrail system. The reduction in height was effected with a drop of 76.2 mm (3.0 in) over the last two 1.9-m (6-ft, 3-in) spans before the 0.95-m (3-ft, 1-1/2-in) spaced spans.

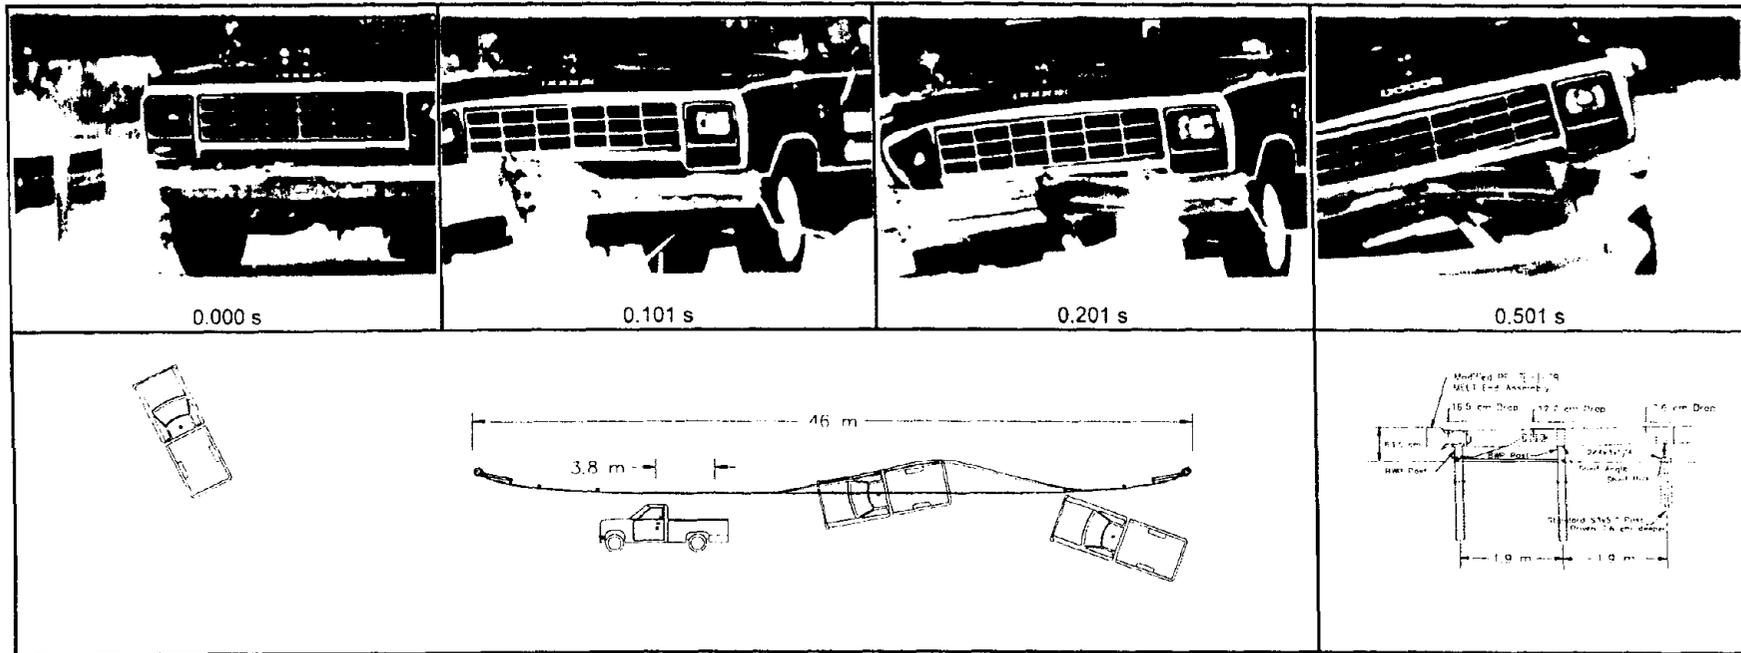
W-beam rail element began to deform, and the vehicle began to redirect. As the vehicle continued forward, the W-beam rail element rode over the top of the posts as the W-beam deformed along the path of the vehicle. The right front tire rode over post 5, causing the post to fracture just above the soil plate. The rear of the vehicle contacted the guardrail and the vehicle was traveling parallel to the installation at 78.4 km/h (48.7 mi/h). Maximum dynamic deflection of the guardrail was 2.0 m (6.7 ft). As the vehicle was being redirected, the W-beam rail element dropped and began to dig into the ground. The vehicle began to roll clockwise and the rear of the vehicle began to rise significantly. The vehicle was airborne and continued to roll clockwise as it lost contact with the installation. Shortly after that, the vehicle landed on its right side, bounced, and righted itself. The vehicle came to rest upright 90 m (296 ft) downstream and 9 m (31 ft) behind the point of impact. A summary of pertinent data from the electronic instrumentation, high-speed film, and field measurements is given in figure 67.

Posts 1 through 11 were displaced laterally and post 5 fractured just above the top of the soil plate. The W-beam rail element had slipped over the tops of post 4 through 8 and the maximum permanent deformation of the W-beam rail element was 1.7 m (5.5 ft). The vehicle was in contact with the installation for 25 m (81 ft). The vehicle sustained damage to the right side. The front bumper, grill, and hood were damaged and the entire right side of the body was dented and scraped. Maximum exterior crush at the right front corner at bumper height of the vehicle was 330 mm (13.0 in). There was no intrusion or deformation of the occupant compartment.

In the first crash test (test no. 471470-20) with the initial design, the mini-MELT successfully contained and redirected the vehicle. Post 5 fractured during the test sequence, but exhibited no undue hazard to adjacent traffic. The vehicle sustained moderate damage with no deformation or intrusion into the passenger compartment. However, as the vehicle was being redirected past the point where the vehicle was parallel with the installation, the vehicle began to roll clockwise. The clockwise roll continued as the vehicle separated from the guardrail. The vehicle eventually rolled 90 degrees onto its right side and then righted itself upon contact with the pavement. The trajectory of the vehicle was judged to pose a minimal hazard to adjacent traffic as the vehicle was traveling almost parallel to the installation after separation and subsequently came to rest 9 m (31 ft) behind the point of impact. The occupant risk factors were all well within the desirable limits set forth in NCHRP 350, as shown in table 28. The impact performance of the mini-Melt was considered unsatisfactory in this test because of the rollover.

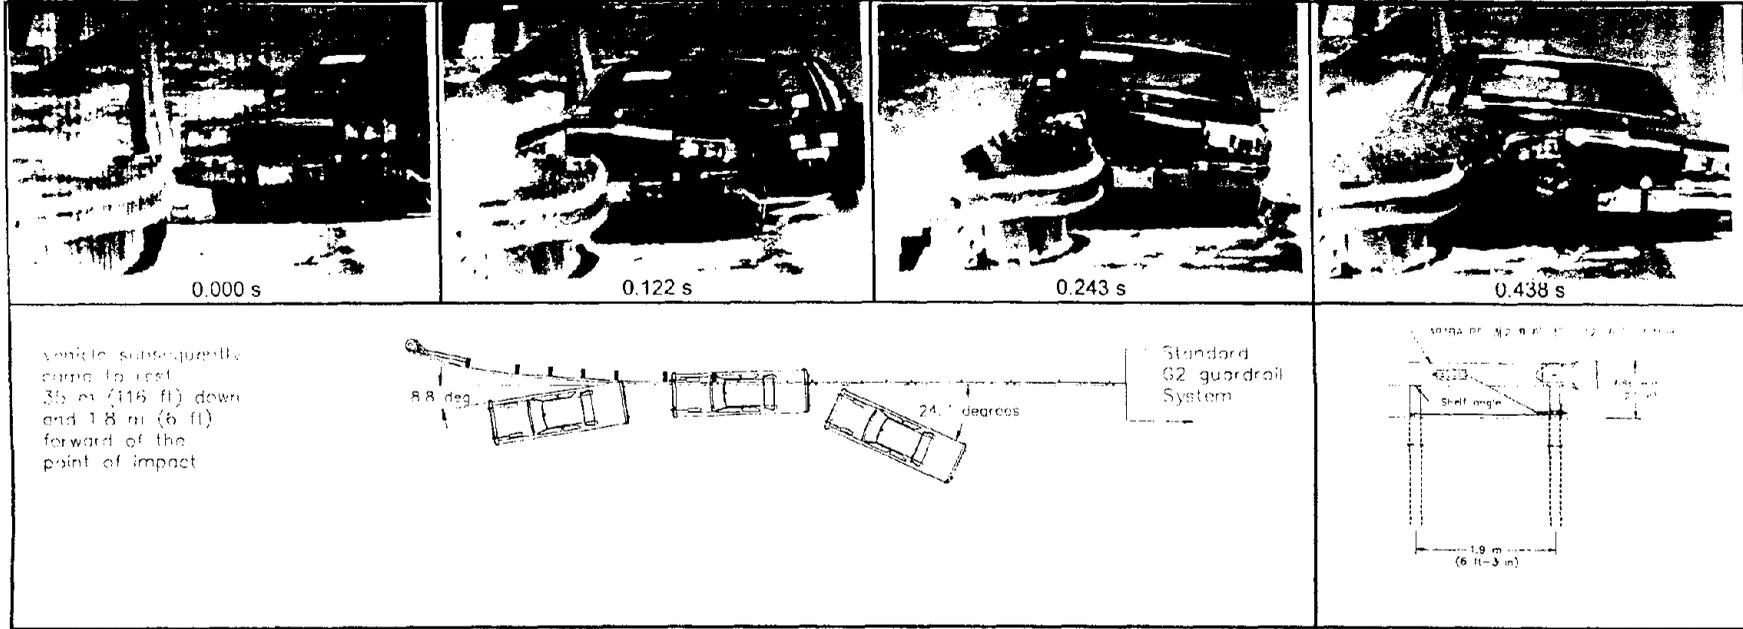
The vehicle impacted the terminal just upstream of post 3 (i.e., at the beginning of length of need) or 3.8 m (12 ft, 6 in) downstream of the end post. As the vehicle impacted the terminal, the W-beam rail element began to deform and post 4 began to displace laterally. The front tire of the vehicle impacted post 3 and the W-beam element began to displace forward at post 5. The vehicle began to redirect and made contact with post 4. The W-beam began to pull back to post 5, and then to bend near post 6. Post 4 fractured at ground level, post 5 fractured and the vehicle rode over it. Post 6 fractured, the vehicle impacted the post, and the rear of the vehicle made contact with the W-beam element. The front of the vehicle contacted post 7, fracturing the post, and at the same time, the vehicle became parallel with the installation traveling at 75.3 km/h (46.8 mi/h). Maximum dynamic deflection of 1.2 m (3.8 ft) occurred between the post 6 and 7 locations. The front tire contacted post 9 and the tire aired out. The vehicle lost contact with the installation traveling at 52.3 km/h (32.5 mi/h) and at an exit angle of 9.1 degrees. As the vehicle exited the rail, it began to yaw counterclockwise, subsequently impacting the guardrail 27 m (89 ft) downstream of the point of initial impact. The vehicle rode along the guardrail for 1.9 m (6.3 ft) and stopped against the guardrail. A summary of pertinent data from the electronic instrumentation, high-speed film, and field measurements is given in figure 70.

Posts 4 through 7 broke off near ground level, and the blockout on post 8 was splintered. A number of other posts were pushed back. For posts 4 through 7 that broke off, the post displacement measurements indicate maximum post movement just prior to breaking of the posts. The W-beam rail element was buckled and torn (but not ruptured) at the lower splice bolts on the outer edge of the splice located at post 8. The tearing propagated over half the width of the W-beam rail element, indicating that the tensile capacity of the W-beam rail

The third crash test (test no. 471470-24) was a repeat of the second crash test on a redesigned mini-MELT. The vehicle was successfully contained and smoothly redirected in this test. The maximum dynamic deflection of the guardrail was 0.96 m (3.15 ft). There were no detached elements or debris to exhibit undue hazards to adjacent traffic. The vehicle sustained moderate damage with no deformation or intrusion into the passenger compartment. The vehicle remained upright and relatively stable during and after the impact sequence. The trajectory of the vehicle was judged to have posed a minimal hazard to adjacent traffic as the vehicle came to rest 1.8 m (6 ft) forward of the installation. Although not required as part of the evaluation criteria for this test, the occupant risk factors were well within the desirable limits set forth in NCHRP Report 230. The modified Mini-MELT was judged to have performed satisfactorily in this transition test.

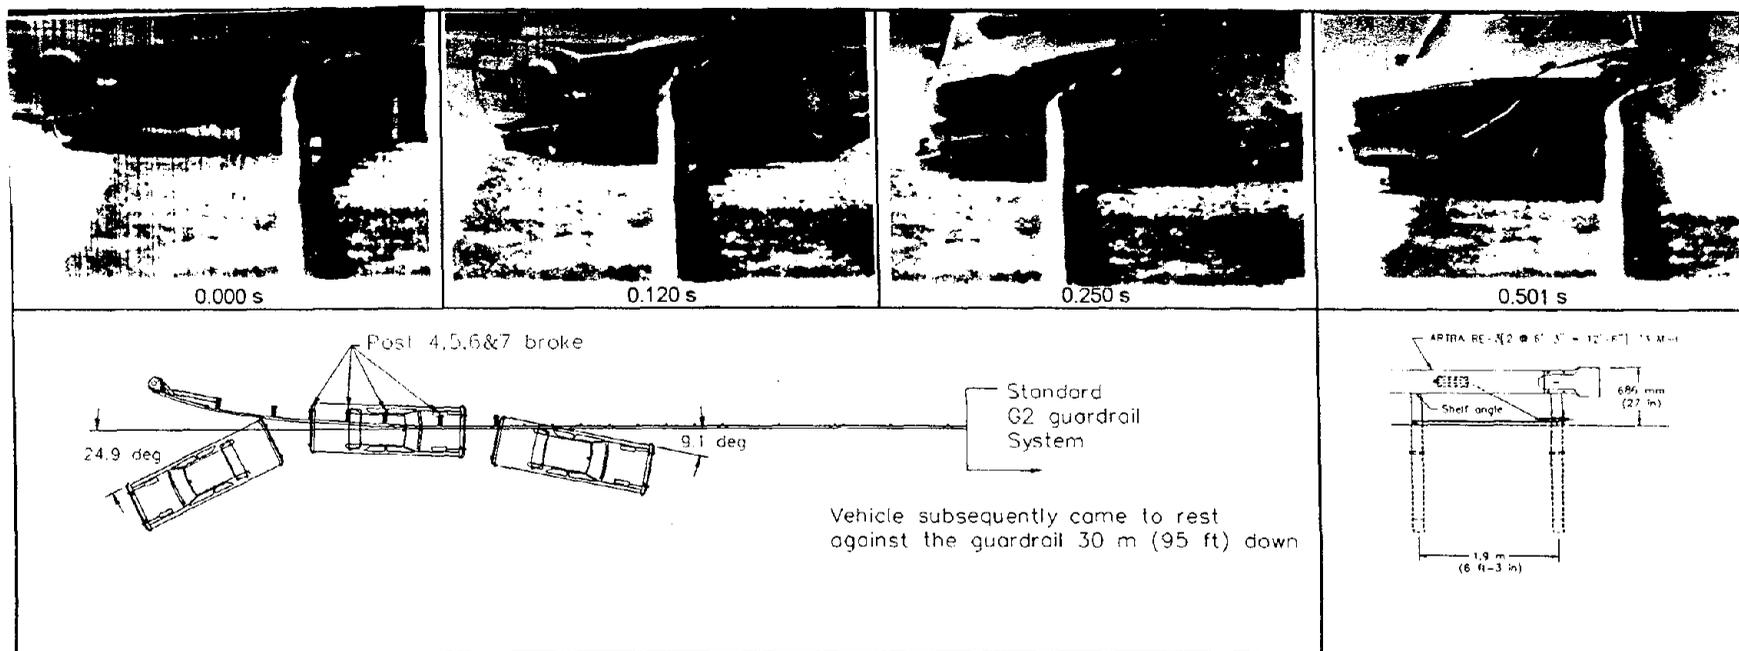
The vehicle's outer tire rod and lower A-arm on the left side, and the sway bar were damaged. The right front and rear tires were aired out and the rims were bent. The front bumper, grill, hood, the left and right front quarter panels, the left door, the left rear quarter panel, and the rear bumper also were damaged. Maximum exterior crush at the left front corner of the vehicle was 380 mm (15.0 in) at bumper height. There was no intrusion or deformation of the occupant compartment.

The modified mini-MELT was then evaluated on the adequacy or strength of the anchorage in the fourth crash test (test no. 471470-25). The terminal successfully contained and smoothly redirected the impacting vehicle. The maximum dynamic deflection of the guardrail was 1.2 m (3.8 ft). The W-beam rail element was buckled and partially torn (but not ruptured) at the lower splice bolts on the outer edge of the splice located at the last wooden post (post 8). Some posts broke off and came to rest behind the test installation, but did not exhibit undue hazards to adjacent traffic or show potential for penetration of the occupant compartment. The vehicle sustained moderate damage with no deformation or intrusion into the passenger compartment. The vehicle remained upright and relatively stable during and after the impact sequence. The trajectory of the vehicle was judged to have posed no potential hazard to adjacent traffic as the vehicle came to rest against the installation. Although not required as part of the evaluation criteria for this test, the occupant risk factors were well within the desirable limits set forth in NCHRP Report 230. The modified mini-MELT was judged to have performed satisfactorily in this length-of-need strength test.

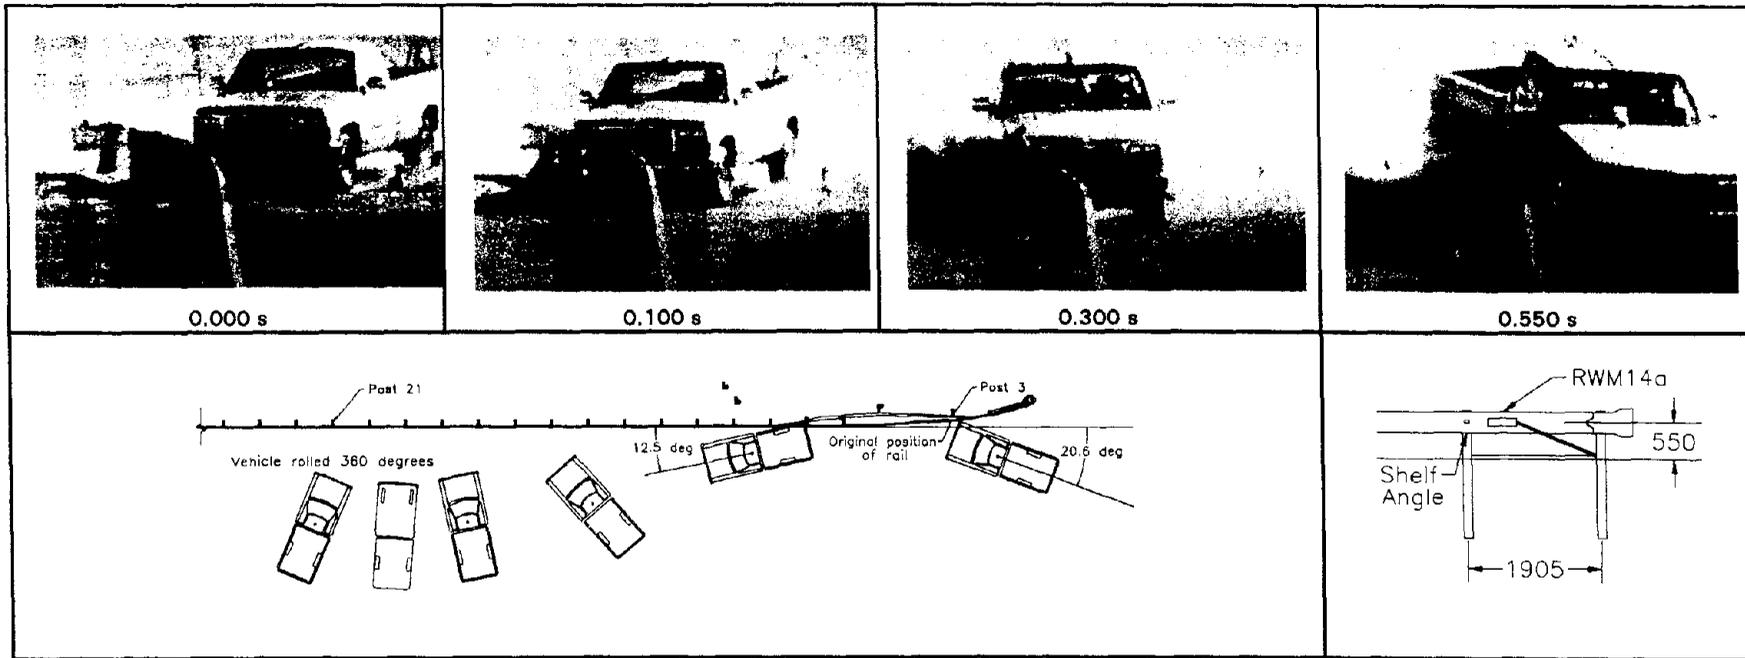
Figure 93. Summary of results for test 471470-32.

In the length-of-need strength test (test no. 471470-32), the MELT successfully contained and redirected the vehicle. However, the right front wheel assembly of the vehicle snagged on post 7 (the first standard line post), causing the vehicle to yaw and pitch significantly and subsequently to roll 360 degrees. The test installation sustained moderate damage. The vehicle sustained moderate damage from impact with the terminal. The subsequent rollover resulted in additional damage to the vehicle with some intrusion into the roof area of the occupant compartment. The exit trajectory of the vehicle was judged to
