Testing of State Roadside Safety Systems Volume I: Technical Report

PUBLICATION NO. FHWA-RD-98-036

APRIL 1999

6. Performing Organization Code	
7. Author(s) King K. Mak, Roger P. Bligh, and Wanda L. Menges				8. Performing Organization Report No. Research Foundation 471470-Vol. I

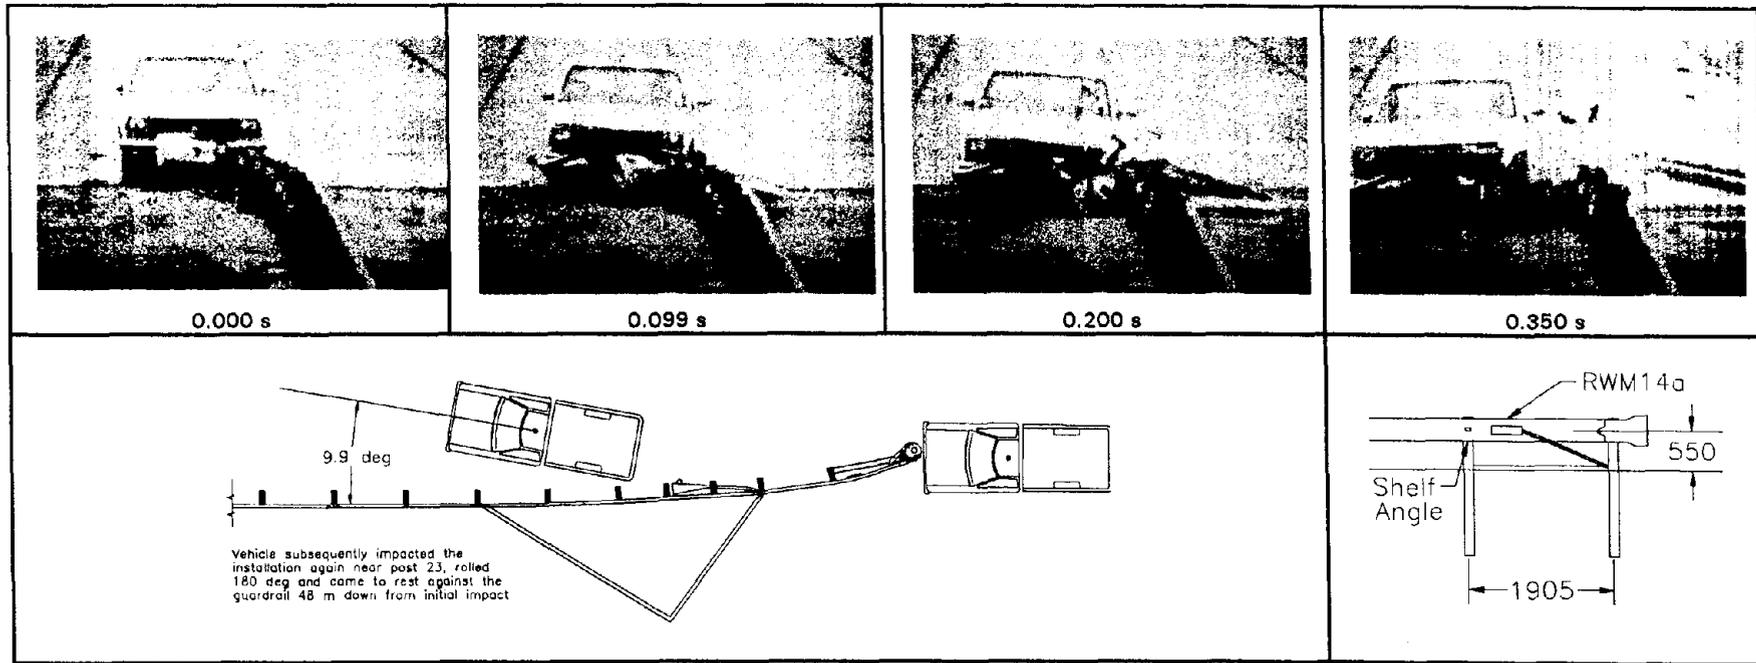
The vehicle impacted the nose of the terminal 2 mm (0.08 in) left of post 1. Upon impact, the W-beam rail element began to flex, twist, and move away from posts 2 and 3. The vehicle contacted the first post and the bumper was pushed into the right front tire. The W-beam rail element began to move away from post 4 and the vehicle began to yaw in a clockwise direction. The W-beam rail element began to buckle at the post 3 location (first buckle). The W-beam rail element began to pull away from posts 5 and 6. The nose of the terminal made contact with post 2 and then the vehicle contacted the post. The nose of the terminal made contact with post 3 and the left front corner of the bumper of the vehicle made contact with the nose of the terminal and post 3. The W-beam rail element began to buckle midspan between posts 4 and 5 (second buckle) and the nose of the terminal contacted post 4. The elbow formed by the first buckle of the W-beam rail element contacted the left door of the vehicle. The vehicle lost contact with the installation traveling at a speed of 84.8 km/h (52.7 mi/h) and at an exit angle of 9.9 degrees behind the installation. Maximum extension of the elbow of the second buckle was 3.3 m (10.8 ft) toward the traffic side of the guardrail.

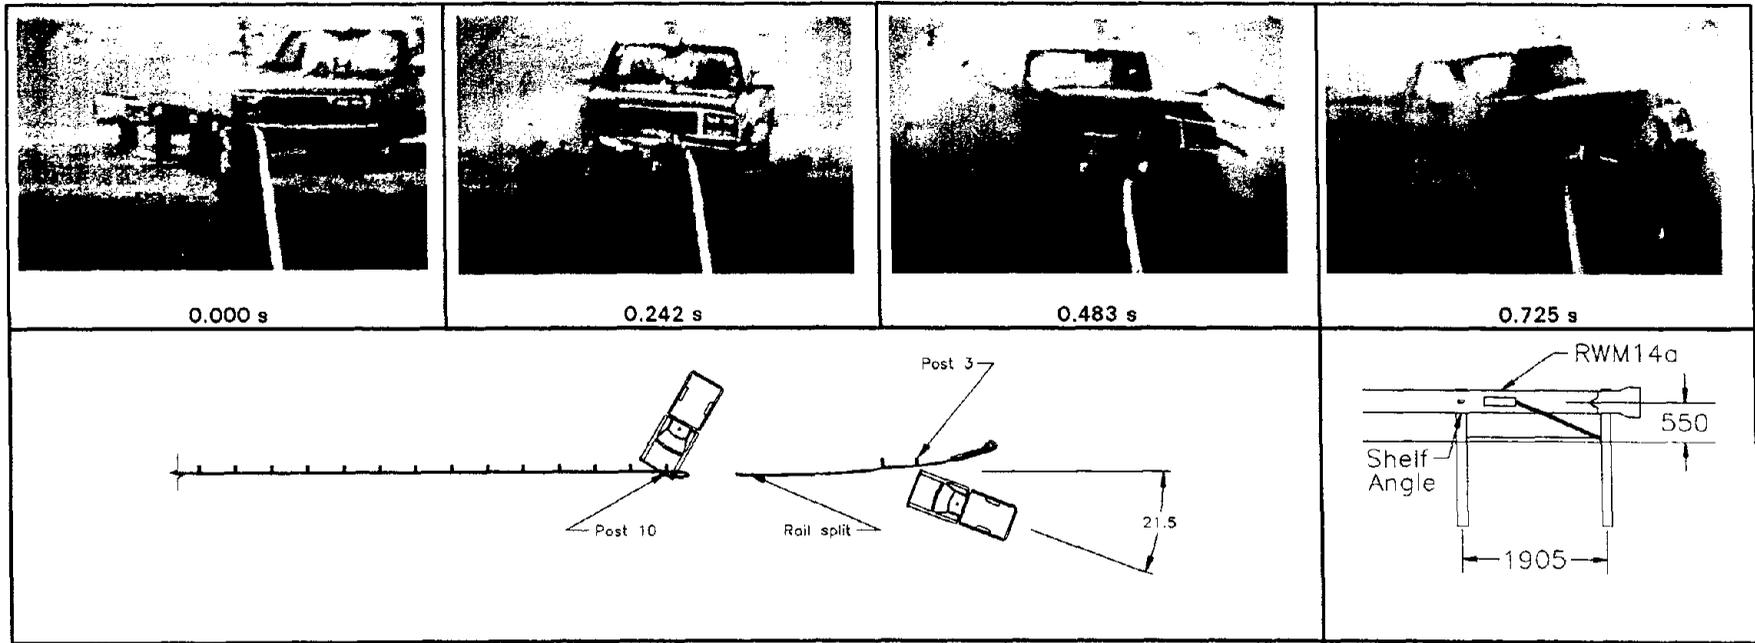
The vehicle impacted the terminal 152 mm (6.0 in) upstream of post 3. Upon impact, post 3 began to move laterally and the W-beam rail element began to flex and move away from post 6. The right front tire made contact with post 4 and the W-beam rail element was moving away from post 7. As the vehicle continued forward, the W-beam rail element began moving back toward posts 6 and 7. The vehicle contacted post 5, fracturing the post. Post 6 fractured and the front of the vehicle made contact with post 6. The right front tire contacted post 6, and then post 7, causing the post to fracture just below ground level. The lower edge of the W-beam rail element began to tear at post 7, and the front of the vehicle made contact with post 8 at an angle of 2.2 degrees. The W-beam rail element then ruptured completely. The vehicle made contact with post 9 and was traveling parallel with the length-of-need section at a speed of 53.6 km/h (33.3 mi/h). The vehicle made contact with post 10, rotated counterclockwise, and came to rest with the right front wheel near post 10. A summary of pertinent data from the electronic instrumentation, high-speed film, and field measurements is given in figure 102.

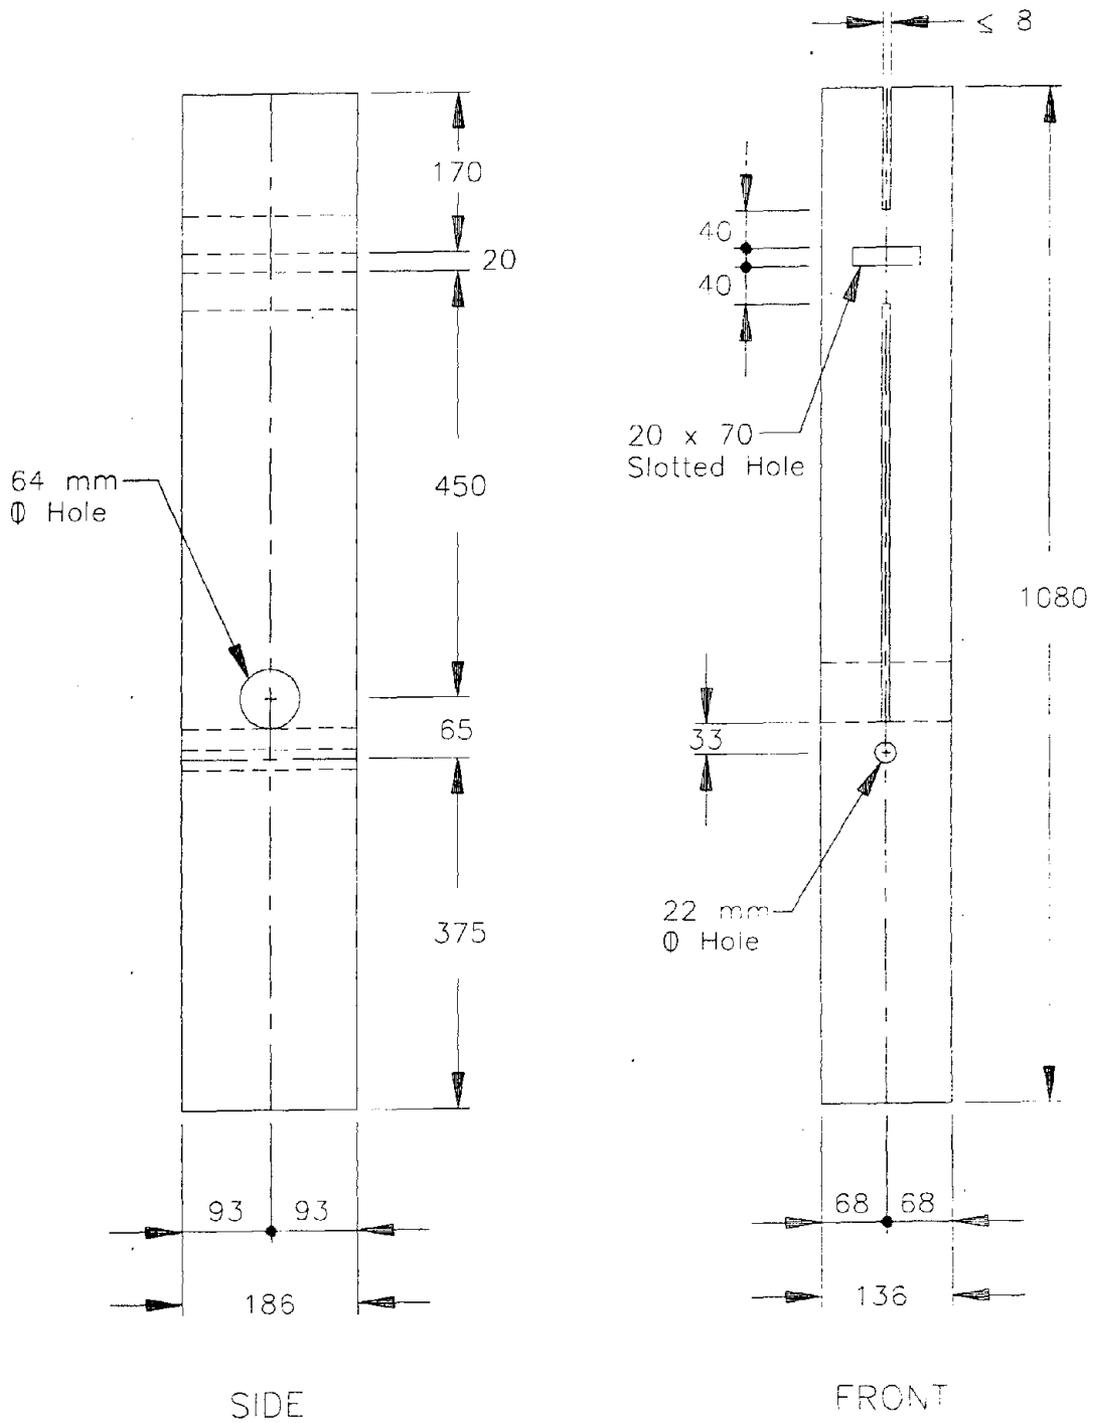
Figure 103. Schematic of modified breakaway wooden MELT post.

An effort was then undertaken by FHWA to modify the breakaway wooden MELT end post so that the post would break away more readily. Figure 103 shows a schematic of the modified breakaway wooden MELT post. Longitudinal slots are cut along the centerline of the weak axis of the post both above and below the post bolt slot. Laboratory tests were first conducted to determine the appropriate dimensions for these slots. Upon selection of the optimal dimensions for the longitudinal slots, a series of pendulum tests were then conducted to assess the anchorage capacity and the breakaway characteristics of the modified MELT end post and a line post modified in a similar manner.
