TRANSPORTATION POOLED FUND PROGRAM QUARTERLY PROGRESS REPORT

Transportation Pooled Fund Program Project # TPF-5(189)	Transportation Pooled Fund Program - Report Period: <input type="checkbox"/> Quarter 1 (January 1 – March 31) <input type="checkbox"/> Quarter 2 (April 1 – June 30) <input type="checkbox"/> Quarter 3 (July 1 – September 30) <input checked="" type="checkbox"/> Quarter 4 (October 4 – December 31)	
Project Title: "Enhancement of Welded Steel Bridge Girders Susceptible to Distortion-Induced Fatigue"		
Project Manager: John Jones, KDOT	Phone: 785-368-7175	E-mail: jjones@ksdot.org
Project Investigator: Caroline Bennett Adolfo Matamoros Stan Rolfe Ron Barrett-Gonzalez	Phone: 785-864-3235 785-864-3761 785-864-3767 785-864-2226	E-mail: crb@ku.edu abm@ku.edu srolfe@ku.edu barretr@ku.edu
Lead Agency Project ID:	Other Project ID (i.e., contract #): KAN00063732	Project Start Date: 08/31/2008
Original Project End Date: 08/31/2011	Current Project End Date: 08/31/2013	Number of Extensions: 1

A large number of steel bridges within the national inventory are affected by distortion-induced fatigue cracks. Repairs for this type of failure can be very costly, both in terms of direct co

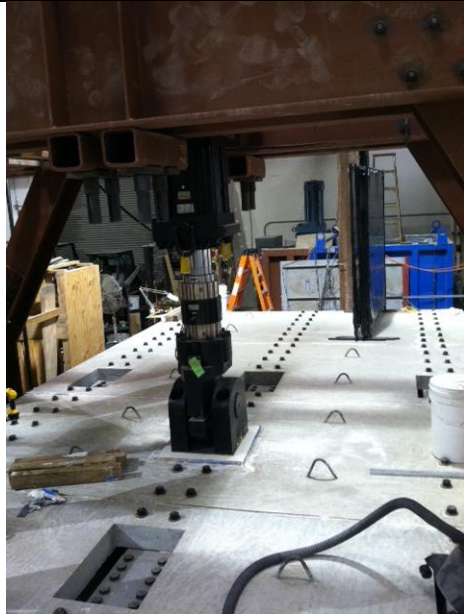
Fig. 1 View of top of bridge with actuator resting on load distribution plate

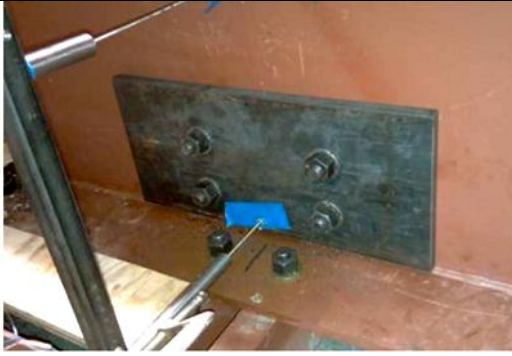
Fig. 3 View of backing plate on fascia side of girder web on Specimen 3

The current test, Specimen 3, has exhibited cracks in two locations: a horizontal crack at the weld toe between the bottom flange and web and a horseshoe-shaped crack at the intersection between the stiffener plate and the web. The first crack was observed at 73,000 cycles in the stiffener weld at a length of 3/8 in. A horizontal crack 1/16-in. long was first observed at 250,000 cycles. The horizontal crack was allowed to grow to approximately 2 in. (281,000 cycles), at which point the horseshoe crack had grown to 1-3/4 in. and 2 in. on either side of the stiffener. Each horseshoe-shaped crack also exhibited spider cracks 1/2-in. long. The retrofit shown in Figs. 3 and 4 was implemented when cracking in Specimen 3 had reached these levels.

Two angles were attached to either side of the stiffener plate and a plate was connected to the back side of the stiffener. The plate was periodically removed and the cracks were inspected. After 1.2 million additional cycles with the retrofit, the horizontal crack had grown by an additional 1/4 in. and there was no growth in the horseshoe-shaped crack.

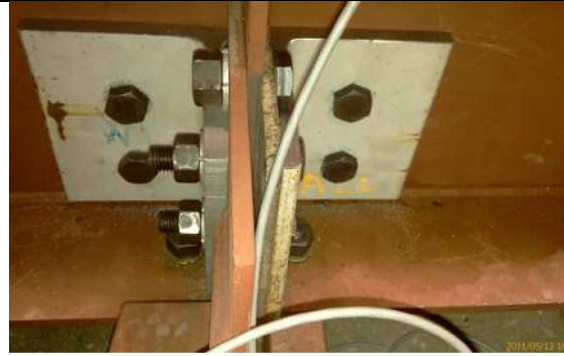
Fig. 4 View of angles bolted to the connection stiffener and girder web on the interior of Specimen 3
