Project Description:

The main objective of this proposed research is to *provide state DOTs a practical and cost-effective long-term fatigue crack monitoring methodology using a **wireless elastomeric skin sensor network***. This research is intended to demonstrate the value-added of fatigue crack monitoring of steel bridges using wireless skin sensors over the traditional bridge inspection.

In order to validate the integrated wireless fatigue crack monitoring system, in this quarter, a field deployment is conducted for the I-70 steel highway bridge which is subject to fatigue damage. Several wireless elastomeric skin sensors were deployed over fatigue-susceptible regions at the midspan in a steel girder. Particularly, two sizes of SECs including large SEC with 3 in. by 3 in. (76.2 mm by 76.2 mm) and small SEC with 1.5 in. by 1.5 in. (38.1 mm by 38.1 mm) were selected for installation. The newly-developed wireless capacitive sensing boards were also deployed for measuring the capacitances of the SECs under traffic loads. The system ran autonomously and collected a large number of data sets triggered by the passing vehicles. Data collected in this field deployment indicates the SE

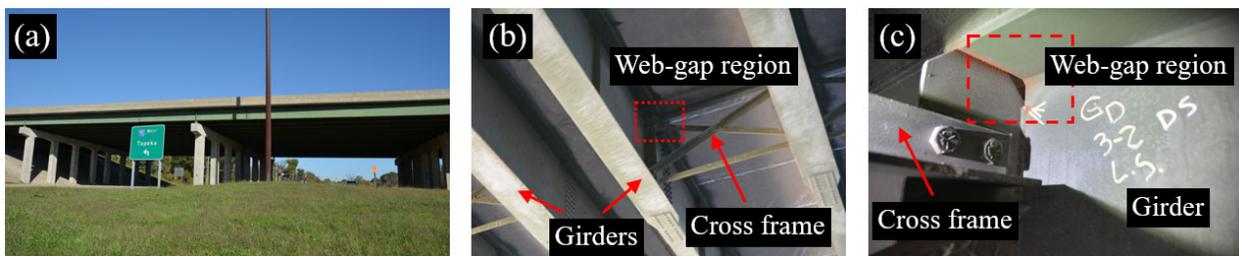
Fig. 1 shows a typical web-gap region with existing fatigue cracks. Driven by the out-of-plane movement of the cross frame, a fatigue crack initiated at the top end of the weld between the connection plate and girder web. Depending on the structural layout, the fatigue crack could either grow along the weld toe or propagate into the girder web.

Figure 1. (a) The test bed bridge in the field; (b) Typical cross frame and longitudinal girders; and (c) Web-gap region between the cross frame and the girder.

The test steel bridge was a part of the I-70 highway near Kansas City, Kansas, at the intersection of the N. 57th Street, as illustrated in Fig. 1a. According to the inspection reports provided by the Kansas Department of Transportation (KDOT), the bridge was named 70-105-41731-127 (westbound) and 70-105-41732-128 (eastbound) and was originally designed in 1984 with some repairs in 2004. The bridge has 8 spans with an overall length of 680 ft. Based on the recent two inspections performed in 2013 and 2017, respectively, multiple locations on the bridge was subject to fatigue damage, typically at web-gap regions in the cross-frame-to-girder connections, as shown in Figure b.

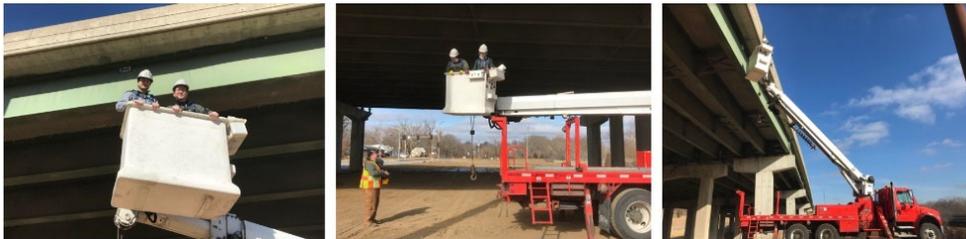
To facilitate the field deployment, a man-lift truck was adopted. The man-lift platform can easily access the fatigue-susceptible regions in the steel girders. A power generator was also used for offering electric power during the deployment. Fig. 2 shows some photos taken during the field visits.

Figure 2. Field deployment of the monitoring system on a steel bridge.

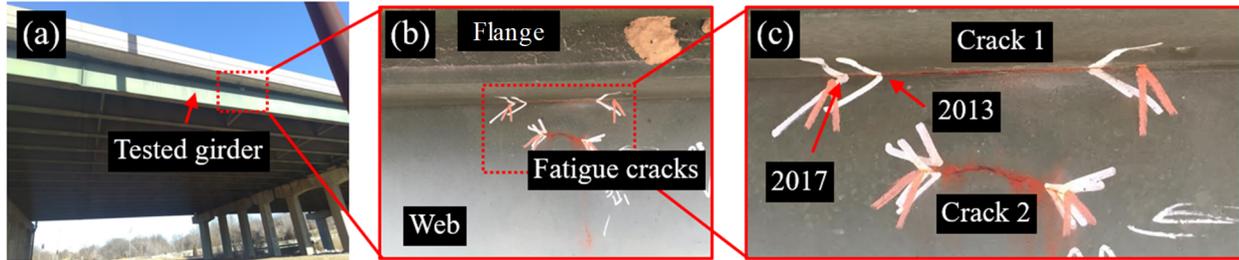
An exterior girder was selected for the SEC installation, as shown in Figure 3a. Two fatigue-susceptible regions were selected for the SECs. The first region is on the web gap region on the exterior side of the girder (Fig. 3b). This region was inspected in both 2013 and 2017. Based on the inspection reports and the marks on the structural surface, two fatigue cracks can be found in this region including: 1) a horizontal crack initiated between the flange and the web (Crack 1); and 2) a horizontal crack in the web (Crack 2). As can be seen in Fig. 3Figure c, both cracks propagated during the period between the past two inspections.

Figure 3. Detail views about the exterior side of the girder prior to the sensor installation. (a) the steel girder for sensor deployment; (b) two fatigue cracks at the exterior side of the girder; and (c) different arrows indicate crack growths at different inspection periods.

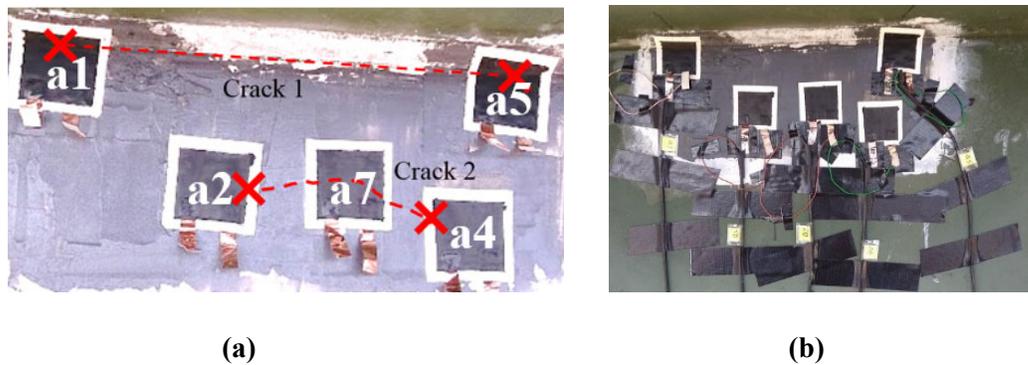
Fig. 4 demonstrates the arrangement of the SECs where 5 small SECs with a size of 1.5 in. by 1.5 in. (38.1 mm by 38.1 mm) were deployed in this region. In particular, two SECs (a1 and a5) were installed to cover Crack 1 and three SECs (a2, a7, and a4) were attached to Crack 2. Additional short cables were attached to the SECs in order to connect them to the wireless capacitive board for data collection, as shown in Fig. 4b.

Figure 4. (a) Arrangement of the SEC arrays; and (b) the SEC arrays after soldering the cables.

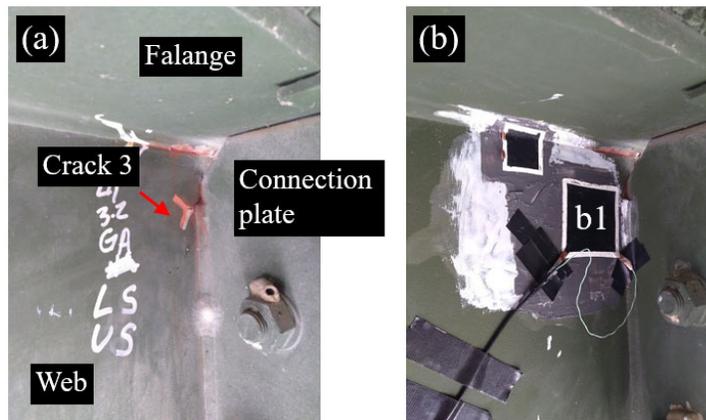
Fig. 5a illustrates the SEC installation on same web-gap region in the interior side of the girder. A fatigue crack (Crack 3) was observed between the connection plate between the cross frame and the girder web. One large SEC was installed in this region, denoted as SEC b1 as shown in Fig. 5b.

Figure 5. SEC installation on the interior side of the girder. (a) The chosen fatigue-susceptible region prior to the installation; and (b) SEC installation.

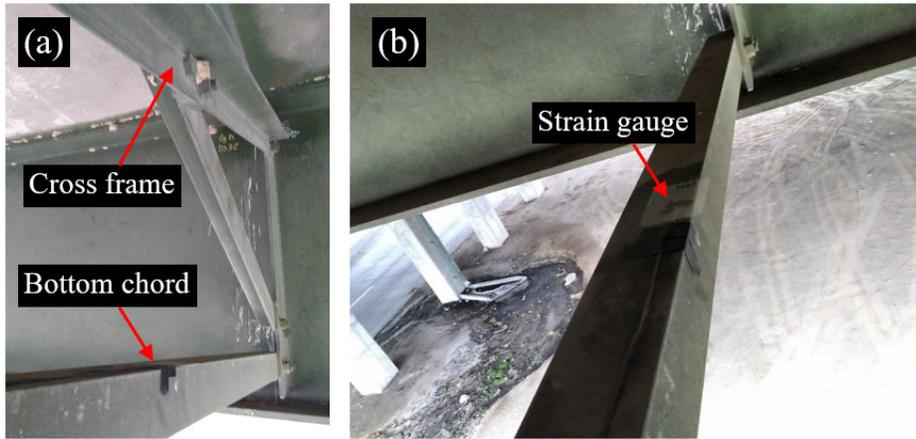
To normalize the capacitance measurement of the SEC, the loading information due to the passing vehicles are needed. In this field deployment, we adopted strain measurements from the cross frame to indirectly infer the traffic load. Fig. 6 shows the strain gauge installation for which the cross frame near the web-gap region was selected for the strain gauge deployment. The strain gauge was installed at the bottom chord of the cross frame, as shown in Fig. 6b.

Figure 6. SEC installation on the interior side of the girder. (a) fatigue-susceptible region prior to the installation; and (b) SEC installation.

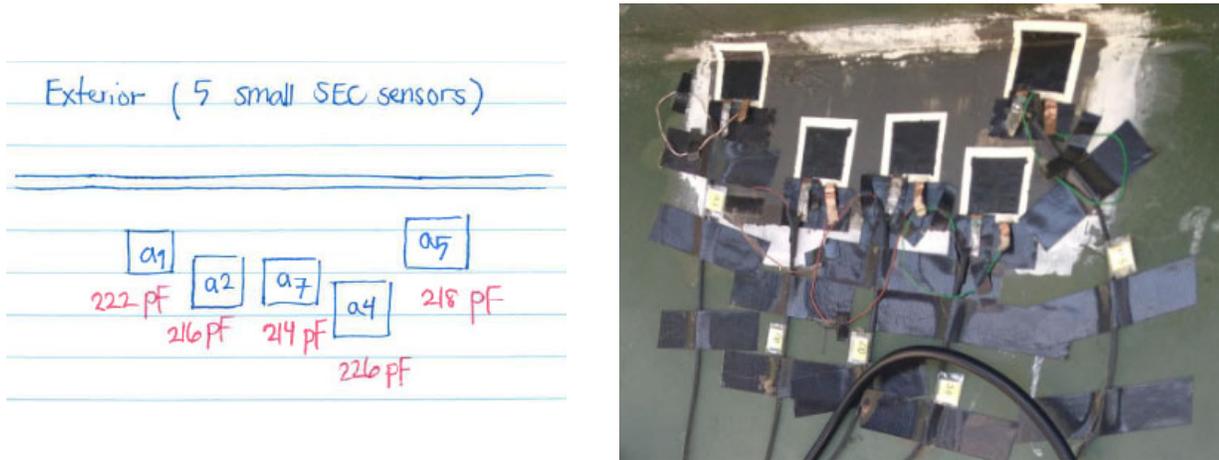
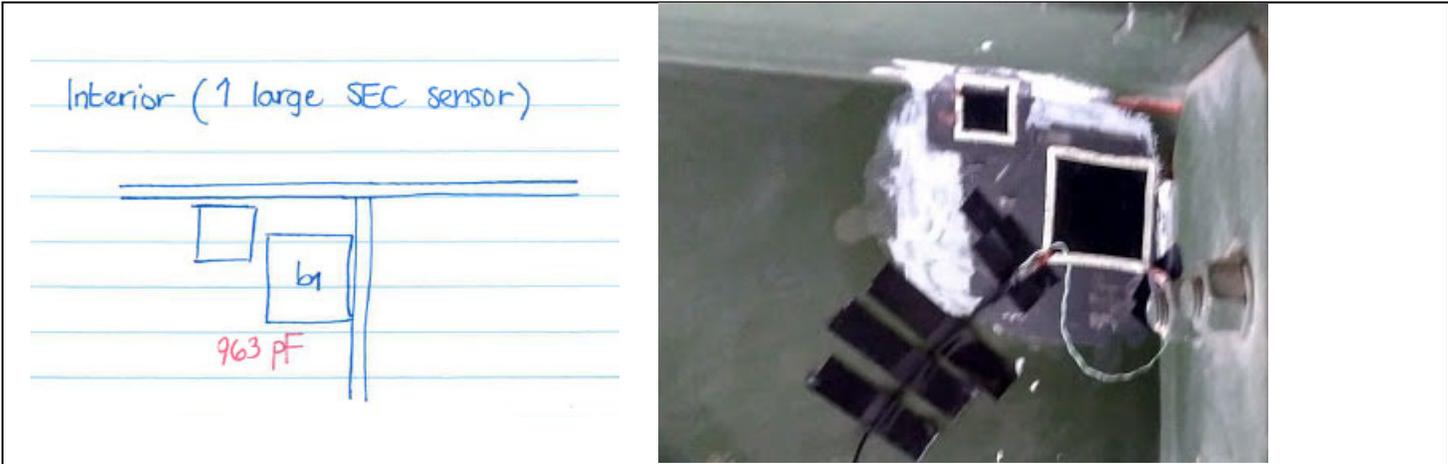
Figure 7. Schematic of sensor layout on the bridge

The manufactured sensor boards were shipped from Arizona team to KU. The sensor boards were all tested for quality assurance at KU as well. During a field visit, we measured the nominal capacitances of all SECs installed on the bridge mid-span. We used the measured nominal capacitances to pre-balance all the sensor boards and calculate their Shunt calibration coefficients. Thus, in our final deployment, we would just need to connect the SECs to the sensor boards. Fig. 7 presents the schematic of sensor deployment on the bridge for the exterior and interior sides of the girder together with their nominal capacitances. Table 1 shows the assigned pre-balanced sensor board to each SEC sensor and their corresponding Shunt calibration coefficients calculated in the lab.

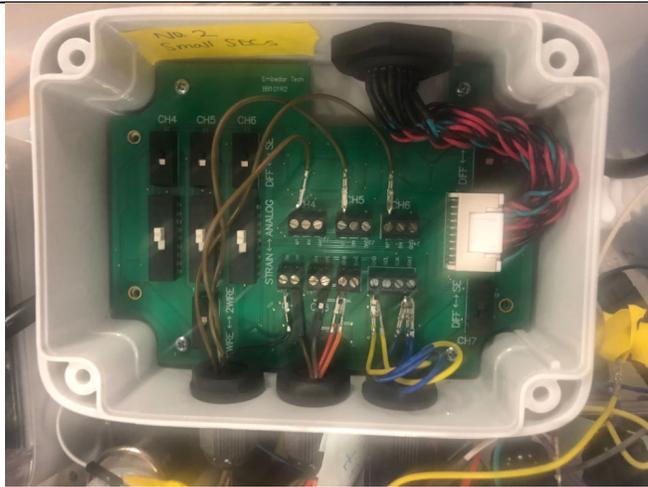
The final task for field deployment was to incorporate the breakout box which is an interface to connect the Xnode's sensing channels to the sensor boards for wireless data collection. Fig. 8 shows the interface board inside the breakout box. This board works as an interface between Xnode and sensor boards to allow integration of the sensor boards to the external channels of Xnode. The breakout box itself has a calibration coefficient for voltage measurements. To calculate the coefficient, we first took measurements from one SEC sensor using the Xnode through the breakout box and the NI-DAQ, respectively. We then matched these two measurements to compute the coefficient. An example of measurements from both Xnode and NIDAQ are shown in Fig. 9 before and after applying the calibration coefficient. For this particular breakout box, the coefficient is equal to 7.66. It can be seen that after applying the coefficient, the measured signal from Xnode and the breakout box matches pretty well with the measurement from NIDAQ. Note that the plotted signal after the calibration coefficient is a zoom-in version of the original signal.

Figure 8. The breakout box

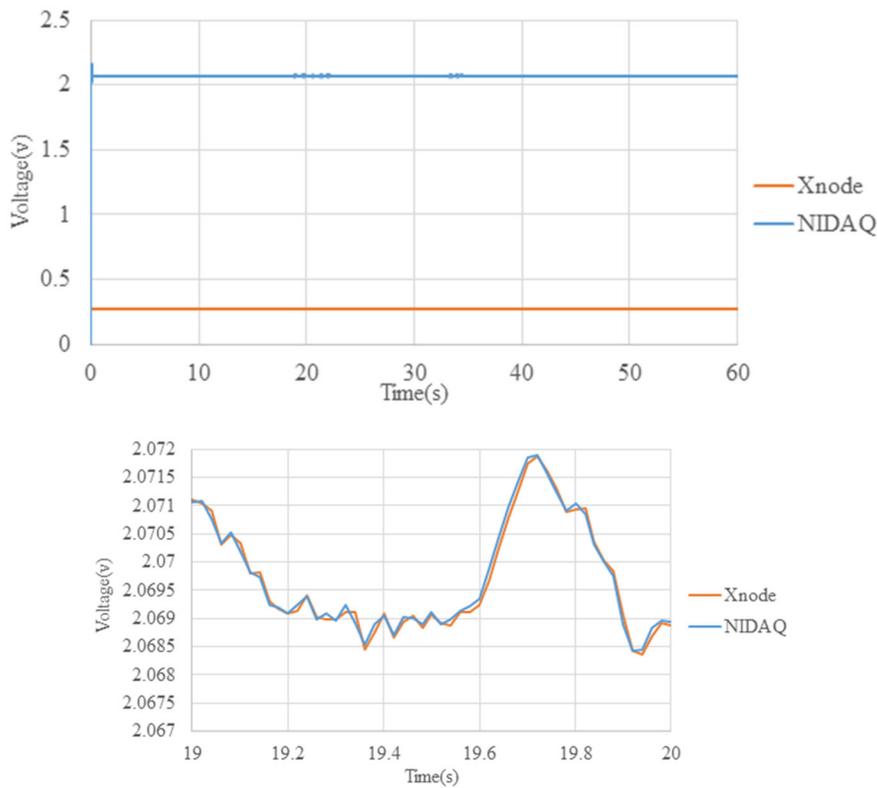
Figure 9. An example of calculation of the breakout box calibration coefficient

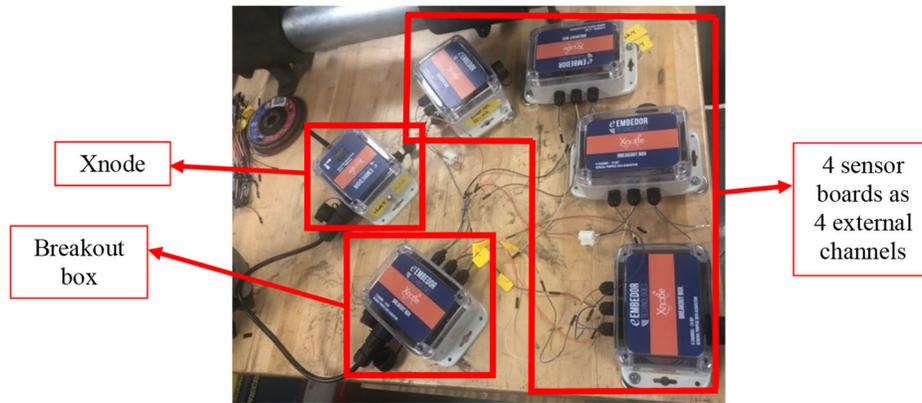
Fig. 10 shows how we used the breakout box to make all the connections required between the Xnode and the sensor boards. The breakout box is connected to the Xnode through a cable, and the sensor boards are connected to the breakout box through a series of jumper wires. In the field, we would just need to connect the SEC sensors to the sensor boards. The details of the connections between the sensor boards, breakout boxes, and Xnode channels for the final deployment are described in Table 1.

Figure 10. Connection of sensor boards to Xnode through the breakout box

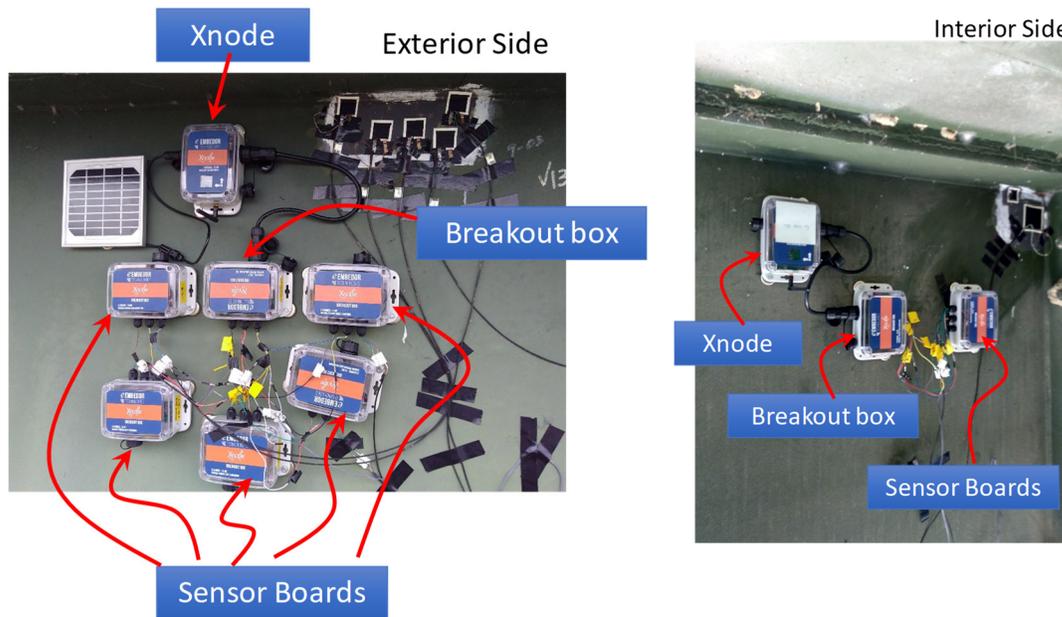
Fig. 11 shows a picture of the final sensor deployment on the bridge. For this deployment, on the facial side of the girder, measurements are taken from 4 small SEC sensors and one strain gauge. On the interior side, one large SEC sensor is connected to an Xnode for measurements.

Figure 11. Sensor layout of the field deployment on 07/16/2018

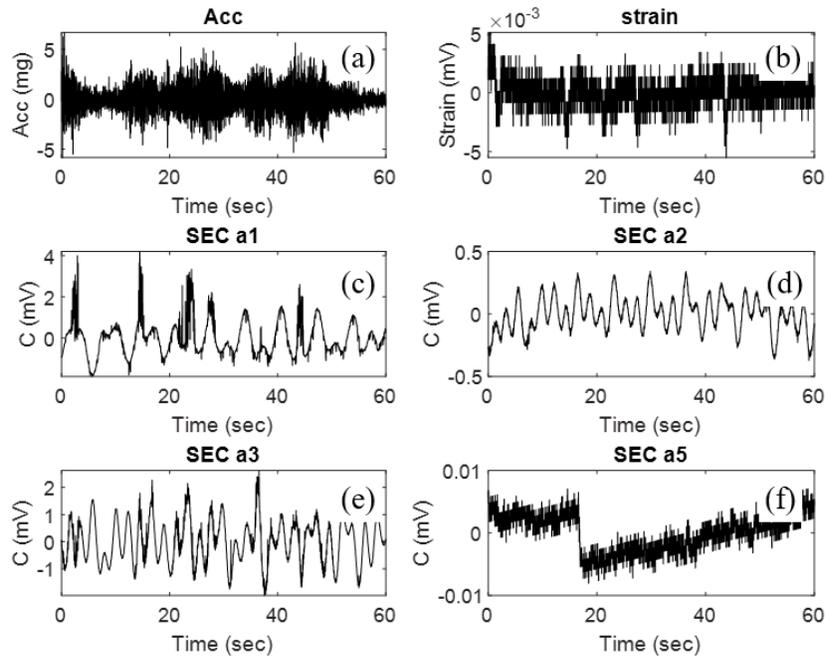
Fig. 12 shows a typical dataset from the exterior side of the girder where more measurements can be found in Appendix D.1. The acceleration measurement is demonstrated in Fig. 12a, where several peaks can be found within the one minute measurement. Similarly, the strain measurement also shows peaks at approximately the same locations. These

results indicate that both the accelerometer and strain gauge can identify the responses caused by the passing vehicles. Notice that strain measurement has low resolution compared with acceleration measurement. This is probably due to quantization error in the strain sensing board.

Fig. 12b to Fig. 12f show the capacitance measurements of the SECs. As can be seen in the figures, SEC a5 produces a very small response compared with other three SECs. On the other hand, SEC a1, a2, and a3 have larger responses but the signals contain two major components including; 1) high-frequency components at the approximate locations when acceleration and strain measurements have large responses due to the traffic loads; 2) low-frequency components throughout the time-series. The first component could be provoked by the traffic load; while the second component is probably caused by the magnetic interference in the field which is not relevant to the traffic loading.

Figure 12. Typical measurements from the exterior side of the girder. (a) acceleration; (b) strain; (c) SEC a1; (d) SEC a2; (e) SEC a3; and (f) SEC a5.

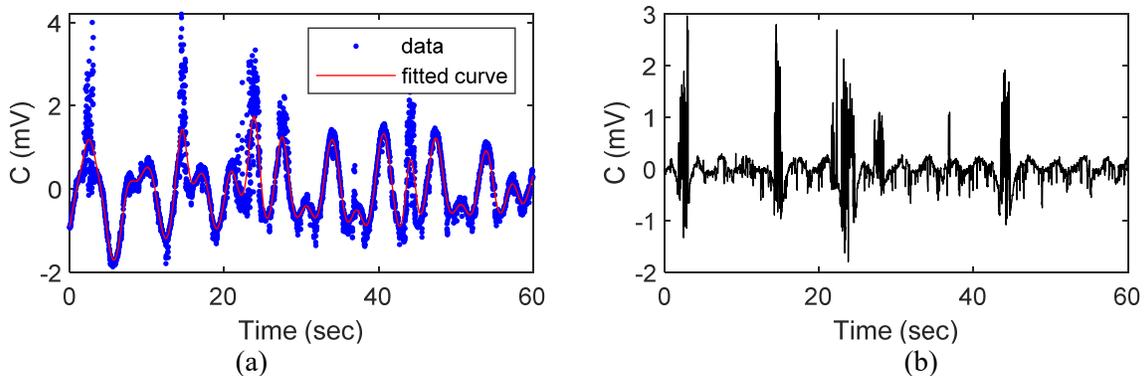
To further remove the low-frequency content while keeping the high frequency responses, a curve fitting technique is applied to fit the low-frequency component. The fitted curve is shown as a red line and the original data of SEC a1 is illustrated as blue dots in Fig. 13a. Next, by subtracting the original data with the fitted curve, the high frequency signal of SEC a1 can be extracted, as shown in Fig. 13b.

Figure 13. (a) curve fitting of SEC a1; and (b) SEC a1's response after removing the low-frequency content

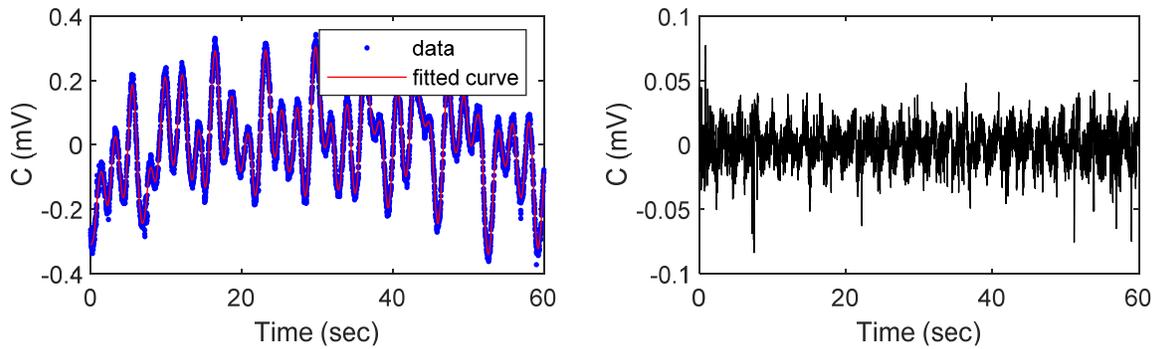
Figure 14. (a) curve fitting of SEC a2; and (b) SEC a2's response after removing the low-frequency content

Using this strategy, the capacitance measurement of SEC a2 can be processed and the result can be found in Fig. 14. Fig. 15 shows the results of SEC a3. The high frequency peaks can be reserved after removing the low-frequency content, as shown in Fig. 15b.

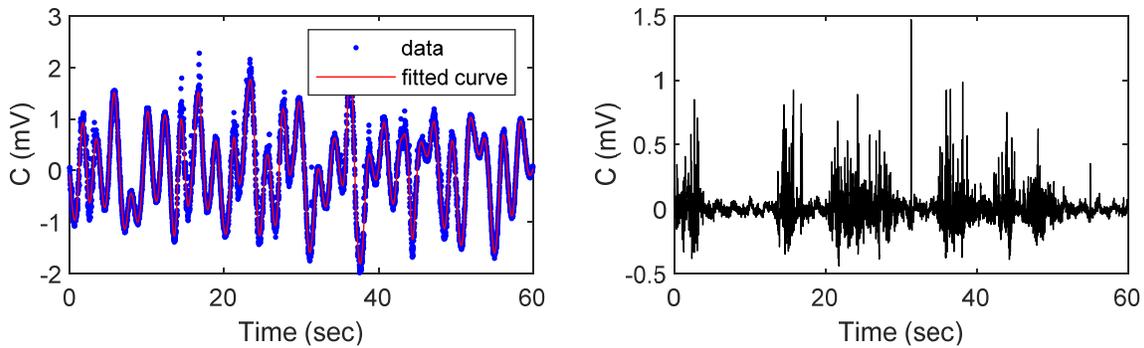
Figure 15. (a) curve fitting of SEC a3; and (b) SEC a3's response after removing the low-frequency content

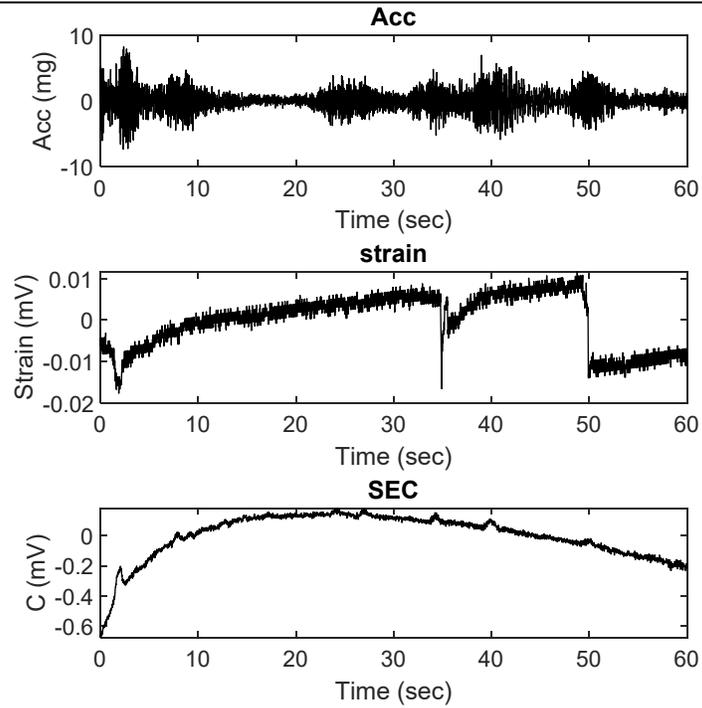
Fig. 16 shows the typical measurements of interior side of the girder. Several regions of high responses can be found in the acceleration measurement, as shown in Fig. 16a. Strain and SEC signals also demonstrate responses with relatively higher amplitudes. Low frequency drifts can be found in the SEC and strain measurements.

Figure 16. Typical measurements from the interior side of the girder. Top: acceleration; middle: strain; and bottom: SEC.

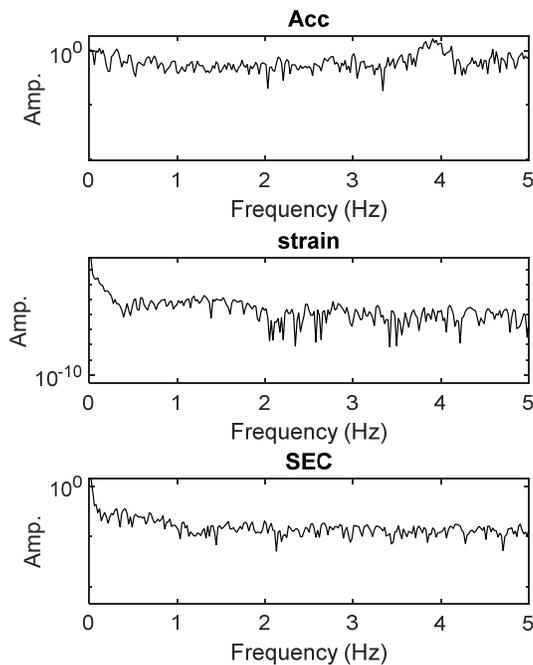
To compute the CGI, the power spectral densities (PSDs) of acceleration, strain, and SEC measurements are extracted first. As can be found in Fig. 17, a peak is located in the higher frequency range of the acceleration PSD curve, while peaks in the strain and SEC's PSDs are at low frequency ranges. Notice that these lower PSD peaks in strain and SEC are caused by the passing traffic loads and drifts in the time series signals.

Figure 17. Power spectral densities (PSDs) of acceleration, strain, and SEC measurements.

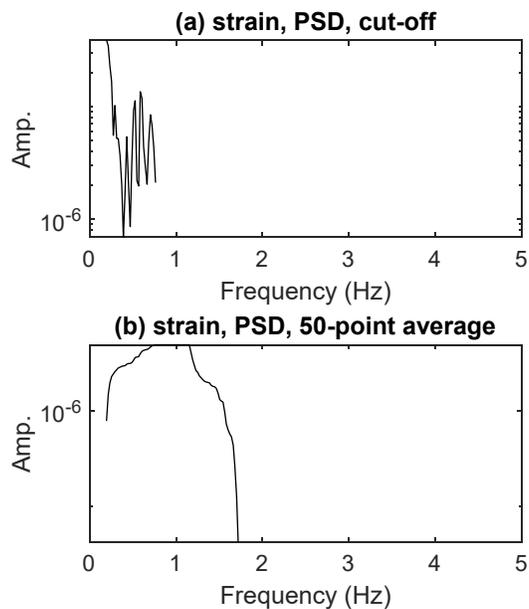
Figure 18. (a) PSD result of the strain measurement after cut-off; and (b) result after applying a low pass filter.

To remove the effect of drifts, a cut-off window is applied to the PSD results of the strain and SEC measurements, respectively. The range of the cut-off window is from 0.2 Hz to 0.8 Hz. These values would keep the meaningful results in the PSDs caused by traffic loads. Meanwhile, the extremely low-frequency content can be removed by selecting 0.2 Hz as the lower bound of the window. The PSD of strain measurement after the cut-off can be found in Fig. 18a. With a similar cut-off window, the PSD of SEC measurement after cut-off can be found in Fig. 19a.

Next, a moving-average low-pass filter is applied to the PSD results. This filter would smooth the PSD curves so that the magnitude of PSD can be more reliably estimated. Results after applying the moving average filter can be seen in Fig. 18b and Fig. 19b.

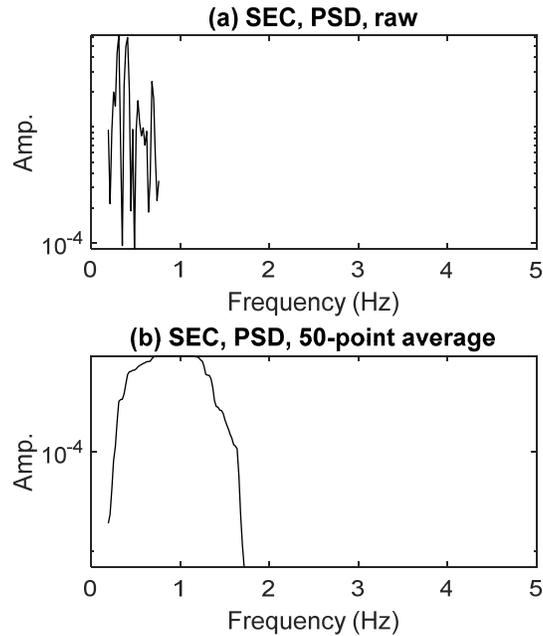
Figure 19. (a) PSD result of the SEC measurement after cut-off; and (b) result after applying a low pass filter.

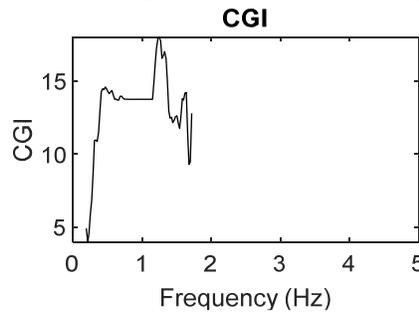
Once the filtered PSD curves of strain and SEC measurements are obtained, the CGI can be calculated. Fig. 20 shows the final CGI result of the large SEC. Notice that only the flat platform around 1 Hz is of interest, as this frequency range is caused by the passing traffic loads. In this regard, the CGI of the large SEC is about 14.

Figure 20. CGI of the large SEC.

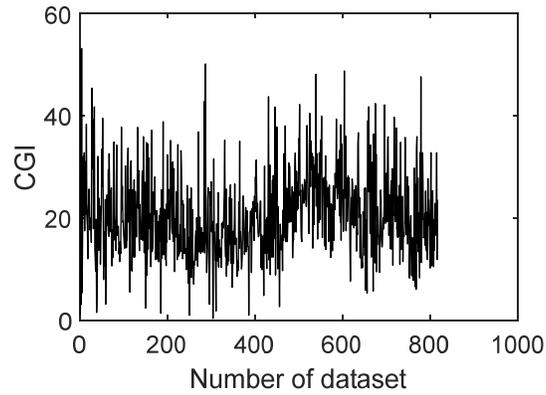
During the field visits on July 16th and 17th, 817 datasets of the large SEC on the interior side of the girder were autonomously collected by the wireless monitoring system. Utilizing the similar approach shown above, 817 datasets are processed such that CGIs of all datasets can be obtained. Fig. 21 shows the CGI results where most CGIs have the magnitudes around 20, while a few datasets produce smaller or larger CGI values. This variation could be attributed to the noise content and low frequency drifts in the strain and SEC measurements.

Figure 21. CGIs of 817 datasets of the large SEC.

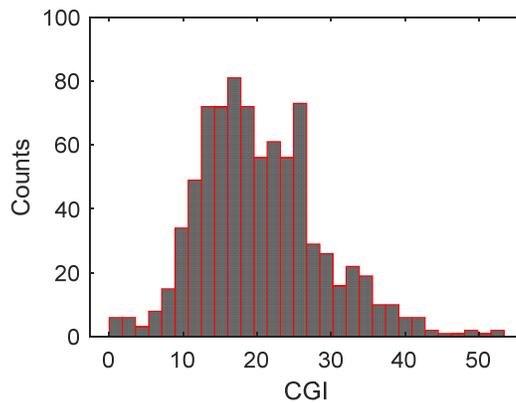
Fig. 22 shows the histogram of the CGIs shown in Fig. 21. As can be seen in the figure, the majority of CGIs are within 10 to 30. This indicates that the proposed CGI approach is able to extract meaningful features from the field measurements. By continuing to collect the data in the field over long-term, it would be feasible to establish multiple histogram of CGIs at different data collection periods. The fatigue crack growth would be monitored through the histogram of CGIs.

Figure 22. Histogram of CGI results in Figure 21.
